# Post-2017 Hurricane Season Assessment of Civil Infrastructure Impacts on Beach and Near-Beach Environments

**ABSTRACT:** *This paper presents an overview of observations and preliminary measurements of coastal infrastructure in the aftermath of Hurricanes Harvey and Irma in 2017. Two teams mobilized by the Geotechnical Extreme Events Reconnaissance (GEER) Association were sent to document perishable data along the Texas coastline (Port Aransas, Holiday Beach, East Matagorda Peninsula, and Follets Island) and Florida Keys (Simonton Beach, Sombrero Beach, and Coco Plum Beach). Significant damage from sediment overwash and road undercutting was observed at beach access paths and roads that transect dune fields. It was also observed that beach access points weaken the line of coastal defense provided by dunes, vegetation, and structures. The lessons learned from these field reconnaissance missions indicate that longshore non-uniformity in the dune system should be well-documented. Measurements of the geometry of beach access pathways and dunes, including the height, width, length, and vegetation coverage, should be collected prior to recovery of the system post-storm.*

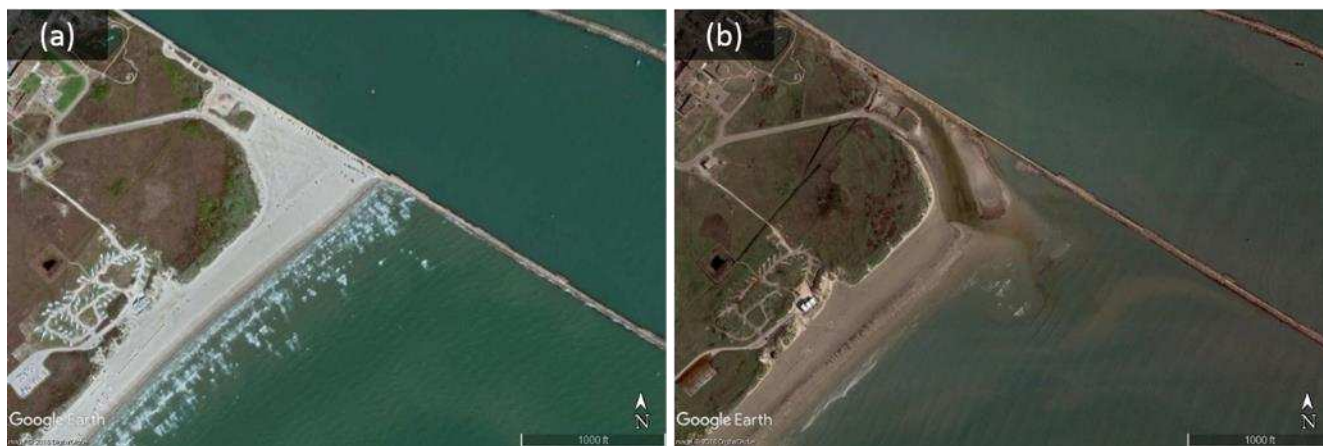
Southwest of the jetties that protect Port Aransas Pass, several paths transect the dune system to provide beach access to Port Aransas. The closest of these beach access points at the end of East Cotter Avenue experienced severe undercutting and paralleled a newly-formed eroded runnel that extended from the road, around a large dune, to the beach (Figure 3). This breach was observed to start at a small culvert under East Cotter Avenue, extend northwest toward the jetty, follow the jetty for approximately 120 m (394 ft), then turn southwest toward the GoM. At the beginning of the breach, a maximum undercut depth of 0.4 m (1.2 ft) was measured on the west side of East Cotter Avenue (Figure 4). The toe of the large dunes between the jetty and East Cotter Avenue and at the end of the beach access road were severely eroded (Figure 5). A scarp measuring approximately 0.9 m (3 ft) was observed and a thick wrack line of debris was deposited at the toe of the scarped dune. This location, along with several other beach access points in Port Aransas, provides evidence that these transects through the dune system provide a pathway for flow channelization, resulting in increased erosion.

Figure 3. (a) Pre-storm satellite imagery (imagery date February 22, 2017) and (b) post-storm satellite imagery (imagery date August 29, 2017) show the eroded runnel created during Hurricane Harvey near Port Aransas Pass (location  $27^{\circ}50'6.39''N$ ,  $97^{\circ}2'50.56''W$ ). Map data: Google Earth, Digital Globe.

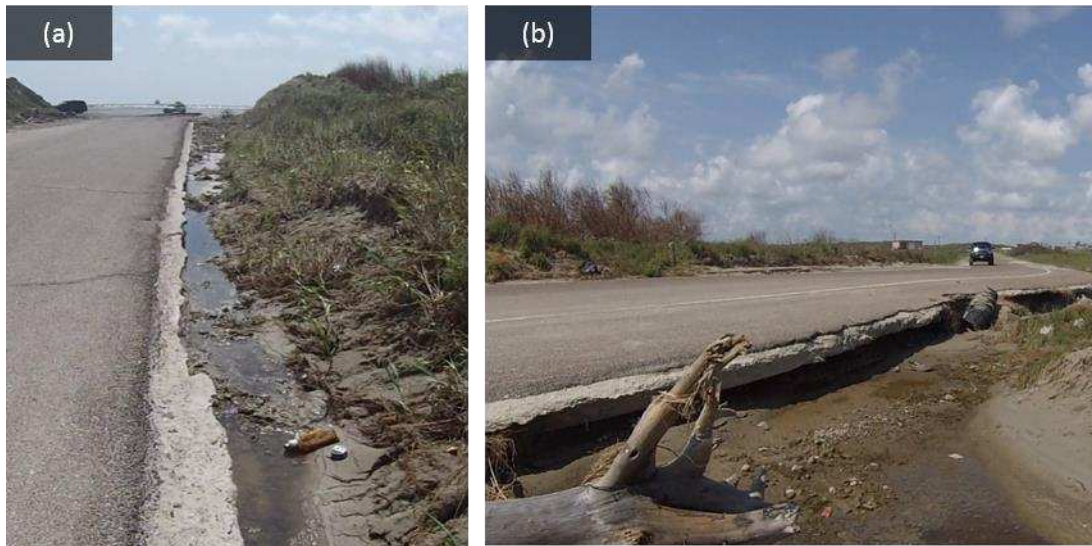
Figure 4. (a) Road undermining due to erosion and scour was observed on both sides of East Cotter Avenue, and (b) a 0.4 m undercut was measured at the beginning of a newly formed breach (collected September 3, 2017; location  $27^{\circ}50'8.53''N$ ,  $97^{\circ}2'55.00''W$ ).

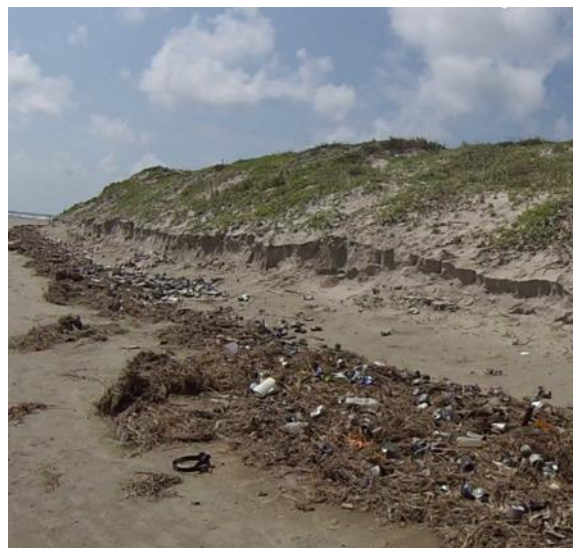
Figure 5. The dune near East Cotter Avenue was eroded and a thick wrack line of debris was deposited at the toe of the scarped dune (collected September 3, 2017; location  $27^{\circ}50'6.60''N$ ,  $97^{\circ}2'51.64''W$ ).

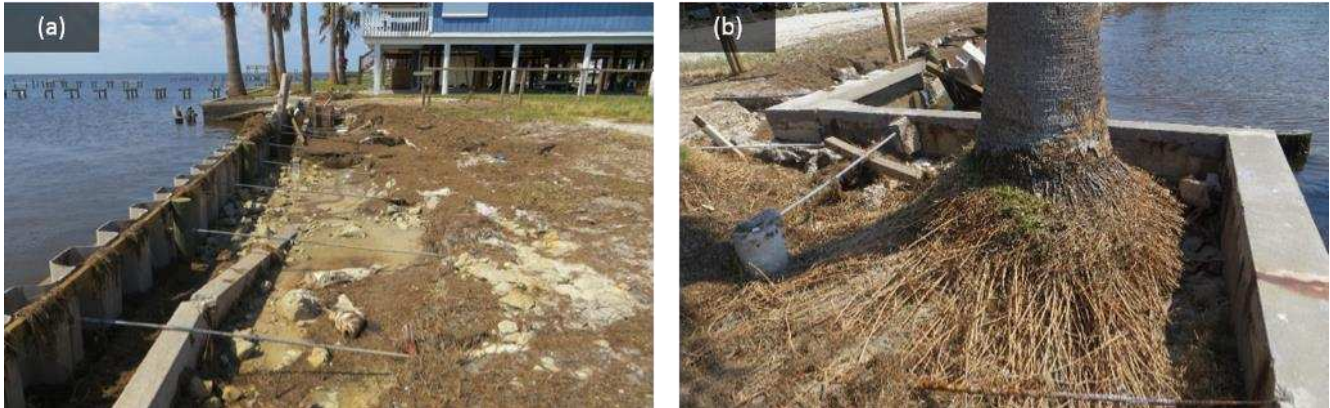
During the reconnaissance survey, houses in Holiday Beach were found heavily damaged by wind and bay surge, particularly those located on the bayfront street that parallels the canals. Anchored bulkhead retaining walls constructed along the bayfront property line were overtopped during Hurricane Harvey and severely eroded on their backsides, exposing supporting steel rods (Figure 6a). Scouring around trees and other fixed obstacles was also observed (Figure 6b). Although Holiday Beach is located on Copano Bay and is not subject to GoM wave action, the damage due to hydrodynamic forces in this region was extensive. Observations show the bulkhead was overtopped during Hurricane Harvey, leaving fish and other debris on land. As the water levels retreated, sediment appeared to be transported from the backside of the bulkhead and around the base of fixed objects, leaving these structures damaged and in need of repair. The condition of the bulkheads and service life

Figure 6. (a) Supporting steel rods were exposed after storm surge retreat scoured the backside of a bulkhead, and (b) scour was also observed around other fixed objects (collected September 3, 2017; location 28°10'11.24"N, 97°1'2.03"W).

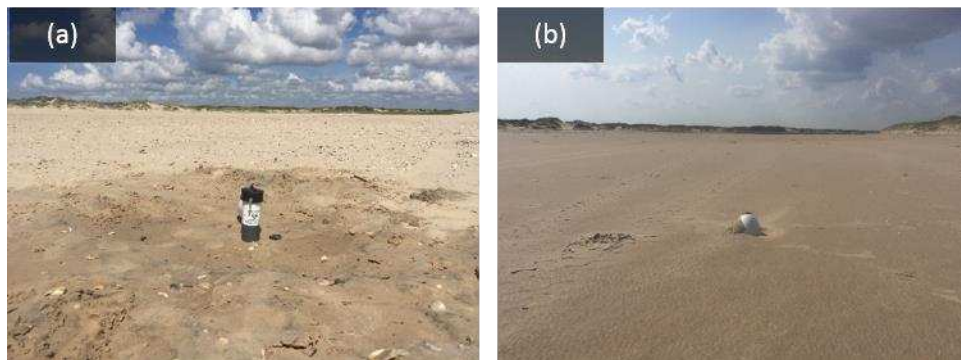
The infilled storm cut through East Matagorda Peninsula hydraulically connects GoM and bay surface waters only during elevated storm water levels. During Hurricane Harvey, the maximum water surface elevation at the backshore (GoM side of the cut) was 1.8 m above Mean Sea Level (MSL) and 1.0 m above MSL at the back-barrier location (bay side of the cut) as measured by rapid response field measurement units containing pressure transducers. The dunes at this site were not overtopped. Surface hydraulic connection through the cut lasted for approximately six hours. During this time, up to 0.50 m (1.6 ft) of GoM sediment was deposited in the backshore (back-barrier) region of the cut as a result of onshore-directed transport of sediment eroded from the shoreface by hurricane wave action. Figure 7 shows before and after photos of the backshore area on the GoM side of the cut, clearly indicating the accretion that occurred at this location. The cut serves as a roadway to access the back-barrier areas and is an example of what can happen to shore-perpendicular gaps in the dune line during hurricane impact.

Figure 7. (a) Pre-storm (collected August 23, 2017) and (b) post-storm observations (collected August 30, 2017) of the backshore area fronting the East Matagorda cut where 0.5 m of sediment accretion was observed (location 28°36'43.57"N, 95°56'24.88"W).

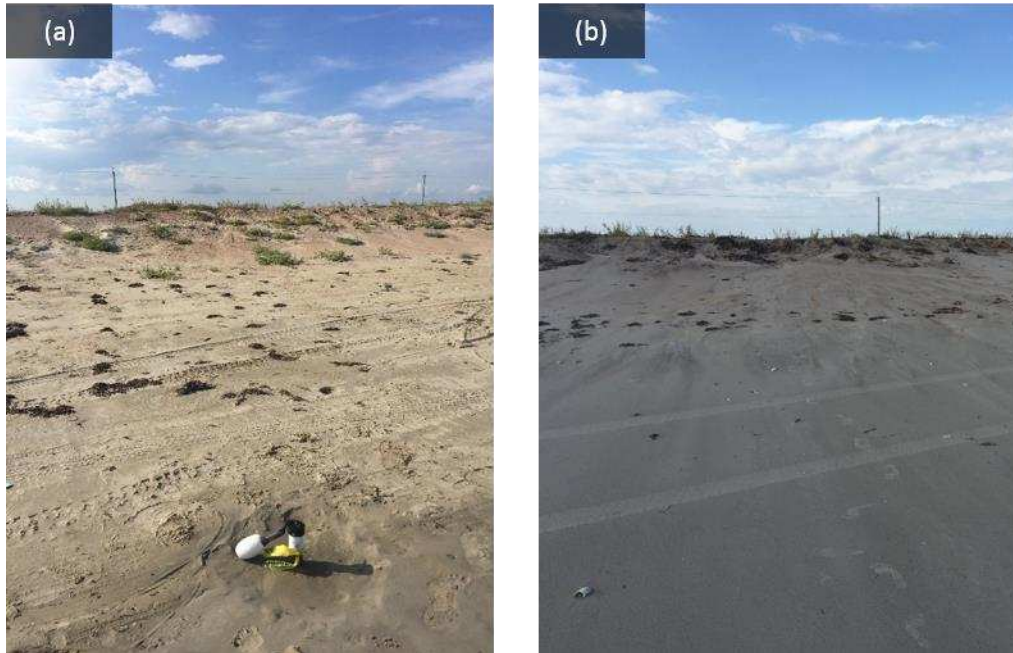
Figure 8. (a) Pre-storm (collected August 24, 2017) and (b) post-storm observations (collected August 31, 2017) of the dune show regrading of the beach profile and washout from heavy rainfall on the dune peak (location  $29^{\circ}1'27.93''N$ ,  $95^{\circ}11'24.93''W$ ).

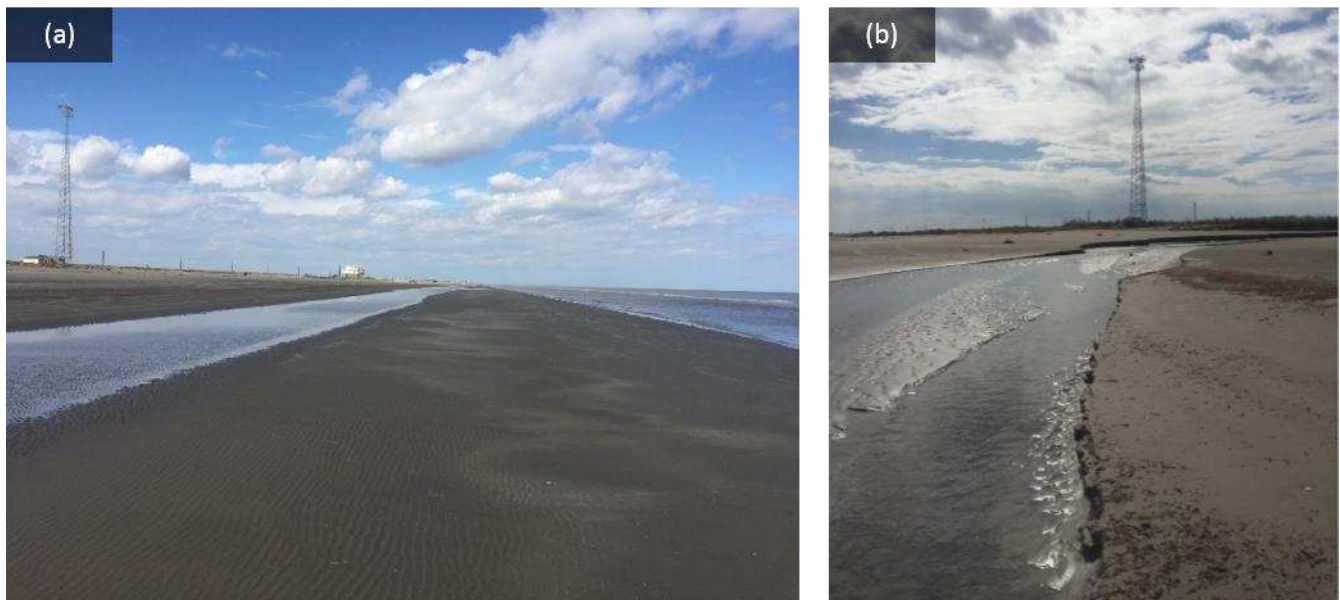
The recently nourished, relatively longshore uniform beach on Follets Island experienced dune collision and re-grading of the beach profile by storm surge and waves, but was not overtopped or severely overwashed as observed in other study locations discussed herein (Figure 8). Significant erosion of the dune line was observed due to heavy rainfall. A shore-parallel ridge-runnel system was observed in the foreshore (Figure 9a). At the beach access point from Bluewater Highway, sediment

deposits were observed on the road (257R) and a channel was formed connecting the flooded backbarrier region to the beach along the eastern and western flanks of the dunes (Figure 9b). This study location on Follets Island shows the protection afforded by dunes against storm flooding, but it also demonstrates damaging erosion along the sides of roadways. It also highlights that beach access points can serve as a funnel as rainwater and storm surge retreat, allowing the channelization of sediment transport.

Figure 9. (a) A ridge-runnel system formed parallel to the shore, and (b) a channel was eroded from the beach access point to the GoM (location  $29^{\circ}1'27.93''N$ ,  $95^{\circ}11'24.93''W$ ).

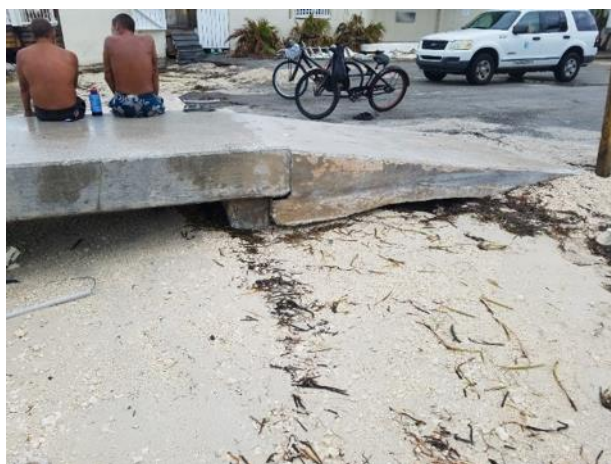
Figure 11. A concrete structure located on the eastern edge of Simonton Beach was undermined due to scour around the structure (collected September 27, 2017; location  $24^{\circ}33'43.32''N$ ,  $81^{\circ}48'20.22''W$ ).

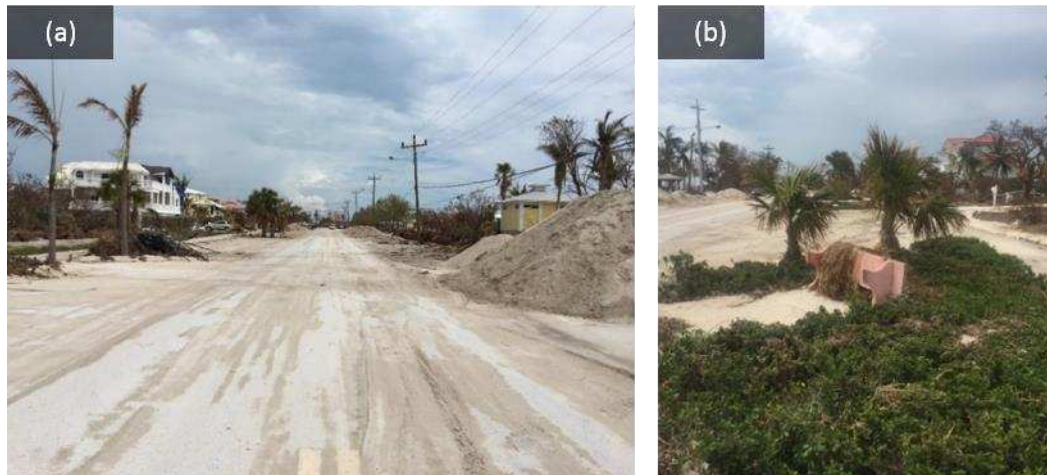
At the time of reconnaissance, sections of Sombrero Beach Road were still covered with sand deposits (Figure 12) that were transported from the small nourished beach in Sombrero Beach Park. Homeowners were removing sand from inside their houses (Figure 13), which were buried with up to about 1 m (3 ft) of sediment. Additional evidence of damage by storm surge and waves was observed as structural and flood damage to houses, including the collapse of a wall located in front of an oceanfront home (Figure 14). Undermining of another home was observed to expose the foundation, likely causing structural damage in the form of large cracks in the floor slab to the beach house (Figure 15).

Figure 12. (a) Large volumes of sediment were deposited on Sombrero Beach Road (facing east) and (b) a concrete bench was overturned, trapping debris on its side (collected September 26, 2017; location 24°41'33.01"N, 81°5'5.57"W).

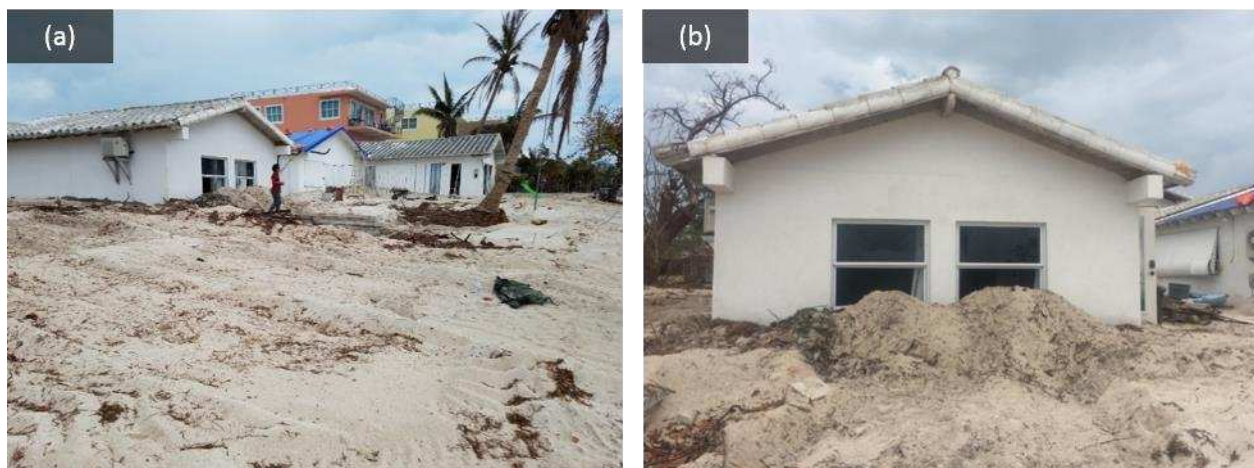
Figure 13. (a) Large volumes of sediment were deposited around houses and other structures and (b) buried them with approximately 1 m of sand, reaching the bottom of window sills (collected September 26, 2017; location 24°41'31.52"N, 81°4'56.31"W).

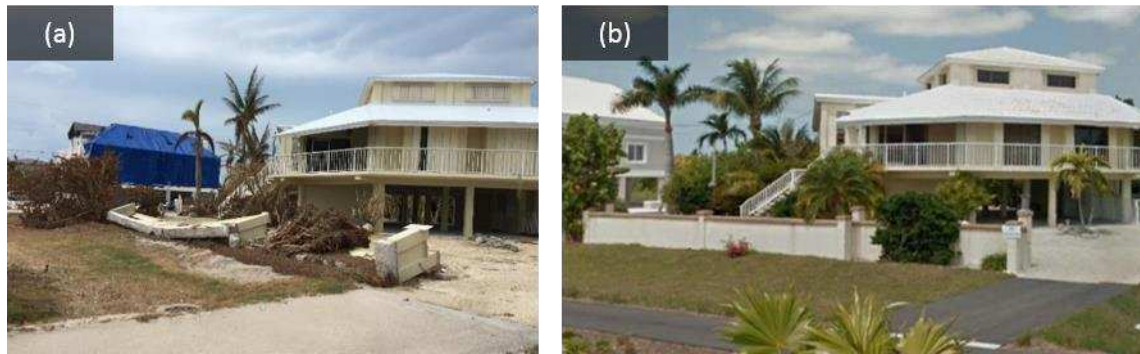
Figure 14. (a) A wall located in front of a home on Sombrero Beach Road collapsed during Hurricane Irma (collected September 26, 2017; location  $24^{\circ}41'34.26''N$ ,  $81^{\circ}5'0.93''W$ ); (b) the pre-existing structure appeared to be intact prior to the storm. Map Data: Google (2018).

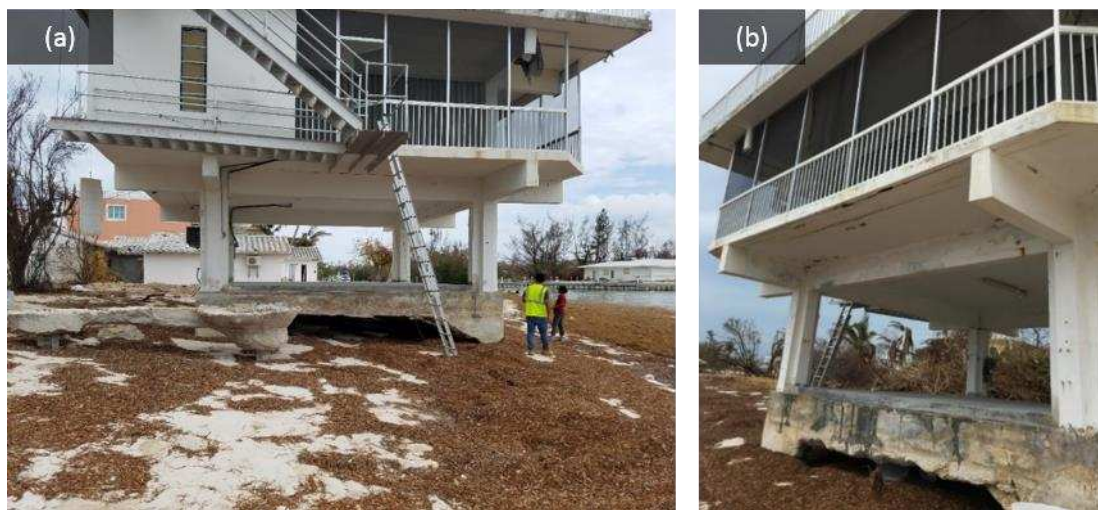
Figure 15. (a) The foundation of an elevated home was undermined due to scouring around the structure; (b) a close-up view shows damage to the structural integrity of the home (collected September 26, 2017; location  $24^{\circ}41'31.86''N$ ,  $81^{\circ}4'57.29''W$ ).

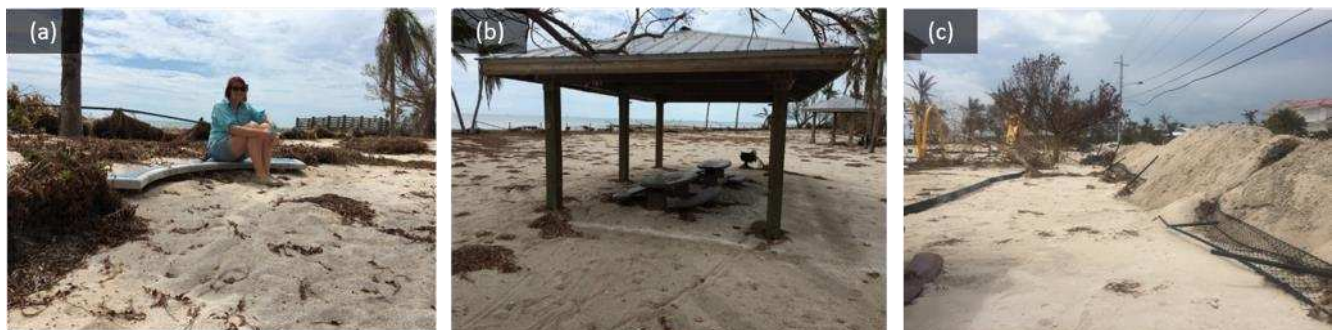
At Sombrero Beach Park, most of the park structures, such as fences, walking paths, and a beach access ramp, were damaged, and playground equipment was buried by about 0.6 m (2 ft) of sediment (Figure 16). Observations at this location further indicate that geotechnical impacts resulting from storm surge and waves are magnified by the surrounding infrastructure. At the park locations, sediment freely moved and deposited around park structures and on the roadway. However, at the walls and foundations of homes, which are impermeable fixed structures, sediment was eroded from around and beneath the structures. Sombrero Beach is another example that civil infrastructure can direct sediment erosion by interfering with the flow and natural sediment transport paths. Furthermore, it also highlights that small sediment-volume beaches, particularly those with no pre-existing dune structure, can be heavily damaged during extreme events.

Figure 16. (a) Concrete park benches were nearly buried with sand (approximately 2 m), (b) some park structures were only mildly damaged and buried with sediment, (c) while others were severely damaged and in need of repair (collected September 26, 2017; location  $24^{\circ}41'32.20''N$ ,  $81^{\circ}5'4.09''W$ ).

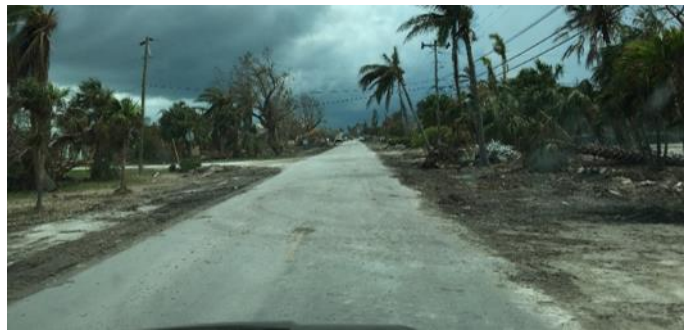
On Coco Plum Drive, evidence of wind and inundation by storm surge was observed from the debris deposited onto the roadway (Figure 17). At Coco Plum Beach Park, large volumes of sediment were transported from the beach, narrowing its

Figure 17. Sand and debris were deposited on Coco Plum Drive (collected September 26, 2017; location  $24^{\circ}43'34.52''N$ ,  $81^{\circ}0'36.53''W$ ).

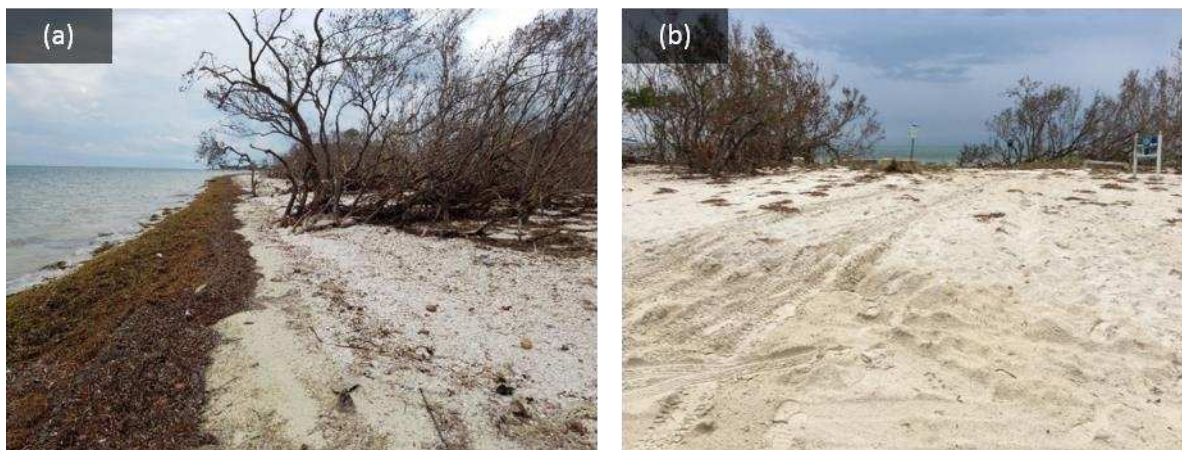
width, and deposited in the parking area (Figure 18). From the observations, the densely vegetated regions of the island trapped much of the sediment in a 20 m to 25 m zone, except at the beach access point where the transect in the vegetation served as a transport pathway through which sediment was channelized.

Figure 18. (a) The beach width was narrowed due to erosion and algae washed up on the beach, and (b) sediment approximately 0.3 m in depth was deposited in the beach access area (collected September 26, 2017; location  $24^{\circ}43'48.42''N$ ,  $81^{\circ}0'5.81''W$ ).
