Post-2017 Hurricane Season Assessment of Civil Infrastructure Impacts on Beach and Near-Beach Environments

ABSTRACT: This paper presents an overview of observations and preliminary measurements of coastal infrastructure in the aftermath of Hurricanes Harvey and Irma in 2017. Two teams mobilized by the Geotechnical Extreme Events Reconnaissance (GEER) Association were sent to document perishable data along the Texas coastline (Port Aransas, Holiday Beach, East Matagorda Peninsula, and Follets Island) and Florida Keys (Simonton Beach, Sombrero Beach, and Coco Plum Beach). Significant damage from sediment overwash and road undercutting was observed at beach access paths and roads that transect dune fields. It was also observed that beach access points weaken the line of coastal defense provided by dunes, vegetation, and structures. The lessons learned from these field reconnaissance missions indicate that longshore non-uniformity in the dune system should be well-documented. Measurements of the geometry of beach access pathways and dunes, including the height, width, length, and vegetation coverage, should be collected prior to recovery of the system post-storm.

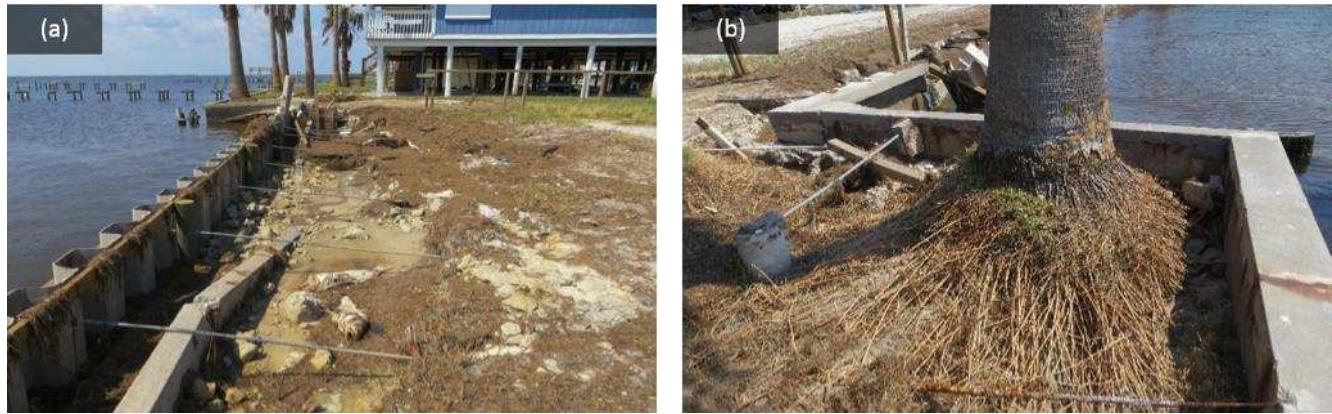
During the reconnaissance survey, houses in Holiday Beach were found heavily damaged by wind and bay surge, particularly those located on the bayfront street that parallels the canals. Anchored bulkhead retaining walls constructed along the bayfront property line were overtopped during Hurricane Harvey and severely eroded on their backsides, exposing supporting steel rods (Figure 6a). Scouring around trees and other fixed obstacles was also observed (Figure 6b). Although Holiday Beach is located on Copano Bay and is not subject to GOM wave action, the damage due to hydrodynamic forces in this region was extensive. Observations show the bulkhead was overtopped during Hurricane Harvey, leaving fish and other debris on land. As the water levels retreated, sediment appeared to be transported from the backside of the bulkhead and around the base of fixed objects, leaving these structures damaged and in need of repair. The condition of the bulkheads and service life

Figure 6. (a) Supporting steel rods were exposed after storm surge retreat scoured the backside of a bulkhead, and (b) scour was also observed around other fixed objects (collected September 3, 2017; location 28°10'11.24"N, 97°1'2.03"W).

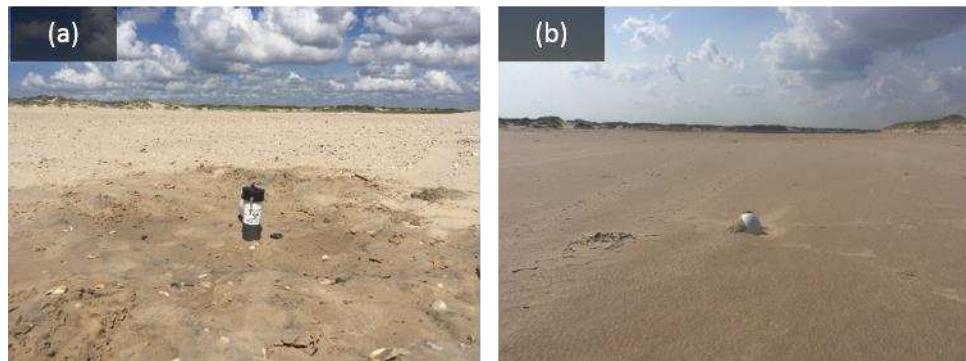
The infilled storm cut through East Matagorda Peninsula hydraulically connects GoM and bay surface waters only during elevated storm water levels. During Hurricane Harvey, the maximum water surface elevation at the backshore (GoM side of the cut) was 1.8 m above Mean Sea Level (MSL) and 1.0 m above MSL at the back-barrier location (bay side of the cut) as measured by rapid response field measurement units containing pressure transducers. The dunes at this site were not overtopped. Surface hydraulic connection through the cut lasted for approximately six hours. During this time, up to 0.50 m (1.6 ft) of GoM sediment was deposited in the backshore (back-barrier) region of the cut as a result of onshore-directed transport of sediment eroded from the shoreface by hurricane wave action. Figure 7 shows before and after photos of the backshore area on the GoM side of the cut, clearly indicating the accretion that occurred at this location. The cut serves as a roadway to access the back-barrier areas and is an example of what can happen to shore-perpendicular gaps in the dune line during hurricane impact.

Figure 7. (a) Pre-storm (collected August 23, 2017) and (b) post-storm observations (collected August 30, 2017) of the backshore area fronting the East Matagorda cut where 0.5 m of sediment accretion was observed (location 28°36'43.57"N, 95°56'24.88"W).

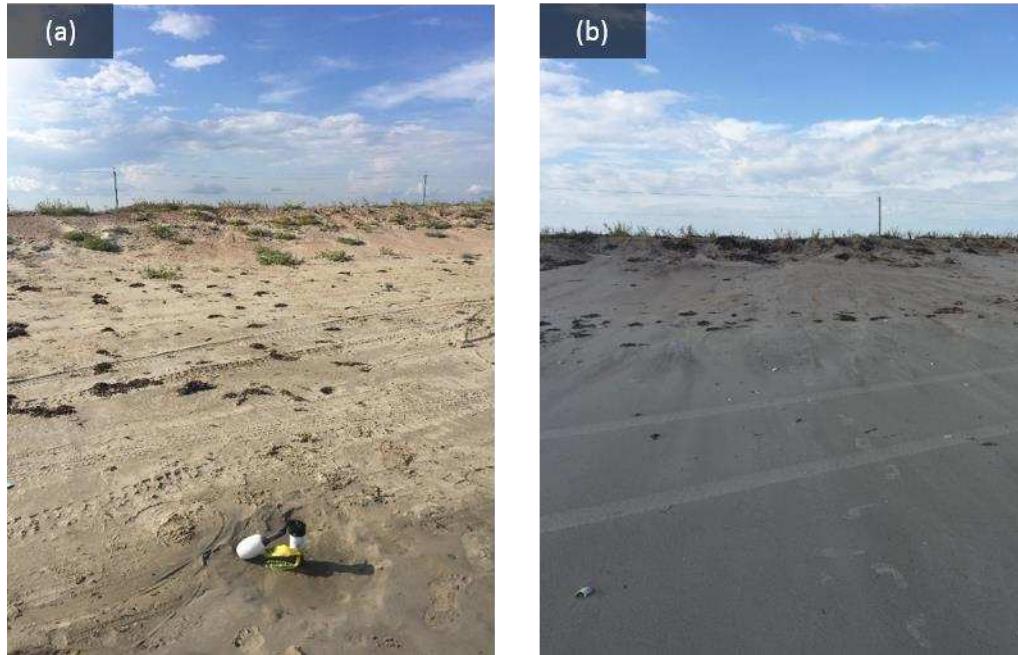
Figure 8. (a) Pre-storm (collected August 24, 2017) and (b) post-storm observations (collected August 31, 2017) of the dune show regrading of the beach profile and washout from heavy rainfall on the dune peak (location $29^{\circ}1'27.93''N$, $95^{\circ}11'24.93''W$).

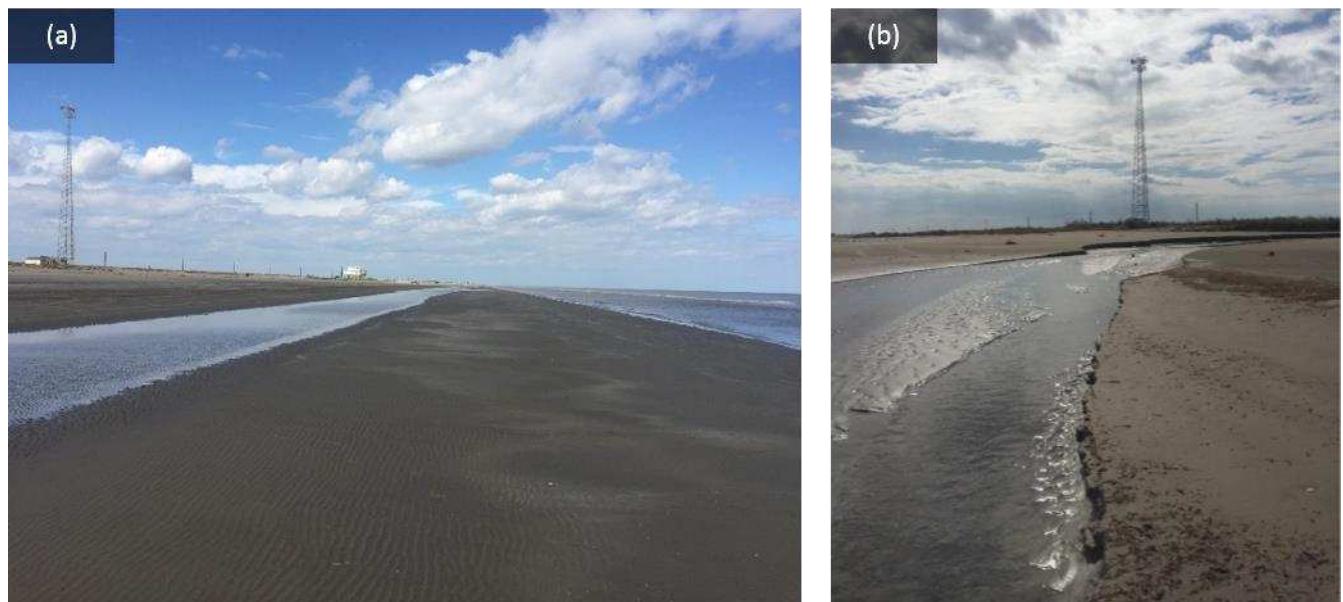
deposits were observed on the road (257R) and a channel was formed connecting the flooded backbarrier region to the beach along the eastern and western flanks of the dunes (Figure 9b). This study location on Follets Island shows the protection afforded by dunes against storm flooding, but it also demonstrates damaging erosion along the sides of roadways. It also highlights that beach access points can serve as a funnel as rainwater and storm surge retreat, allowing the channelization of sediment transport.

Figure 9. (a) A ridge-runnel system formed parallel to the shore, and (b) a channel was eroded from the beach access point to the GoM (location $29^{\circ}1'27.93''N$, $95^{\circ}11'24.93''W$).

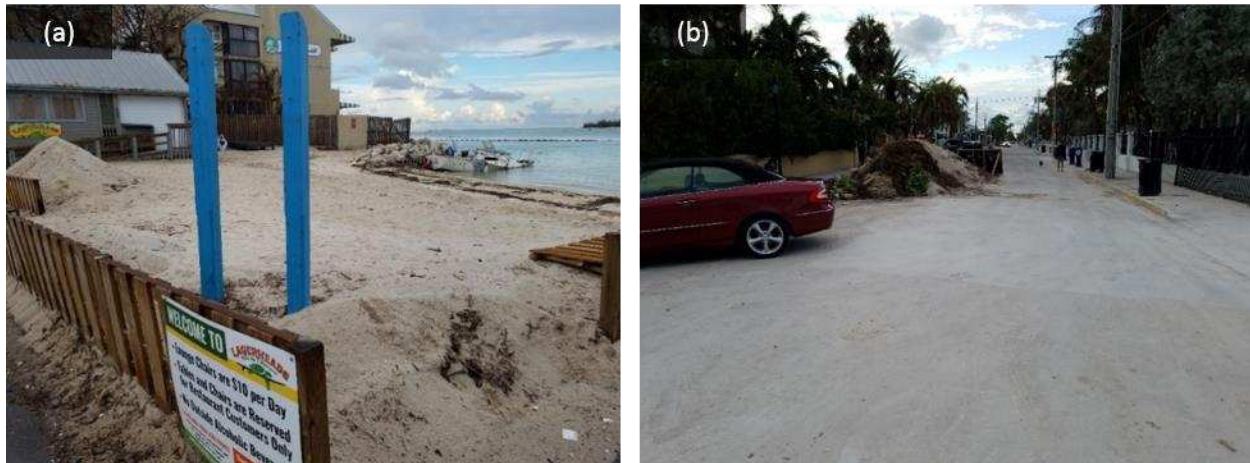
According to a representative of the Engineering Division for the City of Key West, Simonton Beach experienced some of the greatest beach impacts within the City of Key West due to Hurricane Irma. This very small beach was severely eroded, causing sand to be transported either offshore or deposited in the parking lot behind the beach. The beach width was reduced by nearly 4 m and the beach face was noticeably steepened due to the erosion (Figure 10). Additionally, the concrete groin/walkway located on the east side of the beach was damaged by scour and undermining, causing the structure to drop slightly in elevation (Figure 11). Simonton Beach provides evidence that beaches with small sediment volumes can be particularly impacted by storm surge and waves. Also, the lack of a dune system and the beach's location in an area characterized by mostly impervious surfaces and little natural vegetation are both factors that cause sediment to be eroded from the beach and transported further inland. Because the concrete structure is impermeable, the flow is funneled along its length, focusing flow energy and leading to larger erosion potential.

Figure 10. (a) Simonton Beach was severely eroded and (b) sediment was deposited in the parking lot backing the beach (collected September 27, 2017; location 24°33'42.85"N, 81°48'19.64"W).

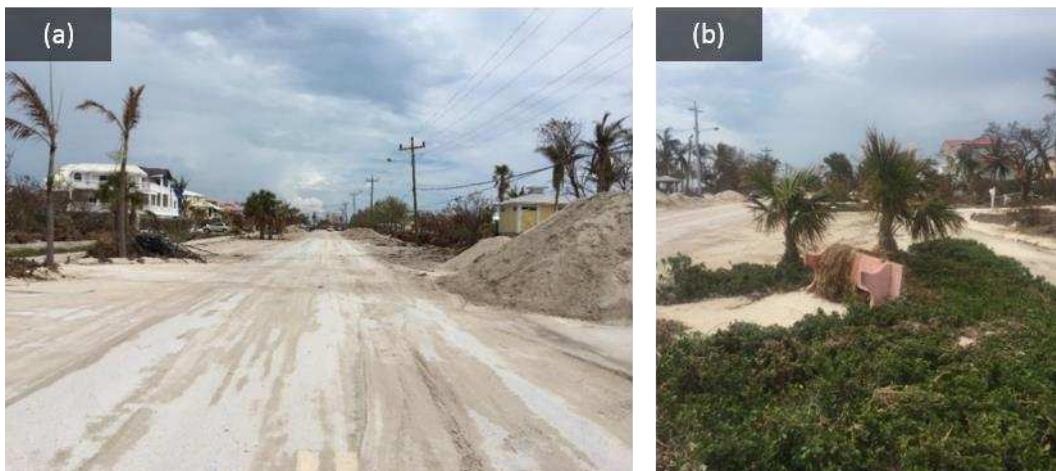
At the time of reconnaissance, sections of Sombrero Beach Road were still covered with sand deposits (Figure 12) that were transported from the small nourished beach in Sombrero Beach Park. Homeowners were removing sand from inside their houses (Figure 13), which were buried with up to about 1 m (3 ft) of sediment. Additional evidence of damage by storm surge and waves was observed as structural and flood damage to houses, including the collapse of a wall located in front of an oceanfront home (Figure 14). Undermining of another home was observed to expose the foundation, likely causing structural damage in the form of large cracks in the floor slab to the beach house (Figure 15).

Figure 12. (a) Large volumes of sediment were deposited on Sombrero Beach Road (facing east) and (b) a concrete bench was overturned, trapping debris on its side (collected September 26, 2017; location $24^{\circ}41'33.01''N$, $81^{\circ}5'5.57''W$).

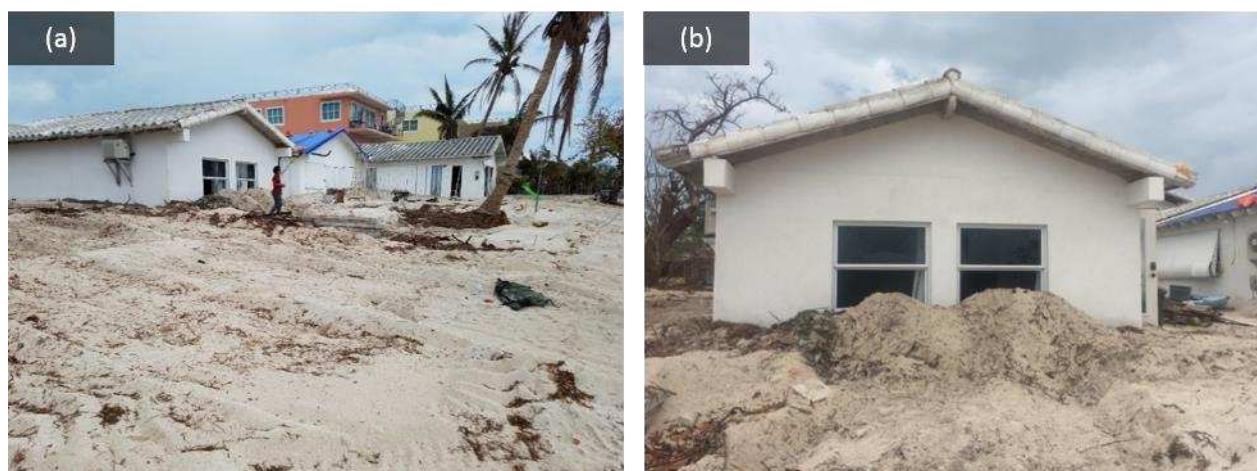
Figure 13. (a) Large volumes of sediment were deposited around houses and other structures and (b) buried them with approximately 1 m of sand, reaching the bottom of window sills (collected September 26, 2017; location $24^{\circ}41'31.52''N$, $81^{\circ}4'56.31''W$).
