Post-2017 Hurricane Season Assessment of Civil Infrastructure Impacts on Beach and Near-Beach Environments

ABSTRACT: *This paper presents an overview of observations and preliminary measurements of coastal infrastructure in the aftermath of Hurricanes Harvey and Irma in 2017. Two teams mobilized by the Geotechnical Extreme Events Reconnaissance (GEER) Association were sent to document perishable data along the Texas coastline (Port Aransas, Holiday Beach, East Matagorda Peninsula, and Follets Island) and Florida Keys (Simonton Beach, Sombrero Beach, and Coco Plum Beach). Significant damage from sediment overwash and road undercutting was observed at beach access paths and roads that transect dune fields. It was also observed that beach access points weaken the line of coastal defense provided by dunes, vegetation, and structures. The lessons learned from these field reconnaissance missions indicate that longshore non-uniformity in the dune system should be well-documented. Measurements of the geometry of beach access pathways and dunes, including the height, width, length, and vegetation coverage, should be collected prior to recovery of the system post-storm.*

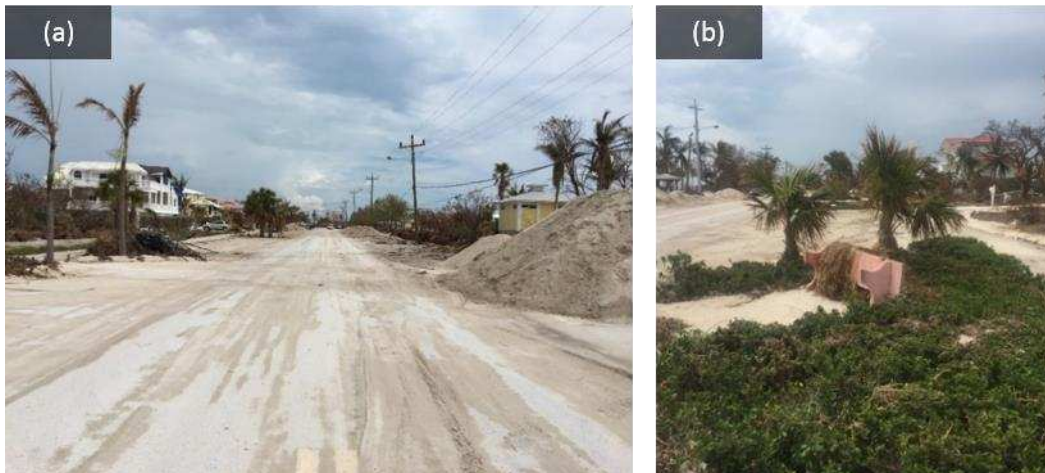
At the time of reconnaissance, sections of Sombrero Beach Road were still covered with sand deposits (Figure 12) that were transported from the small nourished beach in Sombrero Beach Park. Homeowners were removing sand from inside their houses (Figure 13), which were buried with up to about 1 m (3 ft) of sediment. Additional evidence of damage by storm surge and waves was observed as structural and flood damage to houses, including the collapse of a wall located in front of an oceanfront home (Figure 14). Undermining of another home was observed to expose the foundation, likely causing structural damage in the form of large cracks in the floor slab to the beach house (Figure 15).

Figure 12. (a) Large volumes of sediment were deposited on Sombrero Beach Road (facing east) and (b) a concrete bench was overturned, trapping debris on its side (collected September 26, 2017; location $24^{\circ}41'33.01''\text{N}$, $81^{\circ}5'5.57''\text{W}$).

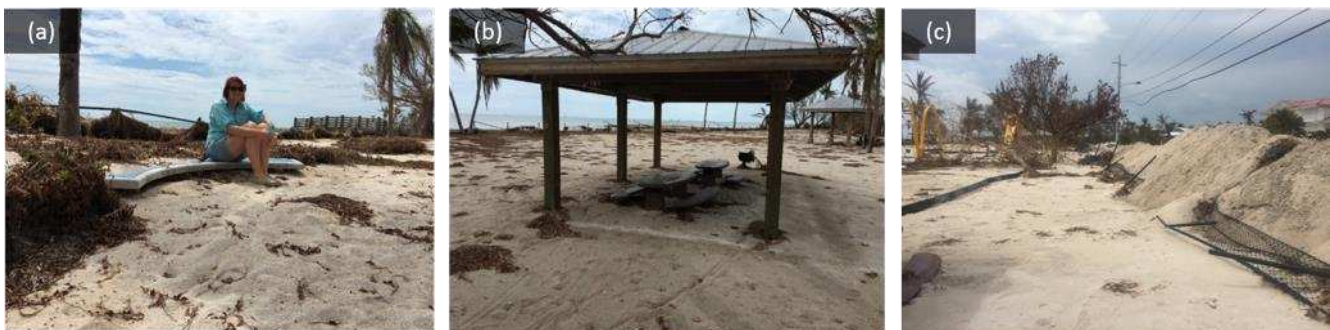
At Sombrero Beach Park, most of the park structures, such as fences, walking paths, and a beach access ramp, were damaged, and playground equipment was buried by about 0.6 m (2 ft) of sediment (Figure 16). Observations at this location further indicate that geotechnical impacts resulting from storm surge and waves are magnified by the surrounding infrastructure. At the park locations, sediment freely moved and deposited around park structures and on the roadway. However, at the walls and foundations of homes, which are impermeable fixed structures, sediment was eroded from around and beneath the structures. Sombrero Beach is another example that civil infrastructure can direct sediment erosion by interfering with the flow and natural sediment transport paths. Furthermore, it also highlights that small sediment-volume beaches, particularly those with no pre-existing dune structure, can be heavily damaged during extreme events.

Figure 16. (a) Concrete park benches were nearly buried with sand (approximately 2 m), (b) some park structures were only mildly damaged and buried with sediment, (c) while others were severely damaged and in need of repair (collected September 26, 2017; location $24^{\circ}41'32.20''\text{N}$, $81^{\circ}5'4.09''\text{W}$).
