Post-2017 Hurricane Season Assessment of Civil Infrastructure Impacts on Beach and Near-Beach Environments

ABSTRACT: *This paper presents an overview of observations and preliminary measurements of coastal infrastructure in the aftermath of Hurricanes Harvey and Irma in 2017. Two teams mobilized by the Geotechnical Extreme Events Reconnaissance (GEER) Association were sent to document perishable data along the Texas coastline (Port Aransas, Holiday Beach, East Matagorda Peninsula, and Follets Island) and Florida Keys (Simonton Beach, Sombrero Beach, and Coco Plum Beach). Significant damage from sediment overwash and road undercutting was observed at beach access paths and roads that transect dune fields. It was also observed that beach access points weaken the line of coastal defense provided by dunes, vegetation, and structures. The lessons learned from these field reconnaissance missions indicate that longshore non-uniformity in the dune system should be well-documented. Measurements of the geometry of beach access pathways and dunes, including the height, width, length, and vegetation coverage, should be collected prior to recovery of the system post-storm.*

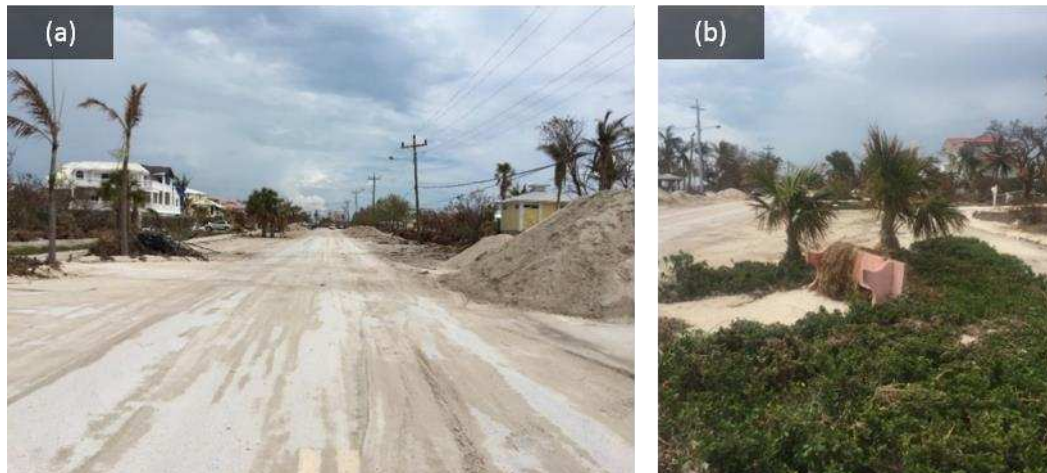
At the time of reconnaissance, sections of Sombrero Beach Road were still covered with sand deposits (Figure 12) that were transported from the small nourished beach in Sombrero Beach Park. Homeowners were removing sand from inside their houses (Figure 13), which were buried with up to about 1 m (3 ft) of sediment. Additional evidence of damage by storm surge and waves was observed as structural and flood damage to houses, including the collapse of a wall located in front of an oceanfront home (Figure 14). Undermining of another home was observed to expose the foundation, likely causing structural damage in the form of large cracks in the floor slab to the beach house (Figure 15).

Figure 12. (a) Large volumes of sediment were deposited on Sombrero Beach Road (facing east) and (b) a concrete bench was overturned, trapping debris on its side (collected September 26, 2017; location 24°41'33.01"N, 81°5'5.57"W).

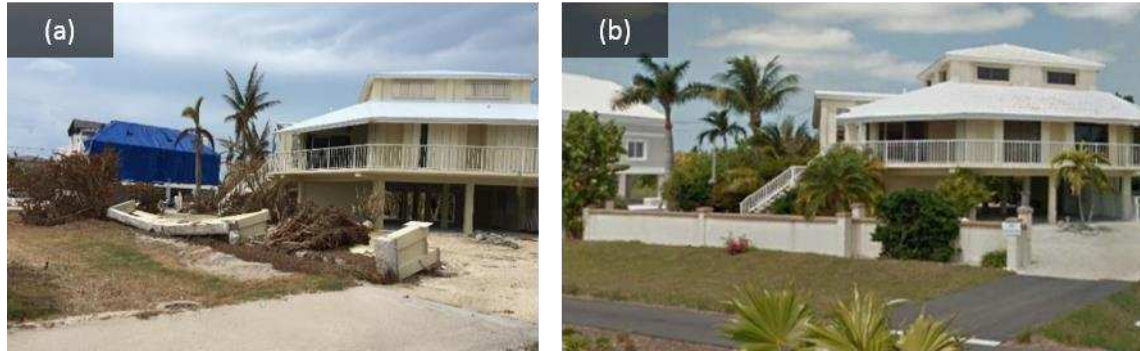
Figure 14. (a) A wall located in front of a home on Sombrero Beach Road collapsed during Hurricane Irma (collected September 26, 2017; location $24^{\circ}41'34.26''N$, $81^{\circ}5'0.93''W$); (b) the pre-existing structure appeared to be intact prior to the storm. Map Data: Google (2018).

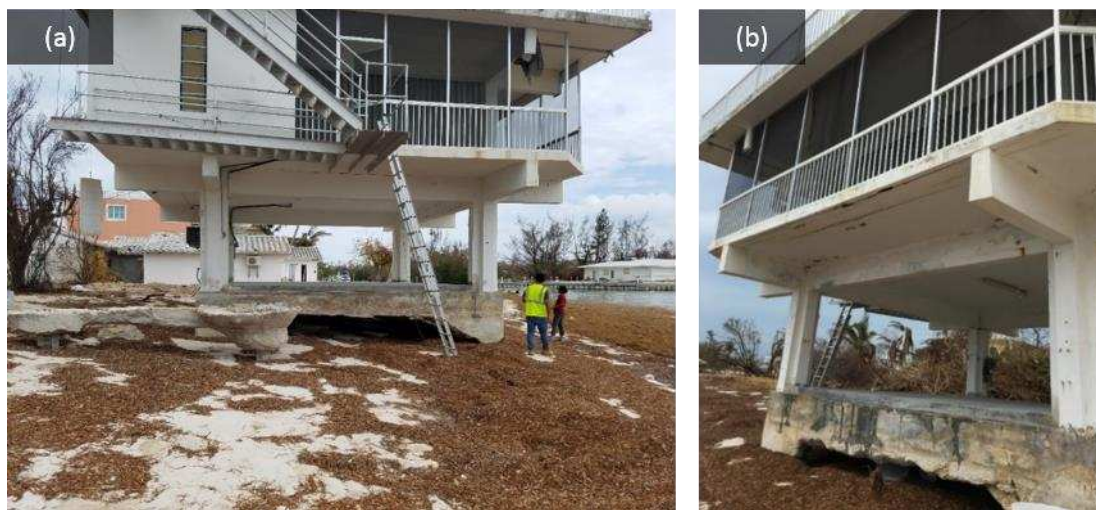
Figure 15. (a) The foundation of an elevated home was undermined due to scouring around the structure; (b) a close-up view shows damage to the structural integrity of the home (collected September 26, 2017; location $24^{\circ}41'31.86''N$, $81^{\circ}4'57.29''W$).
