Reconnaissance of the New Orleans Hurricane and Storm Damage Risk Reduction System after Hurricane Gustav

ABSTRACT: On October 2 and 3, 2008, a group of civil engineers sponsored by the National Science Foundation (NSF) and organized by the Geoengineering Extreme Events Reconnaissance (GEER) Association, visited the New Orleans area to assess levee performance during hurricane Gustav. This paper summarizes the team's observations and understanding of the state of the New Orleans Hurricane and Storm Damage Risk Reduction System (HSDRRS) in the fall of 2008 and the performance of elements of the HSDRRS during Hurricane Gustav. The fundamental conclusion was that the HSDRRS performed well under the surge and wave stresses generated by Gustav. The team's observations led to lessons about dangers to floodwalls from boats and barges, the importance of timely preparation for hurricanes, erosion resistance of clay levees, and the need for continued emphasis on evacuation for life protection.

International Journal of Geoengineering Case Histories, Volume 5, Issue 4, pp. 129-154, doi: 10.4417/IJGCH-05-04-

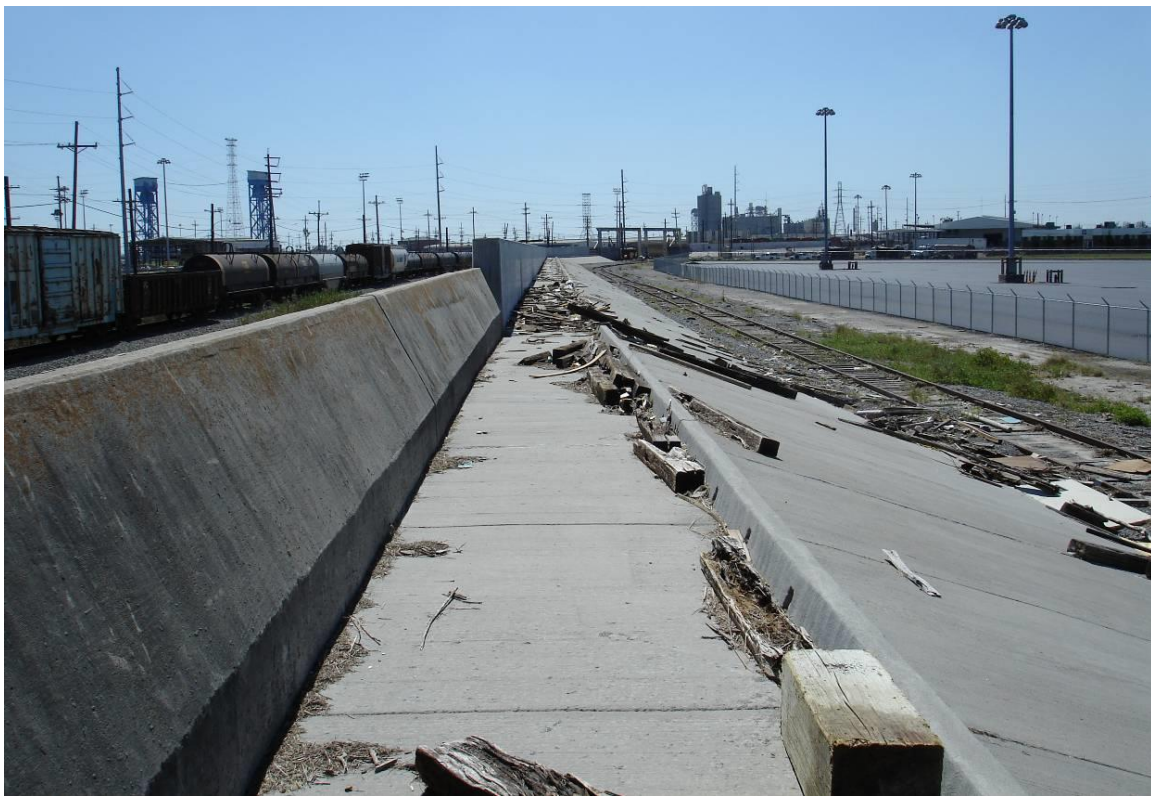
Figure 6. I-wall and splash apron, IHNC west along France Road; new L-wall and splash apron in background. (October 2, 2008, 90.0272° W, 90.0272° W)

At the transition between the new L-wall and the old I-wall (Figure 6), there was storm debris left on top of and behind the higher L-wall, while the top of the lower I-wall was left clean. It is possible that the water elevation or waves during the peak storm surge exceeded the top of the old I-wall on a more consistent basis (elevation of about 4.3 m [14 ft], NAVD88) at this location, sweeping wave debris from the wall top.

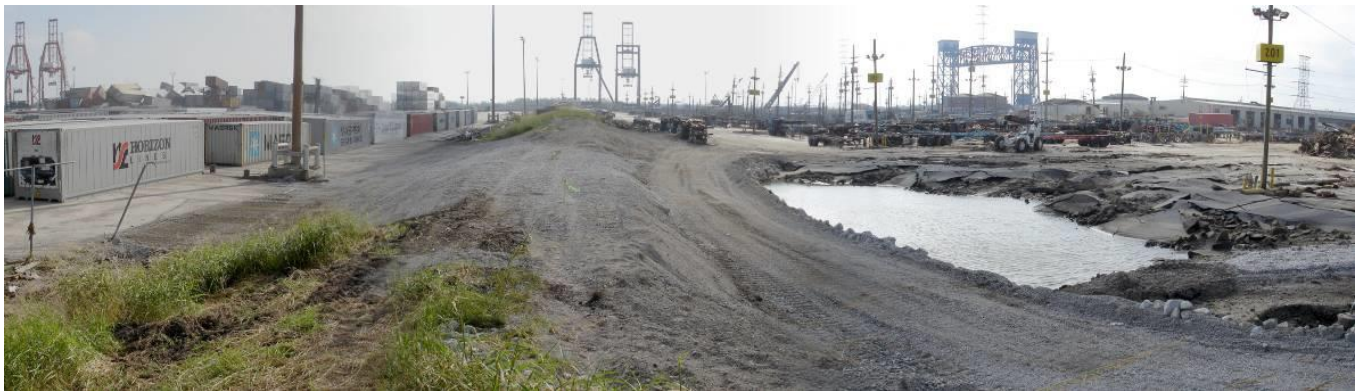
Figure 16. Post-Katrina IHNC West levee breach site, October 2005 (The breach had been temporarily repaired; note scour hole). (October 4, 2005, 29.9880° N, 90.0263° W, L. Wooten)

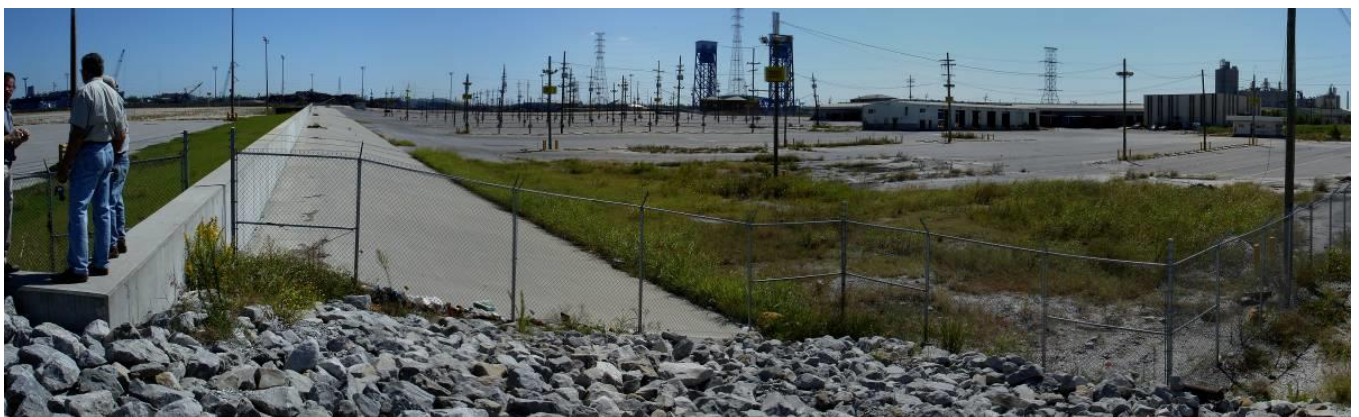
Figure 17. IHNC West new embankment and floodwall at location of breach, as was shown in Figure 14, in October 2008. (October 2, 2010, 29.9880° N, 90.0263° W)

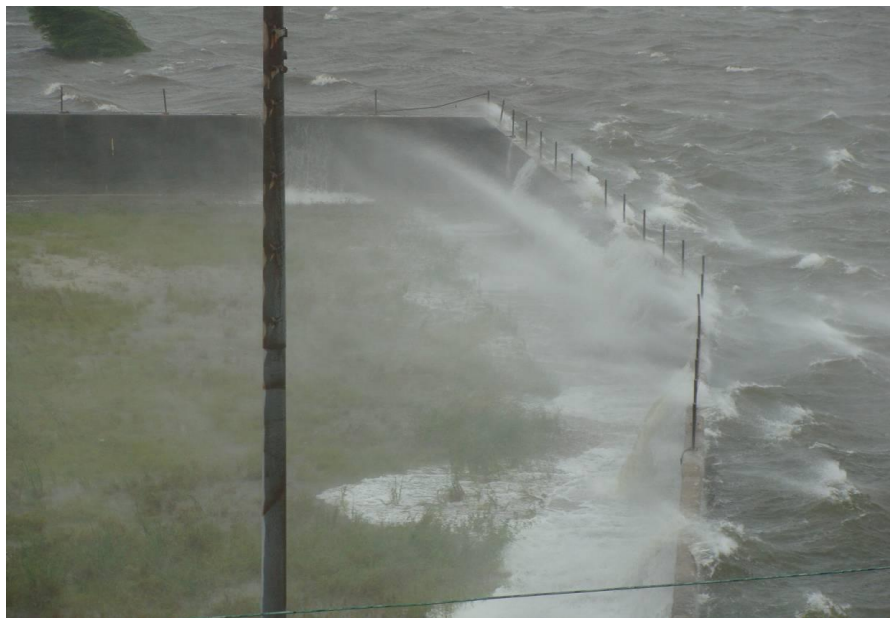
Figure 22. Gustav's storm surge along IHNC East, taken from Claiborne Ave. Bridge looking north at T-wall southeast on September 1, 2008. (September 1, 2008, 29.969° N, 90.027° W, USACE)

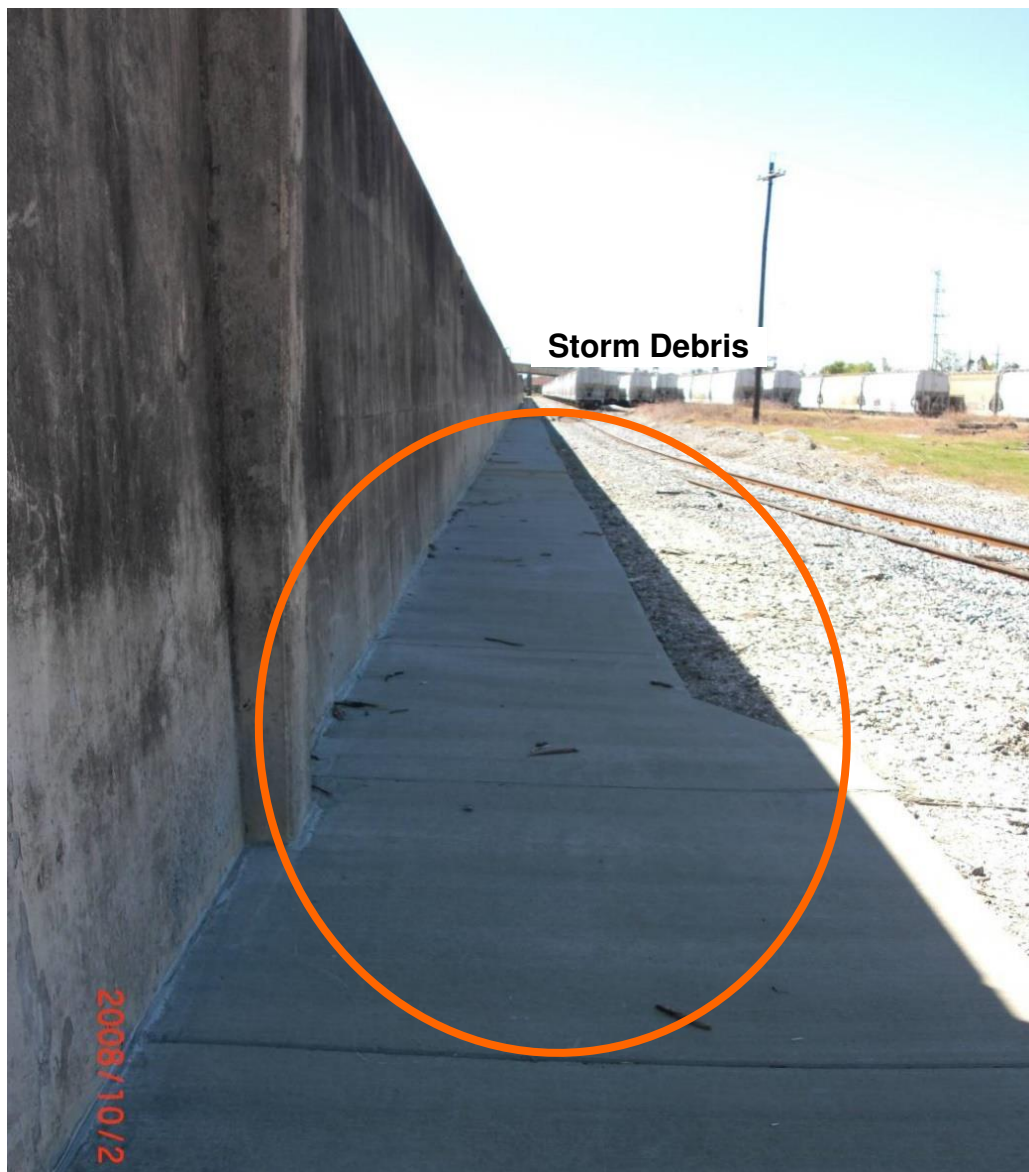
Figure 23. Photograph from October 2, 2008, of IHNC West T-wall (same section as shown during Gustav in Figures 20 and 21). (October 2, 2008, 29.970° N, 90.026° W)

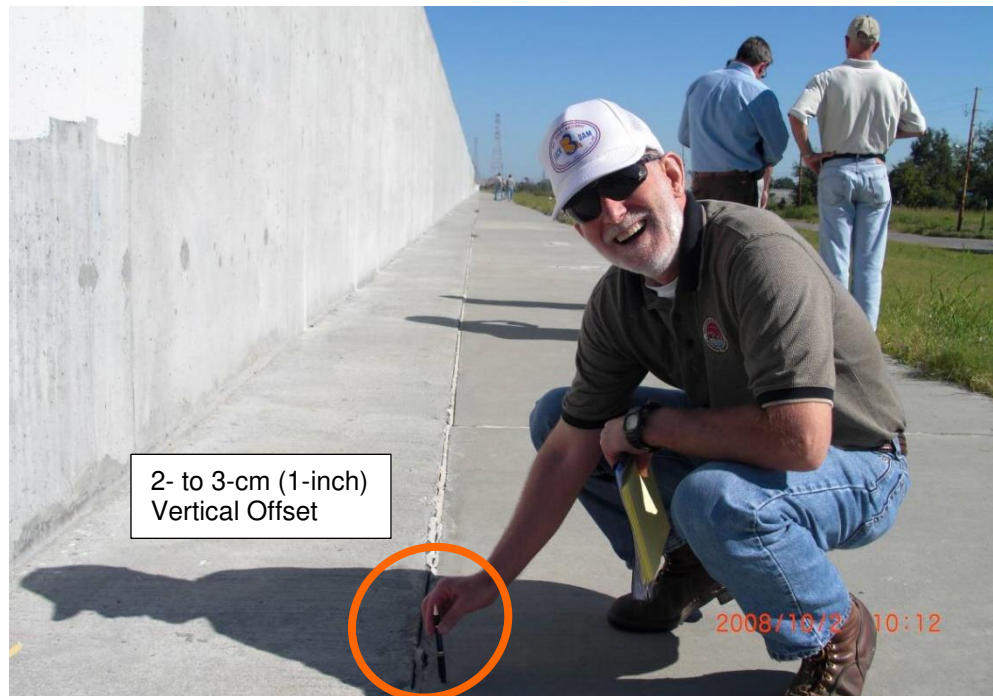
The team noted a 2- to 3-cm-deep (~1-inch-deep) vertical offset between the pile-supported base of the T-wall and the slab-on-grade concrete splash apron (Figure 27). This offset, if the splash apron was cast to be flush with the base of the wall in the summer of 2006, may indicate a differential settlement of the apron relative to the pile-supported T-wall occurring at a rate of about 1 cm per year (0.5 inch per year) in the upper 21 m (70 ft) of the soil profile.

Figure 27. New T-wall section along the east side of the IHNC between Claiborne and Florida Avenues (shown in Figure 23 during Gustav). (October 2, 2008, 29.9691° N, 90.0236° W)

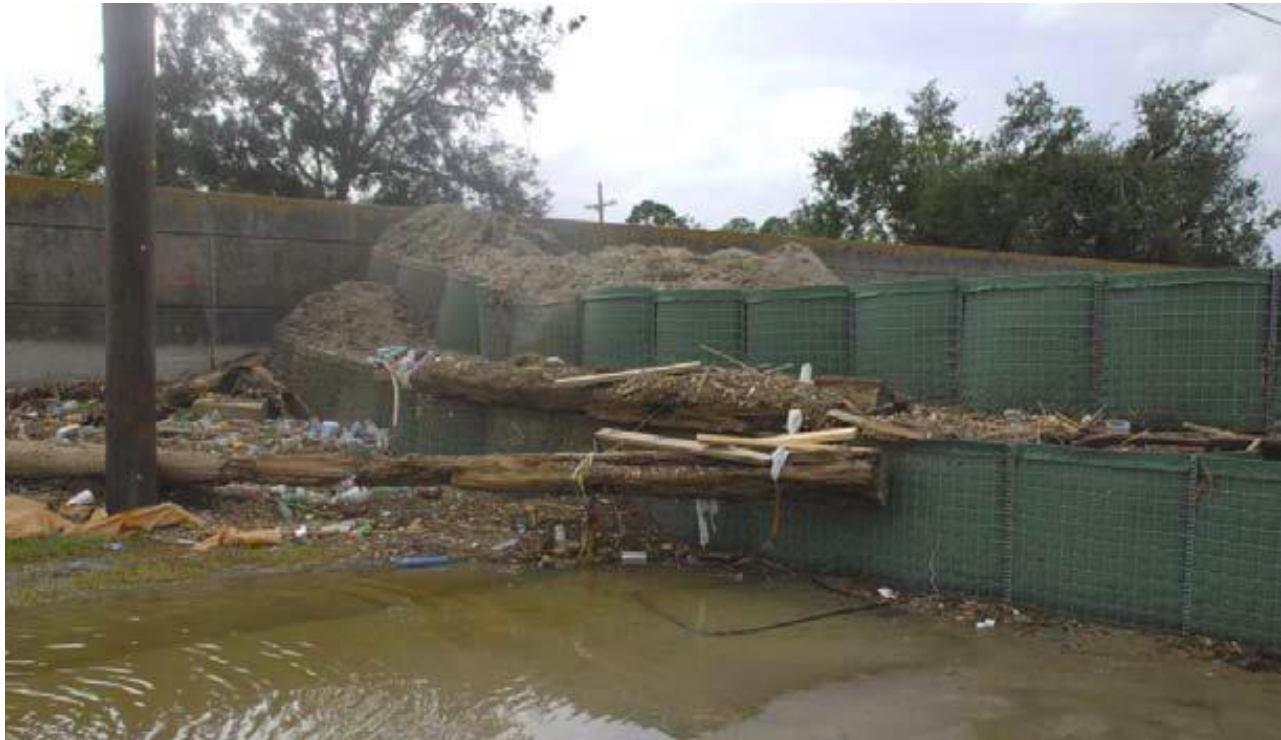
Figure 31. End of temporary bin wall at tie-in to I-Wall, post-Gustav (September 2008, 30.0122° N, 90.0313° W, http://www.mvn.usace.army.mil/HPS/Status%20Report%20Newsletters/Sept_9_2008.pdf)

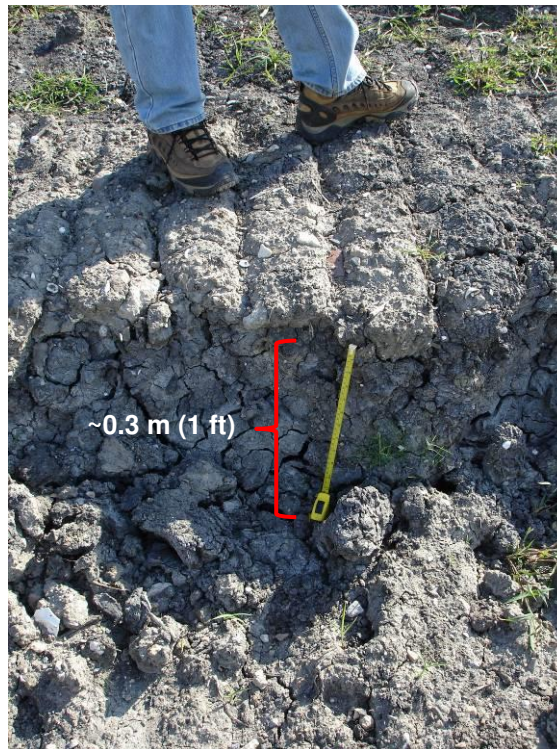
*Figure 36. Scarp above slide on Plaquemines back levee.
(October 3, 2008, 29.8506° N, 89.9085° W)*
