Reconnaissance of the New Orleans Hurricane and Storm Damage Risk Reduction System after Hurricane Gustav

ABSTRACT: On October 2 and 3, 2008, a group of civil engineers sponsored by the National Science Foundation (NSF) and organized by the Geoengineering Extreme Events Reconnaissance (GEER) Association, visited the New Orleans area to assess levee performance during hurricane Gustav. This paper summarizes the team's observations and understanding of the state of the New Orleans Hurricane and Storm Damage Risk Reduction System (HSDRRS) in the fall of 2008 and the performance of elements of the HSDRRS during Hurricane Gustav. The fundamental conclusion was that the HSDRRS performed well under the surge and wave stresses generated by Gustav. The team's observations led to lessons about dangers to floodwalls from boats and barges, the importance of timely preparation for hurricanes, erosion resistance of clay levees, and the need for continued emphasis on evacuation for life protection.

Reconnaissance of the New Orleans Hurricane and Storm Damage Risk Reduction System after Hurricane Gustav.

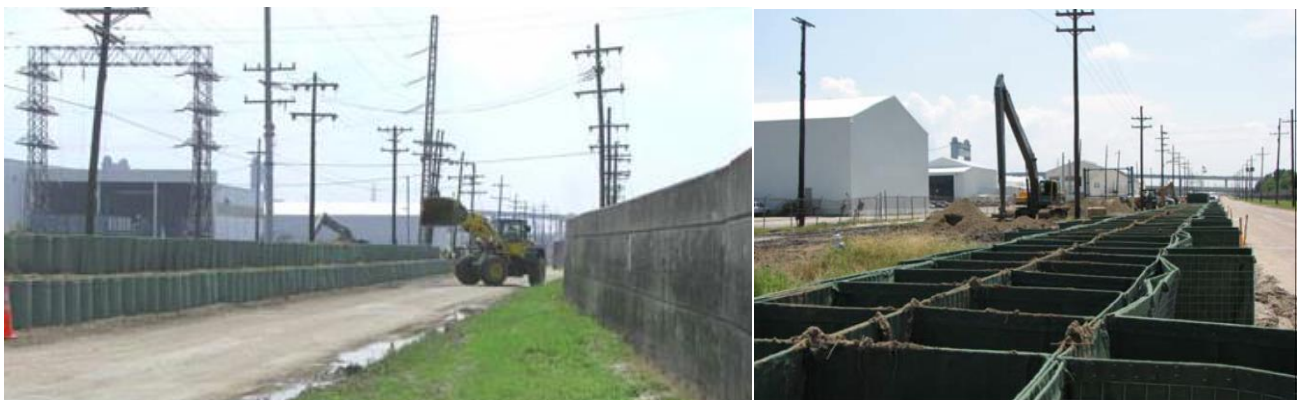
Figure 30. Temporary bin wall under construction, IHNC West along France Road. (August 2008, 30.0157° N, 90.0324° W, http://www.mvn.usace.army.mil/HPS/Status%20Report%20Newsletters/Sept_9_2008.pdf)
