Reconnaissance of the New Orleans Hurricane and Storm Damage Risk Reduction System after Hurricane Gustav

ABSTRACT: On October 2 and 3, 2008, a group of civil engineers sponsored by the National Science Foundation (NSF) and organized by the Geoengineering Extreme Events Reconnaissance (GEER) Association, visited the New Orleans area to assess levee performance during hurricane Gustav. This paper summarizes the team's observations and understanding of the state of the New Orleans Hurricane and Storm Damage Risk Reduction System (HSDRRS) in the fall of 2008 and the performance of elements of the HSDRRS during Hurricane Gustav. The fundamental conclusion was that the HSDRRS performed well under the surge and wave stresses generated by Gustav. The team's observations led to lessons about dangers to floodwalls from boats and barges, the importance of timely preparation for hurricanes, erosion resistance of clay levees, and the need for continued emphasis on evacuation for life protection.

Reference: Wooten L., Gilbert R. B., Marcuson, III W. F., Harder, Jr. L. F., and Nicholson P. G. (2020).

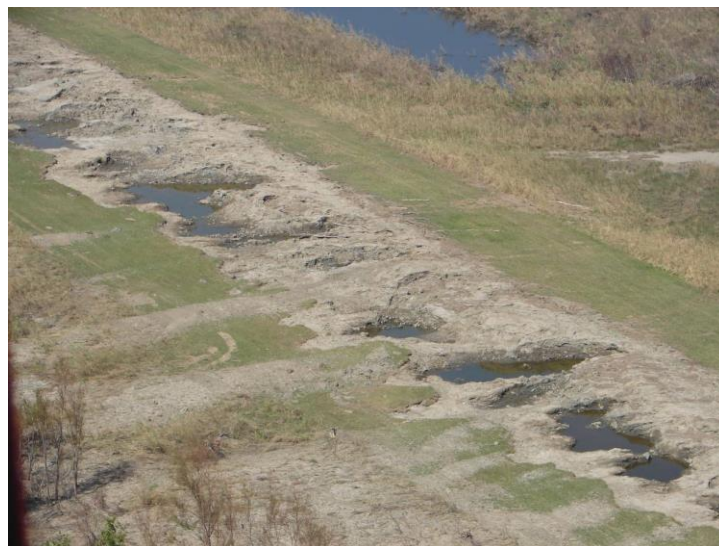
The frontage levees along the Mississippi River Gulf Outlet (MRGO) channel are the closest elements of the HSDRRS to the open waters of the Gulf. These earthen embankments experienced the earliest and highest water levels during both Gustav and Katrina. The high-water levels during Katrina overwhelmed the MRGO frontage levees, with overtopping along the entire stretch of the MRGO and eroded significant lengths of the levee. Figure 11 shows a section of the MRGO frontage levee and the typical extent of the erosion damage caused by the Katrina overtopping.

Figure 11. Post-Katrina MRGO frontage levee. (October 14, 2005, ~89.8° W, ~29.9° N, L. Harder)

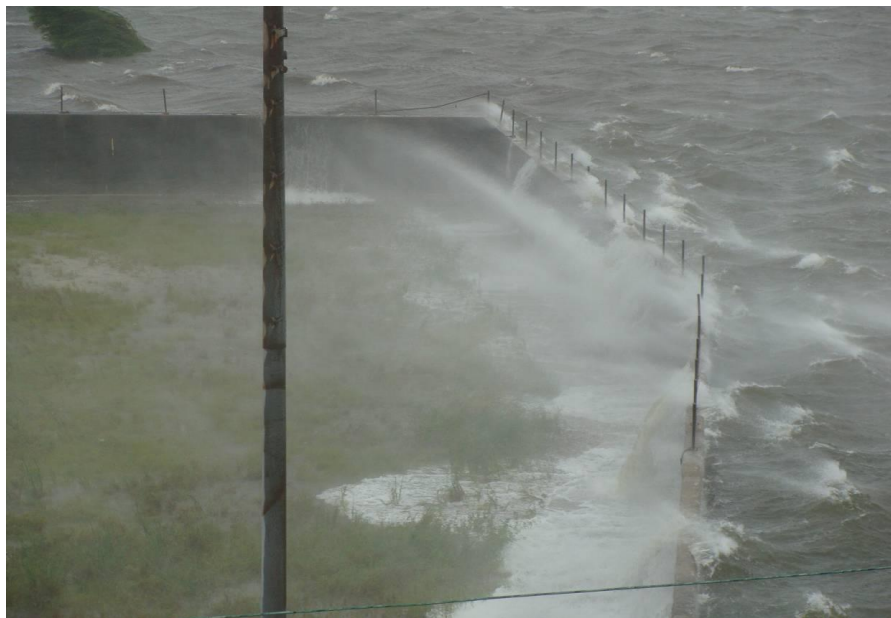
Figure 22. Gustav's storm surge along IHNC East, taken from Claiborne Ave. Bridge looking north at T-wall southeast on September 1, 2008. (September 1, 2008, 29.969° N, 90.027° W, USACE)
