Reconnaissance of the New Orleans Hurricane and Storm Damage Risk Reduction System after Hurricane Gustav

ABSTRACT: On October 2 and 3, 2008, a group of civil engineers sponsored by the National Science Foundation (NSF) and organized by the Geoengineering Extreme Events Reconnaissance (GEER) Association, visited the New Orleans area to assess levee performance during hurricane Gustav. This paper summarizes the team's observations and understanding of the state of the New Orleans Hurricane and Storm Damage Risk Reduction System (HSDRRS) in the fall of 2008 and the performance of elements of the HSDRRS during Hurricane Gustav. The fundamental conclusion was that the HSDRRS performed well under the surge and wave stresses generated by Gustav. The team's observations led to lessons about dangers to floodwalls from boats and barges, the importance of timely preparation for hurricanes, erosion resistance of clay levees, and the need for continued emphasis on evacuation for life protection.

International Journal of Geoengineering Case Histories, Volume 5, Issue 4, pp. 129-154, doi: 10.4417/IJGCH-05-04-

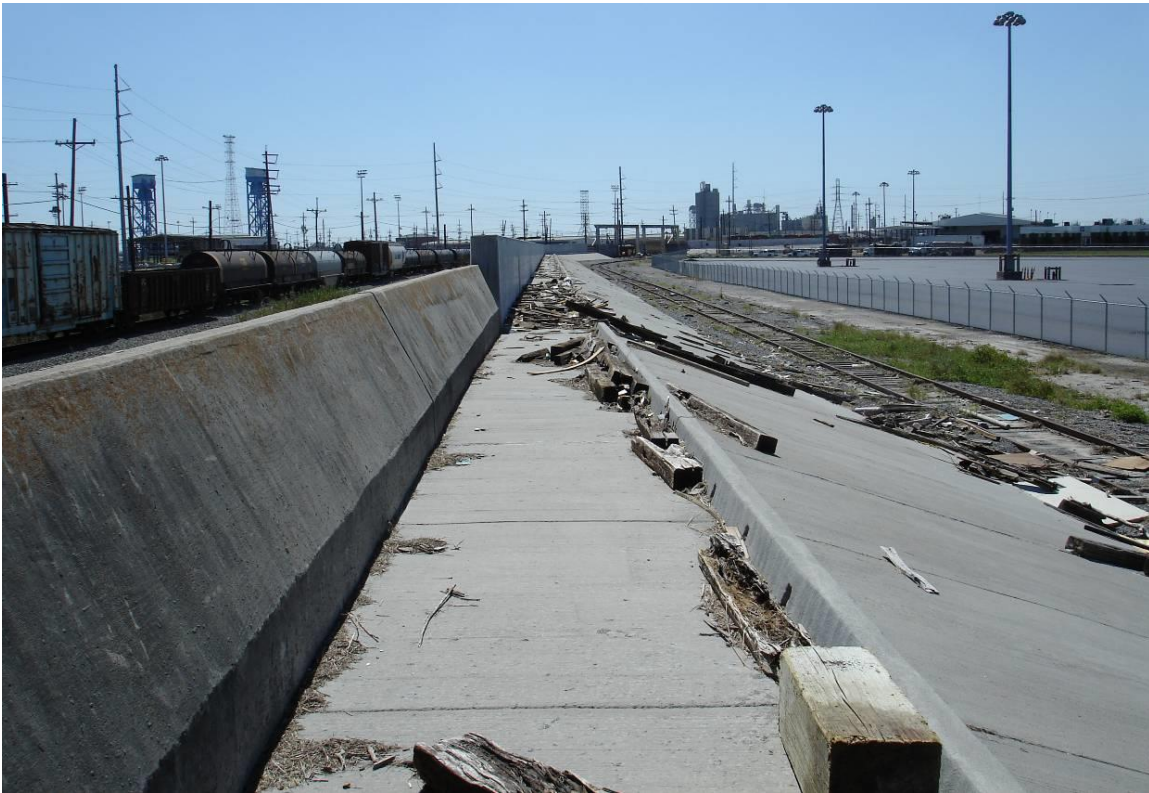
Figure 6. I-wall and splash apron, IHNC west along France Road; new L-wall and splash apron in background. (October 2, 2008, 90.0272° W, 90.0272° W)

At the transition between the new L-wall and the old I-wall (Figure 6), there was storm debris left on top of and behind the higher L-wall, while the top of the lower I-wall was left clean. It is possible that the water elevation or waves during the peak storm surge exceeded the top of the old I-wall on a more consistent basis (elevation of about 4.3 m [14 ft], NAVD88) at this location, sweeping wave debris from the wall top.

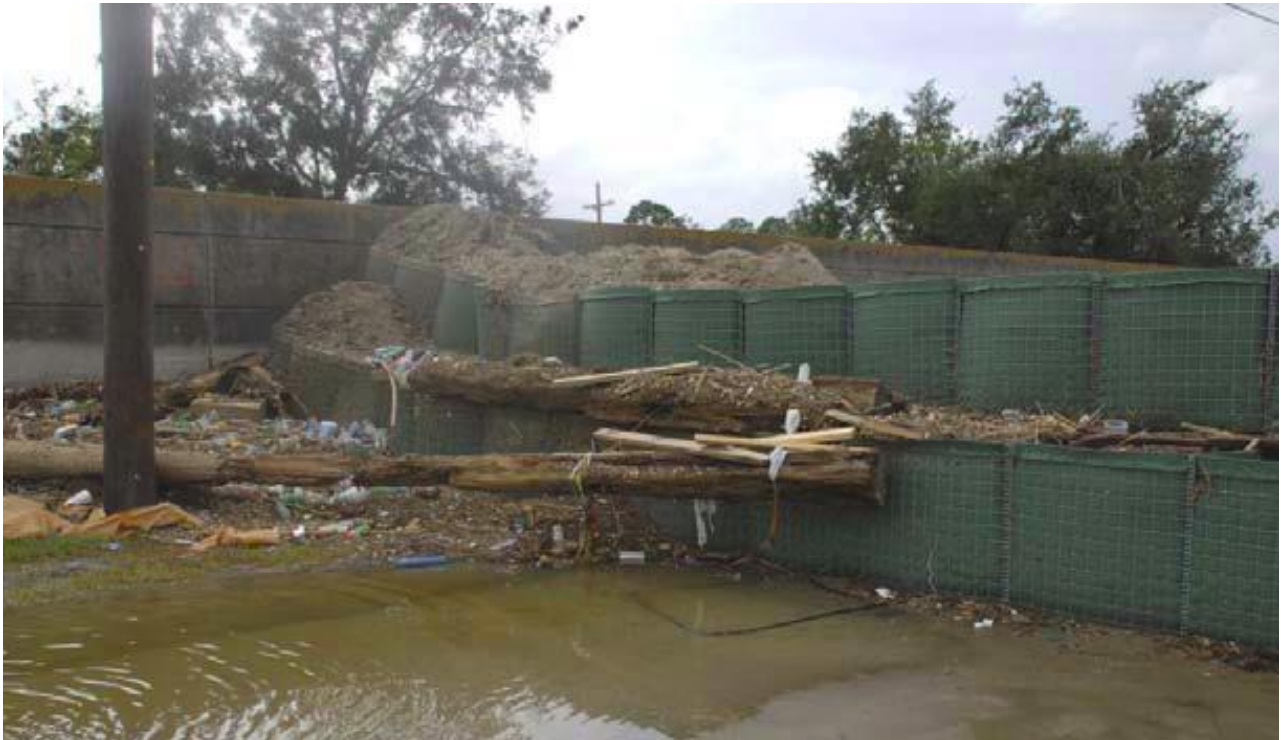
Figure 31. End of temporary bin wall at tie-in to I-Wall, post-Gustav (September 2008, 30.0122° N, 90.0313° W, http://www.mvn.usace.army.mil/HPS/Status%20Report%20Newsletters/Sept_9_2008.pdf)
