## Reconnaissance of the New Orleans Hurricane and Storm Damage Risk Reduction System after Hurricane Gustav

**ABSTRACT:** On October 2 and 3, 2008, a group of civil engineers sponsored by the National Science Foundation (NSF) and organized by the Geoengineering Extreme Events Reconnaissance (GEER) Association, visited the New Orleans area to assess levee performance during hurricane Gustav. This paper summarizes the team's observations and understanding of the state of the New Orleans Hurricane and Storm Damage Risk Reduction System (HSDRRS) in the fall of 2008 and the performance of elements of the HSDRRS during Hurricane Gustav. The fundamental conclusion was that the HSDRRS performed well under the surge and wave stresses generated by Gustav. The team's observations led to lessons about dangers to floodwalls from boats and barges, the importance of timely preparation for hurricanes, erosion resistance of clay levees, and the need for continued emphasis on evacuation for life protection.

International Journal of Geoengineering Case Histories, Volume 5, Issue 4, pp. 129-154, doi: 10.4417/IJGCH-05-04-

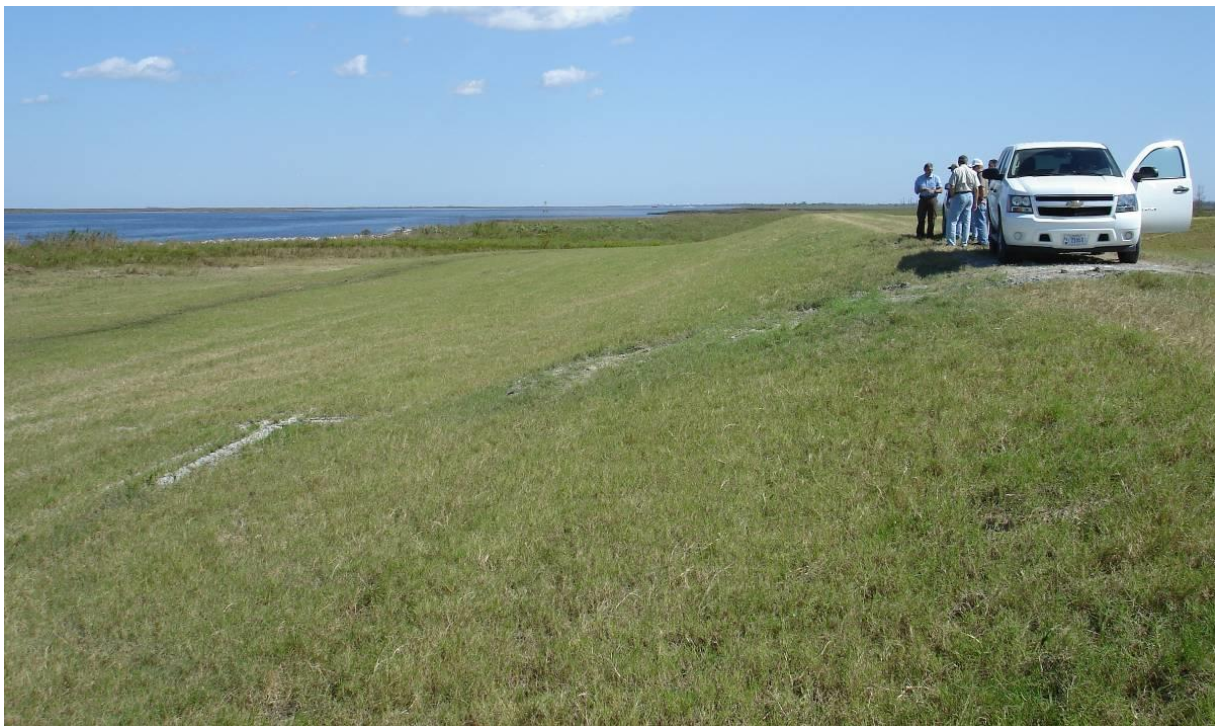
Earthen Levee Reconstruction – The USACE designed and constructed repairs and improvements to the HSDRRS earth levees with two main purposes: (1) to raise the level of protection so that the likelihood of overtopping would be lessened, and (2) to improve the capacity of levees to withstand erosion during overtopping by using clay instead of silty sand fill. Figure 2 shows the eastern part of the HSDRRS plan along the Mississippi River Gulf Outlet (MRGO), which is a typical example of the reconstructed earthen levees, noting the elevations of the pre-Katrina levee crests (blue boxes) and the June 2008 levee crests (brown boxes). Figure 3 is a photograph of the raised earth levee at the southeast corner of the HSDRRS along the MRGO, which is a typical example of the reconstructed earthen levees.

Figure 3. Southeast corner of the MRGO levee, flood side. (October 2, 2008, 29.8889°N, 89.7617°W)

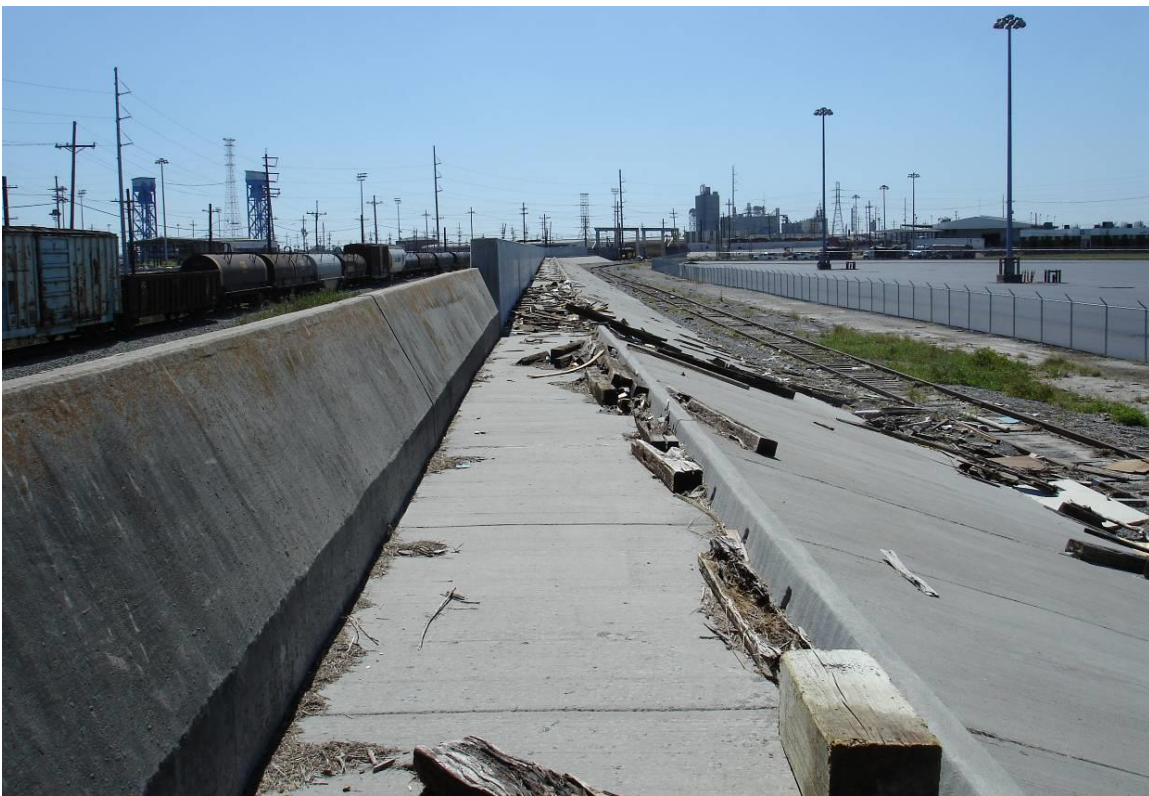
Figure 6. I-wall and splash apron, IHNC west along France Road; new L-wall and splash apron in background. (October 2, 2008, 90.0272° W, 90.0272° W)

At the transition between the new L-wall and the old I-wall (Figure 6), there was storm debris left on top of and behind the higher L-wall, while the top of the lower I-wall was left clean. It is possible that the water elevation or waves during the peak storm surge exceeded the top of the old I-wall on a more consistent basis (elevation of about 4.3 m [14 ft], NAVD88) at this location, sweeping wave debris from the wall top.

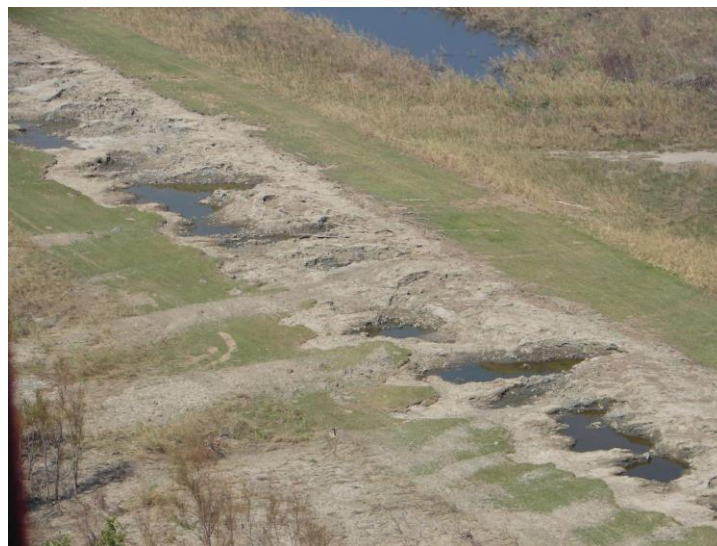
The frontage levees along the Mississippi River Gulf Outlet (MRGO) channel are the closest elements of the HSDRRS to the open waters of the Gulf. These earthen embankments experienced the earliest and highest water levels during both Gustav and Katrina. The high-water levels during Katrina overwhelmed the MRGO frontage levees, with overtopping along the entire stretch of the MRGO and eroded significant lengths of the levee. Figure 11 shows a section of the MRGO frontage levee and the typical extent of the erosion damage caused by the Katrina overtopping.

Figure 11. Post-Katrina MRGO frontage levee. (October 14, 2005, ~89.8° W, ~29.9° N, L. Harder)

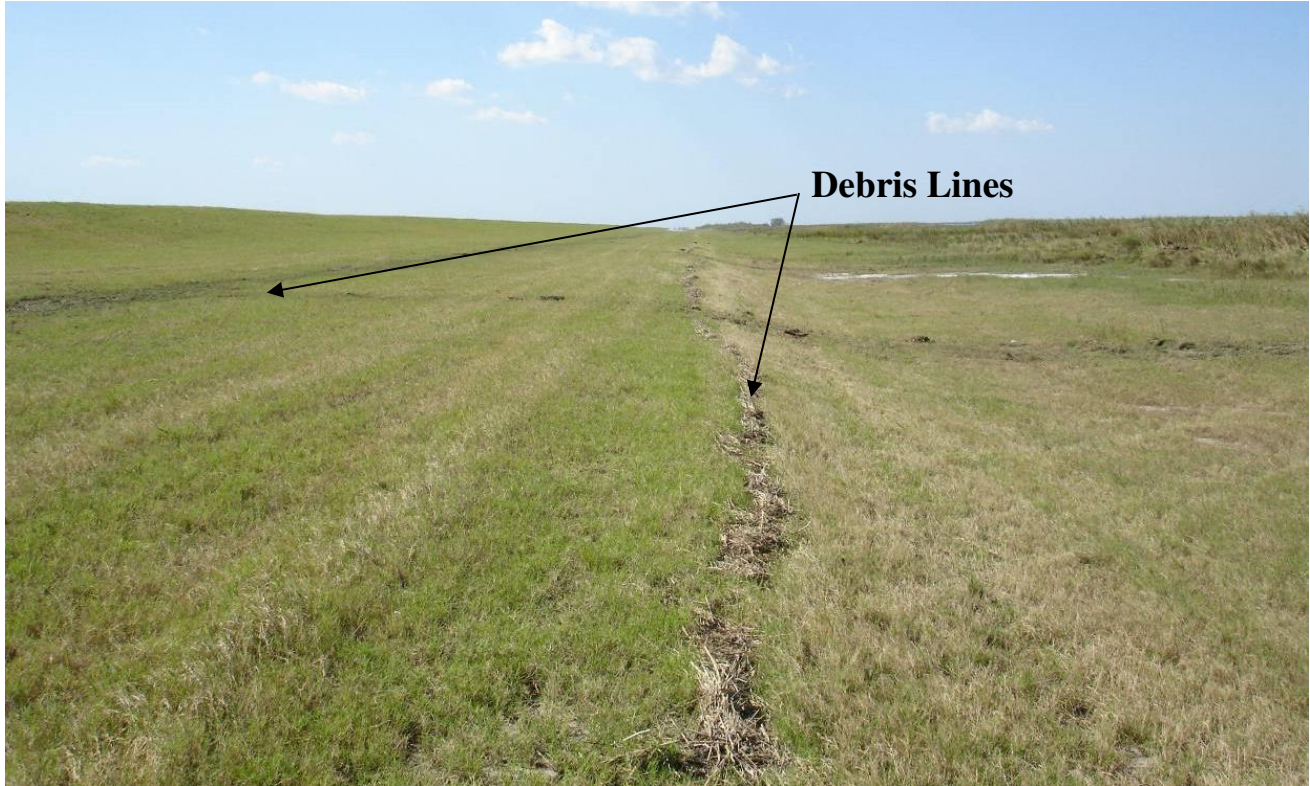
The team observed no signs of either erosion or overtopping during Gustav along the southeast sections of the MRGO frontage levee, which the team believes was representative of the MRGO frontage levees. Based on the limited debris lines along the levee, the high water levels during Gustav were well below the crest of these rebuilt and elevated earthen embankments. The wave and current actions of Gustav also appeared to have caused no erosion on the earth embankments. Figure 12 shows a typical view of the MRGO frontage levee embankment in October 2008.

*Figure 12. MRGO frontage levee, flood side, looking northwest. Upper debris line, believed to be due to Gustav, was cleared prior to our visit, probably as part of the ongoing efforts to maintain the protective grass cover. The lower debris line may represent the high-water level during hurricane Ike, which followed Gustav in September 2008. (October 2, 2008, 29.8889°N, 89.7617°W)*

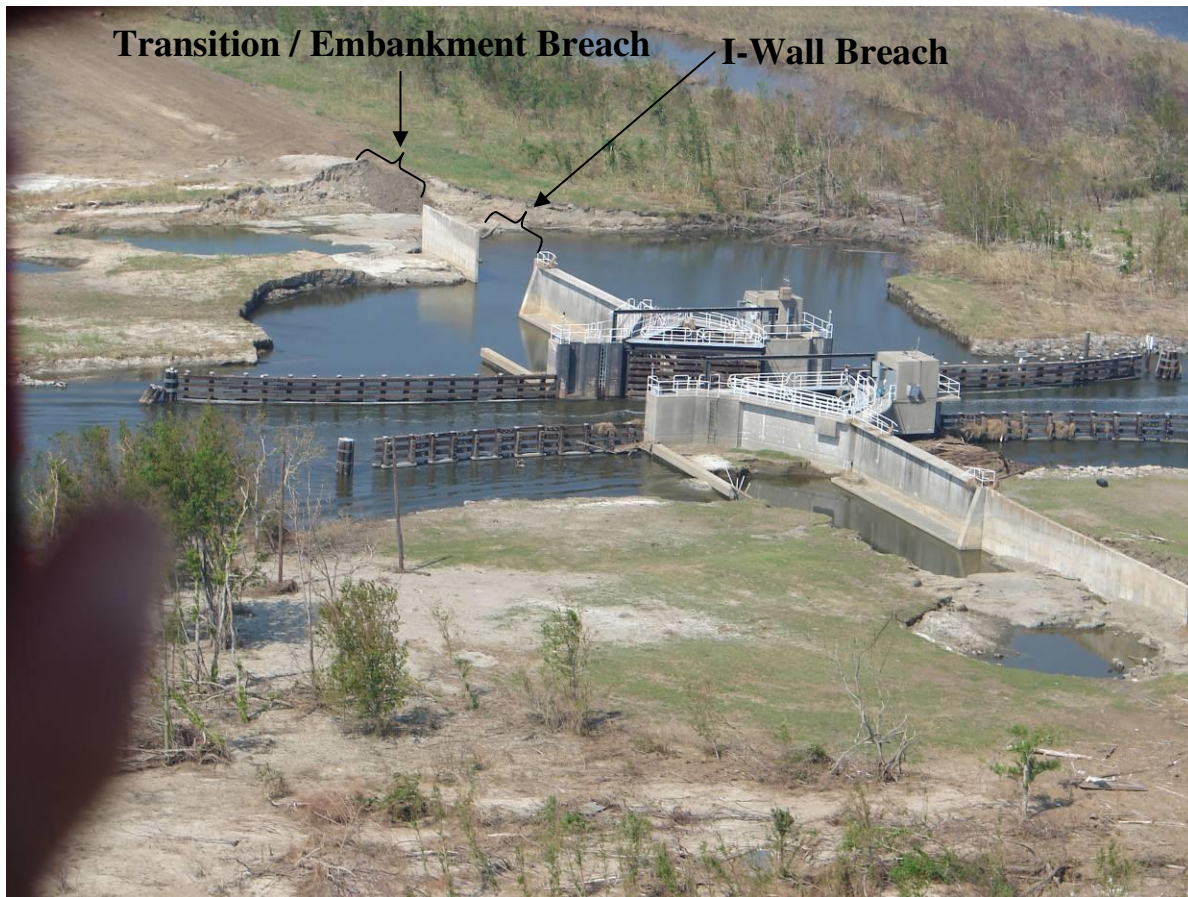
The Bayou Dupree gate structure on the MRGO suffered several severe breaches during Katrina, which overtopped the entire structure by 0.6 to 1.5 m (2 to 5 ft). Figure 13 is an October 2005 photo of the gate structure following Katrina, showing breaches at the I-wall section and at the transition from the I-wall to the embankment.

Figure 13. Post-Katrina Bayou Dupree gate. (October 14, 2005, 29.935° N, 89.837° W, L. Harder)

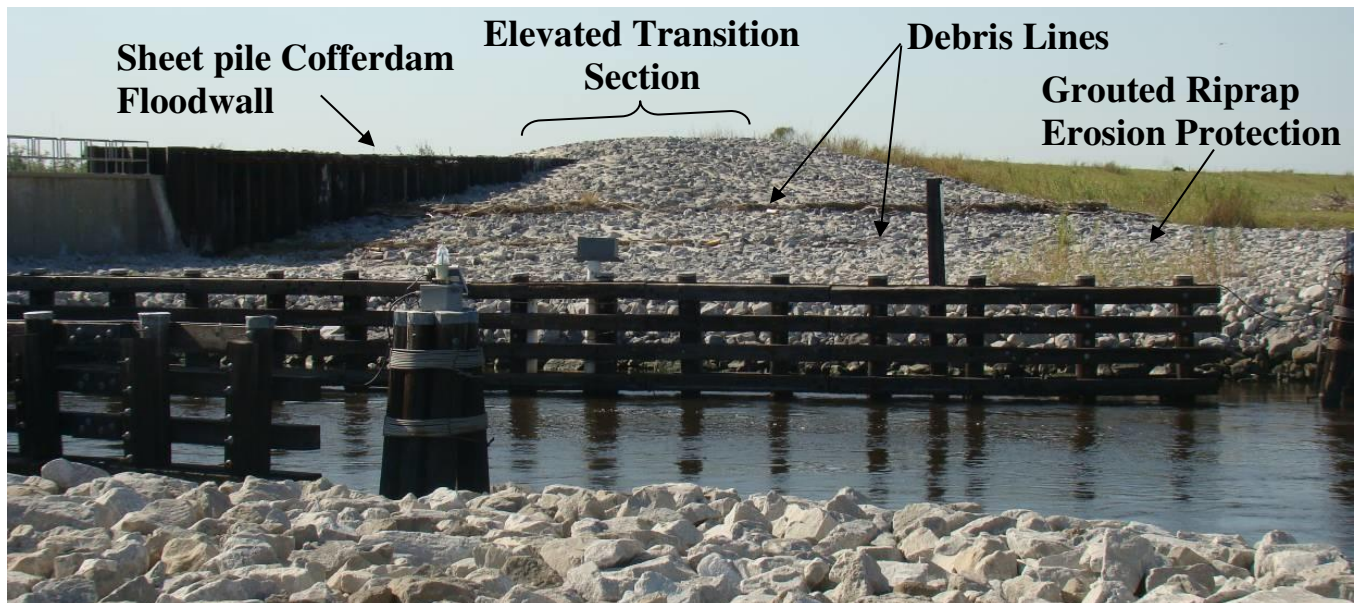
Figure 14 shows the improvements constructed by the USACE to the same Bayou Dupree gate structures. The concrete sheet pile I-wall was replaced with a steel sheet pile cofferdam section, and the transitions to the earthen levees on both sides of the gate were elevated and covered with grouted riprap. The use of grouted riprap to harden vulnerable areas around the gate was extensive, as illustrated in Figure 14. UngROUTED riprap was placed as erosion protection at the toe areas of grouted riprap. The team observed no signs of erosion or damage from Gustav's high water and waves at or near the gate. The limited debris line on the northwest flank appeared to indicate that the highest waters from Gustav were about 1 to 1.5 m (3 to 5 ft) below the crest of any of the gate structure elements (see Figure 14).

Figure 14. Bayou Dupree gate, northwest flank, MRGO side, looking east. The lower debris line may represent the high-water level during Hurricane Ike. (October 2, 2008, 29.9352° N, 89.8358° W)

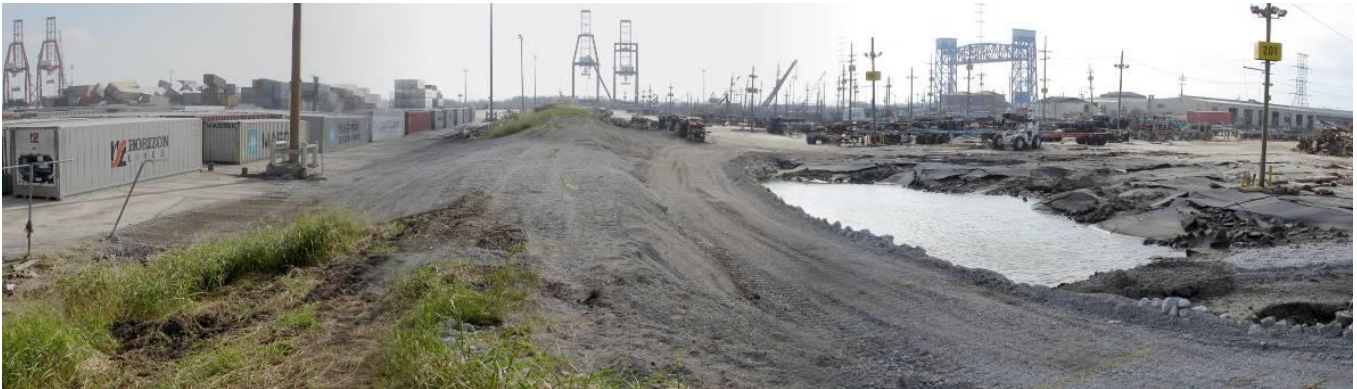
*Figure 16. Post-Katrina IHNC West levee breach site, October 2005 (The breach had been temporarily repaired; note scour hole). (October 4, 2005, 29.9880° N, 90.0263° W, L. Wooten)*

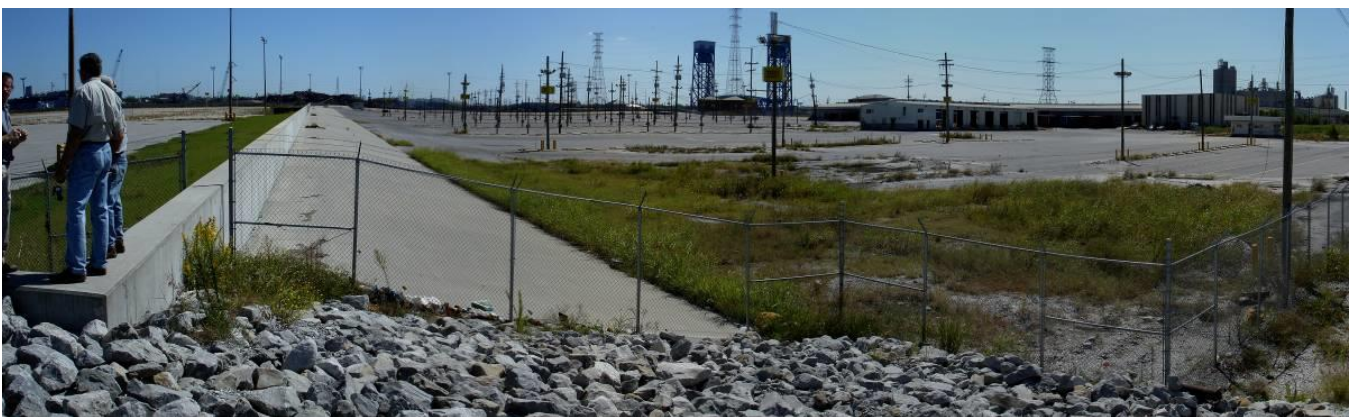
*Figure 17. IHNC West new embankment and floodwall at location of breach, as was shown in Figure 14, in October 2008. (October 2, 2010, 29.9880° N, 90.0263° W)*

Post-Katrina repairs and improvements of these failed and distressed sections included raising and buttressing embankment sections, armoring of embankment-concrete floodwall transitions, replacement of I-walls with L-walls (T-walls were not used due to space constraints), and buttressing of pre-existing I-wall sections to reduce the stick-up height (the height of wall above finished grade). Figures 16-19 show the post-Katrina (October 2005) and post-Gustav (October 2008) conditions at the locations of the earth levee breach (Figures 16 and 17) and of the I-wall breach (Figures 18 and 19) that occurred during Katrina.

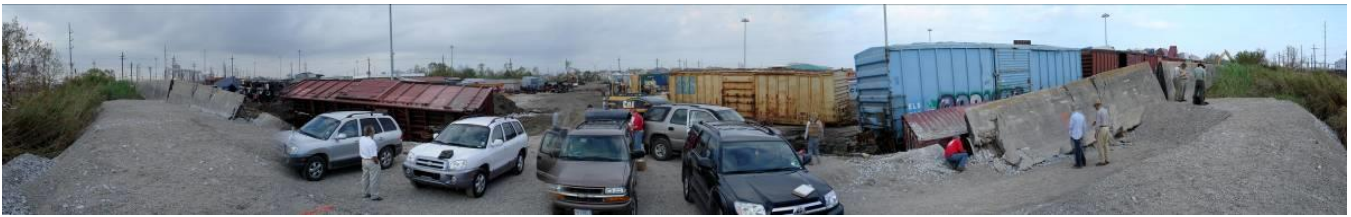
Figure 18. IHNC West I-wall Katrina breach site, October 2005. (October 4, 2005, 29.9899° N, 90.0272° W, L. Wooten)

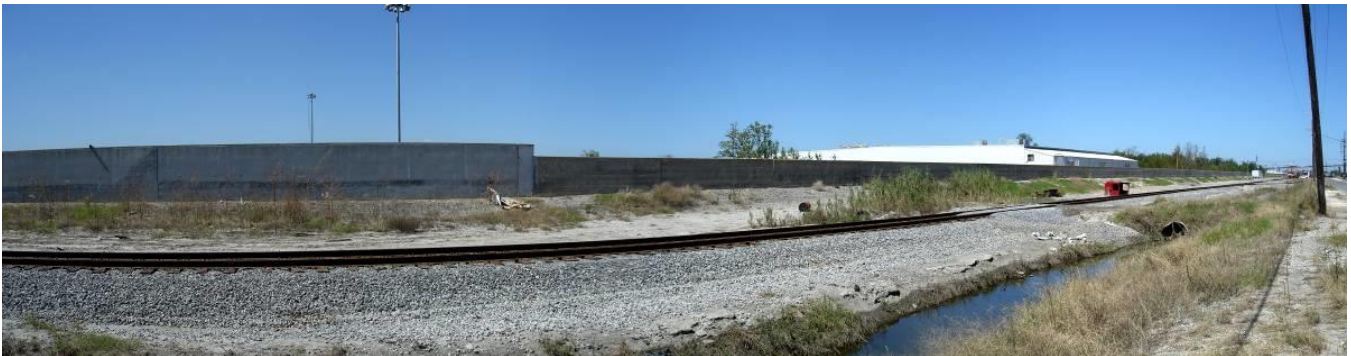
Figure 19. New L-wall and old I-wall transition near location of Katrina I-wall breach on IHNC West. (October 2, 2008, 29.9899° N, 90.0272° W)

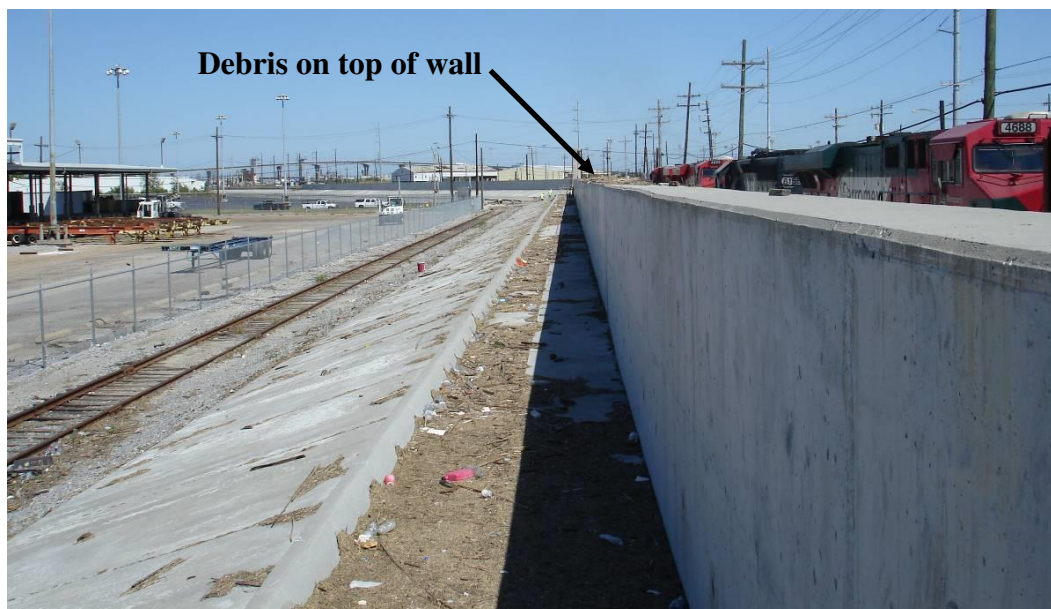
The repairs and improvements of these sections of the hurricane protection appeared to have performed well in light of clear evidence of wave overtopping. Figure 20 shows the debris left by overtopping waves on the protected side of one section of new L-wall along the IHNC West.

Figure 20. Protected side of new L-wall along IHNC West. Note debris left by overtopping on floodwall and slope protection. October 2008. (October 2, 2008, 29.9899° N, 90.0272° W)

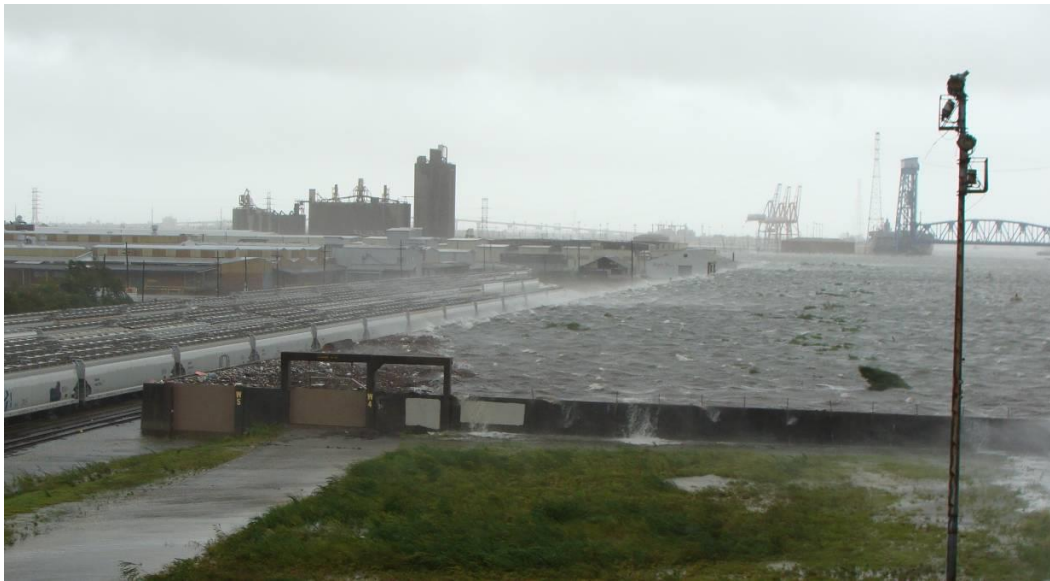
Clear photographic evidence showed wave overtopping during Hurricane Gustav along the T-wall located on the west side of the IHNC just north of Claiborne Avenue (see Figure 15 for location, and Figures 21 and 22 for photographs during hurricane). This T-wall had previously survived Hurricane Katrina. A concrete splash apron at the toe of the wall on the protected side was added after Katrina to protect from erosion. The wall performed well during Gustav. During the field reconnaissance, the team saw no noticeable sign of distress in the wall, including the joints between concrete panels and in the new concrete splash apron. There was evidence of minor erosion beyond the splash apron on the protected side as well as debris left by the overtopping (Figure 23).

*Figure 21. Photograph from September 1, 2008, of Gustav's storm surge. Photograph taken from Claiborne Ave. Bridge looking north. The waves are overtopping the T-wall. (September 1, 2008, 29.969° N, 90.027° W, USACE)*

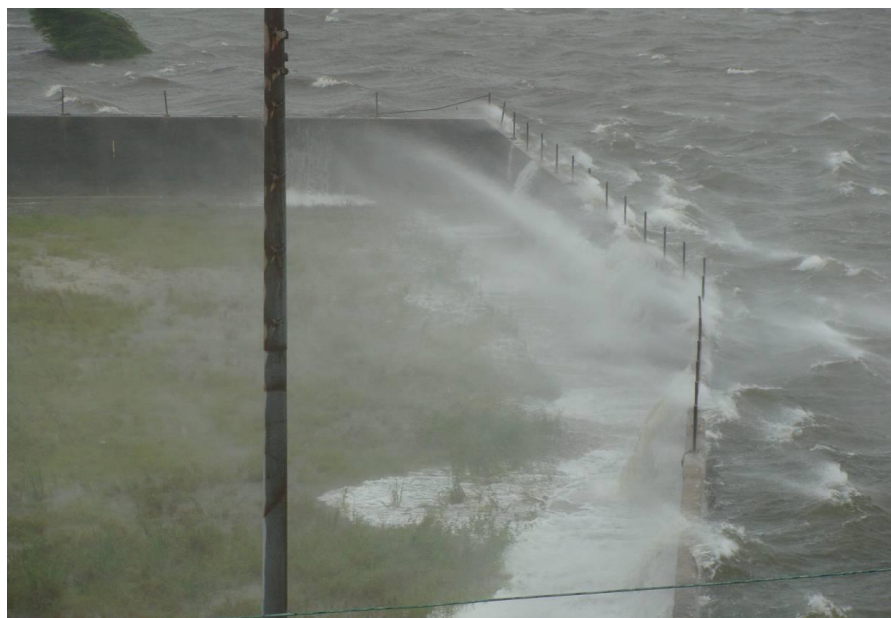
*Figure 22. Gustav's storm surge along IHNC East, taken from Claiborne Ave. Bridge looking north at T-wall southeast on September 1, 2008. (September 1, 2008, 29.969° N, 90.027° W, USACE)*

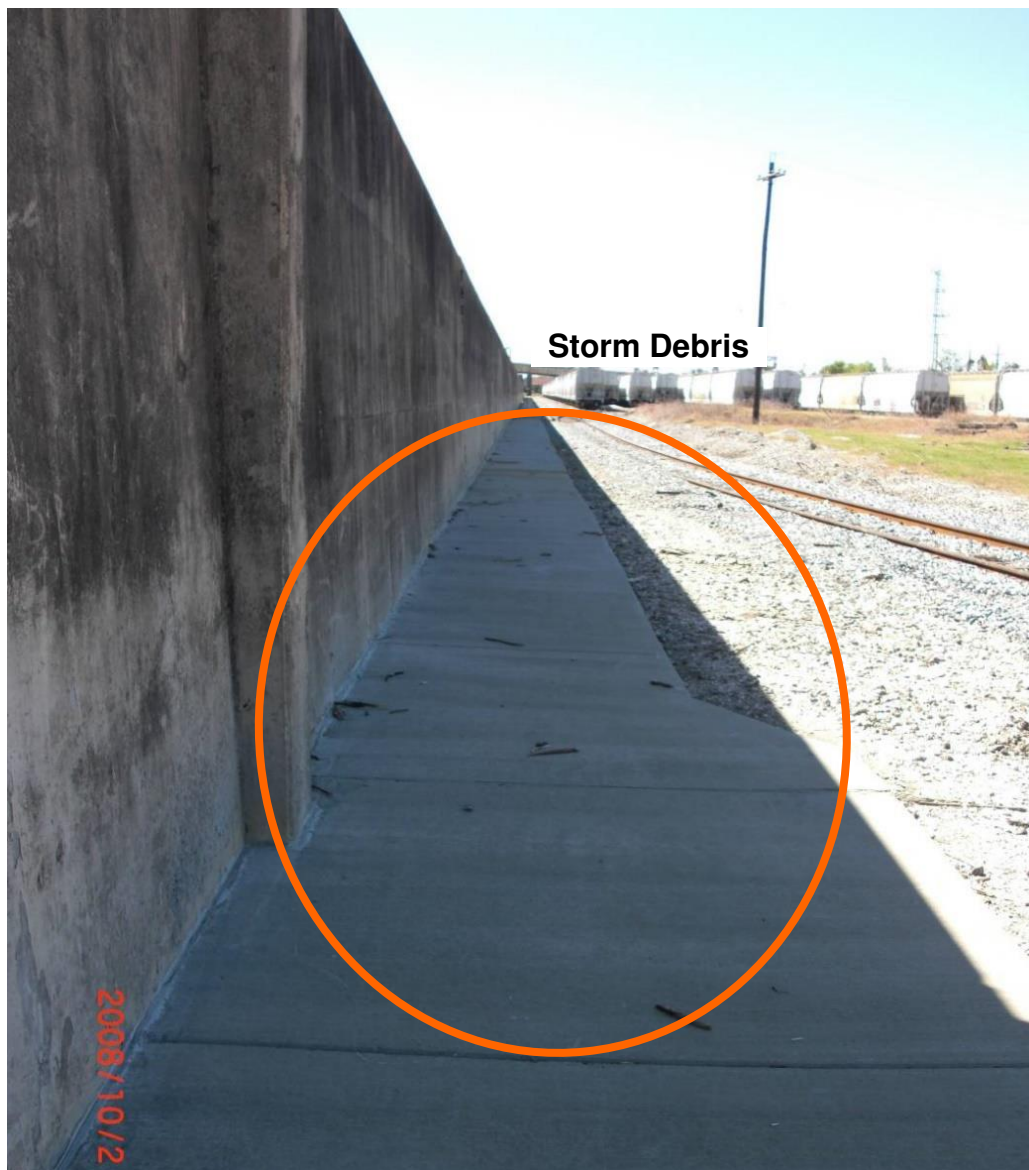
*Figure 23. Photograph from October 2, 2008, of IHNC West T-wall (same section as shown during Gustav in Figures 20 and 21). (October 2, 2008, 29.970° N, 90.026° W)*

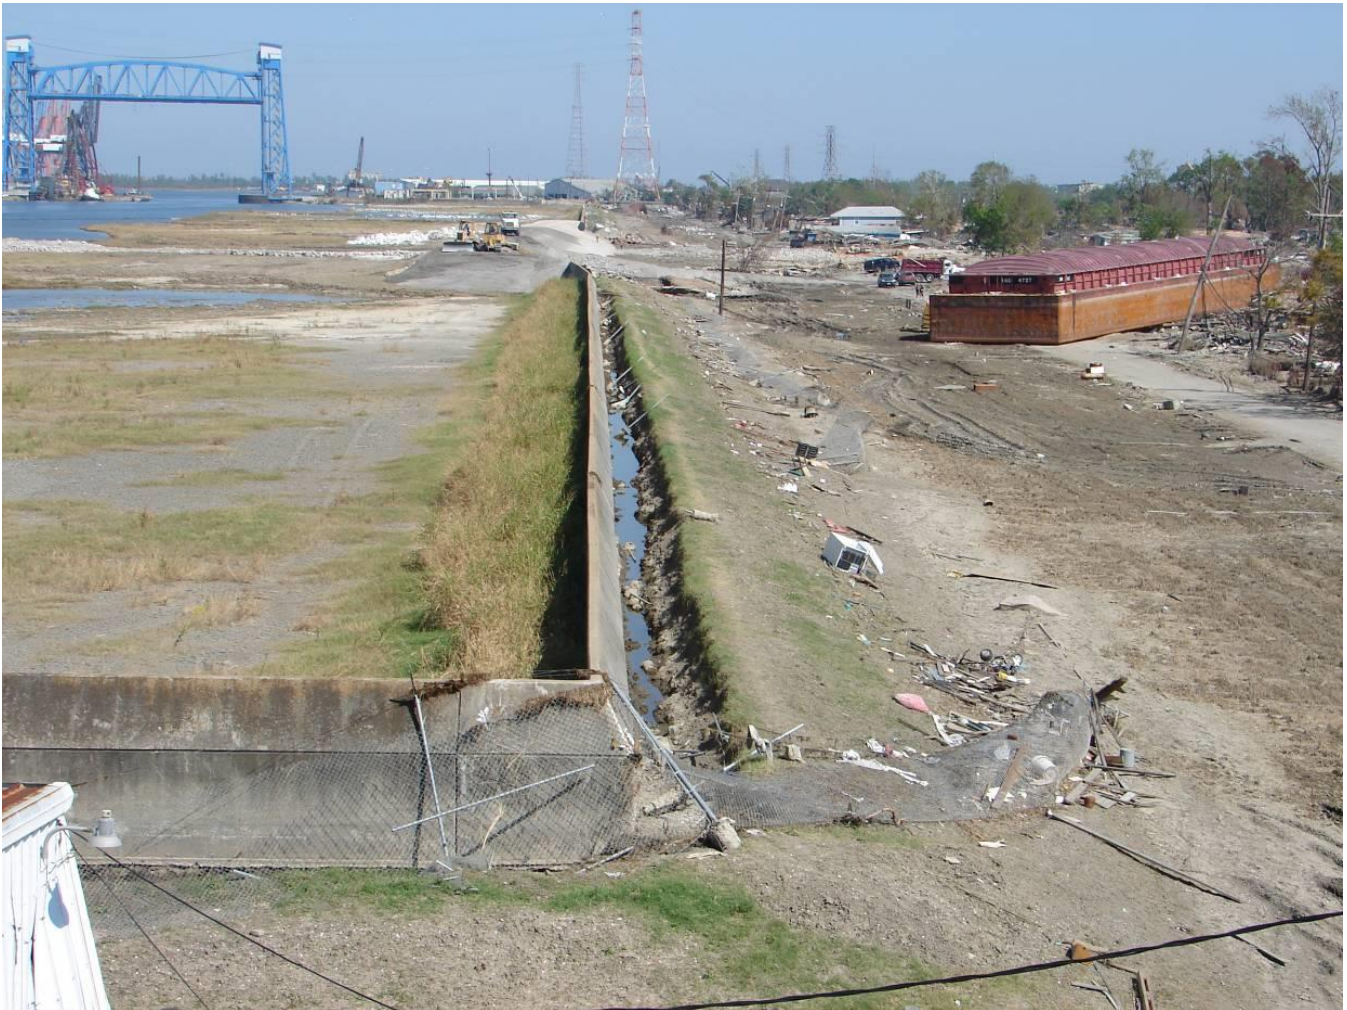
Two breaches occurred during Hurricane Katrina on a stretch of I-wall between Claiborne and Florida Avenues on the east side of the IHNC. Water flow through these breaches flooded the Lower 9<sup>th</sup> Ward. The suspected cause of the southern-most breach was loss of soil support due to overtopping erosion on the protected side of the I-wall (Figure 24), while the suspected cause of the northern-most breach was a stability failure before the surge level reached the top of the wall.

*Figure 24. Post-Katrina IHNC East floodwall with southern-most breach and the scour, looking north, from the Claiborne Avenue Bridge. (October 11, 2005, 29.9685° N, 90.0238° W, L. Harder)*

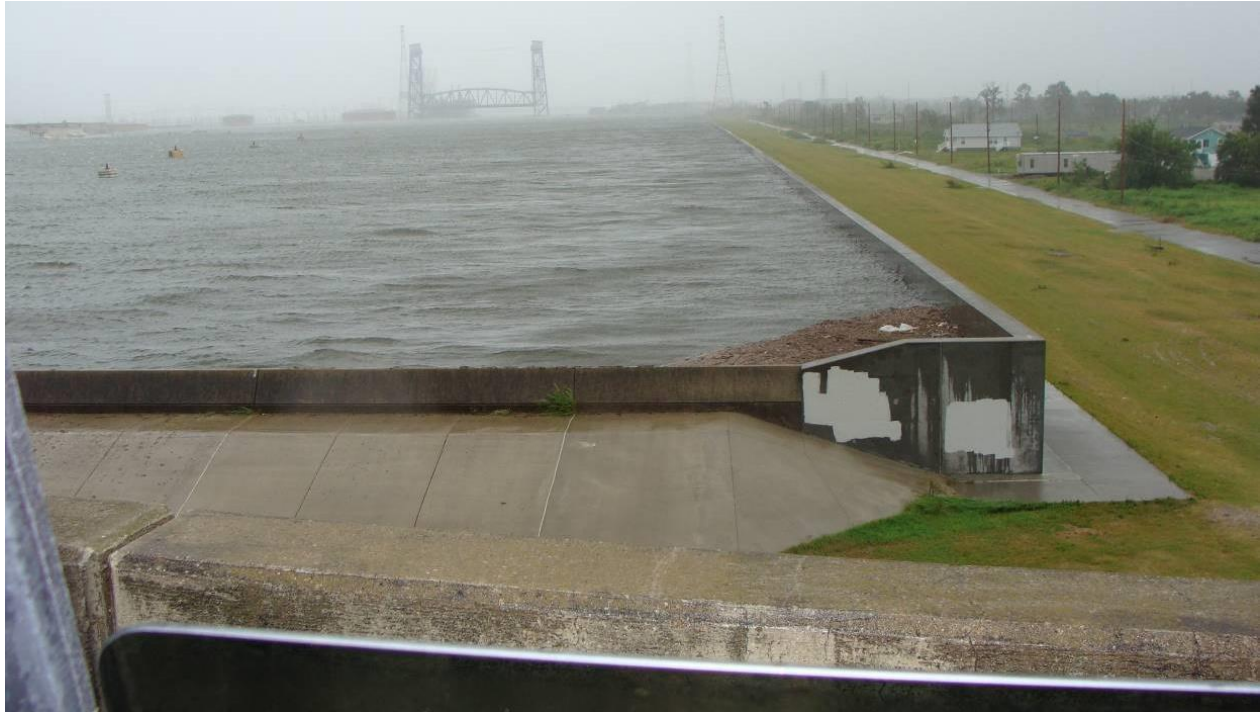
Figure 25. Gustav storm surge at IHNC East floodwall, taken from the Claiborne Avenue Bridge, looking north toward Florida Avenue Bridge (seen in background) from a perspective similar to that in Figure 18. (September 1, 2008, 29.9686° N, 90.0241° W, USACE)

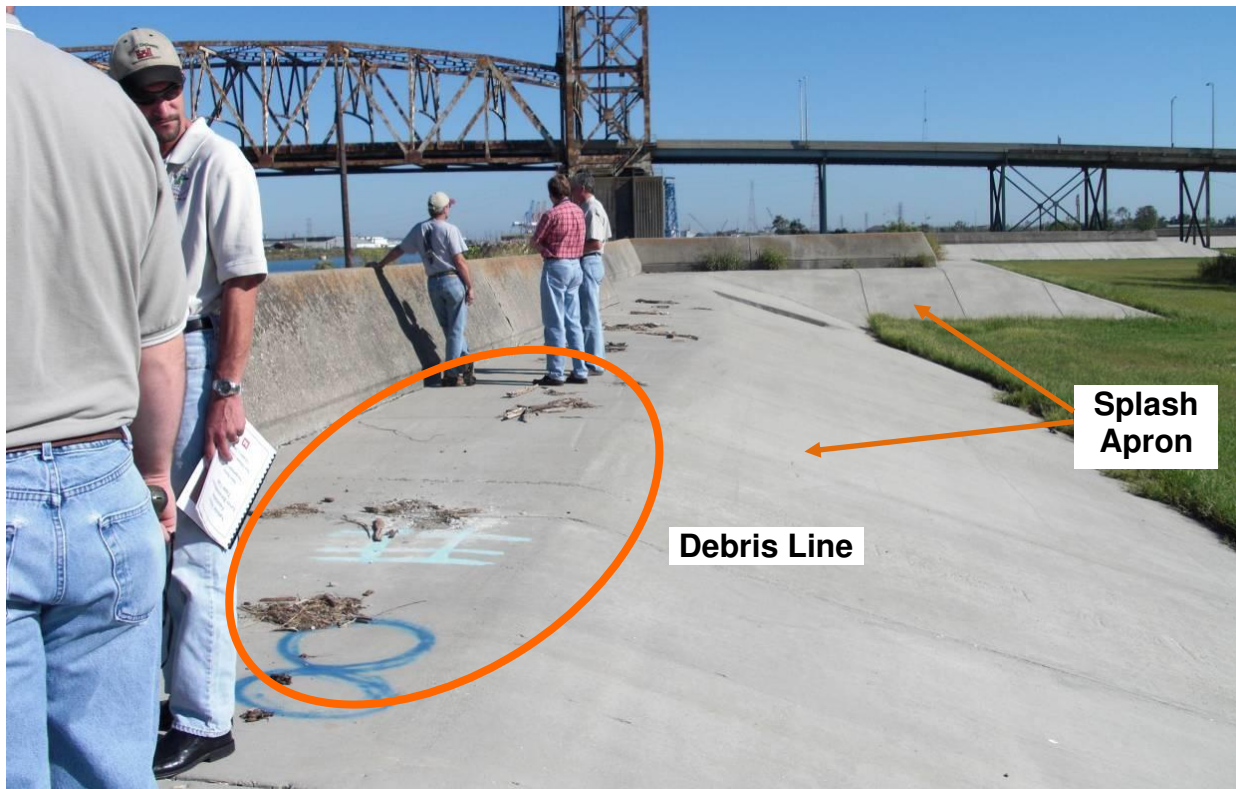
Along the east side of the IHNC south of Claiborne Avenue, the peak still water level was near the top of the old I-wall, and waves apparently overtopped the wall. The top of this wall was at about an elevation of 4.0 m (13 ft), NAVD88. After Gustav, the wall showed no noticeable signs of distress such as movement of the wall due to the surge load or erosion at the toe due to waves overtopping the wall (Figure 26). Also, there was no visible evidence of underseepage on the protected side.

Figure 26. Hardened I-wall along east side of the IHNC south of Claiborne Avenue looking north (IHNC is to the left and Lower 9<sup>th</sup> Ward / Holy Cross to the right). (Oct. 2, 2008, 29.9682° N, 90.0250° W)

This entire stretch of I-wall, even the section between the two breaches that survived Katrina, was replaced with a T-wall (Figures 3, 4, and 25). The I-wall section south of Claiborne Avenue that did not breach in Katrina was left in place but was reinforced with a larger earthen berm and a buttressing structural concrete splash apron to strengthen the section, reduce the wall height, and provide overtopping scour protection (Figure 26).

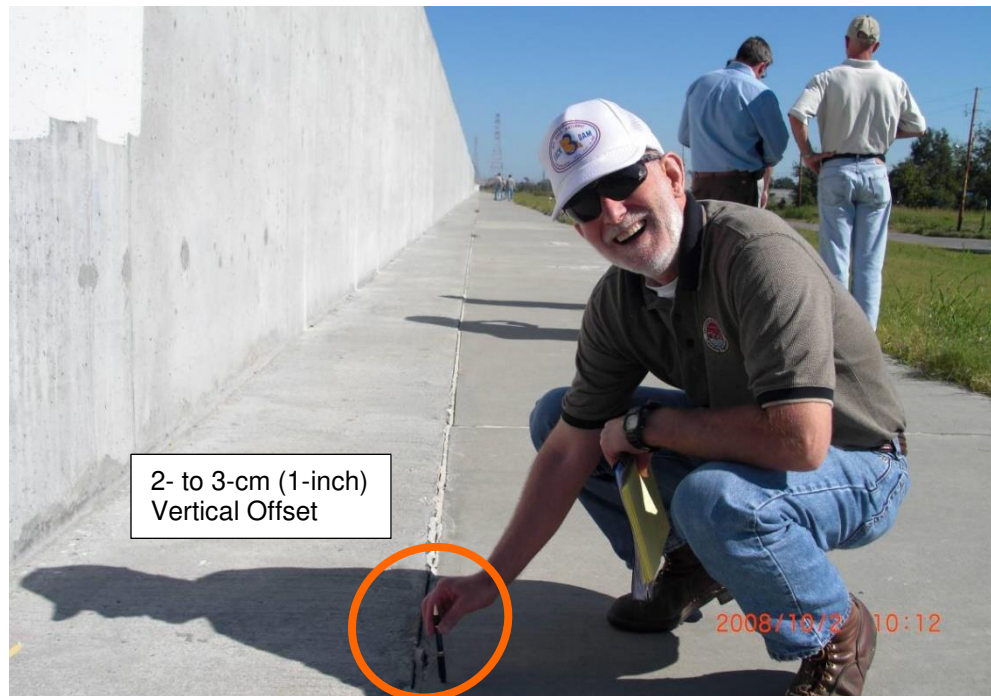
The team noted a 2- to 3-cm-deep (~1-inch-deep) vertical offset between the pile-supported base of the T-wall and the slab-on-grade concrete splash apron (Figure 27). This offset, if the splash apron was cast to be flush with the base of the wall in the summer of 2006, may indicate a differential settlement of the apron relative to the pile-supported T-wall occurring at a rate of about 1 cm per year (0.5 inch per year) in the upper 21 m (70 ft) of the soil profile.

Figure 27. New T-wall section along the east side of the IHNC between Claiborne and Florida Avenues (shown in Figure 23 during Gustav). (October 2, 2008, 29.9691° N, 90.0236° W)

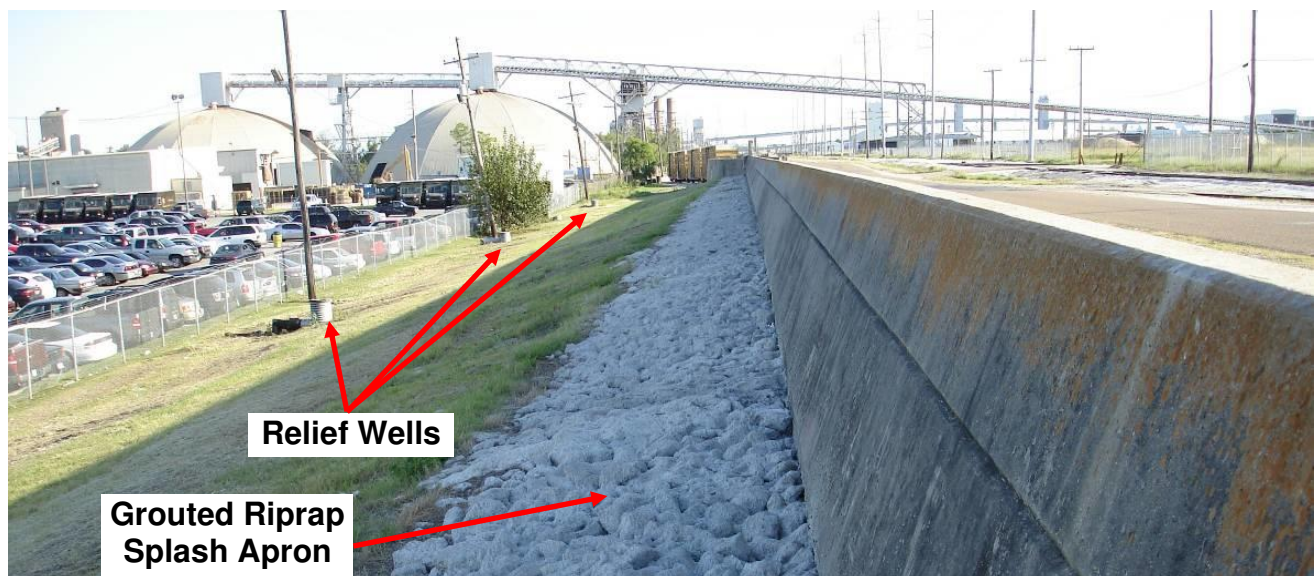
The team visited the section of the HSDRRS near East Morrison Road in New Orleans East to investigate the USACE preliminary reports of damage to the relief wells and of soil moving through the wells. Much of the HSDRRS in this section of New Orleans East along the northeast section of the IHNC consisted of I-walls set in earthen embankments with regularly spaced relief wells located at the toe of those embankments (see Figures 28 and 29). These features were in place at the time of Katrina. After Katrina, the USACE added a grouted riprap splash apron on the protected side of the I-walls.

Figure 28. IHNC floodwall near East Morrison Road. Note splash apron (center) and relief wells (left). (October 2, 2008, 30.0248° N, 90.0295° W)

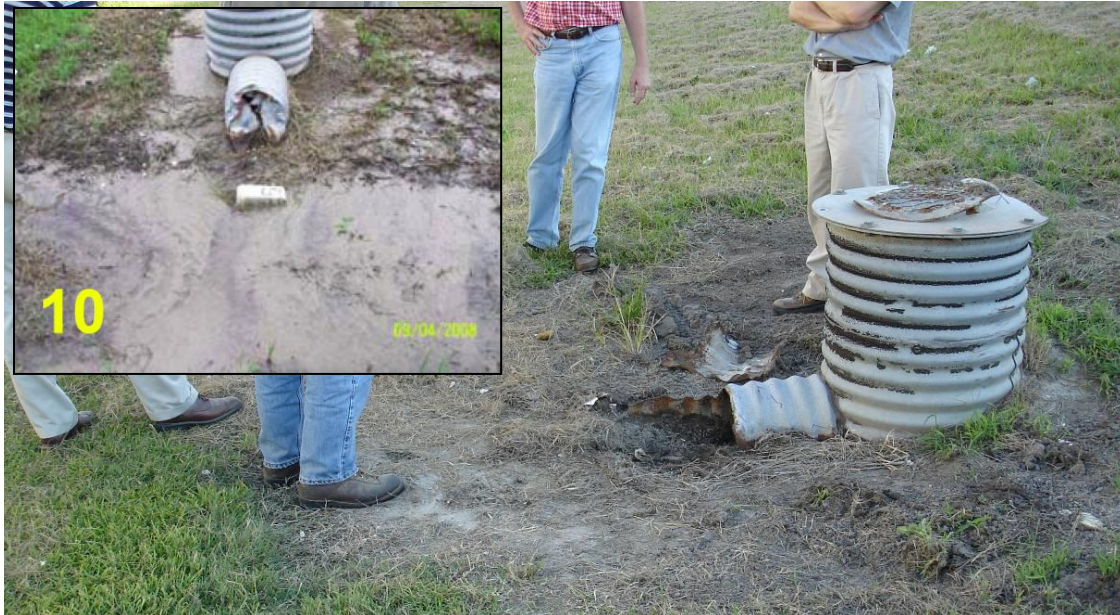
The team observed no signs of damage to the HSDRRS near East Morrison Road due to Hurricane Gustav. The corrugated metal protective casings over the relief well outlets were in various states of deterioration. The team also did not see evidence of extensive sand migration out of the wells, although our observations were made more than a month after Gustav had swept through the region, and the team did not inspect all wells. The inset photo in Figure 28 was taken from the USACE Situation Report dated September 5, 2008, which shows a damaged outlet casing and sand that appears to have discharged from the well.

Figure 29. Relief well cover, as of October 2008, with inset taken from the USACE Hurricane Gustav Damage Assessment Team SITREP on September 5, 2008. (October 2, 2008, 30.0249° N, 90.0294° W)

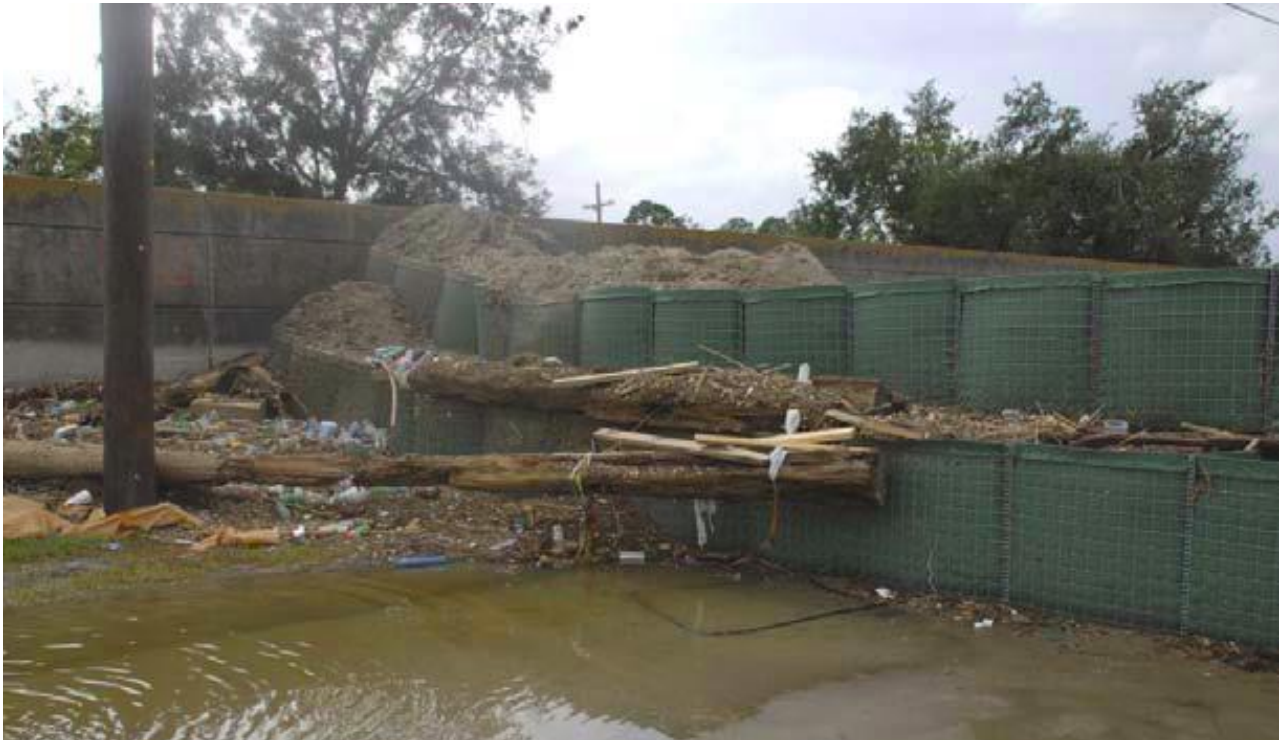
*Figure 31. End of temporary bin wall at tie-in to I-Wall, post-Gustav (September 2008, 30.0122° N, 90.0313° W, [http://www.mvn.usace.army.mil/HPS/Status%20Report%20Newsletters/Sept\\_9\\_2008.pdf](http://www.mvn.usace.army.mil/HPS/Status%20Report%20Newsletters/Sept_9_2008.pdf))*

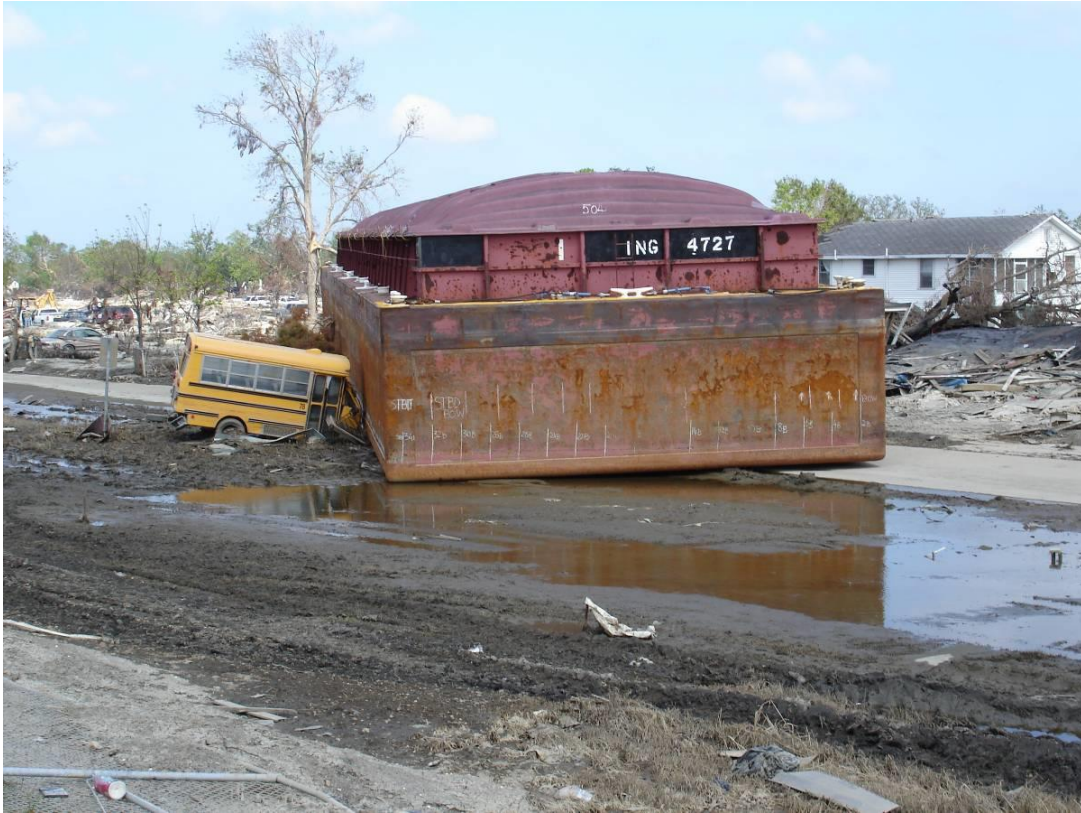
The empty barge that floated into the Lower 9<sup>th</sup> Ward following Katrina and Rita has been well-documented (see Figures 24 and 32). There has been speculation that this barge or another barge could have contributed to the failure of the Lower 9<sup>th</sup> Ward I-wall. The high winds of a hurricane can easily push an empty vessel with enough force to break mooring lines and force the vessel into structures along the IHNC. Such was the case during Hurricane Gustav. The U.S. Coast Guard (USCG) has jurisdiction over the ships and barges in the IHNC.

*Figure 32. Barge in the Lower 9<sup>th</sup> Ward after Katrina. (October 4, 2005, 29.9703° N, 90.0230° W, L. Wooten)*

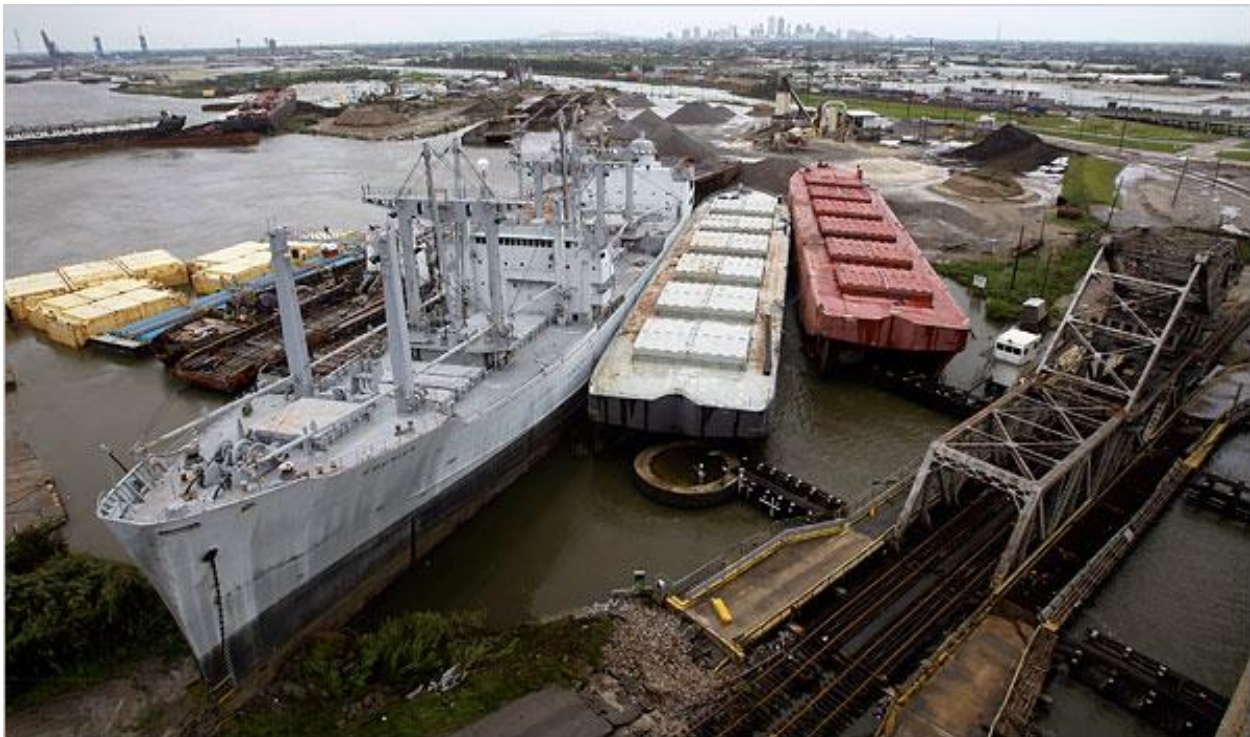
Figure 33 shows how ships and barges were pushed during Gustav against the dolphins protecting the northern railroad bridge that crosses the IHNC just south of the I-10 bridge. This railroad bridge was in the lowered position and thus remained underwater during periods of high water. The Florida Avenue Bridge to the south of these barges and ships was in a slightly raised position so as to be out of the water, but low enough to keep wind loads from having leverage on the support towers. In these positions, both bridges would have confined the ships and barges to the central part of the canal. In preparation for the subsequent hurricane, Ike, the USCG ordered all ships and barges removed from the IHNC.

*Figure 33. Ships and barges pushed against a railroad bridge after Gustav. (September 1, 2008, 30.0050° N, 90.0251° W, Eric Gay, Associated Press)*

- Preparation for a hurricane requires timely action by all responsible parties. Delays by railroads, salvage yards, boat and barge operators, and/or operators of facilities on the flood side of the HSDRRS in clearing potential hazards could put the HSDRRS at risk.
