## Reconnaissance of the New Orleans Hurricane and Storm Damage Risk Reduction System after Hurricane Gustav

**ABSTRACT:** On October 2 and 3, 2008, a group of civil engineers sponsored by the National Science Foundation (NSF) and organized by the Geoengineering Extreme Events Reconnaissance (GEER) Association, visited the New Orleans area to assess levee performance during hurricane Gustav. This paper summarizes the team's observations and understanding of the state of the New Orleans Hurricane and Storm Damage Risk Reduction System (HSDRRS) in the fall of 2008 and the performance of elements of the HSDRRS during Hurricane Gustav. The fundamental conclusion was that the HSDRRS performed well under the surge and wave stresses generated by Gustav. The team's observations led to lessons about dangers to floodwalls from boats and barges, the importance of timely preparation for hurricanes, erosion resistance of clay levees, and the need for continued emphasis on evacuation for life protection.

International Journal of Geoengineering Case Histories, Volume 5, Issue 4, pp. 129-154, doi: 10.4417/IJGCH-05-04-

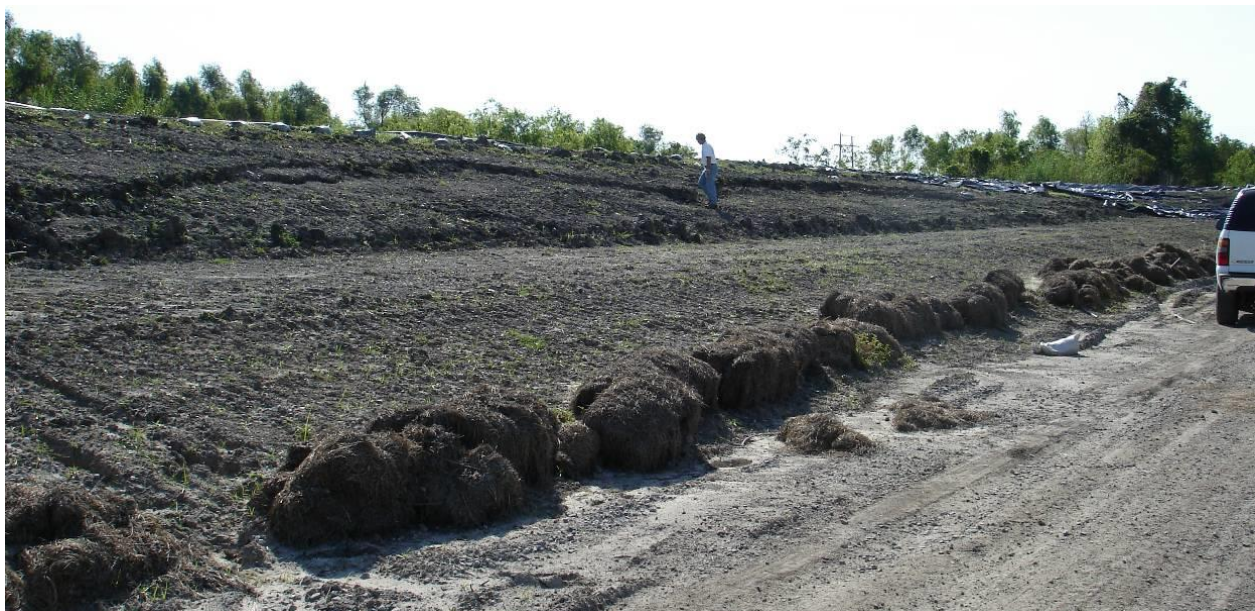
Figure 35. Protected side slope of the Plaquemines Parish back levee and slide.  
(October 3, 2008, 29.8506° N, 89.9085° W)

The non-federal local back levee in Plaquemines Parish was overtopped by Gustav flood levels and was in danger of failure at the location of the slope slide. Desiccation cracks on the levee may have contributed to the slide by allowing overtopping water pressures into embankment zones critical to slope stability. The placement water content, compaction, and organic

- The erosion resistance of non-federal local levees in Plaquemines Parish (not part of the HSDRRS) during overtopping was noted during Katrina. The clay back levees in Plaquemines Parish resisted erosion during Gustav but may have demonstrated a potential vulnerability due to desiccation cracks. Improved control of placement water content and compaction, revised material requirements relative to plasticity and organic content, or landscaping measures such as the establishment of dense vegetation and use of irrigation may be required to prevent desiccation.

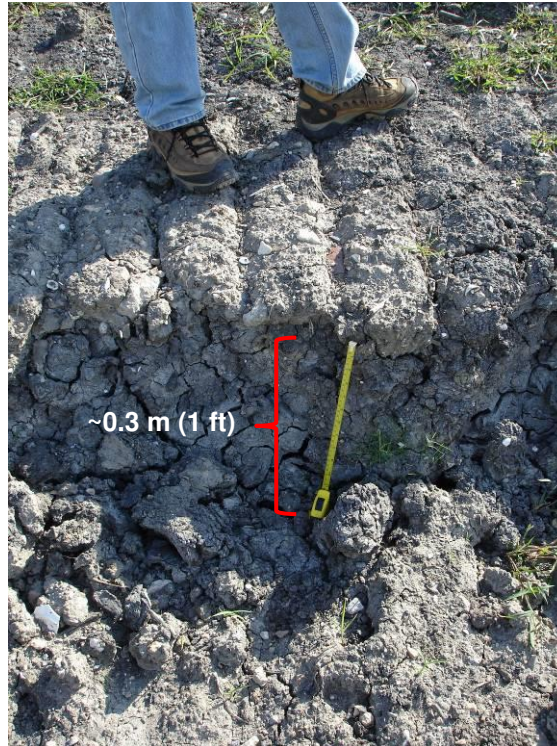
*Figure 36. Scarp above slide on Plaquemines back levee.  
(October 3, 2008, 29.8506° N, 89.9085° W)*
