Reconnaissance of the New Orleans Hurricane and Storm Damage Risk Reduction System after Hurricane Gustav

Reconnaissance of the New Orleans Hurricane and Storm Damage Risk Reduction System after Hurricane Gustav.

International Journal of Geoengineering Case Histories, Volume 5, Issue 4, pp. 129-154, doi: 10.4417/IJGCH-05-04-07

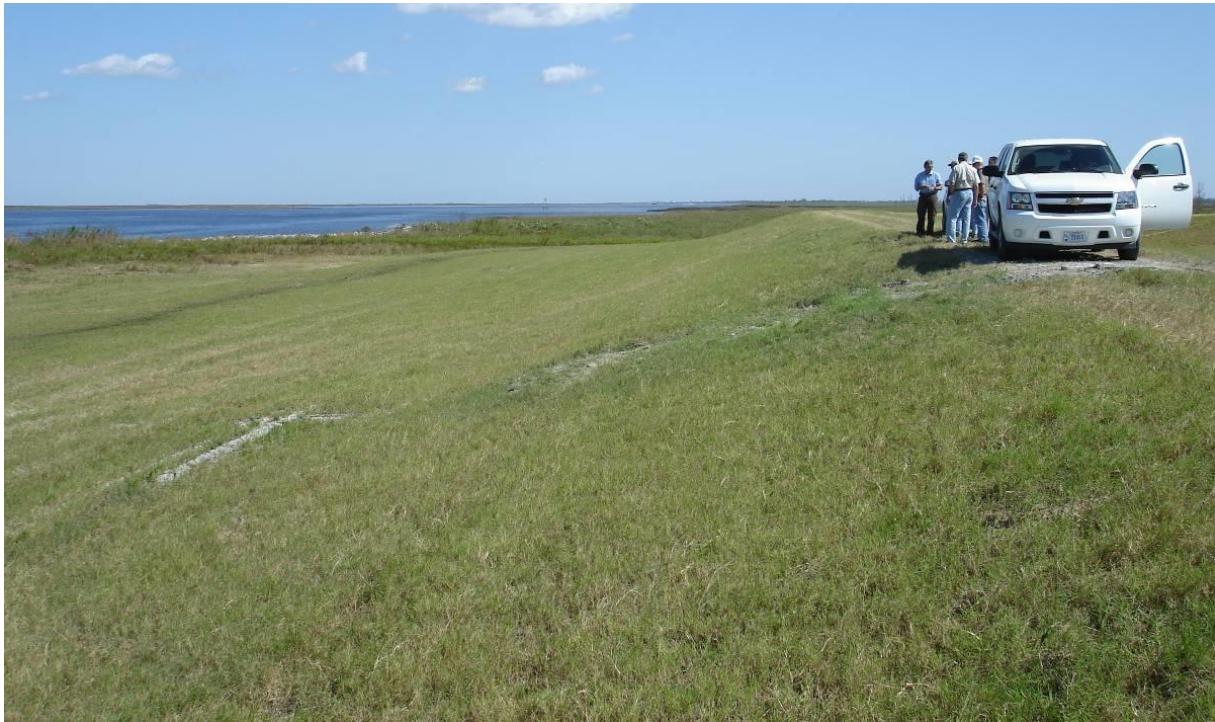
Earthen Levee Reconstruction – The USACE designed and constructed repairs and improvements to the HSDRRS earth levees with two main purposes: (1) to raise the level of protection so that the likelihood of overtopping would be lessened, and (2) to improve the capacity of levees to withstand erosion during overtopping by using clay instead of silty sand fill. Figure 2 shows the eastern part of the HSDRRS plan along the Mississippi River Gulf Outlet (MRGO), which is a typical example of the reconstructed earthen levees, noting the elevations of the pre-Katrina levee crests (blue boxes) and the June 2008 levee crests (brown boxes). Figure 3 is a photograph of the raised earth levee at the southeast corner of the HSDRRS along the MRGO, which is a typical example of the reconstructed earthen levees.

Figure 3. Southeast corner of the MRGO levee, flood side. (October 2, 2008, 29.8889°N, 89.7617°W)

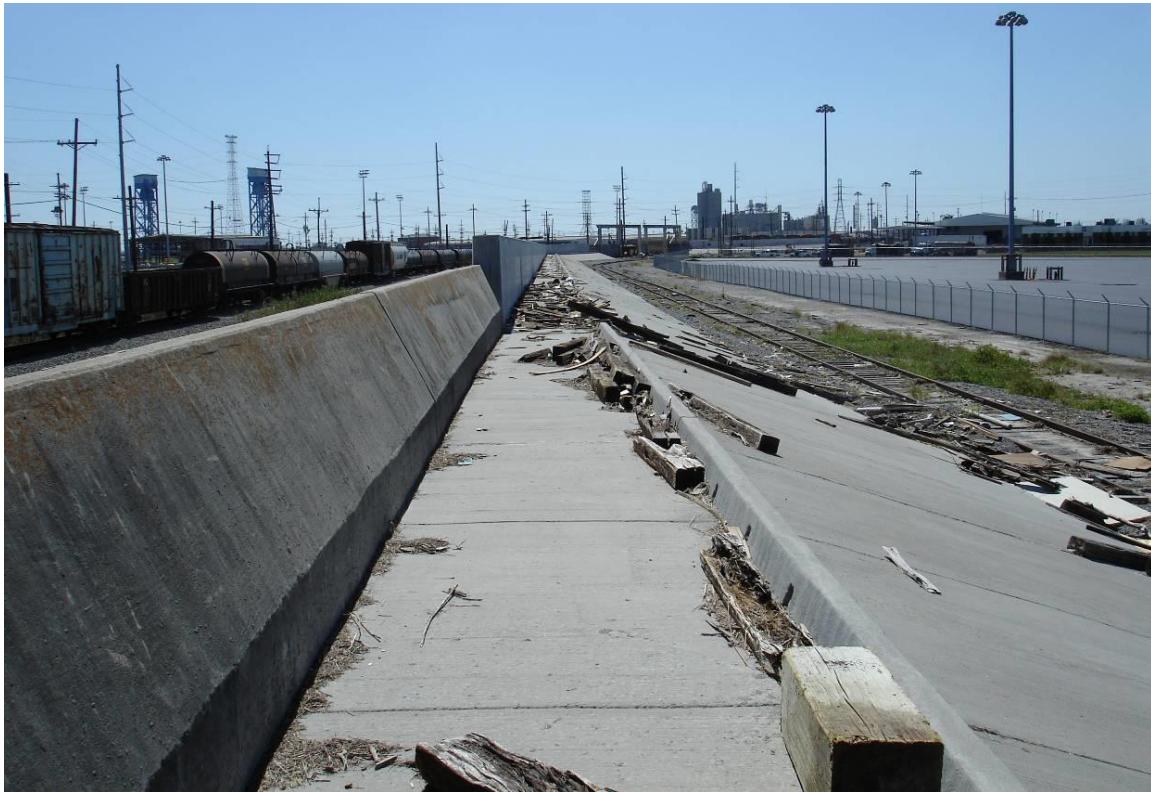
Figure 6. I-wall and splash apron, IHNC west along France Road; new L-wall and splash apron in background. (October 2, 2008, 90.0272° W, 90.0272° W)

At the transition between the new L-wall and the old I-wall (Figure 6), there was storm debris left on top of and behind the higher L-wall, while the top of the lower I-wall was left clean. It is possible that the water elevation or waves during the peak storm surge exceeded the top of the old I-wall on a more consistent basis (elevation of about 4.3 m [14 ft], NAVD88) at this location, sweeping wave debris from the wall top.

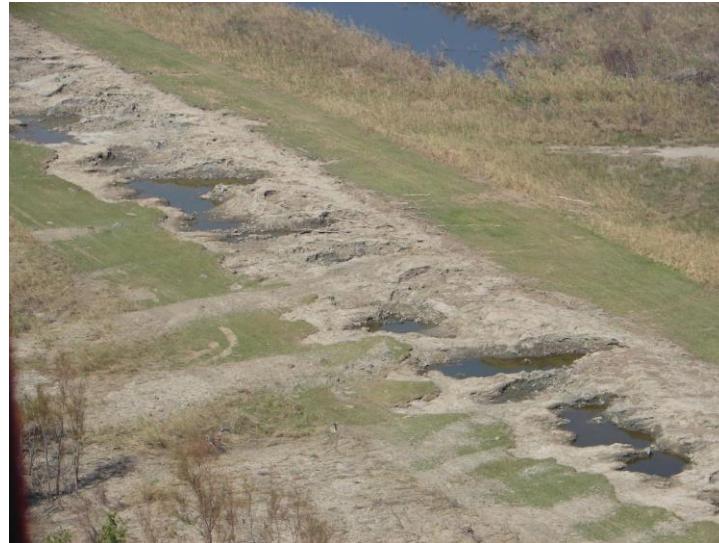
The frontage levees along the Mississippi River Gulf Outlet (MRGO) channel are the closest elements of the HSDRRS to the open waters of the Gulf. These earthen embankments experienced the earliest and highest water levels during both Gustav and Katrina. The high-water levels during Katrina overwhelmed the MRGO frontage levees, with overtopping along the entire stretch of the MRGO and eroded significant lengths of the levee. Figure 11 shows a section of the MRGO frontage levee and the typical extent of the erosion damage caused by the Katrina overtopping.

Figure 11. Post-Katrina MRGO frontage levee. (October 14, 2005, ~89.8° W, ~29.9° N, L. Harder)

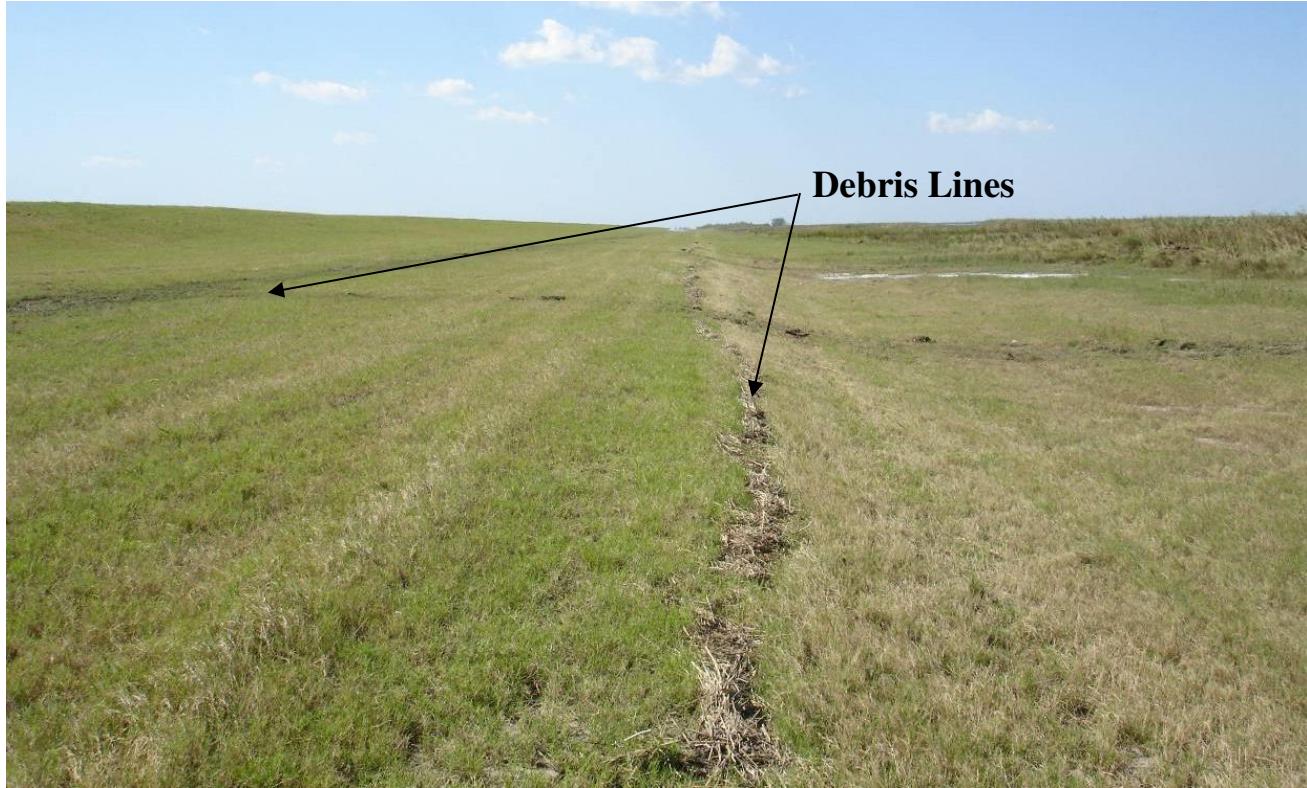
The team observed no signs of either erosion or overtopping during Gustav along the southeast sections of the MRGO frontage levee, which the team believes was representative of the MRGO frontage levees. Based on the limited debris lines along the levee, the high water levels during Gustav were well below the crest of these rebuilt and elevated earthen embankments. The wave and current actions of Gustav also appeared to have caused no erosion on the earth embankments. Figure 12 shows a typical view of the MRGO frontage levee embankment in October 2008.

Figure 12. MRGO frontage levee, flood side, looking northwest. Upper debris line, believed to be due to Gustav, was cleared prior to our visit, probably as part of the ongoing efforts to maintain the protective grass cover. The lower debris line may represent the high-water level during hurricane Ike, which followed Gustav in September 2008. (October 2, 2008, 29.8889°N, 89.7617°W)

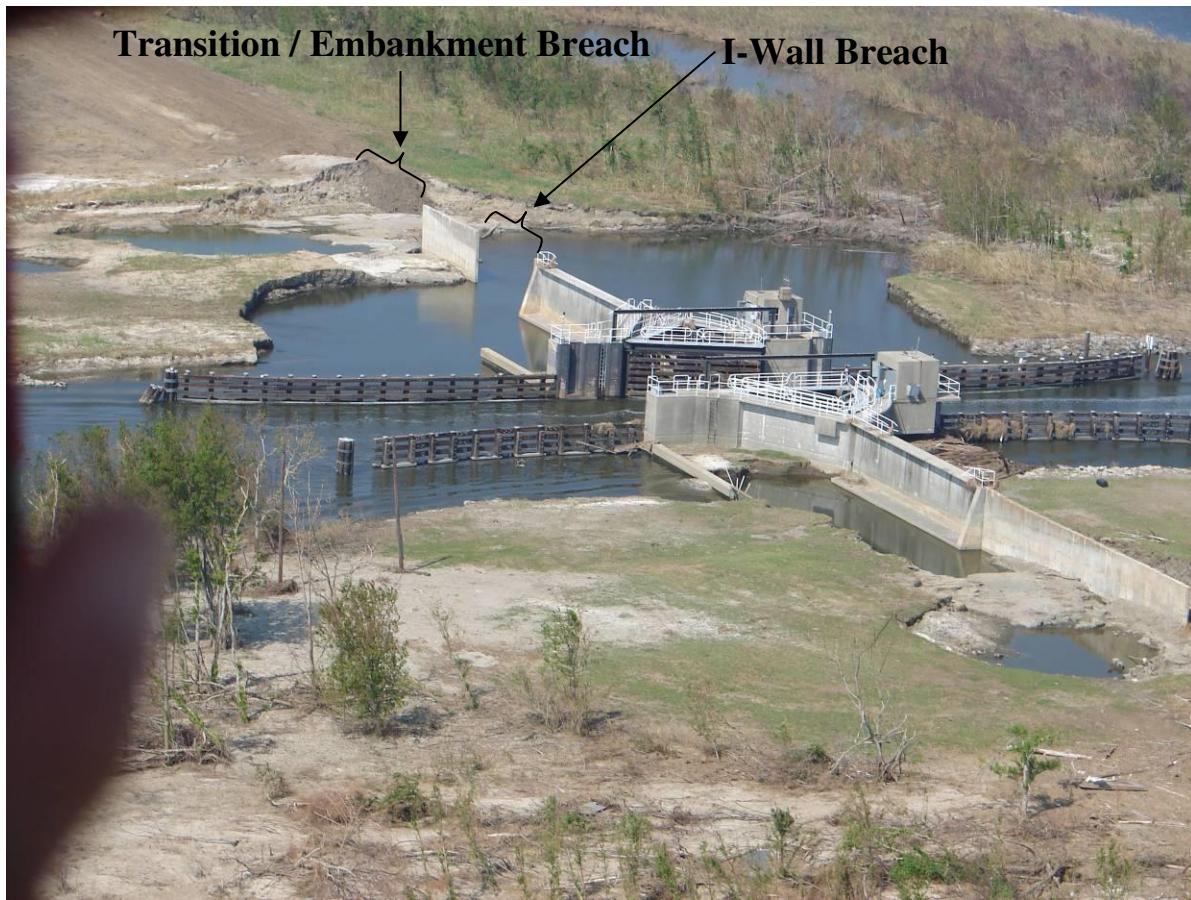
The Bayou Dupree gate structure on the MRGO suffered several severe breaches during Katrina, which overtopped the entire structure by 0.6 to 1.5 m (2 to 5 ft). Figure 13 is an October 2005 photo of the gate structure following Katrina, showing breaches at the I-wall section and at the transition from the I-wall to the embankment.

Figure 13. Post-Katrina Bayou Dupree gate. (October 14, 2005, 29.935° N, 89.837° W, L. Harder)

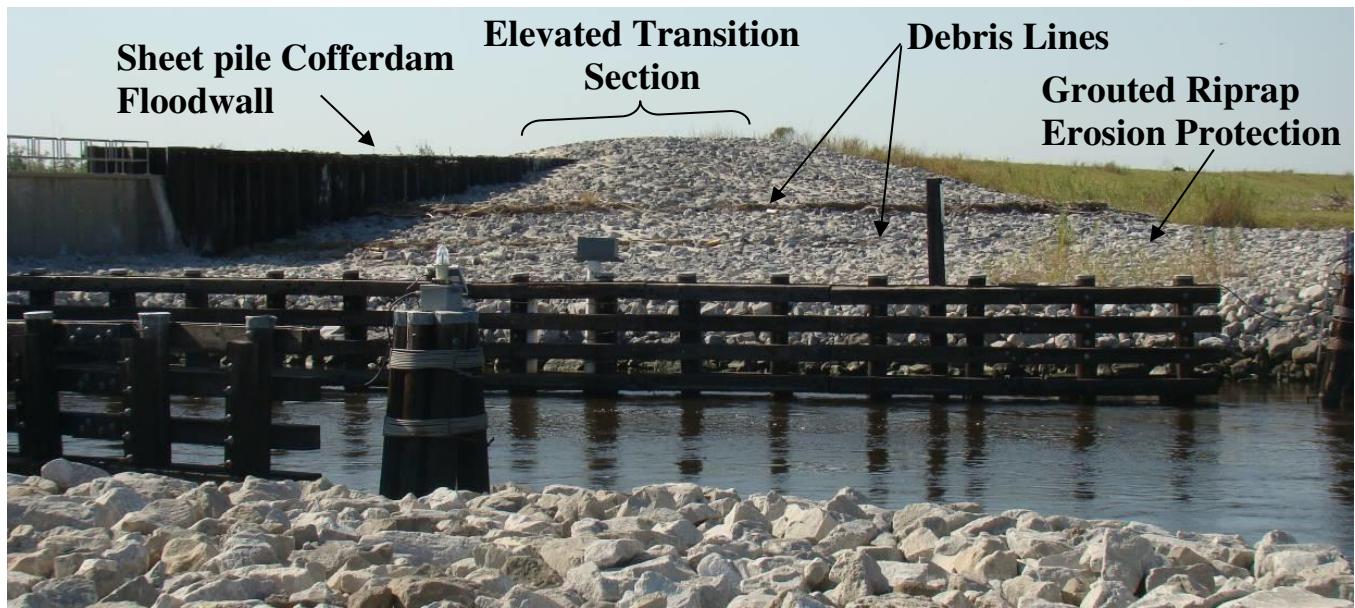
Figure 14 shows the improvements constructed by the USACE to the same Bayou Dupree gate structures. The concrete sheet pile I-wall was replaced with a steel sheet pile cofferdam section, and the transitions to the earthen levees on both sides of the gate were elevated and covered with grouted riprap. The use of grouted riprap to harden vulnerable areas around the gate was extensive, as illustrated in Figure 14. Ungrouted riprap was placed as erosion protection at the toe areas of grouted riprap. The team observed no signs of erosion or damage from Gustav's high water and waves at or near the gate. The limited debris line on the northwest flank appeared to indicate that the highest waters from Gustav were about 1 to 1.5 m (3 to 5 ft) below the crest of any of the gate structure elements (see Figure 14).

Figure 14. Bayou Dupree gate, northwest flank, MRGO side, looking east. The lower debris line may represent the high-water level during Hurricane Ike. (October 2, 2008, 29.9352° N, 89.8358° W)

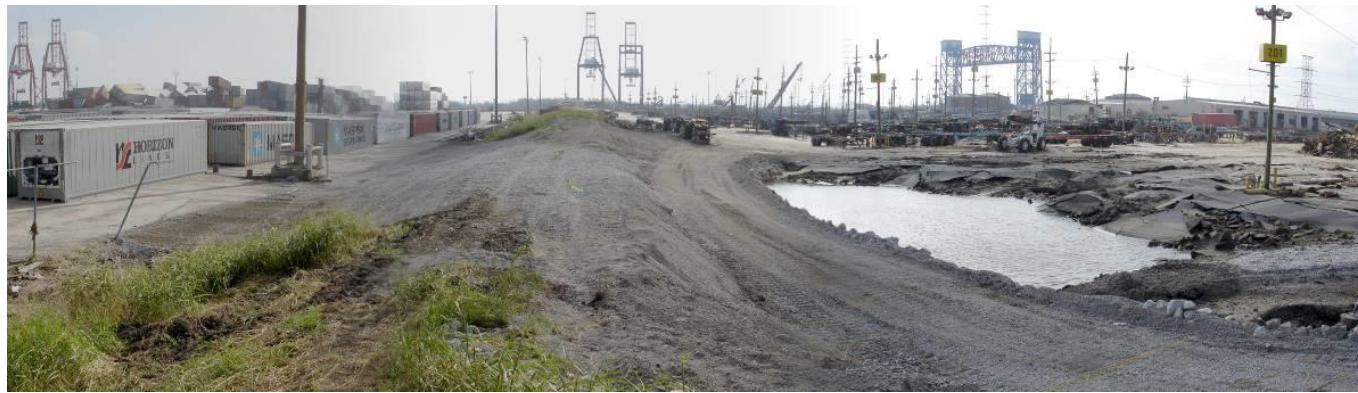
Figure 16. Post-Katrina IHNC West levee breach site, October 2005 (The breach had been temporarily repaired; note scour hole). (October 4, 2005, 29.9880° N, 90.0263° W, L. Wooten)

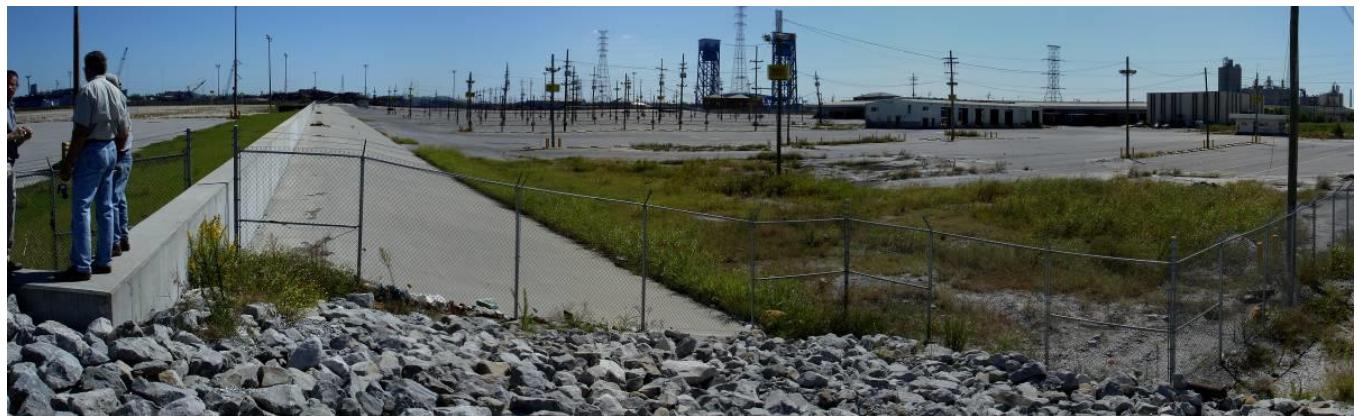
Figure 17. IHNC West new embankment and floodwall at location of breach, as was shown in Figure 14, in October 2008. (October 2, 2010, 29.9880° N, 90.0263° W)

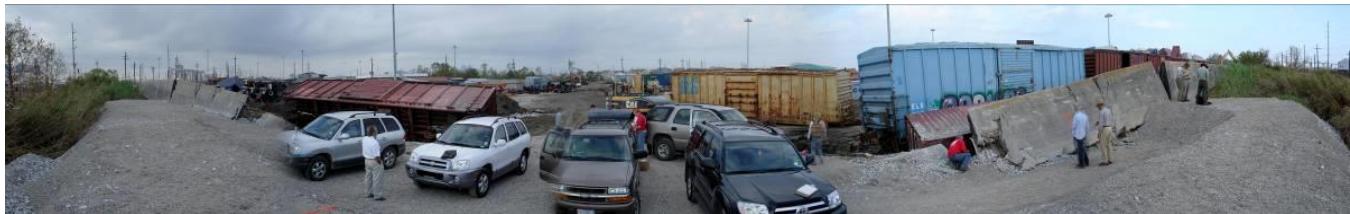
Figure 18. IHNC West I-wall Katrina breach site, October 2005. (October 4, 2005, 29.9899° N, 90.0272° W, L. Wooten)

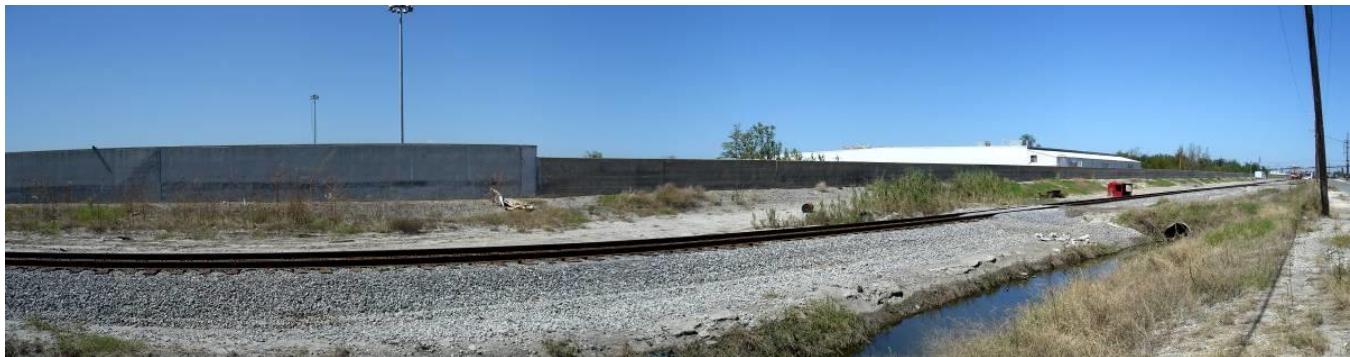
Figure 19. New L-wall and old I-wall transition near location of Katrina I-wall breach on IHNC West. (October 2, 2008, 29.9899° N, 90.0272° W)

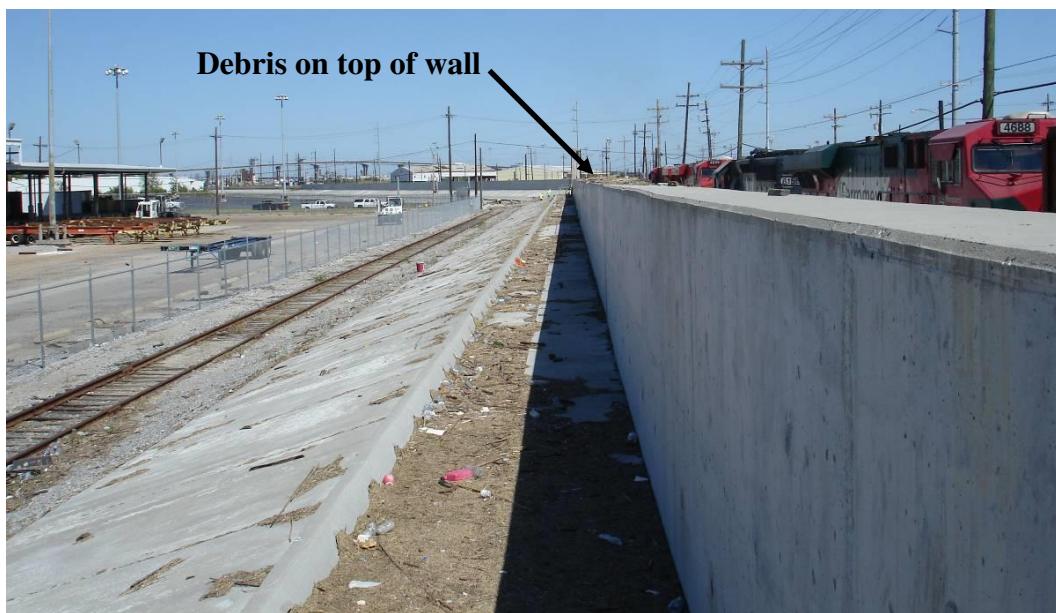
The repairs and improvements of these sections of the hurricane protection appeared to have performed well in light of clear evidence of wave overtopping. Figure 20 shows the debris left by overtopping waves on the protected side of one section of new L-wall along the IHNC West.

Figure 20. Protected side of new L-wall along IHNC West. Note debris left by overtopping on floodwall and slope protection. October 2008. (October 2, 2008, 29.9899° N, 90.0272° W)

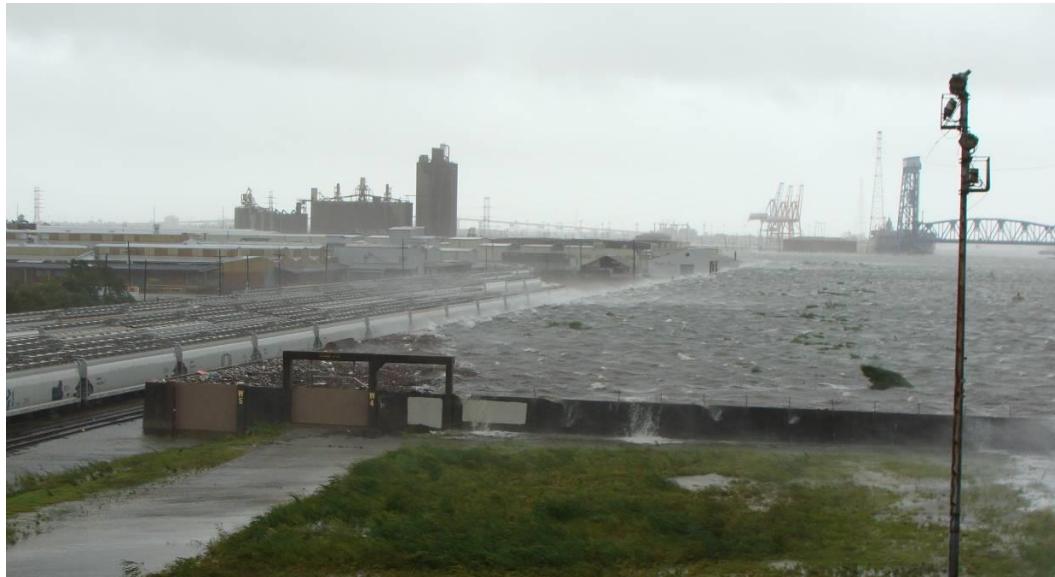
Clear photographic evidence showed wave overtopping during Hurricane Gustav along the T-wall located on the west side of the IHNC just north of Claiborne Avenue (see Figure 15 for location, and Figures 21 and 22 for photographs during hurricane). This T-wall had previously survived Hurricane Katrina. A concrete splash apron at the toe of the wall on the protected side was added after Katrina to protect from erosion. The wall performed well during Gustav. During the field reconnaissance, the team saw no noticeable sign of distress in the wall, including the joints between concrete panels and in the new concrete splash apron. There was evidence of minor erosion beyond the splash apron on the protected side as well as debris left by the overtopping (Figure 23).

Figure 21. Photograph from September 1, 2008, of Gustav's storm surge. Photograph taken from Claiborne Ave. Bridge looking north. The waves are overtopping the T-wall. (September 1, 2008, 29.969° N, 90.027° W, USACE)

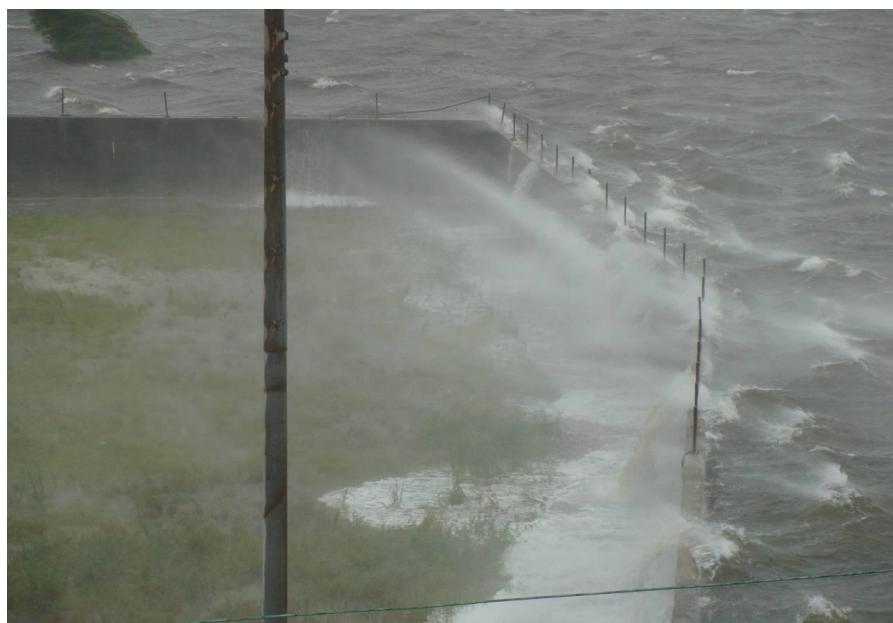
Figure 22. Gustav's storm surge along IHNC East, taken from Claiborne Ave. Bridge looking north at T-wall southeast on September 1, 2008. (September 1, 2008, 29.969° N, 90.027° W, USACE)

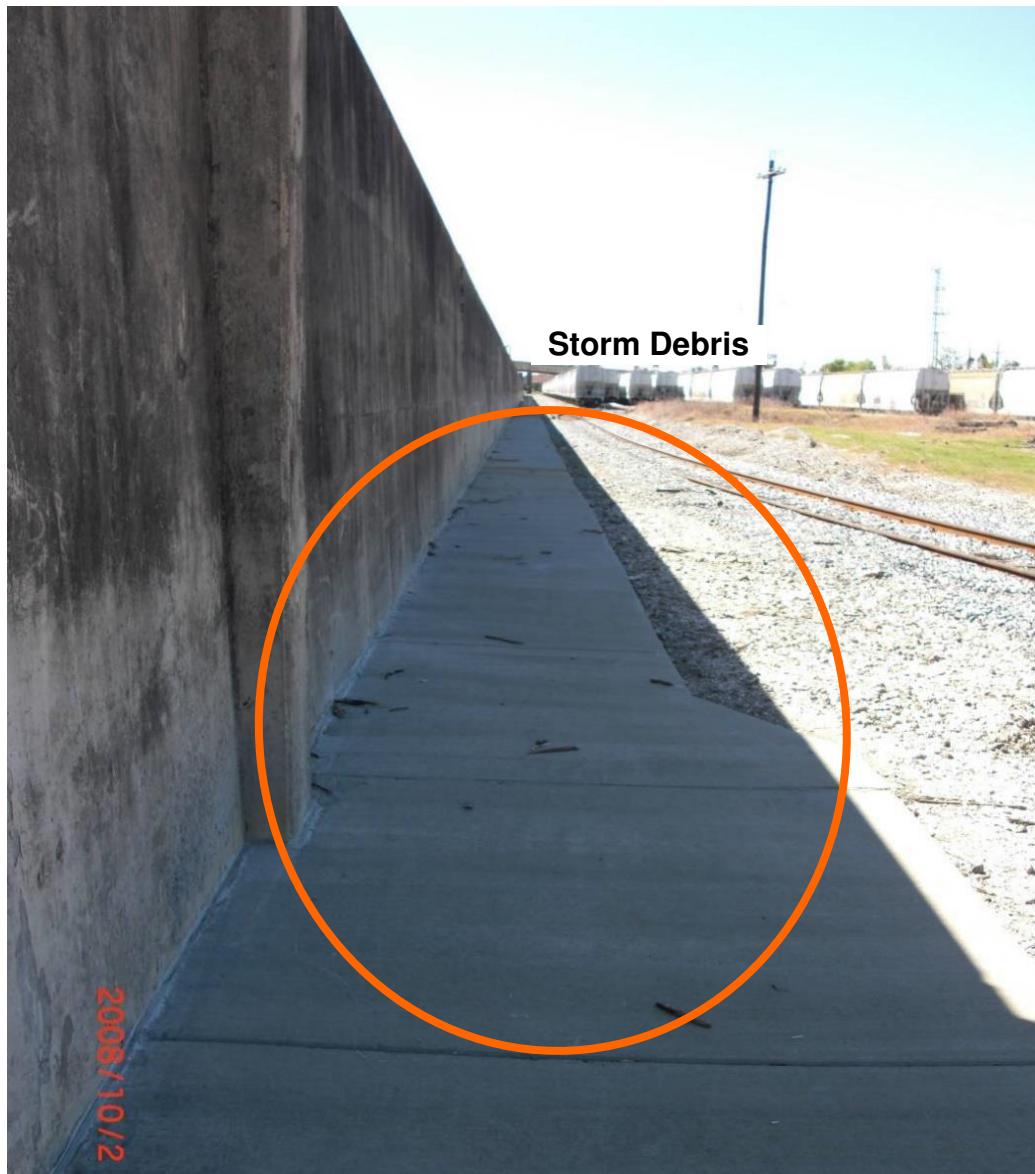
Figure 23. Photograph from October 2, 2008, of IHNC West T-wall (same section as shown during Gustav in Figures 20 and 21). (October 2, 2008, 29.970° N, 90.026° W)

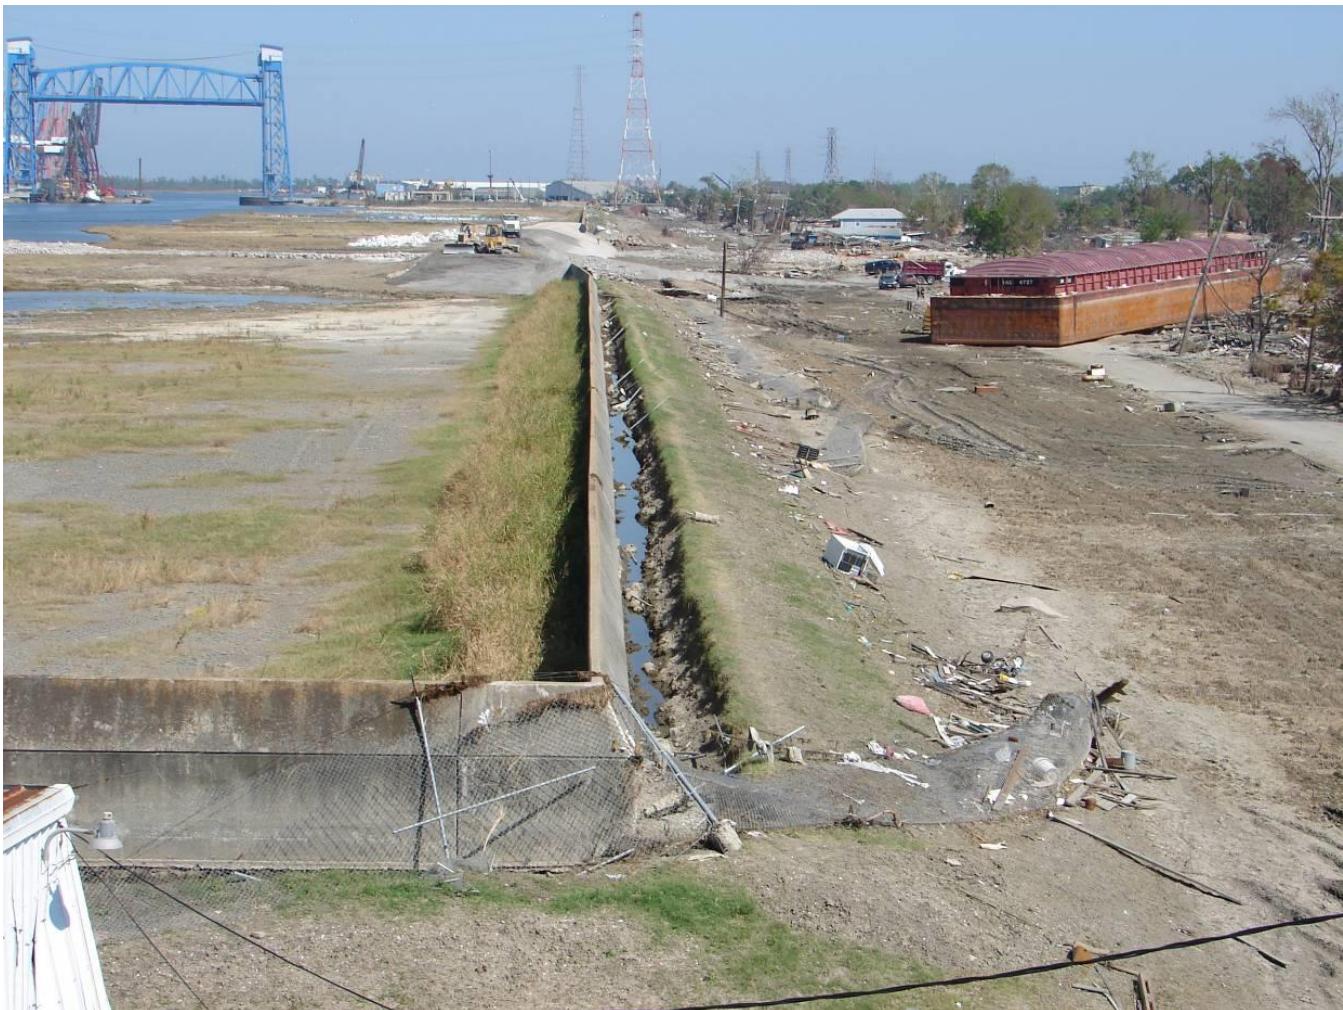
Two breaches occurred during Hurricane Katrina on a stretch of I-wall between Claiborne and Florida Avenues on the east side of the IHNC. Water flow through these breaches flooded the Lower 9th Ward. The suspected cause of the southern-most breach was loss of soil support due to overtopping erosion on the protected side of the I-wall (Figure 24), while the suspected cause of the northern-most breach was a stability failure before the surge level reached the top of the wall.

Figure 24. Post-Katrina IHNC East floodwall with southern-most breach and the scour, looking north, from the Claiborne Avenue Bridge. (October 11, 2005, 29.9685° N, 90.0238° W, L. Harder)

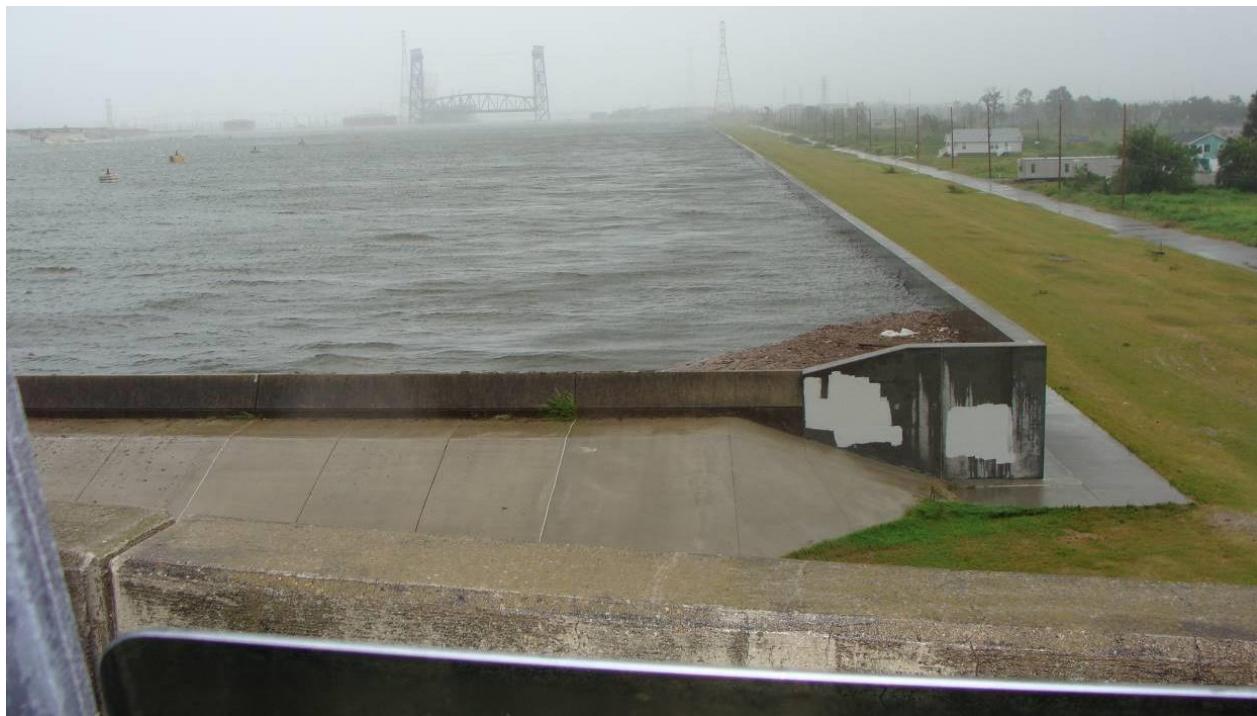
Along the east side of the IHNC south of Claiborne Avenue, the peak still water level was near the top of the old I-wall, and waves apparently overtopped the wall. The top of this wall was at about an elevation of 4.0 m (13 ft), NAVD88. After Gustav, the wall showed no noticeable signs of distress such as movement of the wall due to the surge load or erosion at the toe due to waves overtopping the wall (Figure 26). Also, there was no visible evidence of underseepage on the protected side.

Figure 25. Gustav storm surge at IHNC East floodwall, taken from the Claiborne Avenue Bridge, looking north toward Florida Avenue Bridge (seen in background) from a perspective similar to that in Figure 18. (September 1, 2008, 29.9686° N, 90.0241° W, USACE)

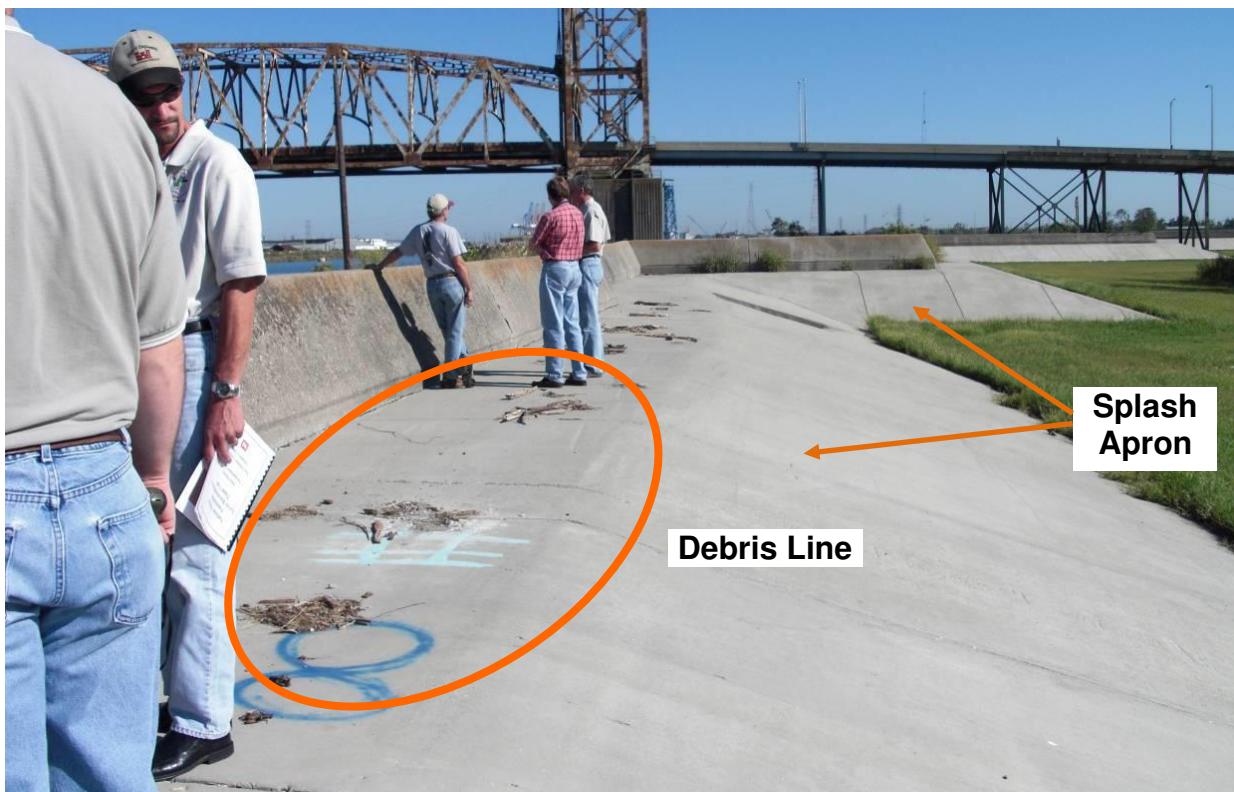
Figure 26. Hardened I-wall along east side of the IHNC south of Claiborne Avenue looking north (IHNC is to the left and Lower 9th Ward / Holy Cross to the right). (Oct. 2, 2008, 29.9682° N, 90.0250° W)

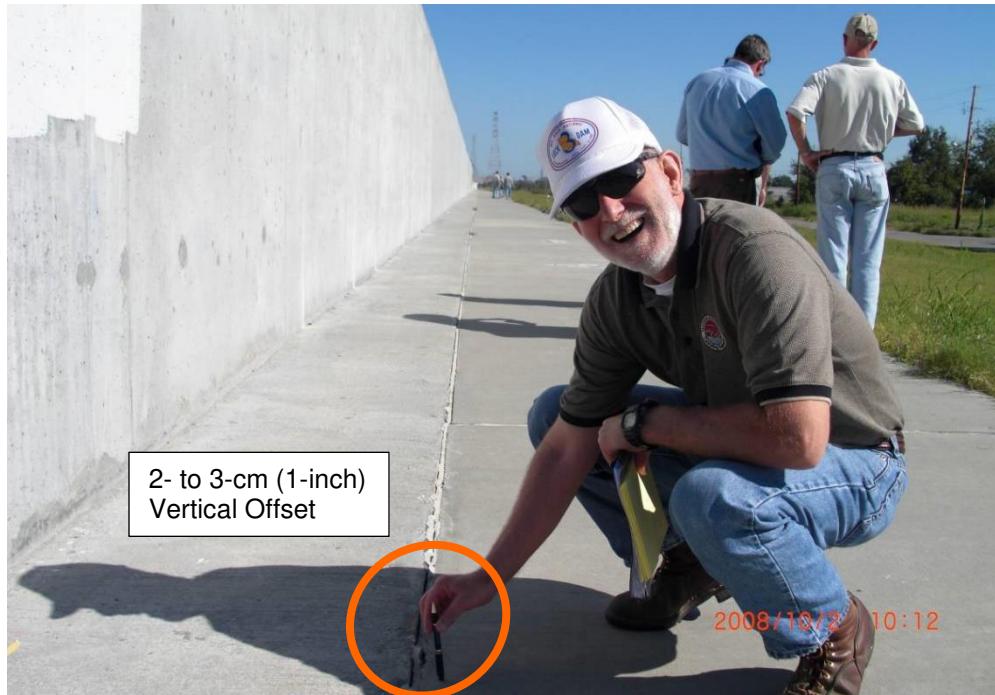
The team noted a 2- to 3-cm-deep (~1-inch-deep) vertical offset between the pile-supported base of the T-wall and the slab-on-grade concrete splash apron (Figure 27). This offset, if the splash apron was cast to be flush with the base of the wall in the summer of 2006, may indicate a differential settlement of the apron relative to the pile-supported T-wall occurring at a rate of about 1 cm per year (0.5 inch per year) in the upper 21 m (70 ft) of the soil profile.

Figure 27. New T-wall section along the east side of the IHNC between Claiborne and Florida Avenues (shown in Figure 23 during Gustav). (October 2, 2008, $29.9691^\circ N$, $90.0236^\circ W$)

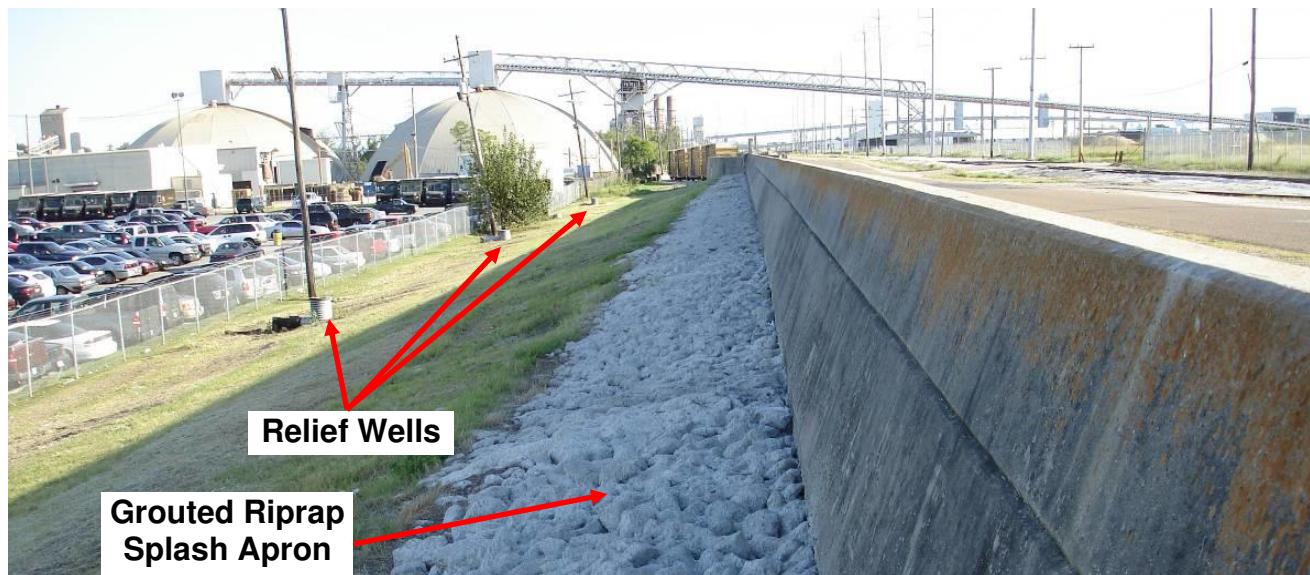
The team visited the section of the HSDRRS near East Morrison Road in New Orleans East to investigate the USACE preliminary reports of damage to the relief wells and of soil moving through the wells. Much of the HSDRRS in this section of New Orleans East along the northeast section of the IHNC consisted of I-walls set in earthen embankments with regularly spaced relief wells located at the toe of those embankments (see Figures 28 and 29). These features were in place at the time of Katrina. After Katrina, the USACE added a grouted riprap splash apron on the protected side of the I-walls.

Figure 28. IHNC floodwall near East Morrison Road. Note splash apron (center) and relief wells (left). (October 2, 2008, $30.0248^\circ N$, $90.0295^\circ W$)

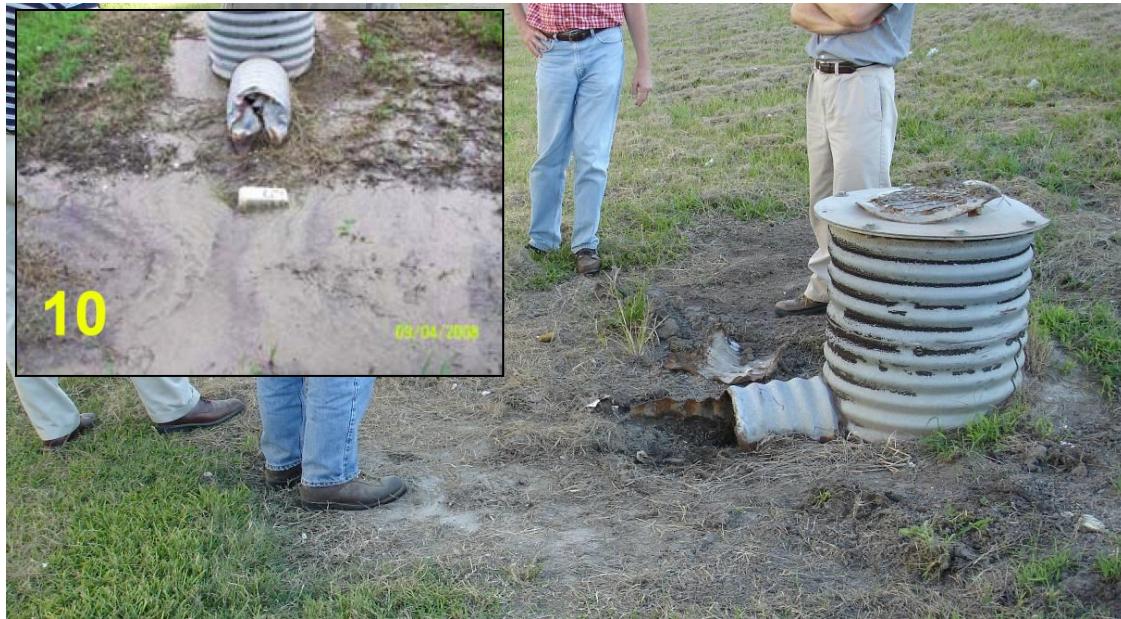
The team observed no signs of damage to the HSDRRS near East Morrison Road due to Hurricane Gustav. The corrugated metal protective casings over the relief well outlets were in various states of deterioration. The team also did not see evidence of extensive sand migration out of the wells, although our observations were made more than a month after Gustav had swept through the region, and the team did not inspect all wells. The inset photo in Figure 28 was taken from the USACE Situation Report dated September 5, 2008, which shows a damaged outlet casing and sand that appears to have discharged from the well.

Figure 29. Relief well cover, as of October 2008, with inset taken from the USACE Hurricane Gustav Damage Assessment Team SITREP on September 5, 2008. (October 2, 2008, 30.0249° N, 90.0294° W)

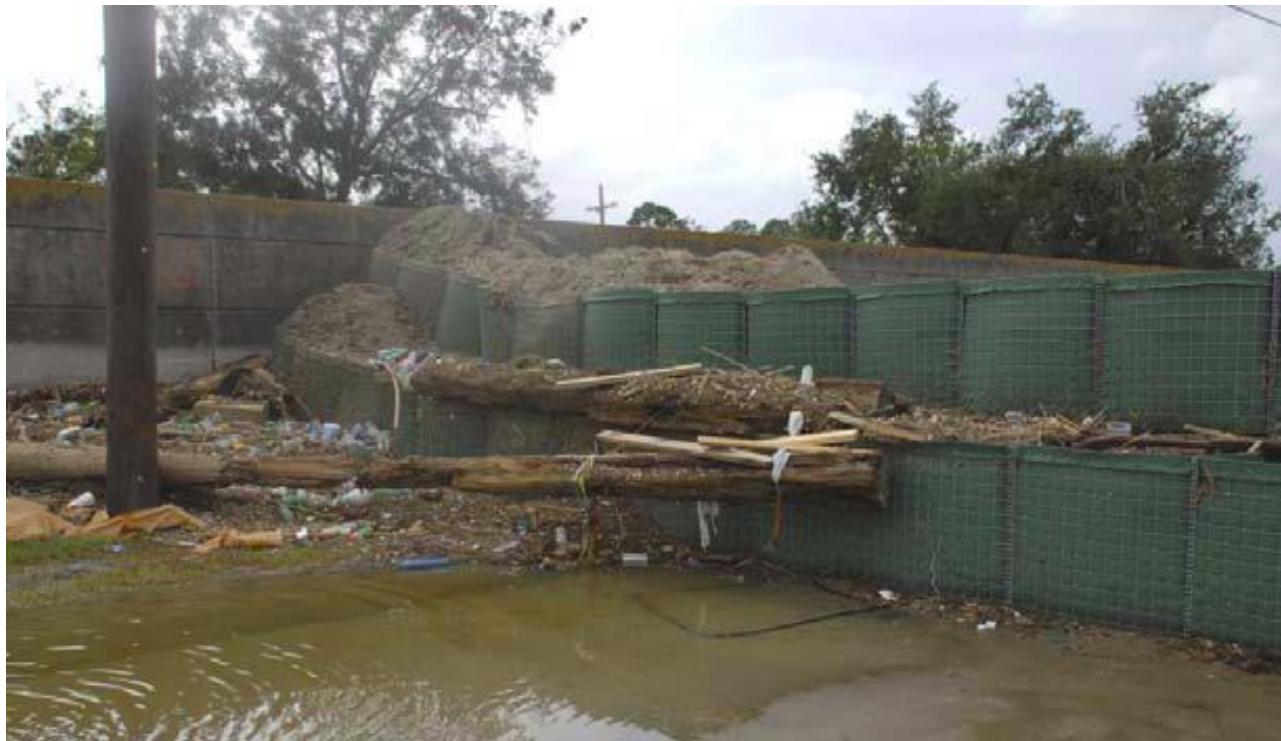
Figure 31. End of temporary bin wall at tie-in to I-Wall, post-Gustav (September 20008, 30.0122° N, 90.0313° W, http://www.mvn.usace.army.mil/HPS>Status%20Report%20Newsletters/Sept_9_2008.pdf)

The majority of the bin wall was constructed about 15 m (50 ft) outboard of and parallel to the I-wall, with two tiers of baskets. The lower tier was four baskets wide and the upper tier was two baskets wide. The top of the bin wall was about 0.6 to 1.0 m (2 to 3 ft) lower than the top of the adjacent floodwall. Surge and waves from Gustav left debris on the first tier (with a height of 0.9 m [3 ft]) of the bin wall but not on the top of the second tier. The bin wall appears to have protected this section of floodwall from any loading during Gustav. If Gustav had generated a storm surge higher than the bin wall, the existing I-wall would have been loaded but to a lesser degree because of the bin wall. Specifically, the bin wall would have: (1) reduced the period of loading, (2) reduced wave loading, and (3) lengthened the seepage path during pre-overtopping periods.

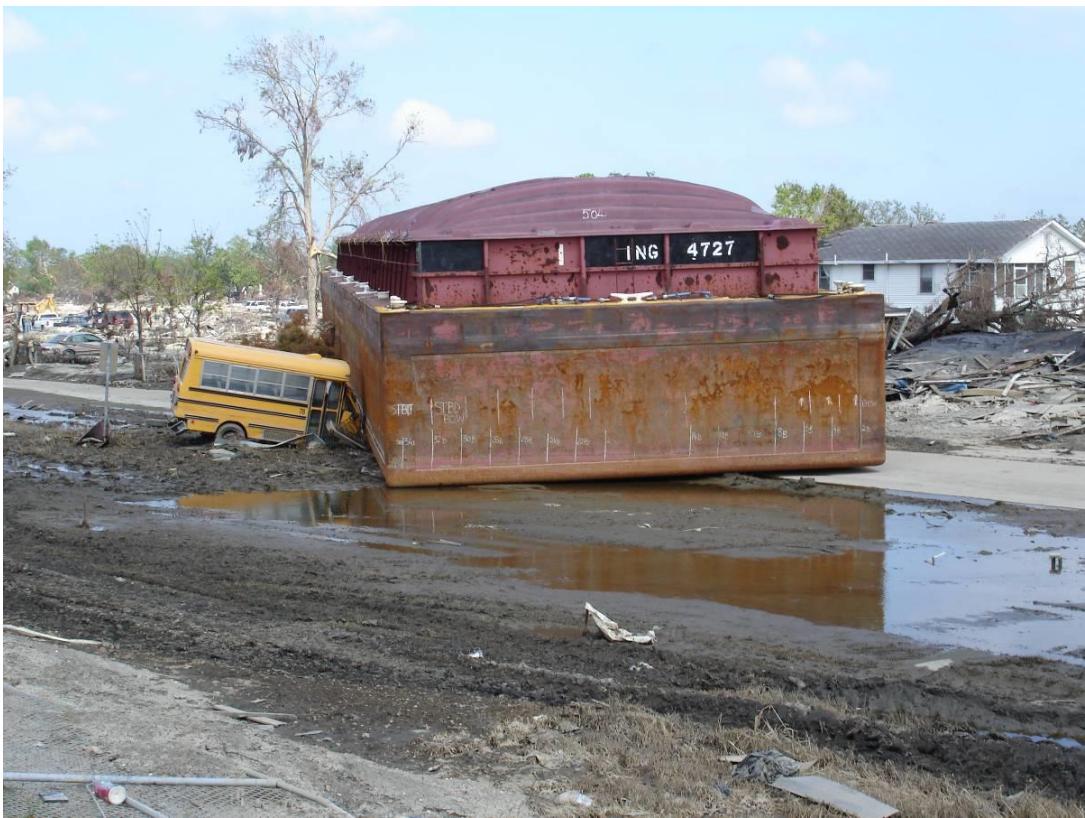
The empty barge that floated into the Lower 9th Ward following Katrina and Rita has been well-documented (see Figures 24 and 32). There has been speculation that this barge or another barge could have contributed to the failure of the Lower 9th Ward I-wall. The high winds of a hurricane can easily push an empty vessel with enough force to break mooring lines and force the vessel into structures along the IHNC. Such was the case during Hurricane Gustav. The U.S. Coast Guard (USCG) has jurisdiction over the ships and barges in the IHNC.

Figure 32. Barge in the Lower 9th Ward after Katrina. (October 4, 2005, 29.9703° N, 90.0230° W, L. Wooten)

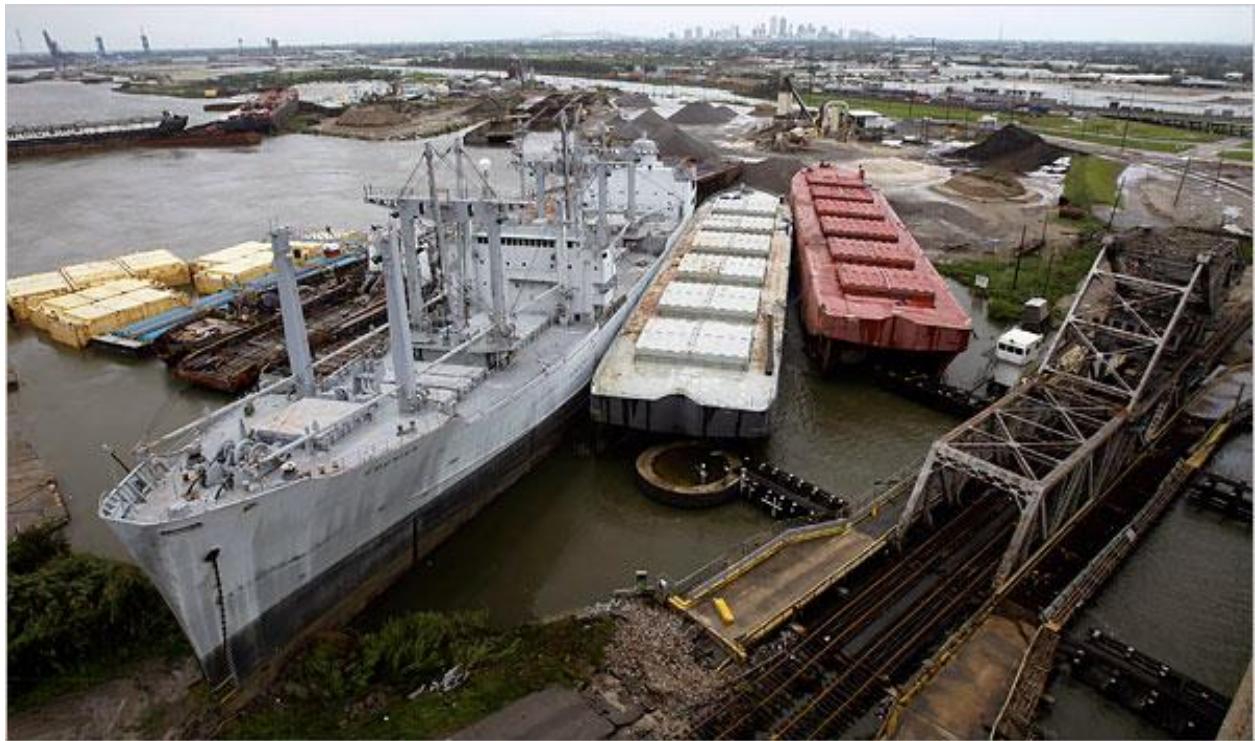
Figure 33 shows how ships and barges were pushed during Gustav against the dolphins protecting the northern railroad bridge that crosses the IHNC just south of the I-10 bridge. This railroad bridge was in the lowered position and thus remained underwater during periods of high water. The Florida Avenue Bridge to the south of these barges and ships was in a slightly raised position so as to be out of the water, but low enough to keep wind loads from having leverage on the support towers. In these positions, both bridges would have confined the ships and barges to the central part of the canal. In preparation for the subsequent hurricane, Ike, the USCG ordered all ships and barges removed from the IHNC.

Figure 33. Ships and barges pushed against a railroad bridge after Gustav. (September 1, 2008, 30.0050° N, 90.0251° W, Eric Gay, Associated Press)
