Reconnaissance of the New Orleans Hurricane and Storm Damage Risk Reduction System after Hurricane Gustav

Reconnaissance of the New Orleans Hurricane and Storm Damage Risk Reduction System after Hurricane Gustav.

International Journal of Geoengineering Case Histories, Volume 5, Issue 4, pp. 129-154, doi: 10.4417/IJGCH-05-04-07

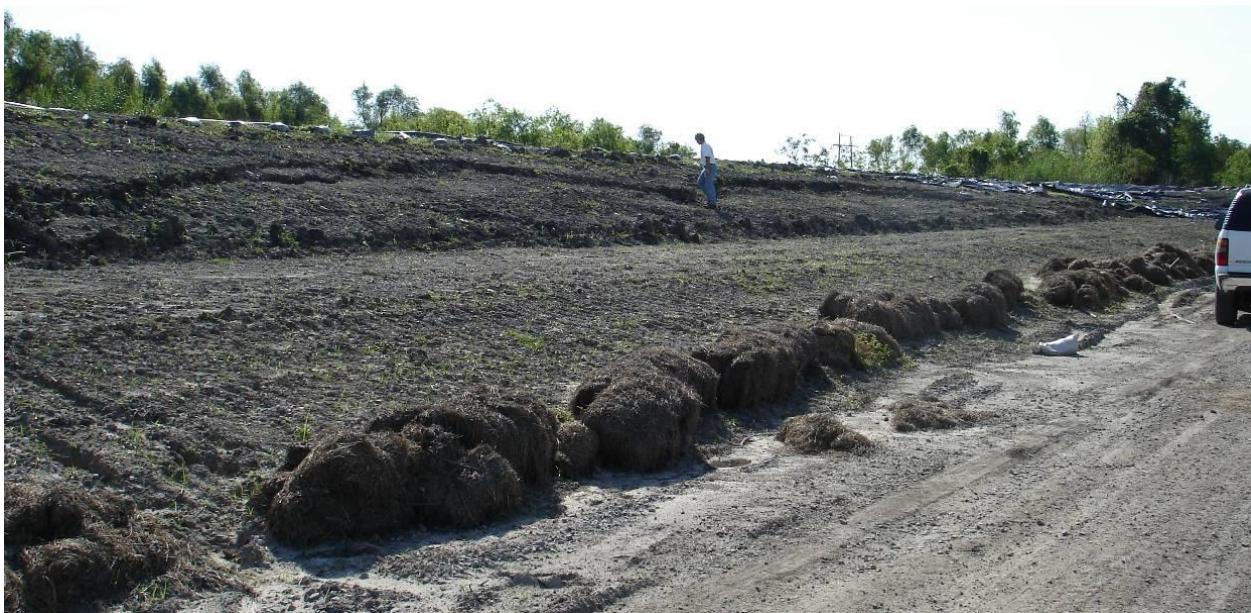
Figure 35. Protected side slope of the Plaquemines Parish back levee and slide.
(October 3, 2008, 29.8506° N, 89.9085° W)

The non-federal local back levee in Plaquemines Parish was overtopped by Gustav flood levels and was in danger of failure at the location of the slope slide. Desiccation cracks on the levee may have contributed to the slide by allowing overtopping water pressures into embankment zones critical to slope stability. The placement water content, compaction, and organic

content of the back-levee soils were not known and may be factors in the susceptibility of the levee soils to desiccation cracks and erosion.

- The erosion resistance of non-federal local levees in Plaquemines Parish (not part of the HSDRRS) during overtopping was noted during Katrina. The clay back levees in Plaquemines Parish resisted erosion during Gustav but may have demonstrated a potential vulnerability due to desiccation cracks. Improved control of placement water content and compaction, revised material requirements relative to plasticity and organic content, or landscaping measures such as the establishment of dense vegetation and use of irrigation may be required to prevent desiccation.

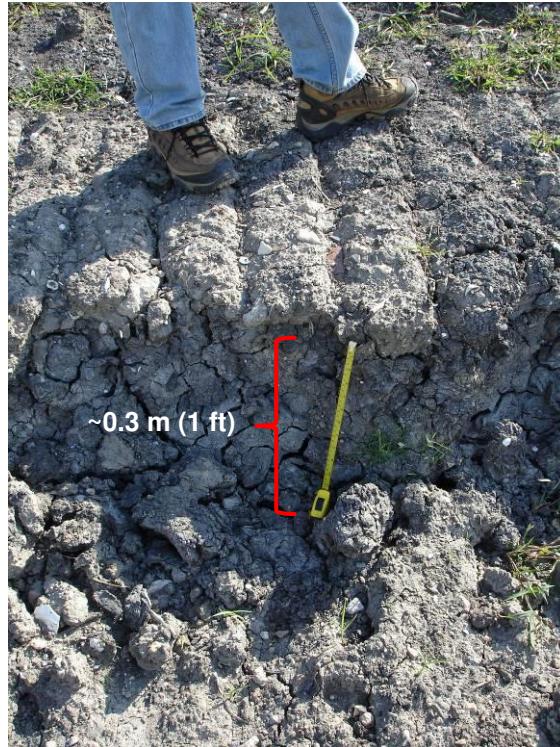
*Figure 36. Scarp above slide on Plaquemines back levee.
(October 3, 2008, 29.8506° N, 89.9085° W)*
