Bridge Abutment Remediation – A Case Study

One such failure occurred on a 40-year-old bridge abutment on a busy highway-overpass located over an important rail network and local council-controlled roads. The failure did not result in the closure of the highway to traffic; however, it

International Journal of Geoengineering Case Histories, Volume 7, Issue 4, pp. 1-7,

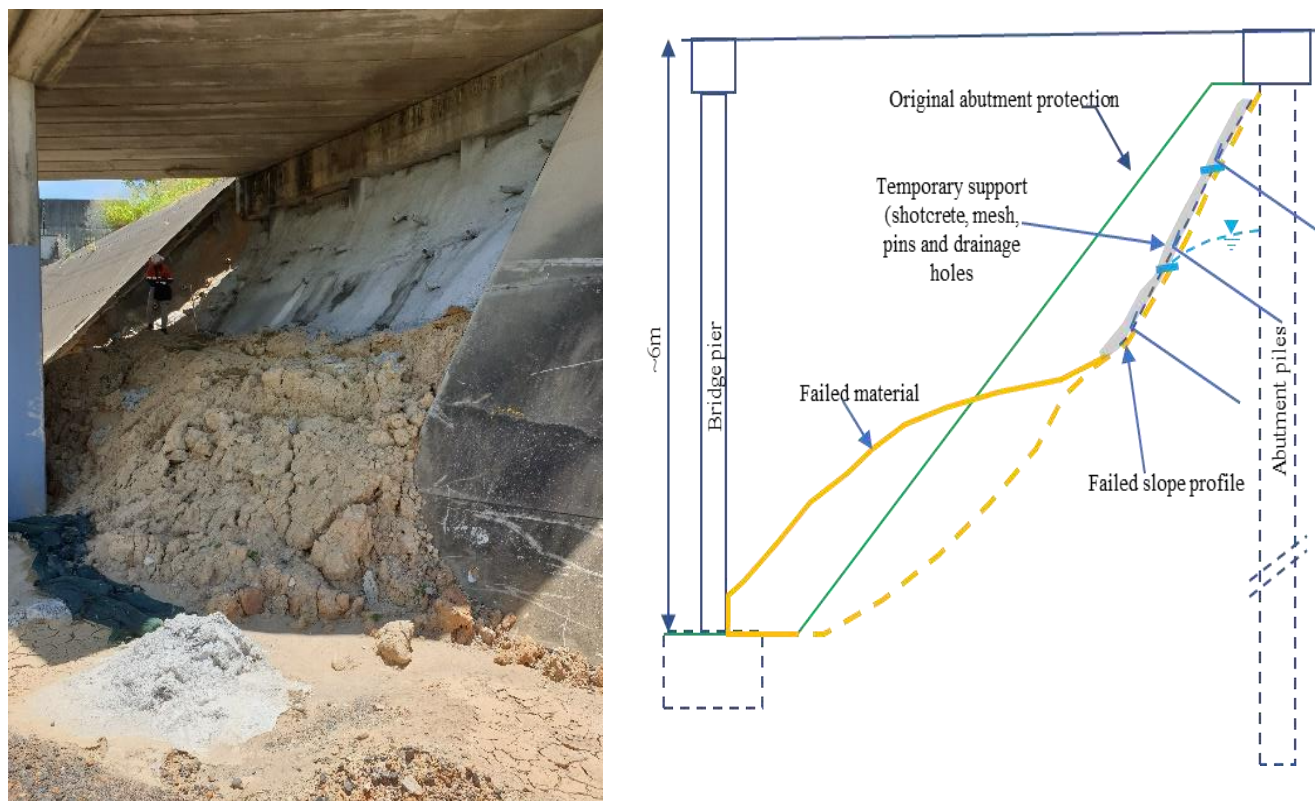
Figure 3. Temporary remediation (shotcrete with mesh, drainage holes, and driven pins) installed within 24 hours of the failure. The sketch illustrates the slope profile and temporary remediation installed. Seepage continued to occur two meters below the headstock at a reducing rate.

Due to a forecast of further rainfall in the days following the failure, there was an urgent requirement to making the abutment safe and prevent further slips from the exposed surface. The following immediate and urgent mitigation measures were implemented within 24 hours (Figure 3):

- Removal of failed material from batter face and abutting against slope toe to provide passive support.
- Installation of two rows of 1-m long drainage pipes.
- Installation of three rows of 2-meter long, 20-millimeters diameter cogged steel reinforcement bars (driven) at 1-meter spacing.
- Application of 160 millimeters (average) thick shotcrete with SL82 mesh.
- Closure of one lane on the road below with temporary traffic lights with contra flow.
- Risk management advice included daily inspections of the site (to later be reduced to weekly, granted there were no further movements) and checks after rainfall events.

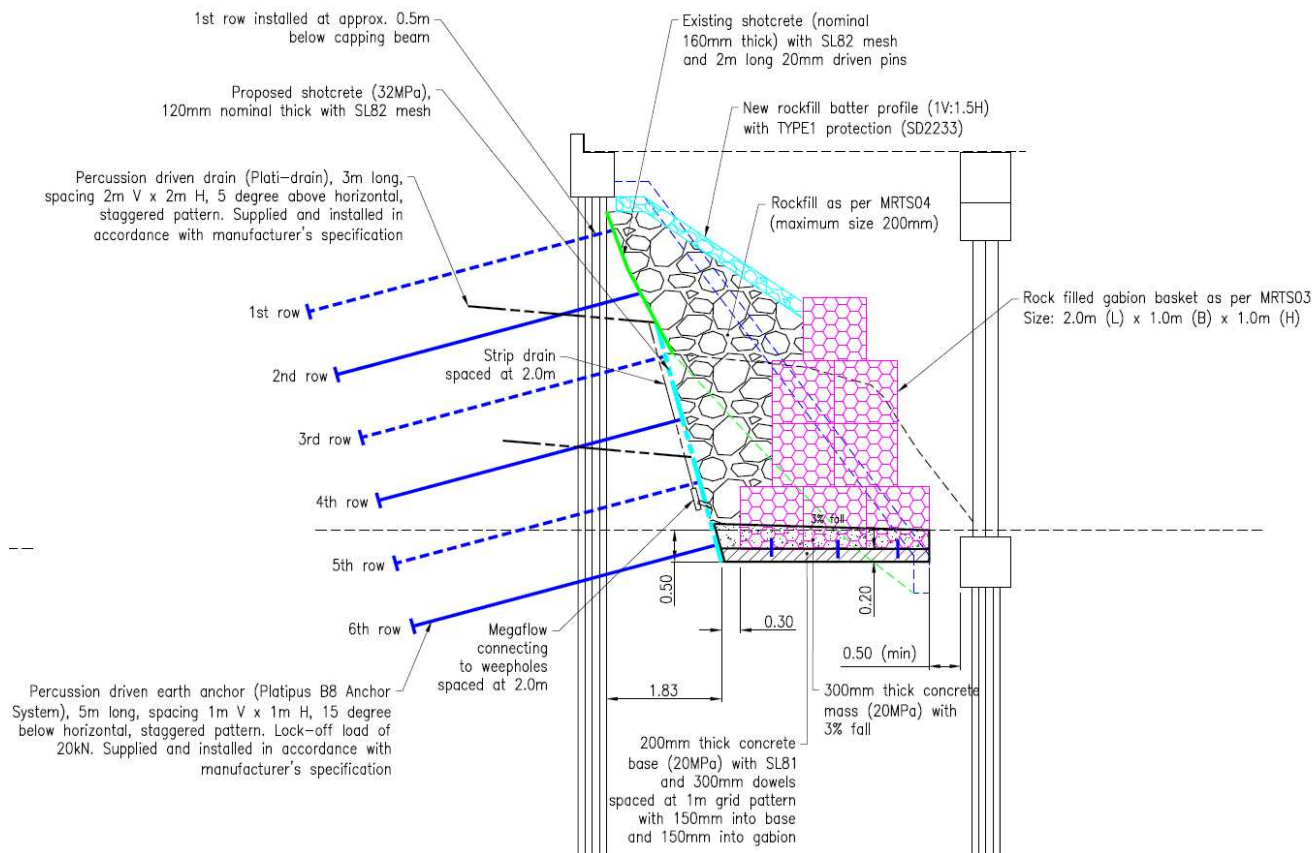
Figure 4. Permanent remediation of the bridge abutment.

- Installation of percussion anchors (300 millimeters wide head, 20 kilo Newton lock-off load) via slots cut into existing shotcrete (urgent works) at 1 meter vertical and horizontal spacing in a staggered pattern.
- Staged excavation at 1.2 meters lifts, followed by installation of percussion anchors, mesh and shotcrete, a row at a time until the toe of excavation was reached for formation of foundation for gabion.
- Installation of percussion drainage (three meters long by two rows at two meters staggered spacing).

It is worth noting that percussion anchors were chosen as they are quick to install, do not need specialized equipment, suit the application in a small space, and can be loaded soon after installation. Figure 4 shows the final design adopted to remediate the bridge abutment.

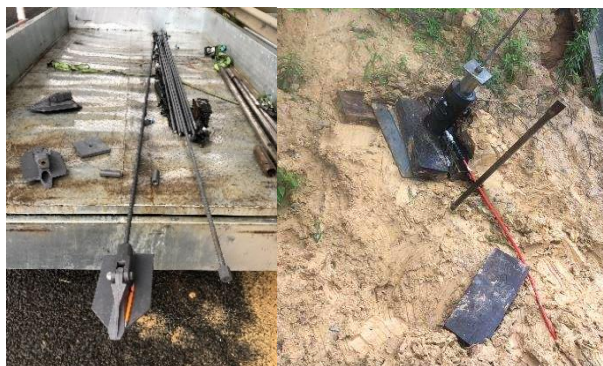
Figure 5. Percussion anchor (180-millimeter head) and load testing.

The construction of the remediation works commenced in May 2022. The appointed contractor proposed an alternative anchor head size to the size proposed in the design. This was mainly to accommodate a smaller machine to drive the percussion anchors. The proposal was accepted provided that the working load of 80 kilo Newton could be achieved. Three test anchors (180 millimeters head size) were tested prior to the commencement of production anchors. Two of the anchors achieved >25 kilo Newton and the test had to be terminated due to soft material around the collar (Figure 5). One anchor was tested to 100 kilo Newton (at 850 millimeters extension) and the test was terminated as the load reached 80 per cent of ultimate breaking load of the steel tendon, 120 kilo Newton. On that basis, the proposed 180 millimeters anchor head was accepted as the minimum size that could be used. However, during construction, a mixture of 180-millimeter and 300-millimeter head sizes were used since there was a supply issue with the smaller heads. No issues were encountered during installation of the anchors.

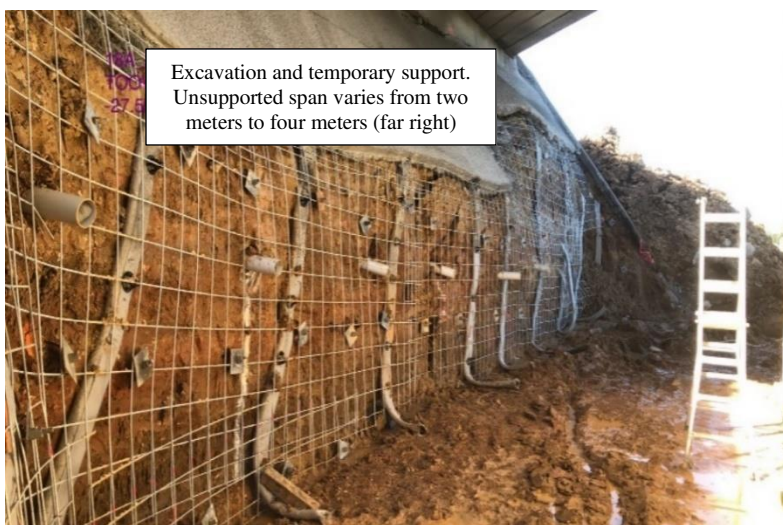
The excavation, anchor installation, and shotcrete application progressed well for the first three rows of anchors, after which, the contractor inadvertently excavated to full depth not following the support sequences specified in the design drawings. This resulted in the exposure of the slope face between 2-4 meters high without full protection. Consequently, approximately, 0.5 meter thick soil movement occurred behind the highest exposed face (Figure 6) with displacement of 250 millimeters in shotcrete below the headstock. On the same day, 13 millimeters of rainfall exacerbated the movement. Additional rows of anchors and steel mesh were installed to stabilize the movement. As a precautionary measure, the highway speed was also reduced to 60 kilometers per hour to minimize any vibration-induced movements. Surveillance was also increased to ensure safety was not compromised. The rate of the movement reduced after the installation of additional support measures and ceased two days after shotcrete application was completed (Figure 7).

Figure 6. Excavation completed to formation level. The abutment is supported with percussion anchors and reinforced shotcrete. Note larger unsupported span on the far right.
