Bridge Abutment Remediation – A Case Study

Reference: Sundaram, M., Sugawara, J. and Sivakumar, S. (2022). Bridge Abutment Remediation – A Case Study.

International Journal of Geoengineering Case Histories, Volume 7, Issue 4, pp. 1-7,

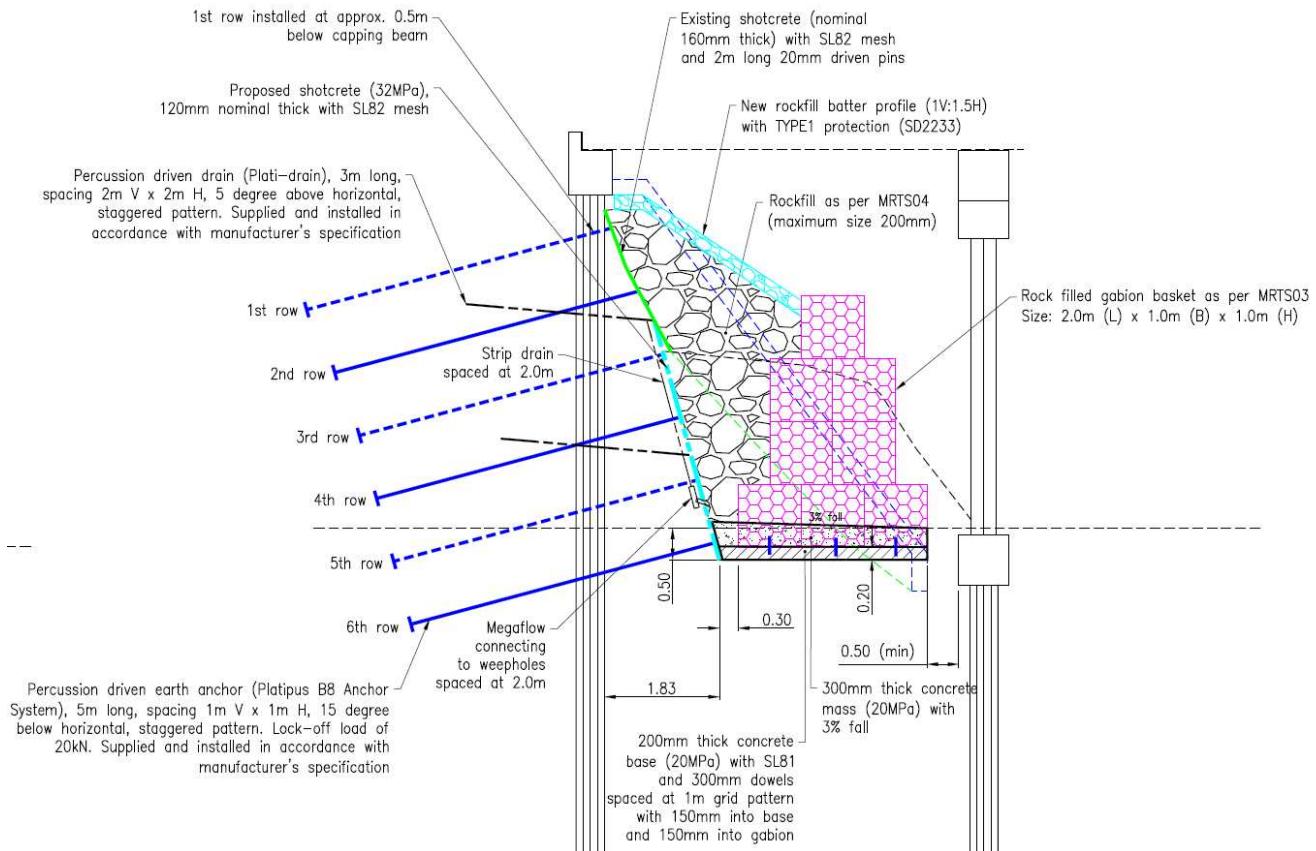
Figure 4. Permanent remediation of the bridge abutment.

- Installation of percussion anchors (300 millimeters wide head, 20 kilo Newton lock-off load) via slots cut into existing shotcrete (urgent works) at 1 meter vertical and horizontal spacing in a staggered pattern.
- Staged excavation at 1.2 meters lifts, followed by installation of percussion anchors, mesh and shotcrete, a row at a time until the toe of excavation was reached for formation of foundation for gabion.
- Installation of percussion drainage (three meters long by two rows at two meters staggered spacing).

It is worth noting that percussion anchors were chosen as they are quick to install, do not need specialized equipment, suit the application in a small space, and can be loaded soon after installation. Figure 4 shows the final design adopted to remediate the bridge abutment.

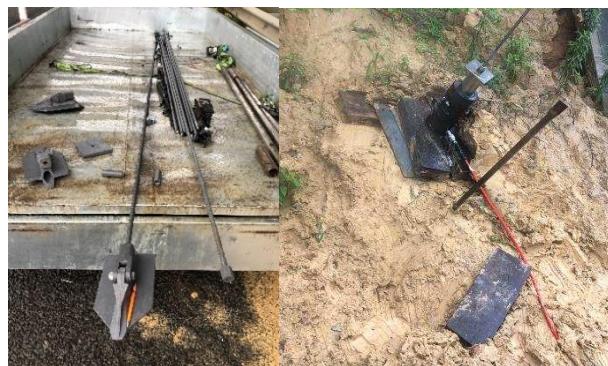
The construction of the remediation works commenced in May 2022. The appointed contractor proposed an alternative anchor head size to the size proposed in the design. This was mainly to accommodate a smaller machine to drive the percussion anchors. The proposal was accepted provided that the working load of 80 kilo Newton could be achieved. Three test anchors (180 millimeters head size) were tested prior to the commencement of production anchors. Two of the anchors achieved >25 kilo Newton and the test had to be terminated due to soft material around the collar (Figure 5). One anchor was tested to 100 kilo Newton (at 850 millimeters extension) and the test was terminated as the load reached 80 per cent of ultimate breaking load of the steel tendon, 120 kilo Newton. On that basis, the proposed 180 millimeters anchor head was accepted as the minimum size that could be used. However, during construction, a mixture of 180-millimeter and 300-millimeter head sizes were used since there was a supply issue with the smaller heads. No issues were encountered during installation of the anchors.

Figure 5. Percussion anchor (180-millimeter head) and load testing.

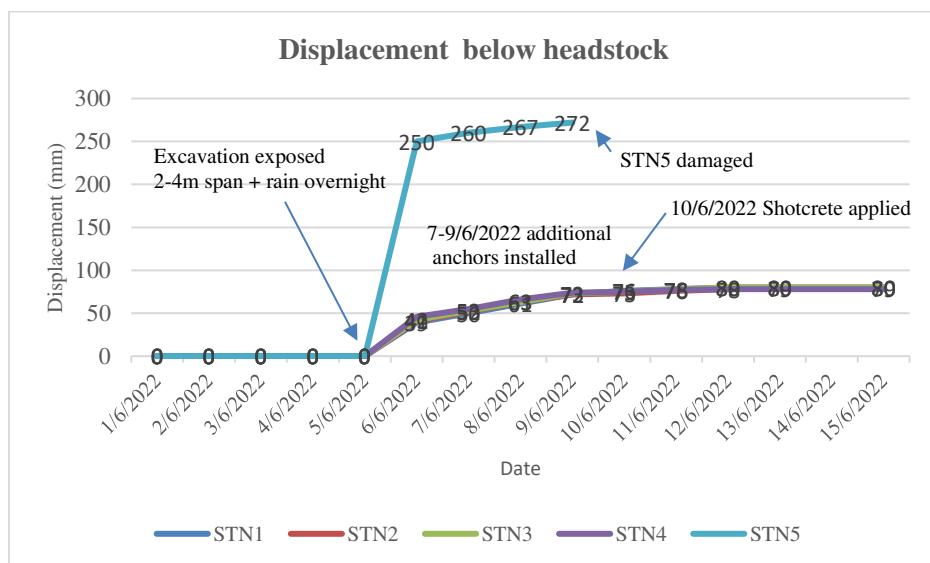
Figure 7. Displacement (mm) in shotcrete below headstock. Station 5 (STN5) located on far right. Displacement ceased two days after shotcrete application.
