## Bridge Abutment Remediation – A Case Study

Reference: Sundaram, M., Sugawara, J. and Sivakumar, S. (2022). Bridge Abutment Remediation – A Case Study.

International Journal of Geoengineering Case Histories, Volume 7, Issue 4, pp. 1-7,

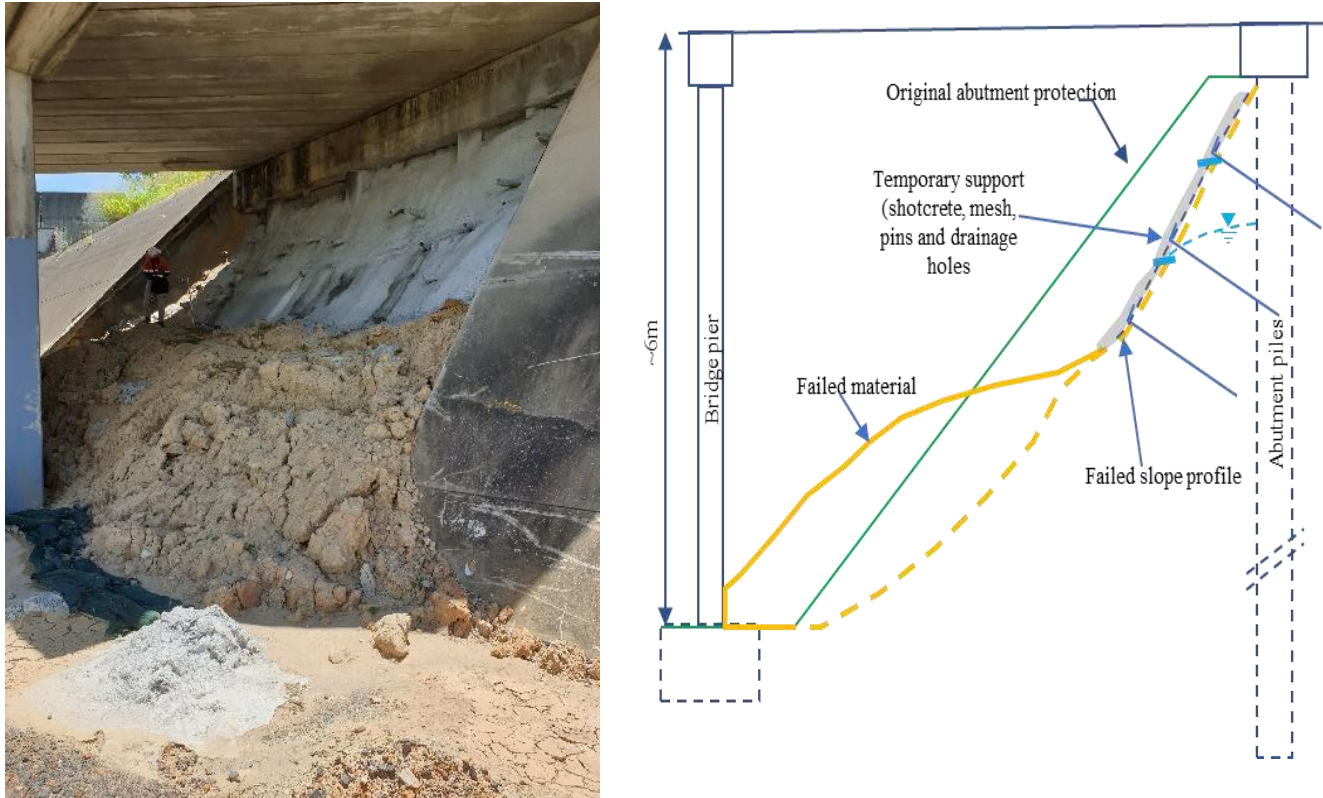
Figure 3. Temporary remediation (shotcrete with mesh, drainage holes, and driven pins) installed within 24 hours of the failure. The sketch illustrates the slope profile and temporary remediation installed. Seepage continued to occur two meters below the headstock at a reducing rate.

- Removal of failed material from batter face and abutting against slope toe to provide passive support.
- Installation of two rows of 1-m long drainage pipes.
- Installation of three rows of 2-meter long, 20-millimeters diameter coggled steel reinforcement bars (driven) at 1-meter spacing.
- Application of 160 millimeters (average) thick shotcrete with SL82 mesh.
- Closure of one lane on the road below with temporary traffic lights with contra flow.
- Risk management advice included daily inspections of the site (to later be reduced to weekly, granted there were no further movements) and checks after rainfall events.

The above measures appeared to have worked well, with no further movement observed on the abutment slope which withstood subsequent rainfall events.
