Bridge Abutment Remediation – A Case Study

Reference: Sundaram, M., Sugawara, J. and Sivakumar, S. (2022). Bridge Abutment Remediation – A Case Study.

International Journal of Geoengineering Case Histories, Volume 7, Issue 4, pp. 1-7,

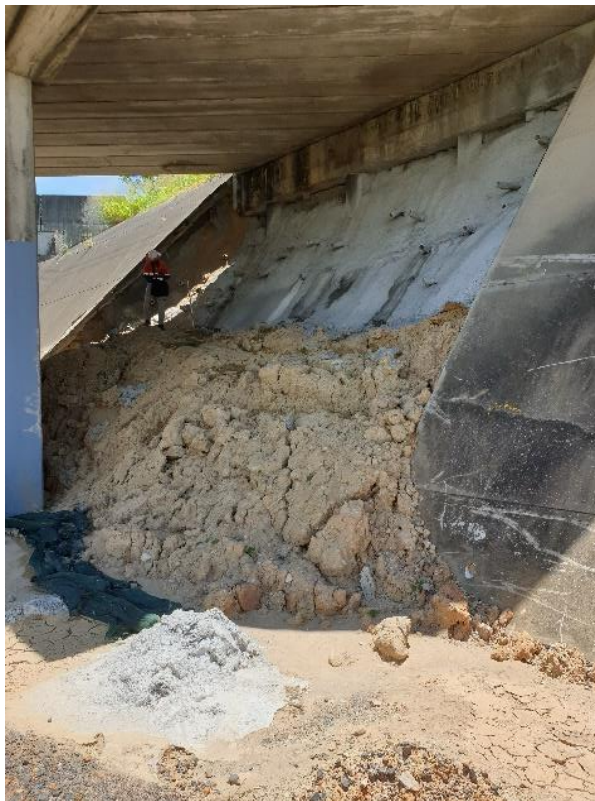
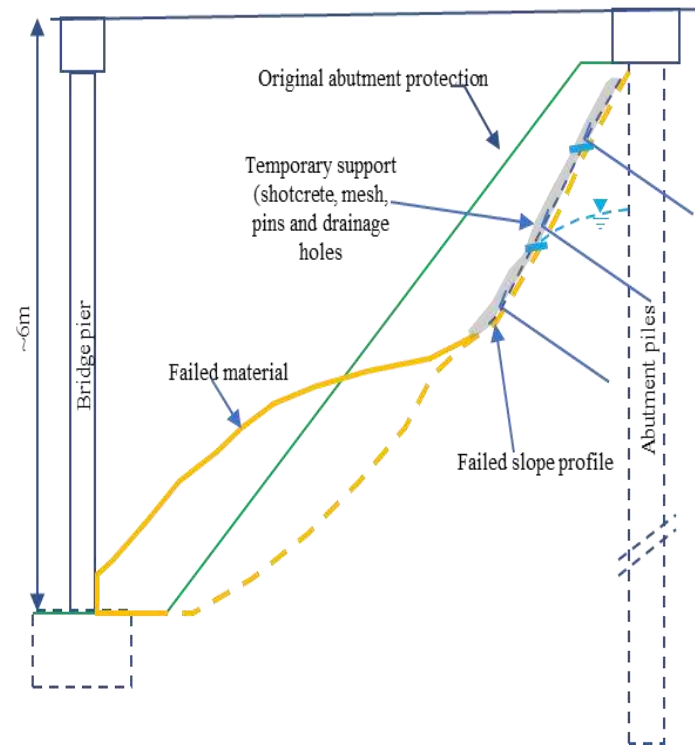
Figure 3. Temporary remediation (shotcrete with mesh, drainage holes, and driven pins) installed within 24 hours of the failure. The sketch illustrates the slope profile and temporary remediation installed. Seepage continued to occur two meters below the headstock at a reducing rate.

Due to a forecast of further rainfall in the days following the failure, there was an urgent requirement to making the abutment safe and prevent further slips from the exposed surface. The following immediate and urgent mitigation measures were implemented within 24 hours (Figure 3):

- Removal of failed material from batter face and abutting against slope toe to provide passive support.
- Installation of two rows of 1-m long drainage pipes.
- Installation of three rows of 2-meter long, 20-millimeters diameter coggled steel reinforcement bars (driven) at 1-meter spacing.
- Application of 160 millimeters (average) thick shotcrete with SL82 mesh.
- Closure of one lane on the road below with temporary traffic lights with contra flow.
- Risk management advice included daily inspections of the site (to later be reduced to weekly, granted there were no further movements) and checks after rainfall events.
