Images Collected from the Internet Reveal the Failing Mechanism of the Tailing Dam Breach at Kolontar, Hungary

ABSTRACT: *The failure of the red sludge tailing dam at Kolontar in 2010 was the most severe environmental disaster in the history of Hungary. The official investigations are confidential because the legal case has not been closed. The publicly accessible information from the breach of the dam are the photographs taken by the media and news agencies. Collecting these images and analyzing the recorded fractures and displacements of the dam reveal the failing mechanism. The breach of the dam resulted from failing to sliding, which had been developed in three stages. This conclusion is consistent with the observed movements of the dam deduced from a persistent scattered radar interferometry deformation analysis conducted between 2003 and 2010.*

Reference: Garai J., and Kovács I. (2025). *Images Collected from the Internet Reveal the Failing Mechanism of the Tailing Dam Breach at Kolontar, Hungary*. International Journal of Geoengineering Case Histories, Vol.8, Issue 1, p.64-81. doi: 10.4417/IJGCH-08-01-04

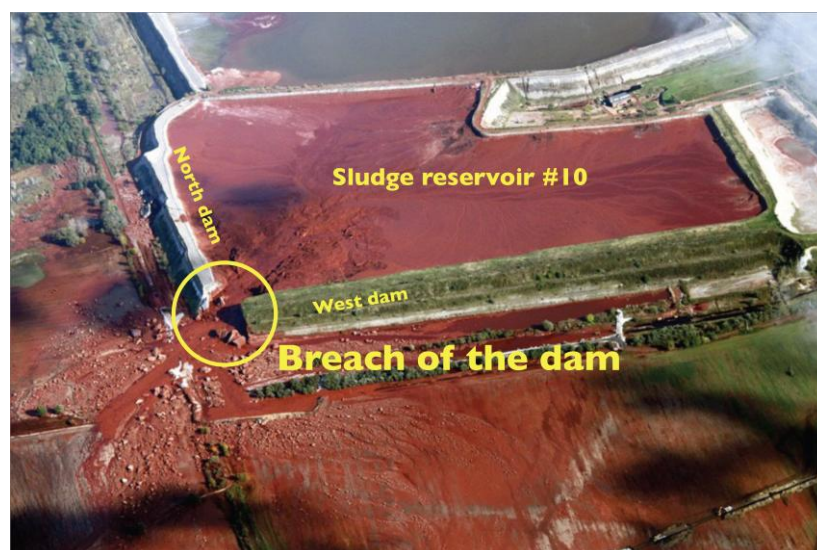
The failure of the dam occurred on October 4th around noon. The dam broke over a 50 m length, resulting in the release of 1 million m^3 of highly basic sludge (Figures 1, 2). The flood of sludge killed 10 people and another 286 were injured (Banvolgyi, Gy., 2010).

Figure 2. Aerial photo of the breach of the tailing dam. (Source: <https://www.ndtv.com/world-news/hungarys-toxic-sludge-spill-as-big-as-gulf-oil-leak-435094>.)

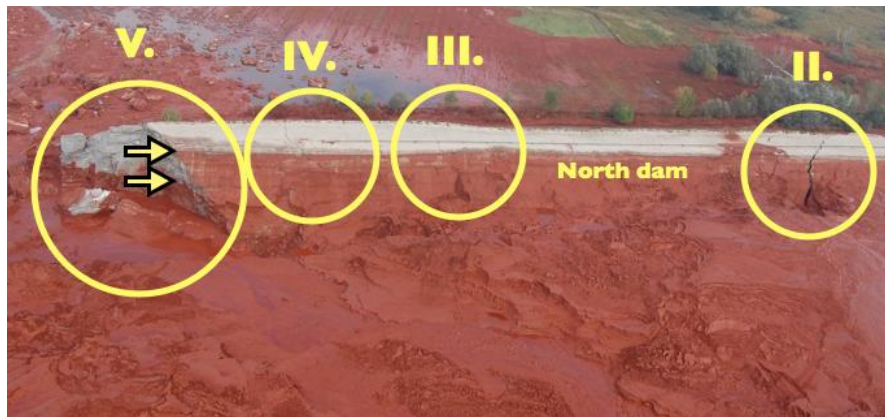
At Location V, the mark of the red sludge on the fracture (Figure 8) is lower than the original one, which indicates that this fracture occurred after the breach, when the sludge level in the reservoir was already lowered.

Figure 8. Photo showing fracture Locations II-V. The red mark of the sludge on the open surface of the fracture at Location V is shown. This mark is much lower than the original level in the reservoir, indicating that this fracture was formed after the breach, when the sludge level was significantly lower. (Source: <http://toleducation.org/achievements/red-legacy/>.)

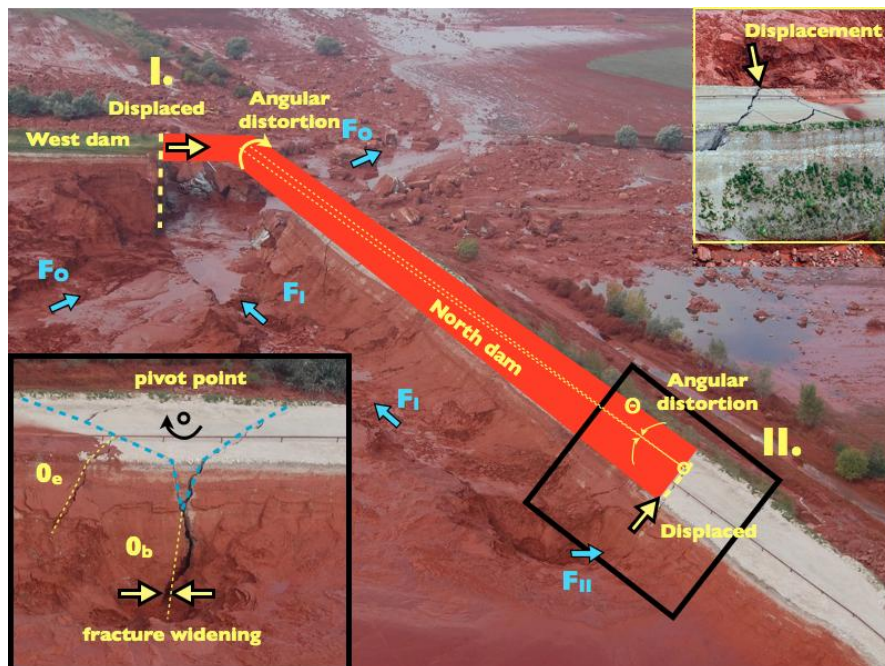
Displacements outward from the reservoir at Locations I and II of the western part of the North dam had been identified (Figure 9). The dam remained intact between these two locations; it is reasonable to assume that the entire dam section between them had been displaced. The displacements at the two ends of the failed dam section are different, which induced an angular distortion on the failed section. This distortion can be identified from the widening of the fracture at Location II (see Figure 9) and from the position of the detached pipe at Location II (see Figure 10). Thus, the failed section of the dam between Locations I and II has been displaced, and an angular distortion has been induced (Figure 9).

Figure 9. The failed section of the North dam is shown in red. This entire section had been displaced outward from the reservoir. Angular distortion also occurred from the bigger displacement at Location I. The widening of fracture 0_b supports the angular distortion. The channels created by the outflow are visible on the surface of the red sludge. The identified flow directions (F) are shown. (Sources: <http://www.hungarianambiance.com/2011/09/possibility-of-act-of-terrorism-cant-be.html> and <https://phys.org/news/2011-04-wildlife-largely-absent-red-sludge.html#nRlv>.)

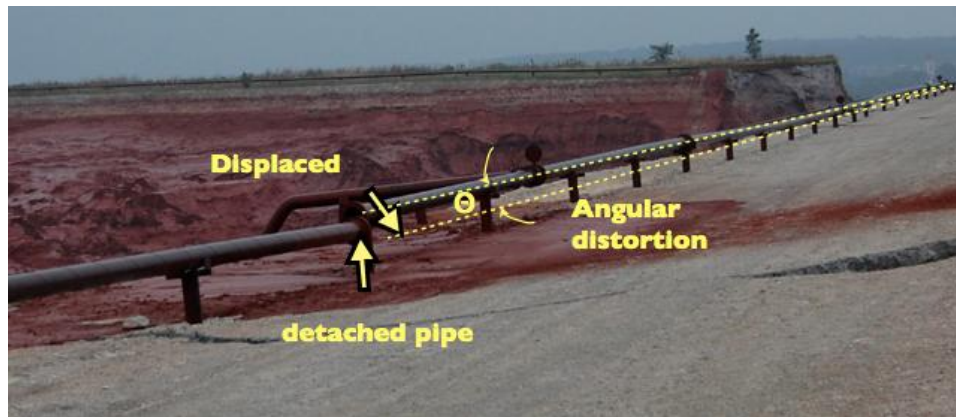
Figure 10. The angular distortion of the failed section of the dam can be seen from the position of the displaced broken pipe. On the failed part of the dam the pipe moved towards the reservoir despite the outward movement of the failed dam section. This indicates that the displacement resulting from angular distortion exceeded the outward displacement of the dam. (Source:

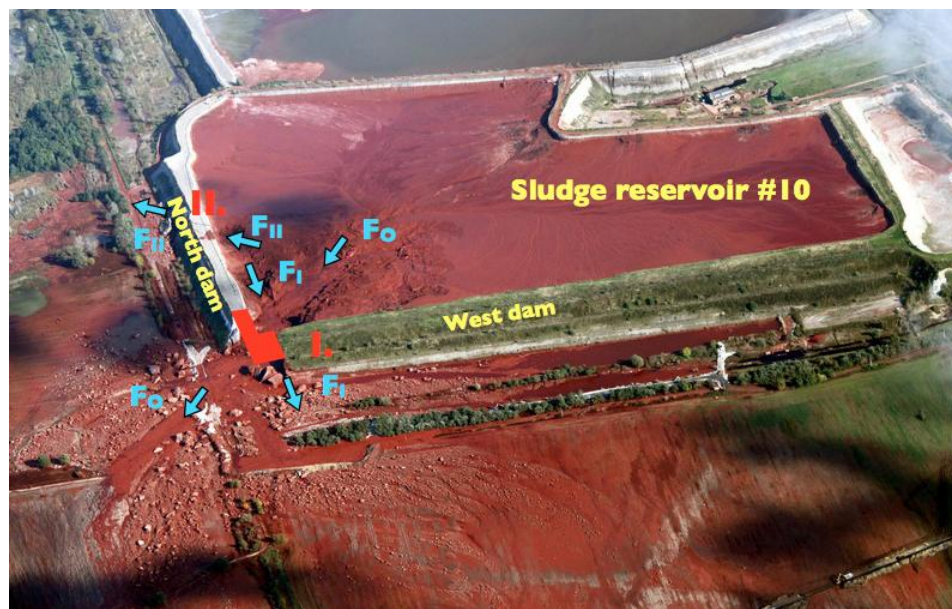
Figure 11. Based on the created flow channels in the red sludge, the flow directions were reconstructed. The initial flows F_1 and F_2 occurred at Locations I and II, pointing toward the direction of the existing fractures. The direction of flow F_1 changed to F_0 when the western part of the North dam had been washed away, creating a big opening. (Source: <https://www.ndtv.com/world-news/hungarys-toxic-sludge-spill-as-big-as-gulf-oil-leak-435094>.)

The flow directions pointing towards Location I (F_I) and Location II (F_{II}) are narrow, indicating that these were the initial flows which were active right after the breach of the dam. These channels, F_I and F_{II} , are also deeper than the third one, F_O . The bigger depth of these channels indicates that these are the initial flows, when the initial hydraulic gradient was the highest. The flow directions further confirm that the fractures developed at Locations I and II initiated the breach of the dam. The third identified flow direction (F_O) is shallower and wider, pointing toward the direction of the biggest opening. It is concluded that the flow F_I changed its direction to F_O when part of the North dam had been washed away.

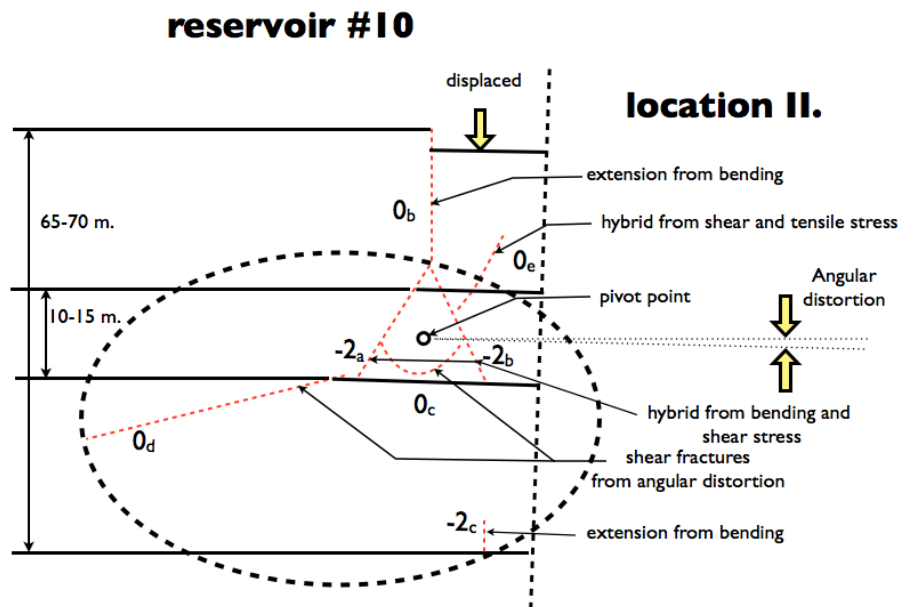
Location II is in the middle of the North dam. The fracture pattern is quite complex. Based on the fracture pattern, it can be identified that the fractures -2_a and -2_b relate to bending (Figure 6). The tension side of the bending was the outer side of the reservoir. However, on this side (outward from the reservoir), shear fractures 0_c and 0_d are also present, indicating compression stress on the same side (Figures 4 and 5).

Figure 13. The identified fractures at Location II are shown. Dashed circles mark fractures, formed from compression and tension in the same location. The coexistence of the extension and shear fractures in the same location can only be possible if the stress conditions changed in time.

The coexistence of compressional and tensional stresses at the same side of the dam is possible only if the stress conditions changed in time. At the breach, displacement and angular distortion occurred. These movements should develop compression stress on the outward and tensile stress in the inward side and shear stress. The bending related fractures -2_a and -2_b are not consistent with the stress condition at breaching, which indicates that these fractures -2_a and -2_b were already present when the breach occurred. The fracture pattern -2_a and -2_b is an indicative of failing from bending (Figure 6), which developed from the pressure of the red sludge acting from the reservoir site on the dam. The bending related fracture pattern is further supported by the location of the fractures, which is in the middle of the North dam, where the maximum bending moment should occur in a beam subject to uniform load (Figure 14).

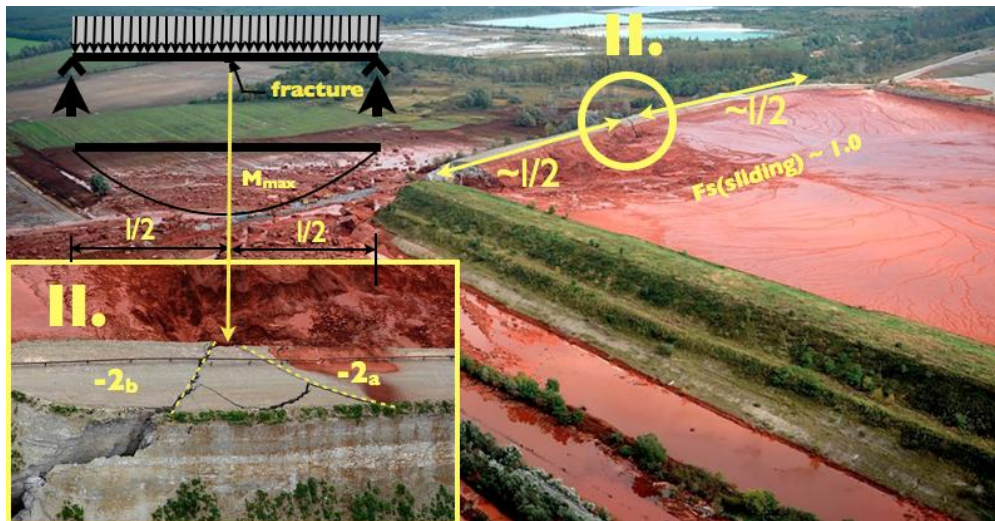
Figure 14. Location II is at the middle of the North dam, where the bending moment has its maximum under uniformly distributed load. The fracture pattern (Figure 6) and the location suggest that these fractures (-2a, and -2b) occurred from the bending. These fractures were formed before the breach of the dam. (Sources: <http://toleducation.org/achievements/red-legacy/>; <http://www.hungarianambiance.com/2011/09/possibility-of-act-of-terrorism-cant-be.html>.)

The allowable angular distortion in buildings is $1/300$ (Skempton and MacDonald, 1956). In masonry or concrete structures, fractures start to develop when the angular distortion exceeds this value, which might be too conservative for the dam because its material is not as rigid as these building materials. Using this conservative value on the approximately 500 m long dam, many decimeters of displacement in the middle of the dam were required to develop these fractures. Thus, the dam suffered a very significant deformation before the breach. The displacement occurred in the horizontal direction, indicating that, at the time of the fracture formation, the resistance against sliding was already exhausted. The developed fractures (-2_a and -2_b) reduced the bending moment at Location II close to zero, and the dam did not fail.

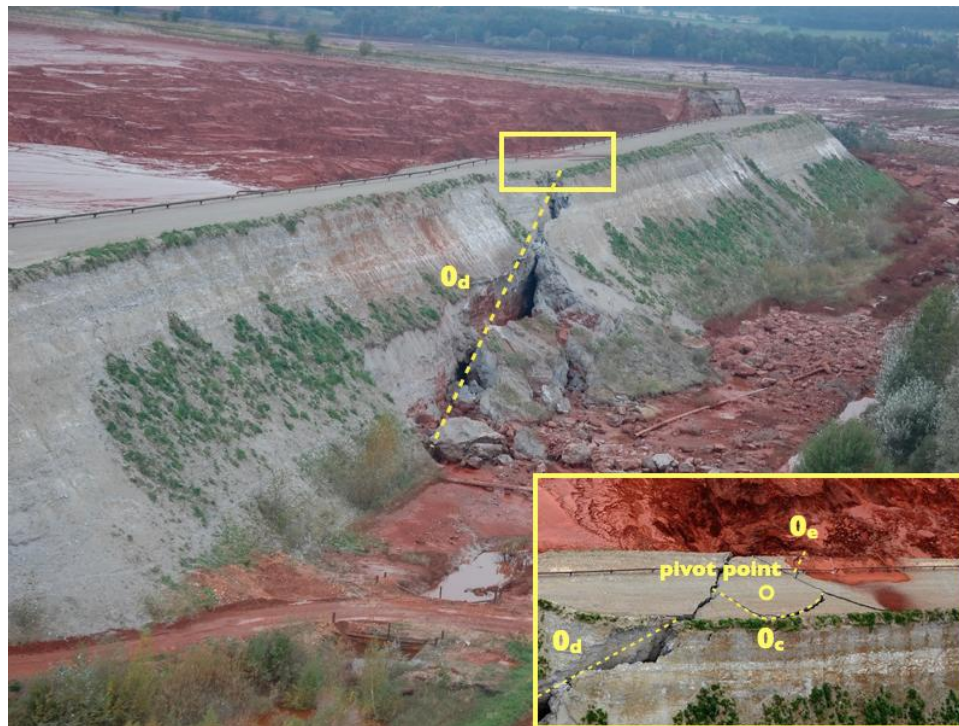
The last straw leading to the breach of the entire dam section was when the tensional resistance of the West dam was exhausted. The dam, whose sliding resistance had already been exhausted, had been detached at fracture 0_a and the dam moved outward from the reservoir, activating the preexisting bending fractures at Location II. The displacement also induced an angular distortion which generated tensile and shear stresses on the reservoir side, resulting in fractures 0_b and 0_c respectively. The angular distortion of the dam produced compression stress at the outward site of the reservoir, which resulted in the development of shear fractures 0_c and 0_d on the outward side of the dam (Figure 15). The detachment occurred along the extension fracture (0_b) (Figure 9), and the preexisting fracture -2_a (Figure 14). Fracture 0_c (Figure 9) is a hybrid fracture caused by extension (angular distortion) and shear stresses (displacement).

Figure 15. Shear fractures (0_c and 0_d) caused by compressional stress at Location II are shown. These fractures were formed at the breach, resulting from the angular distortion of the failed dam section. On the opposite (reservoir) side, at the same time, extension fracture 0_b occurred (Figure 9), extending the existing fracture of -2_b . (Sources: <https://www.nbcnews.com/slideshow/toxic-red-sludge-floods-towns-near-budapest-39514793>; <http://www.hungarianambiance.com/2011/09/possibility-of-act-of-terrorism-cant-be.html>).

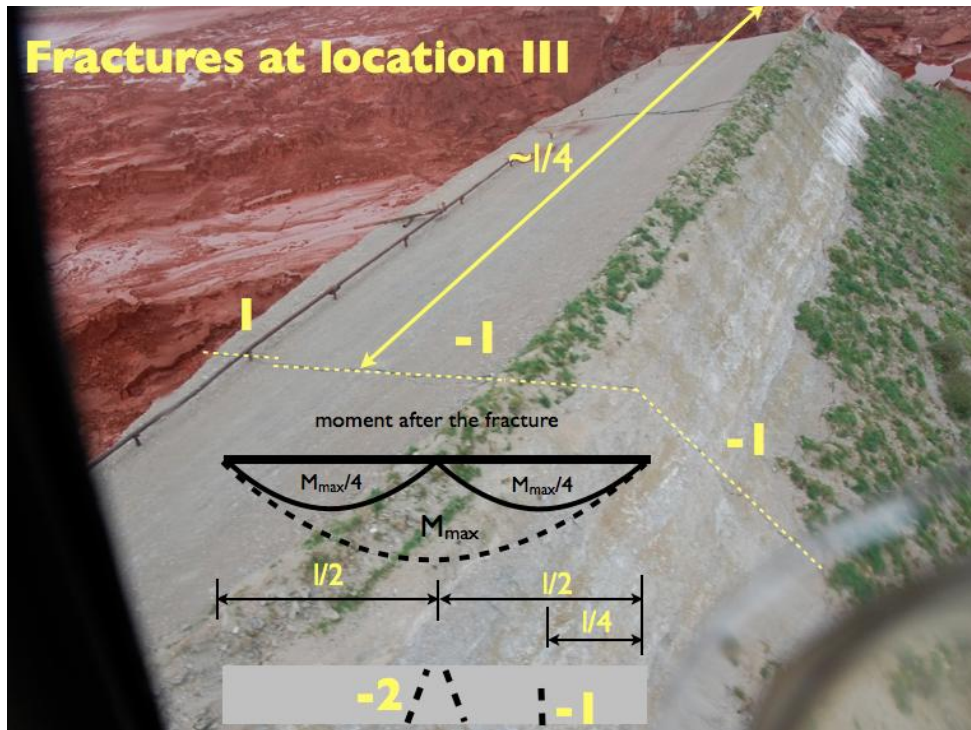
There are two independent fractures (1 and -1) perpendicular to the axis of the North dam. Based on the fracture direction, it is concluded that these fractures are the result of tensile stress acting in the direction of the axis of the dam (Figure 4). Both of these fractures resulted from bending, but there is a time gap between their occurrences. Following the development of fractures $-2_{a,b}$ at Location II, the maximum bending moment shifted from the middle of the dam to 1/4 of the length of the dam, which is where Location III is (Figure 16). The tensile strength relating to the bending moment of sludge pressure caused fracture -1 at the outward side of the dam. This failure occurred before the breach of the dam. At this weakened cross section, the angular distortion occurring at the breach and the additional flow pressures after the breach led to the development fracture 1 on the opposite side.

Figure 16. The location and the shape of fracture -1 is shown. Both the location and the shape of the rupture indicate that the failing was caused by bending. Following the formation of fractures -2 at Location II, the maximum moment was formed at Location III, resulting in the fracture of -1. (Source: <http://www.hungarianambiance.com/2011/09/possibility-of-act-of-terrorism-cant-be.html>.)

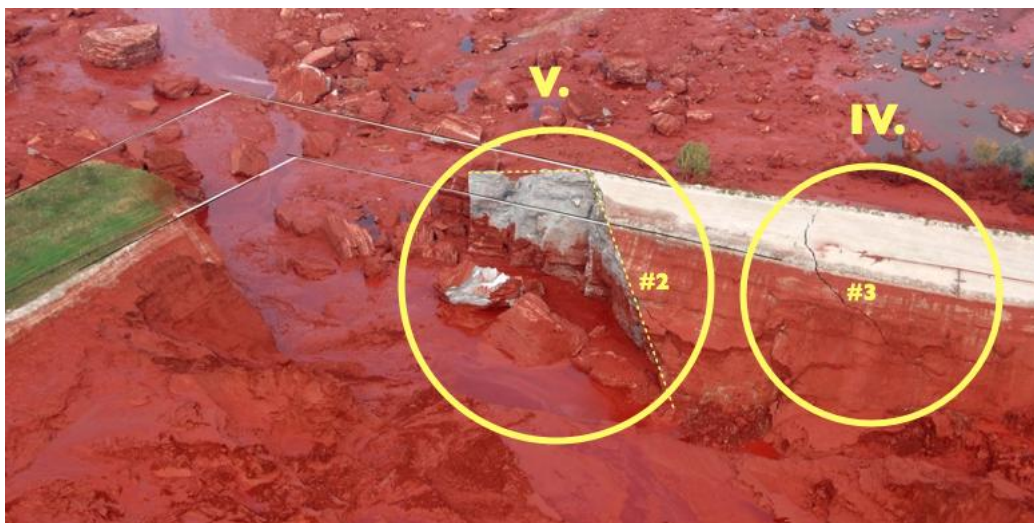
The fracture pattern of these sites shows hybrid failure (Figure 17).

Figure 17. The fractures at Locations IV and V are hybrid fractures caused by the outflowing pressure of the red sludge and the additional settlement. These fractures occurred after the breach of the dam and they have no relevance to the failing of the dam. (Source: https://commons.wikimedia.org/wiki/File:Ajka_accident_d7df9fea08_b.jpg.)

If the fractures at Locations IV and V existed before the breach, then the transformation of the force and the torque would be very limited beyond these locations. Elimination of the torque would not allow the development of the angular distortion beyond Location IV or V. Thus, these fractures at Locations IV and V were formed after the breach. The mark of the red sludge on the surface of fracture 2 also shows that this failing occurred after the breach when the level of the red sludge was reduced from its original elevation (Figure 8). The widening of fracture 3 towards the top of the dam indicates that additional angular distortion in the vertical direction occurred, most likely resulting from the outflow of the sludge, which washed out the soil below the dam section at the opening. The settlement of the dam section led to the development of the extension fracture 4. All fractures at Locations IV and V had been developing after the breach of the dam; therefore, these fractures have no relevance to the breach. The list of all the fractures, as well as the type and the cause of the respective failure, is given in Table 1.
