Images Collected from the Internet Reveal the Failing Mechanism of the Tailing Dam Breach at Kolontar, Hungary

ABSTRACT: *The failure of the red sludge tailing dam at Kolontar in 2010 was the most severe environmental disaster in the history of Hungary. The official investigations are confidential because the legal case has not been closed. The publicly accessible information from the breach of the dam are the photographs taken by the media and news agencies. Collecting these images and analyzing the recorded fractures and displacements of the dam reveal the failing mechanism. The breach of the dam resulted from failing to sliding, which had been developed in three stages. This conclusion is consistent with the observed movements of the dam deduced from a persistent scattered radar interferometry deformation analysis conducted between 2003 and 2010.*

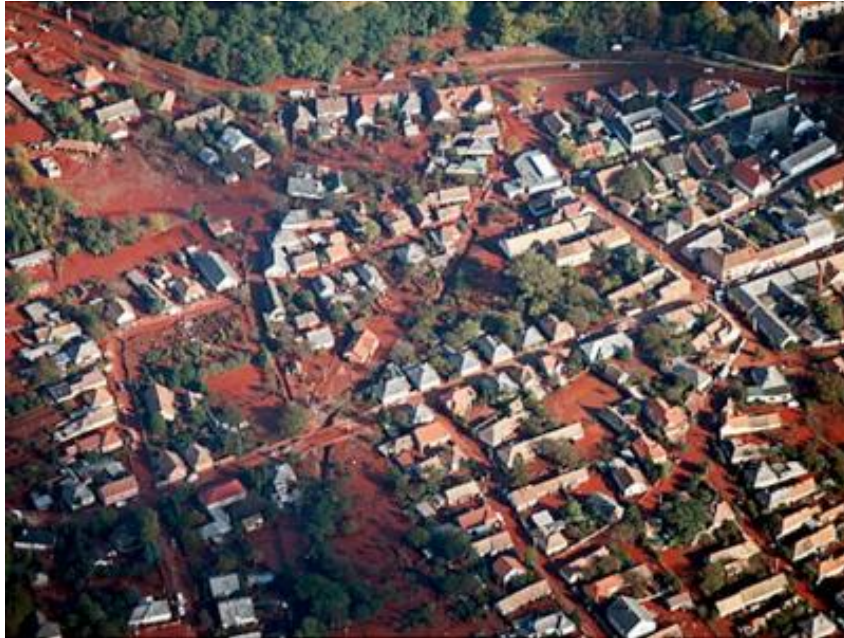
Figure 1. The scale of the disaster: the highly toxic sludge flooded the neighboring villages in the valley of Torna. (Source: <http://www.nydailynews.com/news/world/bodies-found-hungary-toxic-red-sludge-seeped-danube-river-article-1.188733>.)

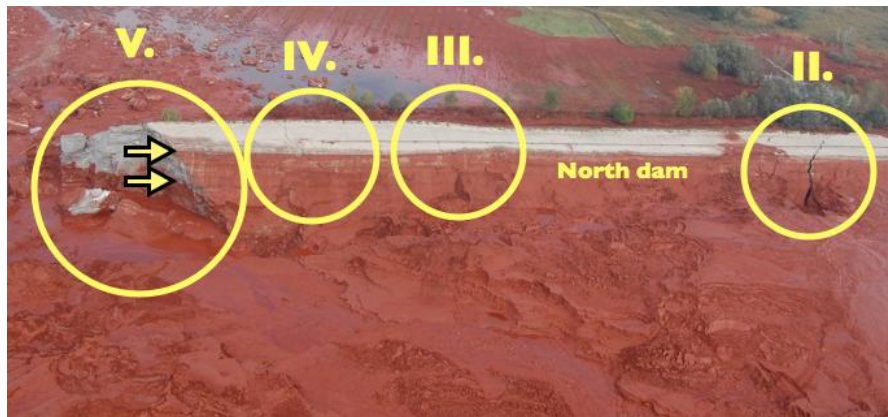
At Location V, the mark of the red sludge on the fracture (Figure 8) is lower than the original one, which indicates that this fracture occurred after the breach, when the sludge level in the reservoir was already lowered.

Figure 8. Photo showing fracture Locations II-V. The red mark of the sludge on the open surface of the fracture at Location V is shown. This mark is much lower than the original level in the reservoir, indicating that this fracture was formed after the breach, when the sludge level was significantly lower. (Source: <http://toleducation.org/achievements/red-legacy/>.)

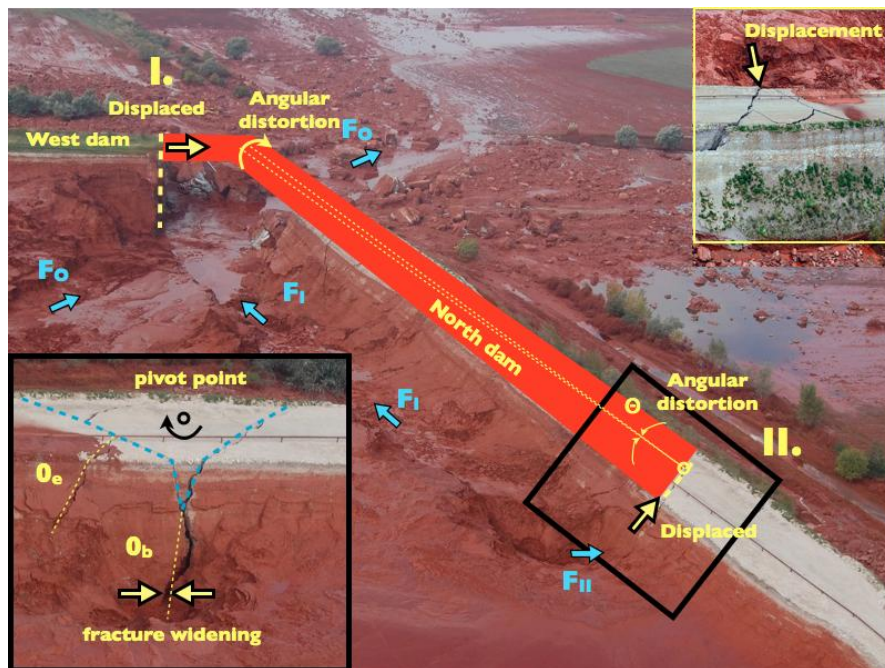
Displacements outward from the reservoir at Locations I and II of the western part of the North dam had been identified (Figure 9). The dam remained intact between these two locations; it is reasonable to assume that the entire dam section between them had been displaced. The displacements at the two ends of the failed dam section are different, which induced an angular distortion on the failed section. This distortion can be identified from the widening of the fracture at Location II (see Figure 9) and from the position of the detached pipe at Location II (see Figure 10). Thus, the failed section of the dam between Locations I and II has been displaced, and an angular distortion has been induced (Figure 9).

Figure 9. The failed section of the North dam is shown in red. This entire section had been displaced outward from the reservoir. Angular distortion also occurred from the bigger displacement at Location I. The widening of fracture 0_b supports the angular distortion. The channels created by the outflow are visible on the surface of the red sludge. The identified flow directions (F) are shown. (Sources: <http://www.hungarianambiance.com/2011/09/possibility-of-act-of-terrorism-cant-be.html> and <https://phys.org/news/2011-04-wildlife-largely-absent-red-sludge.html#nRlv>.)

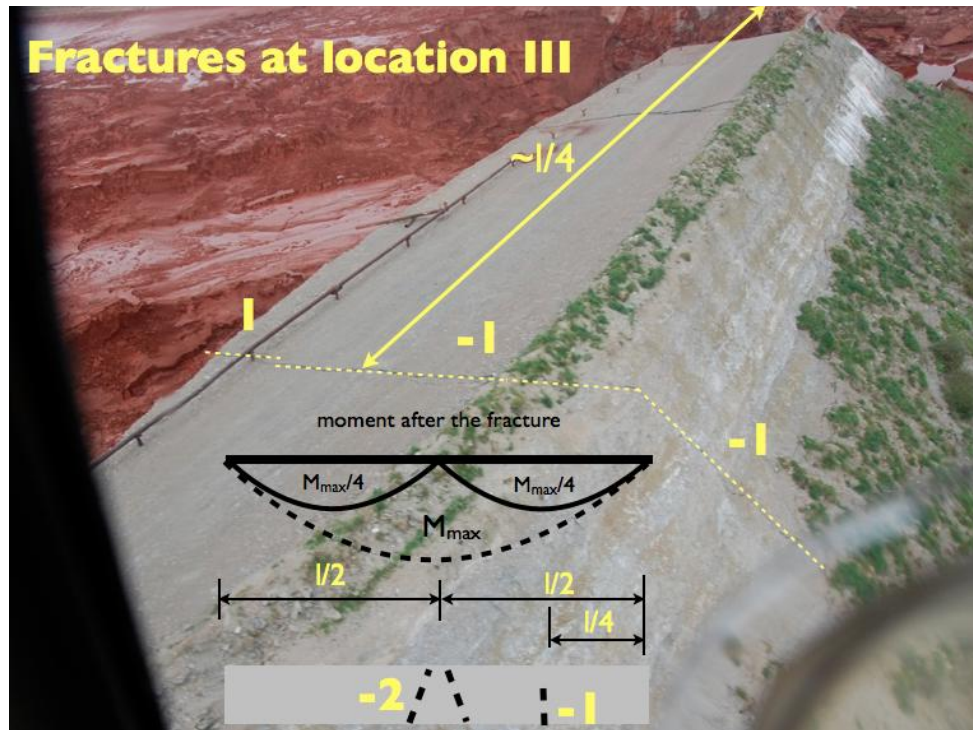
There are two independent fractures (1 and -1) perpendicular to the axis of the North dam. Based on the fracture direction, it is concluded that these fractures are the result of tensile stress acting in the direction of the axis of the dam (Figure 4). Both of these fractures resulted from bending, but there is a time gap between their occurrences. Following the development of fractures $-2_{a,b}$ at Location II, the maximum bending moment shifted from the middle of the dam to 1/4 of the length of the dam, which is where Location III is (Figure 16). The tensile strength relating to the bending moment of sludge pressure caused fracture -1 at the outward side of the dam. This failure occurred before the breach of the dam. At this weakened cross section, the angular distortion occurring at the breach and the additional flow pressures after the breach led to the development fracture 1 on the opposite side.

Figure 16. The location and the shape of fracture -1 is shown. Both the location and the shape of the rupture indicate that the failing was caused by bending. Following the formation of fractures -2 at Location II, the maximum moment was formed at Location III, resulting in the fracture of -1. (Source: <http://www.hungarianambiance.com/2011/09/possibility-of-act-of-terrorism-cant-be.html>.)
