# Images Collected from the Internet Reveal the Failing Mechanism of the Tailing Dam Breach at Kolontar, Hungary

**ABSTRACT:** *The failure of the red sludge tailing dam at Kolontar in 2010 was the most severe environmental disaster in the history of Hungary. The official investigations are confidential because the legal case has not been closed. The publicly accessible information from the breach of the dam are the photographs taken by the media and news agencies. Collecting these images and analyzing the recorded fractures and displacements of the dam reveal the failing mechanism. The breach of the dam resulted from failing to sliding, which had been developed in three stages. This conclusion is consistent with the observed movements of the dam deduced from a persistent scattered radar interferometry deformation analysis conducted between 2003 and 2010.*

**Reference:** Garai J., and Kovács I. (2025). *Images Collected from the Internet Reveal the Failing Mechanism of the Tailing Dam Breach at Kolontar, Hungary*. International Journal of Geoengineering Case Histories, Vol.8, Issue 1, p.64-81. doi: 10.4417/IJGCH-08-01-04

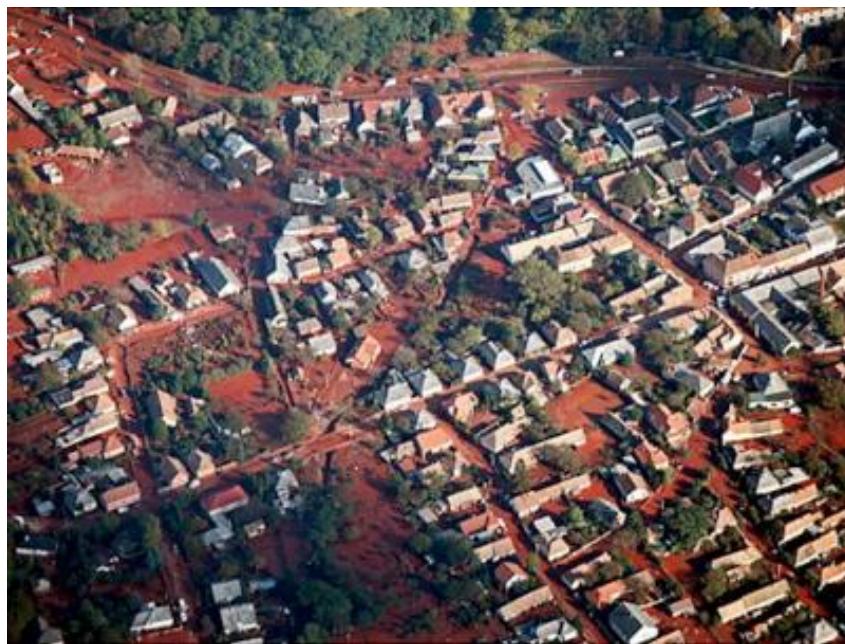
The failure of the dam occurred on October 4th around noon. The dam broke over a 50 m length, resulting in the release of 1 million m<sup>3</sup> of highly basic sludge (Figures 1, 2). The flood of sludge killed 10 people and another 286 were injured (Banvolgyi, Gy., 2010).

**Figure 1.** The scale of the disaster: the highly toxic sludge flooded the neighboring villages in the valley of Torna. (Source: <http://www.nydailynews.com/news/world/bodies-found-hungary-toxic-red-sludge-seeped-danube-river-article-1.188733>.)

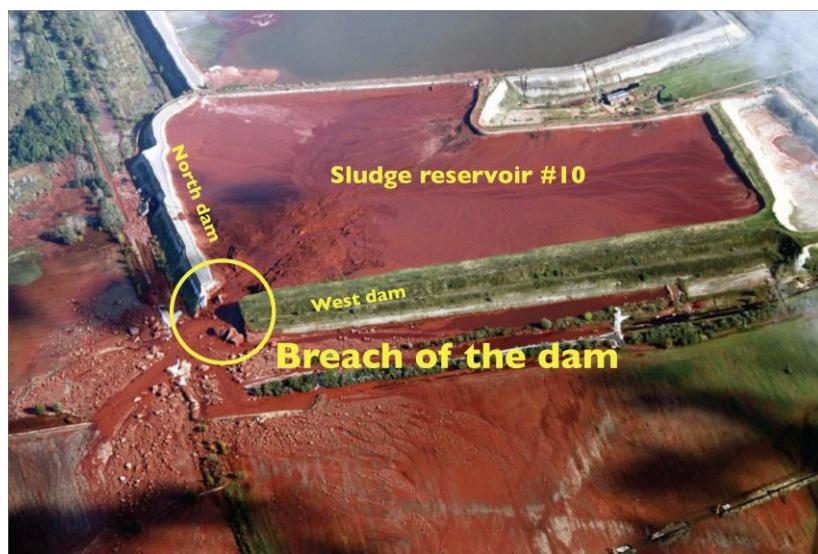
**Figure 2.** Aerial photo of the breach of the tailing dam.  
(Source: <https://www.ndtv.com/world-news/hungarys-toxic-sludge-spill-as-big-as-gulf-oil-leak-435094>.)

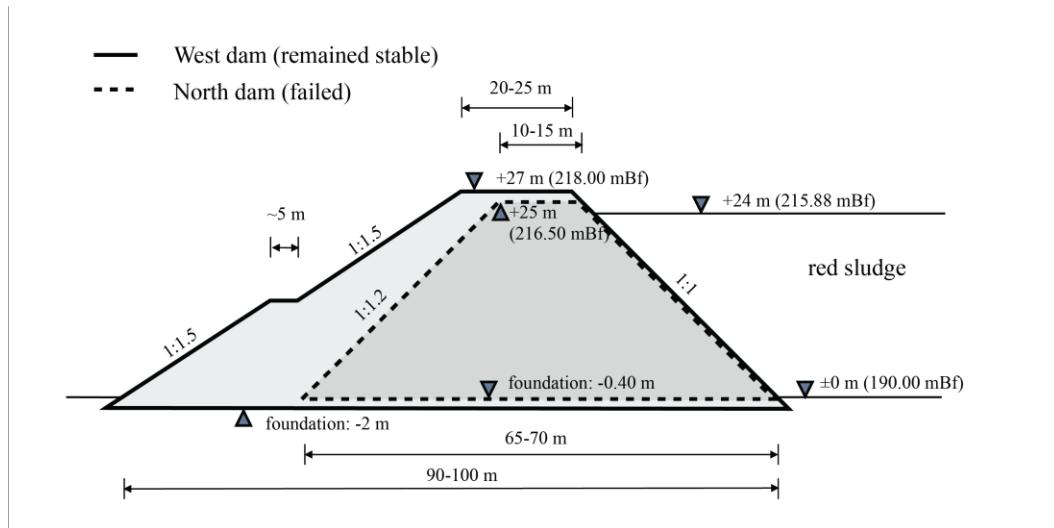
The dam was built in two stages. In the first stage, between 1993 and 1995, the dam was built to about a height of 14 m. In the second stage the dam was completed. The filling of the reservoir had begun in 1998 and continued until the end of 2009. Resulting from slag-ash building technology, the crown of the dam was not evenly leveled out. In order to reach the maximum designed and licensed capacity, a 0.3-1.4 m additional layer on the top of the North dam of the reservoir was added in July 2010. (Turi et al., 2013) The final heights of the dams were between 25-27 m, supporting the 24 m high sludge (Farkas et al., 2013). The cross sections of the dams are not uniform (see Figure 3). The failed North dam has a smaller cross section than the West dam because an additional reservoir was planned to be built at the North side. It was assumed that the failed dam does not need to support horizontal load because the pressure of the stored sludge from the two sides would cancel out each other. The planned joint reservoir was never implemented.

**Figure 3.** The cross sections of the North and West dams (Farkas et. al., 2013). The Northern dam primarily was designed to separate two reservoirs. The cross section of the dam therefore is significantly smaller in comparison to the West dam, which was designed to support the sludge pressure of the reservoir.

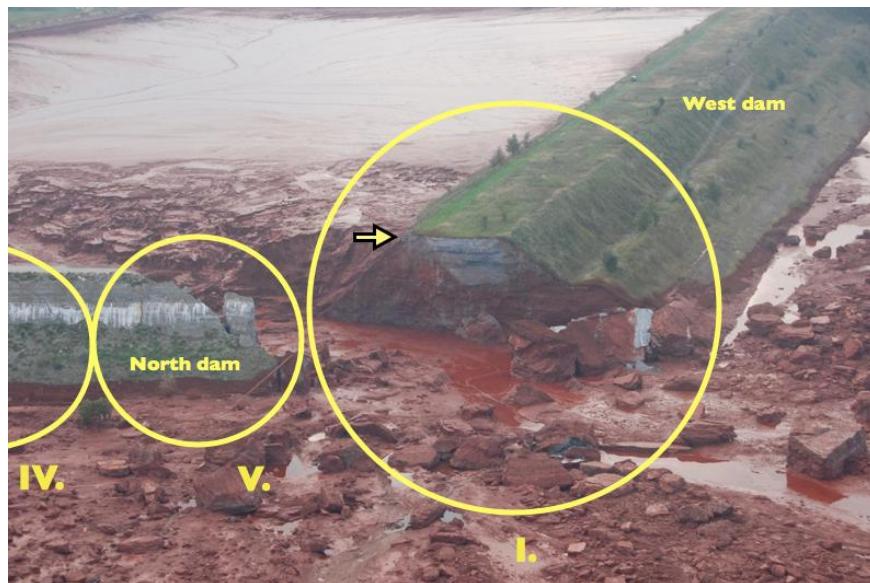
**Figure 7.** Photo showing the fracture Locations I, IV, and V. The red mark of the sludge on the open surface of the fracture at Location I is the same as the original sludge level. Thus, this fracture occurred right at the breach of the dam before the sludge level decreased in the reservoir. (Source: [https://www.aljazeera.com/photo\\_galleries/europe/20101072047436735](https://www.aljazeera.com/photo_galleries/europe/20101072047436735); <http://www.kormany.hu/en/photo-galleries/negy-eve-tortent-a-vorosiszap-katasztrof/>.)

This location has one characteristic fracture ( $0_a$ ), which has been exposed at the breach (Figure 7). The fracture occurred at the corner of the North and West dams and its surface is perpendicular to the West dam. This fracture is clearly the result of tensional stress acting in the direction of the axis of the West dam. The fracture occurred at the breach because the marks of the red sludge on the exposed surface are at the same elevation as the original level in the reservoir (Figure 7). The North

dam has been detached following the development of this fracture and displaced from the West dam, creating an opening. This opening was one of the initiators of the breach. The direction of the flow channel  $F_1$  is consistent with this conclusion.

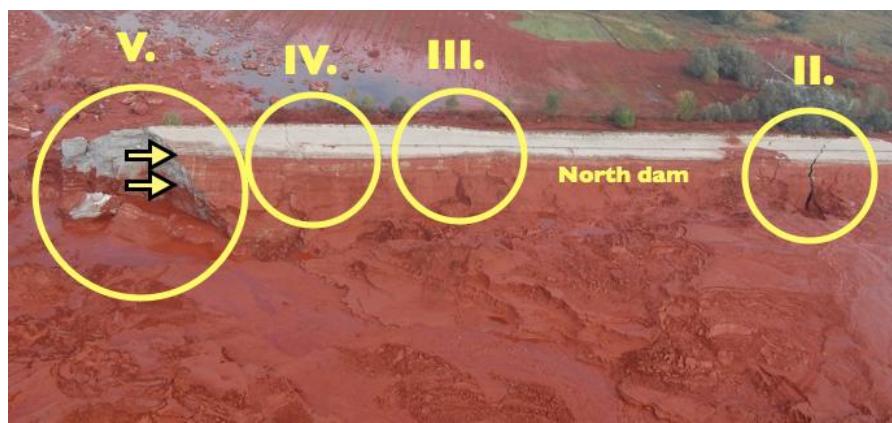
At Location V, the mark of the red sludge on the fracture (Figure 8) is lower than the original one, which indicates that this fracture occurred after the breach, when the sludge level in the reservoir was already lowered.

**Figure 8.** Photo showing fracture Locations II-V. The red mark of the sludge on the open surface of the fracture at Location V is shown. This mark is much lower than the original level in the reservoir, indicating that this fracture was formed after the breach, when the sludge level was significantly lower. (Source: <http://toleducation.org/achievements/red-legacy/>.)

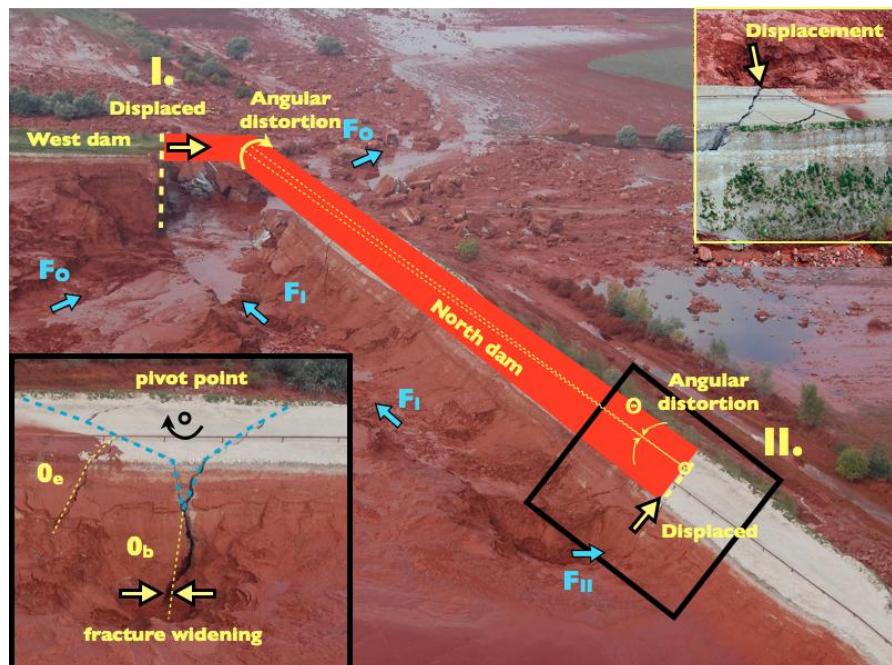
Displacements outward from the reservoir at Locations I and II of the western part of the North dam had been identified (Figure 9). The dam remained intact between these two locations; it is reasonable to assume that the entire dam section between them had been displaced. The displacements at the two ends of the failed dam section are different, which induced an angular distortion on the failed section. This distortion can be identified from the widening of the fracture at Location II (see Figure 9) and from the position of the detached pipe at Location II (see Figure 10). Thus, the failed section of the dam between Locations I and II has been displaced, and an angular distortion has been induced (Figure 9).

**Figure 9.** The failed section of the North dam is shown in red. This entire section had been displaced outward from the reservoir. Angular distortion also occurred from the bigger displacement at Location I. The widening of fracture  $O_b$  supports the angular distortion. The channels created by the outflow are visible on the surface of the red sludge. The identified flow directions ( $F$ ) are shown. (Sources: <http://www.hungarianambiance.com/2011/09/possibility-of-act-of-terrorism-cant-be.html> and <https://phys.org/news/2011-04-wildlife-largely-absent-red-sludge.html#nRlv>)

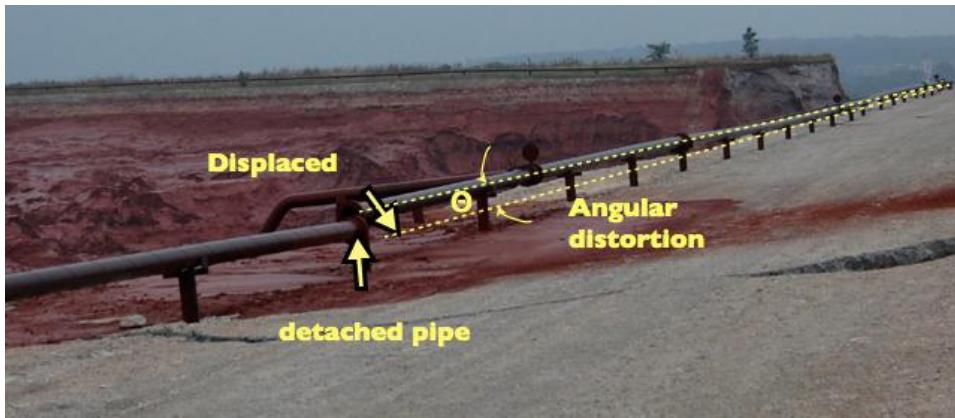
**Figure 10.** The angular distortion of the failed section of the dam can be seen from the position of the displaced broken pipe. On the failed part of the dam the pipe moved towards the reservoir despite the outward movement of the failed dam section. This indicates that the displacement resulting from angular distortion exceeded the outward displacement of the dam. (Source: [http://www.nbcnews.com/id/39610356/ns/world\\_news-europe/t/human-negligence-toxic-sludge-boss-arrested/](http://www.nbcnews.com/id/39610356/ns/world_news-europe/t/human-negligence-toxic-sludge-boss-arrested/).)

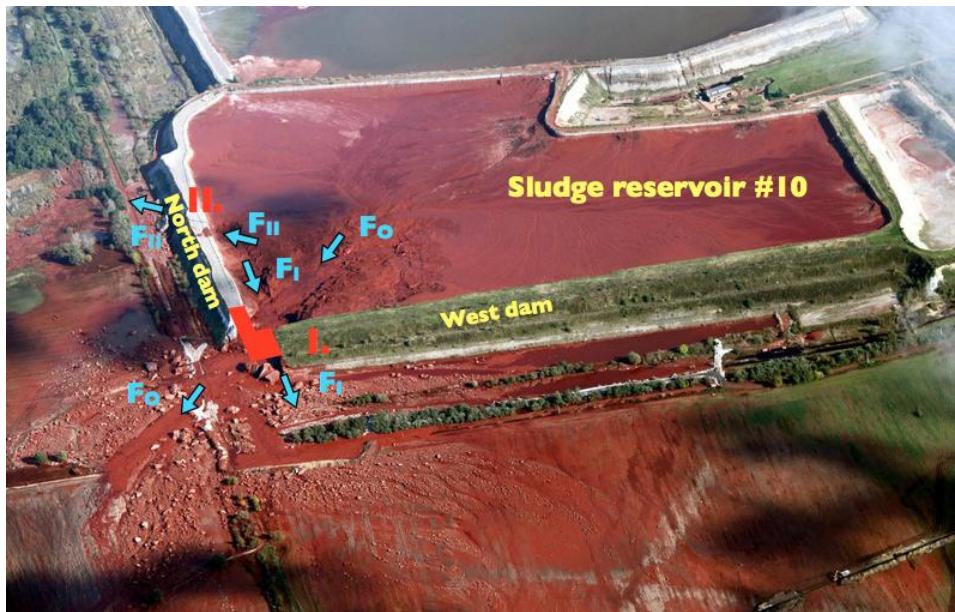
**Figure 11.** Based on the created flow channels in the red sludge, the flow directions were reconstructed. The initial flows  $F_1$  and  $F_2$  occurred at Locations I and II, pointing toward the direction of the existing fractures. The direction of flow  $F_1$  changed to  $F_0$  when the western part of the North dam had been washed away, creating a big opening. (Source: <https://www.ndtv.com/world-news/hungarys-toxic-sludge-spill-as-big-as-gulf-oil-leak-435094>.)

The flow directions pointing towards Location I ( $F_I$ ) and Location II ( $F_{II}$ ) are narrow, indicating that these were the initial flows which were active right after the breach of the dam. These channels,  $F_I$  and  $F_{II}$ , are also deeper than the third one,  $F_O$ . The bigger depth of these channels indicates that these are the initial flows, when the initial hydraulic gradient was the highest. The flow directions further confirm that the fractures developed at Locations I and II initiated the breach of the dam. The third identified flow direction ( $F_O$ ) is shallower and wider, pointing toward the direction of the biggest opening. It is concluded that the flow  $F_I$  changed its direction to  $F_O$  when part of the North dam had been washed away.

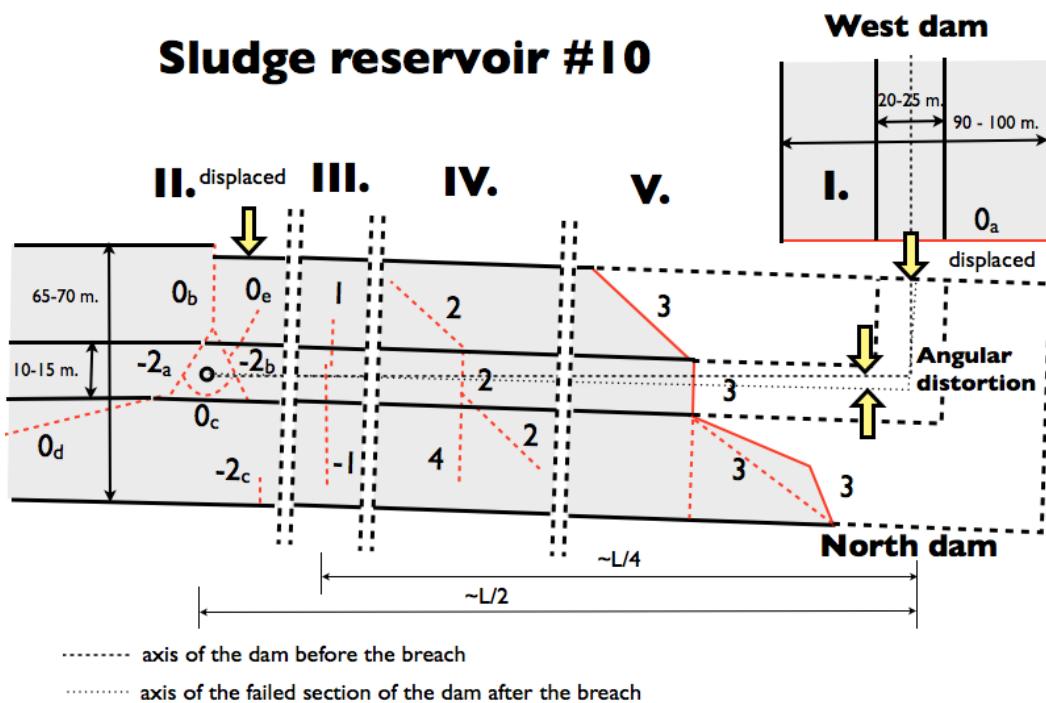
The five locations of the fractures can be seen in Figures 7 and 8. The individual fractures are numbered in the sequence of their occurrence. Minus and plus signs are used to indicate if the fractures occurred before or after the breach respectively. Number zero has been assigned to the fractures that occurred at the breach of the dam. The schematic patterns of the identified fractures and the assigned numbers are shown in Figure 12.

**Figure 12.** The sketch of the identified fractures is shown. The fractures are numbered in the sequence of their occurrence. Minus and plus signs are used to indicate if the fracture occurred before or after the breach respectively. Number zero has been assigned to the fractures that occurred at the breach of the dam.

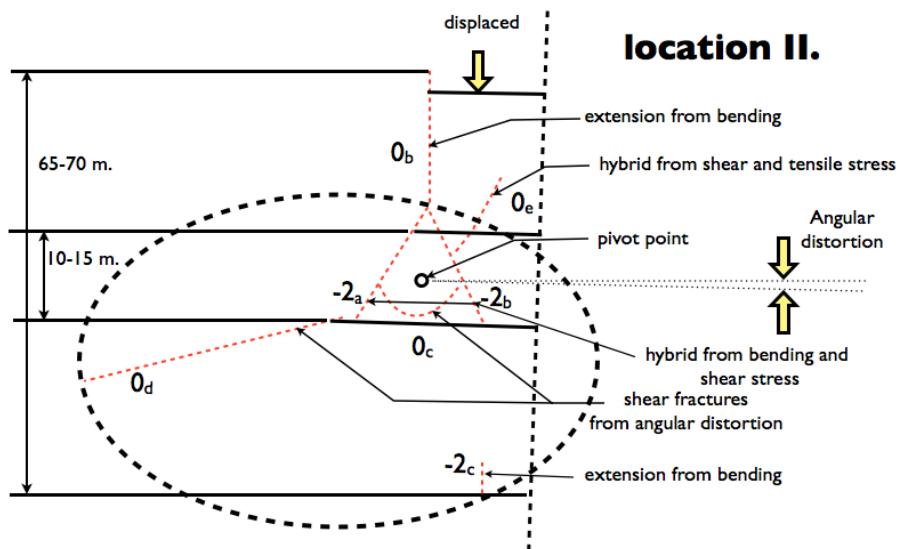
Location II is in the middle of the North dam. The fracture pattern is quite complex. Based on the fracture pattern, it can be identified that the fractures  $-2_a$  and  $-2_b$  relate to bending (Figure 6). The tension side of the bending was the outer side of the reservoir. However, on this side (outward from the reservoir), shear fractures  $0_c$  and  $0_d$  are also present, indicating compression stress on the same side (Figures 4 and 5).

**Figure 13.** The identified fractures at Location II are shown. Dashed circles mark fractures, formed from compression and tension in the same location. The coexistence of the extension and shear fractures in the same location can only be possible if the stress conditions changed in time.

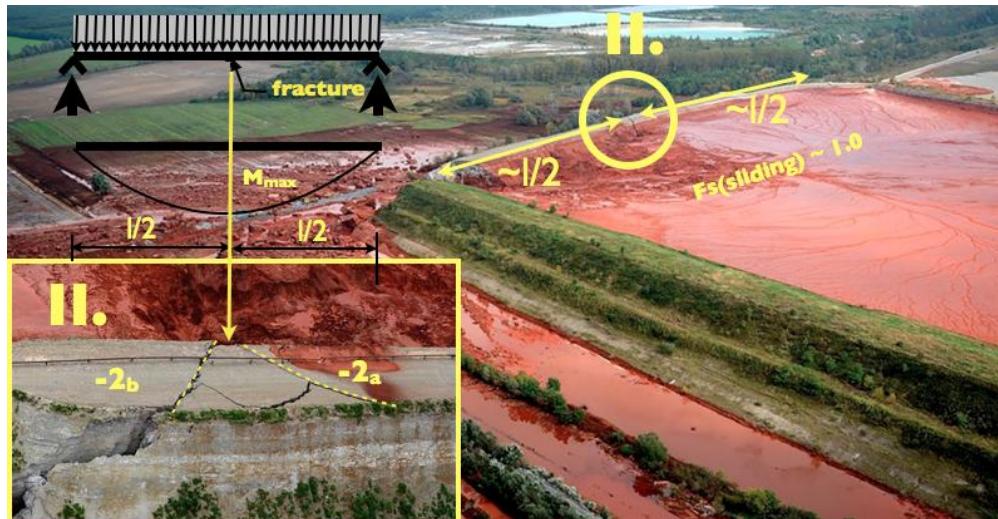
The coexistence of compressional and tensional stresses at the same side of the dam is possible only if the stress conditions changed in time. At the breach, displacement and angular distortion occurred. These movements should develop compression stress on the outward and tensile stress in the inward side and shear stress. The bending related fractures  $-2_a$  and  $-2_b$  are not consistent with the stress condition at breaching, which indicates that these fractures  $-2_a$  and  $-2_b$  were already present when the breach occurred. The fracture pattern  $-2_a$  and  $-2_b$  is an indicative of failing from bending (Figure 6), which developed from the pressure of the red sludge acting from the reservoir site on the dam. The bending related fracture pattern is further supported by the location of the fractures, which is in the middle of the North dam, where the maximum bending moment should occur in a beam subject to uniform load (Figure 14).

**Figure 14.** Location II is at the middle of the North dam, where the bending moment has its maximum under uniformly distributed load. The fracture pattern (Figure 6) and the location suggest that these fractures (-2<sub>a</sub> and -2<sub>b</sub>) occurred from the bending. These fractures were formed before the breach of the dam. (Sources: <http://toleducation.org/achievements/red-legacy/>; <http://www.hungarianambiance.com/2011/09/possibility-of-act-of-terrorism-cant-be.html.>)

The allowable angular distortion in buildings is 1/300 (Skempton and MacDonald, 1956). In masonry or concrete structures, fractures start to develop when the angular distortion exceeds this value, which might be too conservative for the dam because its material is not as rigid as these building materials. Using this conservative value on the approximately 500 m long dam, many decimeters of displacement in the middle of the dam were required to develop these fractures. Thus, the dam suffered a very significant deformation before the breach. The displacement occurred in the horizontal direction, indicating that, at the time of the fracture formation, the resistance against sliding was already exhausted. The developed fractures (-2<sub>a</sub> and -2<sub>b</sub>) reduced the bending moment at Location II close to zero, and the dam did not fail.

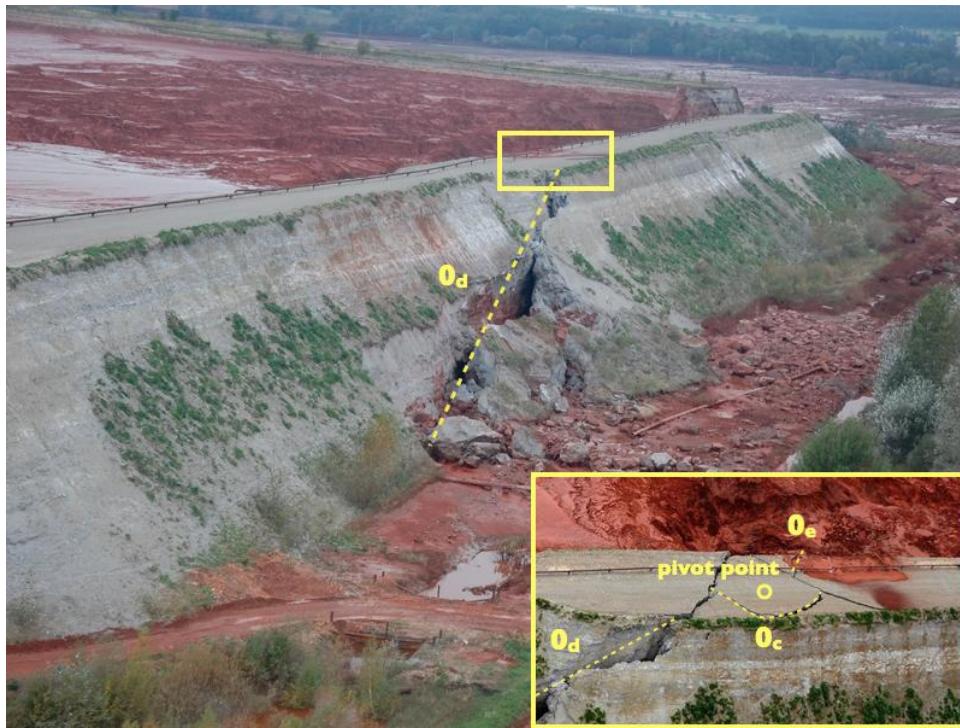
The last straw leading to the breach of the entire dam section was when the tensional resistance of the West dam was exhausted. The dam, whose sliding resistance had already been exhausted, had been detached at fracture 0<sub>a</sub> and the dam moved outward from the reservoir, activating the preexisting bending fractures at Location II. The displacement also induced an angular distortion which generated tensile and shear stresses on the reservoir side, resulting in fractures 0<sub>b</sub> and 0<sub>c</sub> respectively. The angular distortion of the dam produced compression stress at the outward site of the reservoir, which resulted in the development of shear fractures 0<sub>c</sub> and 0<sub>d</sub> on the outward side of the dam (Figure 15). The detachment occurred along the extension fracture (0<sub>b</sub>) (Figure 9), and the preexisting fracture -2<sub>a</sub> (Figure 14). Fracture 0<sub>e</sub> (Figure 9) is a hybrid fracture caused by extension (angular distortion) and shear stresses (displacement).

**Figure 15.** Shear fractures ( $0_c$  and  $0_d$ ) caused by compressional stress at Location II are shown. These fractures were formed at the breach, resulting from the angular distortion of the failed dam section. On the opposite (reservoir) side, at the same time, extension fracture  $0_b$  occurred (Figure 9), extending the existing fracture of -2b. (Sources: <https://www.nbcnews.com/slideshow/toxic-red-sludge-floods-towns-near-budapest-39514793>; <http://www.hungarianambiance.com/2011/09/possibility-of-act-of-terrorism-cant-be.html>).

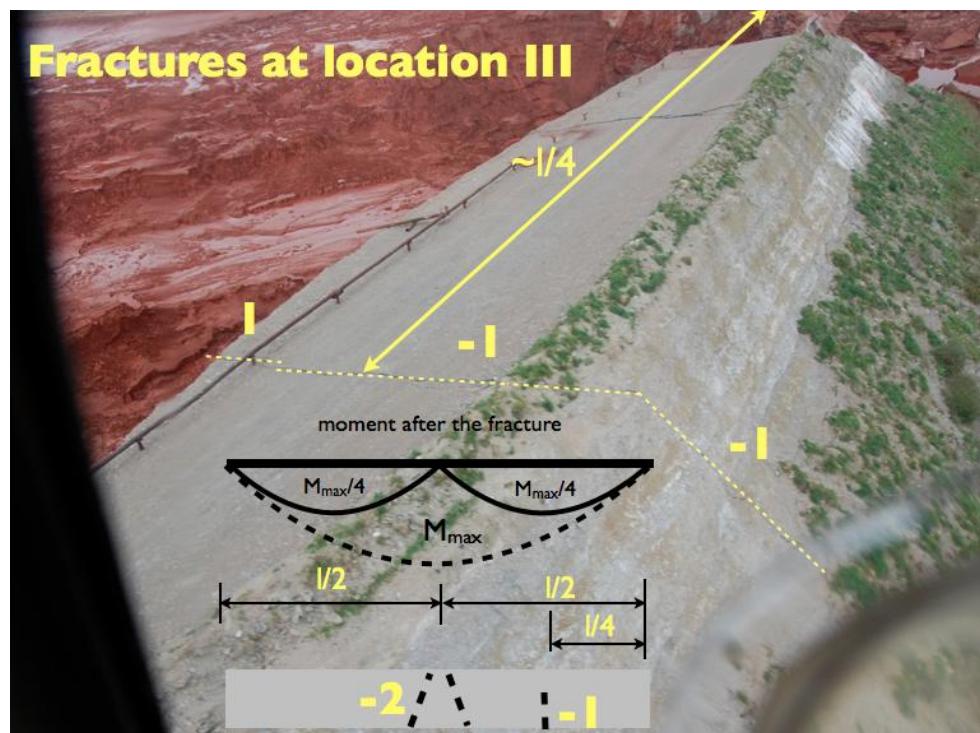
There are two independent fractures (1 and -1) perpendicular to the axis of the North dam. Based on the fracture direction, it is concluded that these fractures are the result of tensile stress acting in the direction of the axis of the dam (Figure 4). Both of these fractures resulted from bending, but there is a time gap between their occurrences. Following the development of fractures -2<sub>a,b</sub> at Location II, the maximum bending moment shifted from the middle of the dam to 1/4 of the length of the dam, which is where Location III is (Figure 16). The tensile strength relating to the bending moment of sludge pressure caused fracture -1 at the outward side of the dam. This failure occurred before the breach of the dam. At this weakened cross section, the angular distortion occurring at the breach and the additional flow pressures after the breach led to the development fracture 1 on the opposite side.

Figure 16. The location and the shape of fracture -1 is shown. Both the location and the shape of the rupture indicate that the failing was caused by bending. Following the formation of fractures -2 at Location II, the maximum moment was formed at Location III, resulting in the fracture of -1. (Source: <http://www.hungarianambiance.com/2011/09/possibility-of-act-of-terrorism-cant-be.html>.)

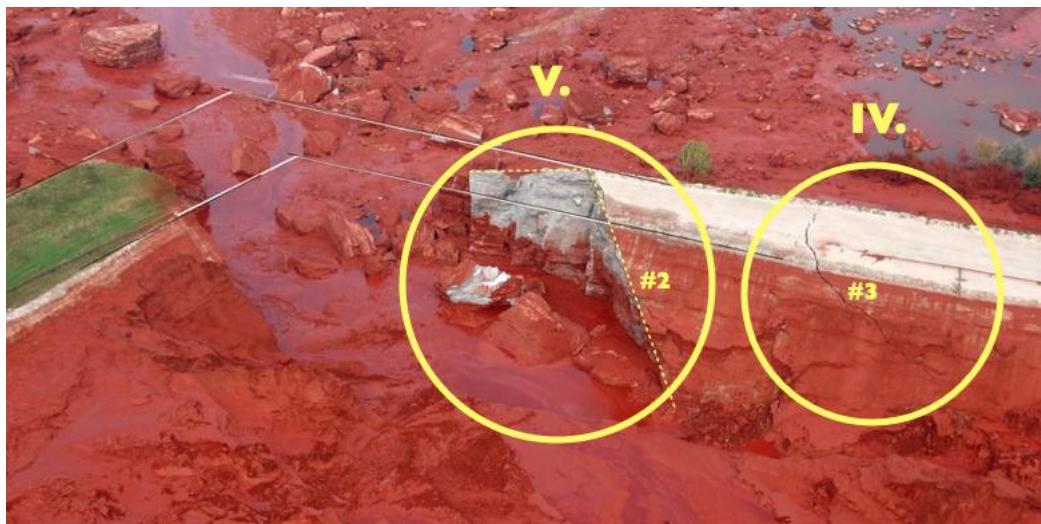
The fracture pattern of these sites shows hybrid failure (Figure 17).

Figure 17. The fractures at Locations IV and V are hybrid fractures caused by the outflowing pressure of the red sludge and the additional settlement. These fractures occurred after the breach of the dam and they have no relevance to the failing of the dam. (Source: [https://commons.wikimedia.org/wiki/File:Ajka\\_accident\\_d7df9fea08\\_b.jpg](https://commons.wikimedia.org/wiki/File:Ajka_accident_d7df9fea08_b.jpg).)

If the fractures at Locations IV and V existed before the breach, then the transformation of the force and the torque would be very limited beyond these locations. Elimination of the torque would not allow the development of the angular distortion beyond Location IV or V. Thus, these fractures at Locations IV and V were formed after the breach. The mark of the red sludge on the surface of fracture 2 also shows that this failing occurred after the breach when the level of the red sludge was reduced from its original elevation (Figure 8). The widening of fracture 3 towards the top of the dam indicates that additional angular distortion in the vertical direction occurred, most likely resulting from the outflow of the sludge, which washed out the soil below the dam section at the opening. The settlement of the dam section led to the development of the extension fracture 4. All fractures at Locations IV and V had been developing after the breach of the dam; therefore, these fractures have no relevance to the breach. The list of all the fractures, as well as the type and the cause of the respective failure, is given in Table 1.

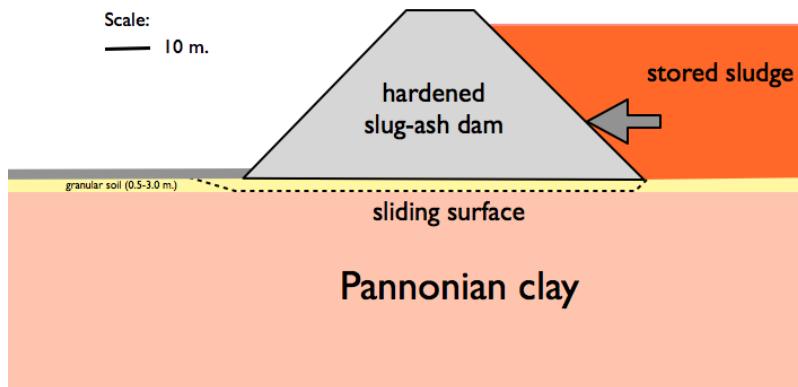
The granular soil (sandy gravel) under the dams, with its weight and its bearing capacity at the toe of the dam, increased the resistance against sliding. Thus, the failure of the dam occurred where the thickness of the granular soil is the smallest (Ndagijimana, 2019). This conclusion is consistent with the failed section of the dam, where the granular layer was the

thinnest (0,5 m) under the dam (Farkas et al., 2013). The dams with a bigger cross section had additional weights, which prevented the sliding failure, even though the resistance against sliding was nearly exhausted.

**Figure 18.** Schematic cross section of the soil profile and sliding surface of the failing is shown. The high pH and the cation exchange weakened the internal friction of the clay on the surface of the layer. The increasing horizontal pressure of the sludge on the dam led to the sliding failure of the dam along this weak resistant layer. The weight of the granular layer and its bearing capacity at the toe of the dam increased the resistance against sliding. Thus, failure of the dam occurred where the thickness of the granular layer was the thinnest.
