Images Collected from the Internet Reveal the Failing Mechanism of the Tailing Dam Breach at Kolontar, Hungary

Jozsef Garai, Retired Professor from the Department of Civil Engineering, University of Debrecen, Ótemető u. 2-4, 4028 Debrecen, Hungary; email: jozsefgarai29@gmail.com

Reference: Garai J., and Kovács I. (2025). *Images Collected from the Internet Reveal the Failing Mechanism of the Tailing Dam Breach at Kolontar, Hungary*. International Journal of Geoengineering Case Histories, Volume 8, Issue 1, 52 (2011) 10 4417/HGGH 20 21 24

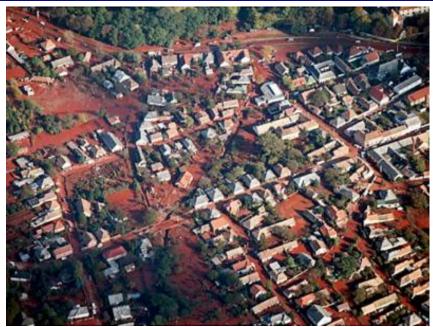
The failure of the dam occurred on October 4th around noon. The dam broke over a 50 m length, resulting in the release of 1 million m³ of highly basic sludge (Figures 1, 2). The flood of sludge killed 10 people and another 286 were injured (Banvolgyi, Gy., 2010).

Figure 1. The scale of the disaster: the highly toxic sludge flooded the neighboring villages in the valley of Torna. (Source: http://www.nydailynews.com/news/world/bodies-found-hungary-toxic-red-sludge-seeped-danube-river-article-1.188733.)

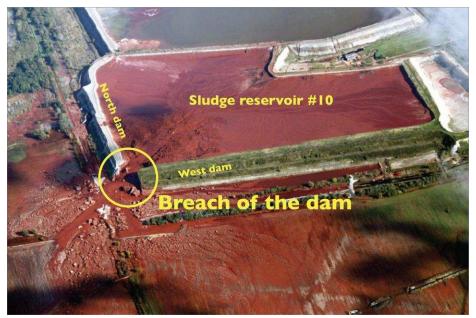
Figure 2. Aerial photo of the breach of the tailing dam. (Source: https://www.ndtv.com/world-news/hungarys-toxic-sludge-spill-as-big-as-gulf-oil-leak-435094.)

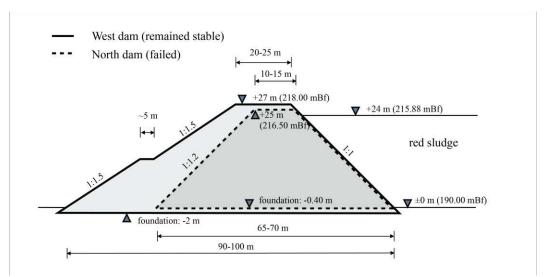
Figure 3. The cross sections of the North and West dams (Farkas et. al., 2013). The Northern dam primarily was designed to separate two reservoirs. The cross section of the dam therefore is significantly smaller in comparison to the West dam, which was designed to support the sludge pressure of the reservoir.

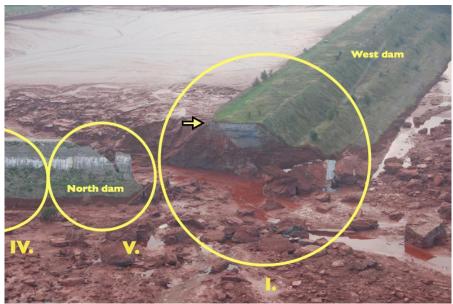
Figure 7. Photo showing the fracture Locations I, IV, and V. The red mark of the sludge on the open surface of the fracture at Location I is the same as the original sludge level. Thus, this fracture occurred right at the breach of the dam before the sludge level decreased in the reservoir.

This location has one characteristic fracture (0_a) , which has been exposed at the breach (Figure 7). The fracture occurred at the corner of the North and West dams and its surface is perpendicular to the West dam. This fracture is clearly the result of tensional stress acting in the direction of the axis of the West dam. The fracture occurred at the breach because the marks of the red sludge on the exposed surface are at the same elevation as the original level in the reservoir (Figure 7). The North dam has been detached following the development of this fracture and displaced from the West dam, creating an opening. This opening was one of the initiators of the breach. The direction of the flow channel F_I is consistent with this conclusion.

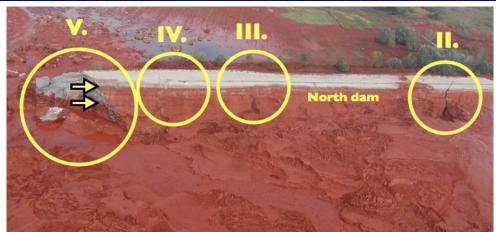
At Location V, the mark of the red sludge on the fracture (Figure 8) is lower than the original one, which indicates that this fracture occurred after the breach, when the sludge level in the reservoir was already lowered.

Figure 8. Photo showing fracture Locations II-V. The red mark of the sludge on the open surface of the fracture at Location V is shown. This mark is much lower than the original level in the reservoir, indicating that this fracture was formed after the breach, when the sludge level was significantly lower.

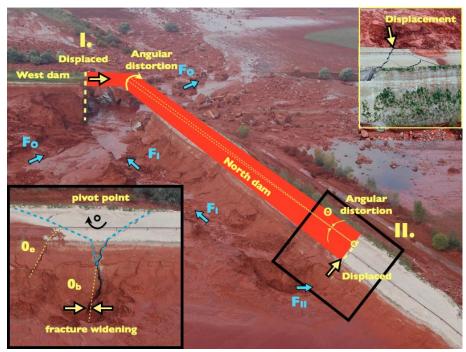
Displacements outward from the reservoir at Locations I and II of the western part of the North dam had been identified (Figure 9). The dam remained intact between these two locations; it is reasonable to assume that the entire dam section between them had been displaced. The displacements at the two ends of the failed dam section are different, which induced an angular distortion on the failed section. This distortion can be identified from the widening of the fracture at Location II (see Figure 9) and from the position of the detached pipe at Location II (see Figure 10). Thus, the failed section of the dam between Locations I and II has been displaced, and an angular distortion has been induced (Figure 9).

Figure 9. The failed section of the North dam is shown in red. This entire section had been displaced outward from the reservoir. Angular distortion also occurred from the bigger displacement at Location I. The widening of fracture 0_b supports the angular distortion. The channels created by the outflow are visible on the surface of the red sludge. The identified flow directions (F) are shown.

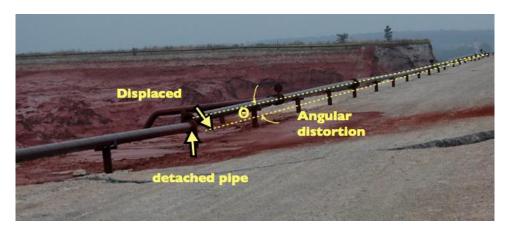
Figure 10. The angular distortion of the failed section of the dam can be seen from the position of the displaced broken pipe. On the failed part of the dam the pipe moved towards the reservoir despite the outward movement of the failed dam section. This indicates that the displacement resulting from angular distortion exceeded the outward displacement of the dam.

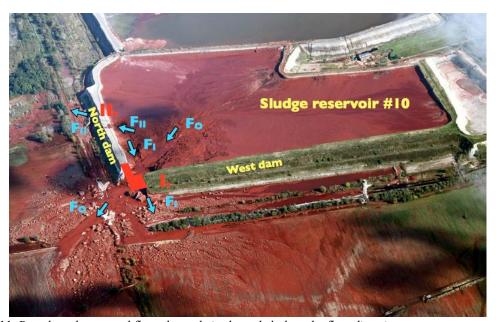
Figure 11. Based on the created flow channels in the red sludge, the flow directions were reconstructed. The initial flows F_1 and F_2 occurred at Locations I and II, pointing toward the direction of the existing fractures. The direction of flow F_1 changed to F_0 when the western part of the North dam had been washed away, creating a big opening. (Source: https://www.ndtv.com/world-news/hungarys-toxic-sludge-spill-as-big-as-gulf-oil-leak-435094.)

The flow directions pointing towards Location I (F_I) and Location II (F_{II}) are narrow, indicating that these were the initial flows which were active right after the breach of the dam. These channels, F_I and F_{II} , are also deeper than the third one, F_O . The bigger depth of these channels indicates that these are the initial flows, when the initial hydraulic gradient was the highest. The flow directions further confirm that the fractures developed at Locations I and II initiated the breach of the dam. The third identified flow direction (F_O) is shallower and wider, pointing toward the direction of the biggest opening. It is concluded that the flow F_I changed its direction to F_O when part of the North dam had been washed away.

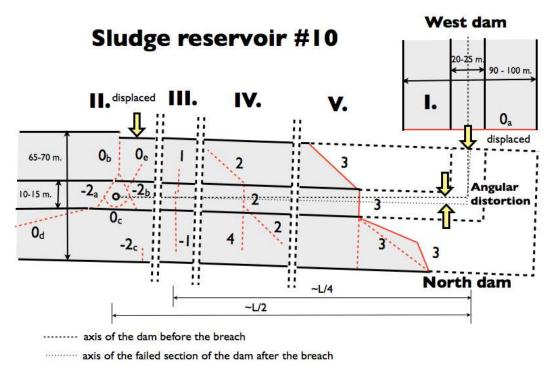
Figure 12. The sketch of the identified fractures is shown. The fractures are numbered in the sequence of their occurrence. Minus and plus signs are used to indicate if the fracture occurred before or after the breach respectively. Number zero has been assigned to the fractures that occurred at the breach of the dam.

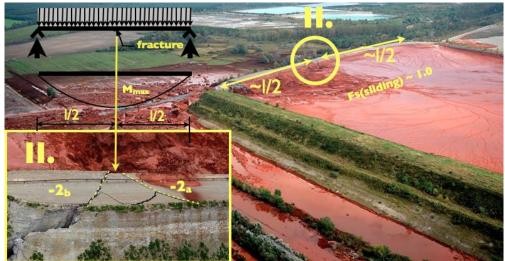
The coexistence of compressional and tensional stresses at the same side of the dam is possible only if the stress conditions changed in time. At the breach, displacement and angular distortion occurred. These movements should develop compression stress on the outward and tensile stress in the inward side and shear stress. The bending related fractures -2_a and -2_b are not consistent with the stress condition at breaching, which indicates that these fractures -2_a and -2_b were already present when the breach occurred. The fracture pattern -2_a and -2_b is an indicative of failing from bending (Figure 6), which developed from the pressure of the red sludge acting from the reservoir site on the dam. The bending related fracture pattern is further supported by the location of the fractures, which is in the middle of the North dam, where the maximum bending moment should occur in a beam subject to uniform load (Figure 14).

Figure 14. Location II is at the middle of the North dam, where the bending moment has its maximum under uniformly distributed load. The fracture pattern (Figure 6) and the location suggest that these fractures (-2_a, and -2_b) occurred from the bending. These fractures were formed before the breach of the dam.

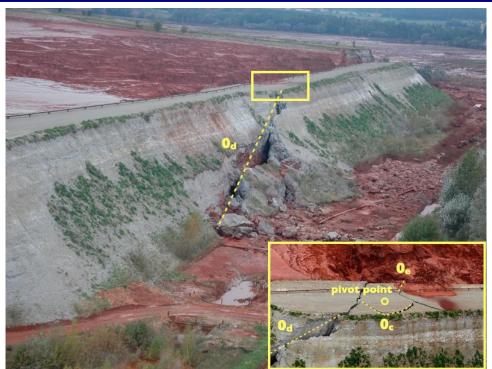
The last straw leading to the breach of the entire dam section was when the tensional resistance of the West dam was exhausted. The dam, whose sliding resistance had already been exhausted, had been detached at fracture 0_a and the dam moved outward from the reservoir, activating the preexisting bending fractures at Location II. The displacement also induced an angular distortion which generated tensile and shear stresses on the reservoir side, resulting in fractures 0_b and 0_c respectively. The angular distortion of the dam produced compression stress at the outward site of the reservoir, which resulted in the development of shear fractures 0_c and 0_d on the outward side of the dam (Figure 15). The detachment occurred along the extension fracture 0_b (Figure 9), and the preexisting fracture 0_b (Figure 14). Fracture 0_c (Figure 9) is a hybrid fracture caused by extension (angular distortion) and shear stresses (displacement).

Figure 15. Shear fractures (0_c and 0_d) caused by compressional stress at Location II are shown. These fractures were formed at the breach, resulting from the angular distortion of the failed dam section. On the opposite (reservoir) side, at the same time, extension fracture 0_b occurred (Figure 9), extending the existing fracture of -2_b . (Sources: http://www.nbcnews.com/slideshow/toxic-red-sludge-floods-towns-near-budapest-39514793; https://www.hungarianambiance.com/2011/09/possibility-of-act-of-terrorism-cant-be.html).

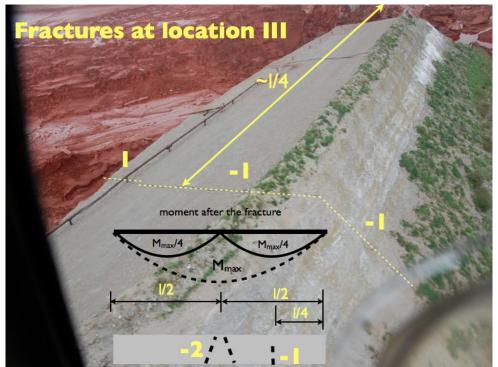
There are two independent fractures (1 and -1) perpendicular to the axis of the North dam. Based on the fracture direction, it is concluded that these fractures are the result of tensile stress acting in the direction of the axis of the dam (Figure 4). Both of these fractures resulted from bending, but there is a time gap between their occurrences. Following the development of fractures -2_{a,b} at Location II, the maximum bending moment shifted from the middle of the dam to 1/4 of the length of the dam, which is where Location III is (Figure 16). The tensile strength relating to the bending moment of sludge pressure caused fracture -1 at the outward side of the dam. This failure occurred before the breach of the dam. At this weakened cross section, the angular distortion occurring at the breach and the additional flow pressures after the breach led to the development fracture 1 on the opposite side.

Figure 16. The location and the shape of fracture -1 is shown. Both the location and the shape of the rupture indicate that the failing was caused by bending. Following the formation of fractures -2 at Location II, the maximum moment was formed at Location III, resulting in the fracture of -1.

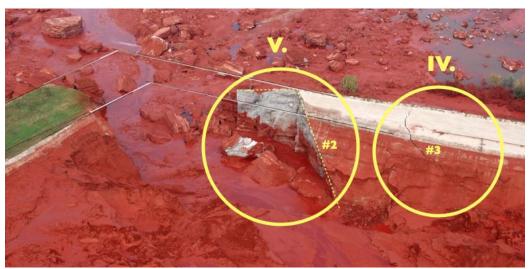
The fracture pattern of these sites shows hybrid failure (Figure 17).

Figure 17. The fractures at Locations IV and V are hybrid fractures caused by the outflowing pressure of the red sludge and the additional settlement. These fractures occurred after the breach of the dam and they have no relevance to the failing of the dam. (Source:

If the fractures at Locations IV and V existed before the breach, then the transformation of the force and the torque would be very limited beyond these locations. Elimination of the torque would not allow the development of the angular distortion beyond Location IV or V. Thus, these fractures at Locations IV and V were formed after the breach. The mark of the red sludge on the surface of fracture 2 also shows that this failing occurred after the breach when the level of the red sludge was reduced from its original elevation (Figure 8). The widening of fracture 3 towards the top of the dam indicates that additional angular distortion in the vertical direction occurred, most likely resulting from the outflow of the sludge, which washed out the soil below the dam section at the opening. The settlement of the dam section led to the development of the extension fracture 4. All fractures at Locations IV and V had been developing after the breach of the dam; therefore, these fractures have no relevance to the breach. The list of all the fractures, as well as the type and the cause of the respective failure, is given in Table 1.
