Images Collected from the Internet Reveal the Failing Mechanism of the Tailing Dam Breach at Kolontar, Hungary

ABSTRACT: *The failure of the red sludge tailing dam at Kolontar in 2010 was the most severe environmental disaster in the history of Hungary. The official investigations are confidential because the legal case has not been closed. The publicly accessible information from the breach of the dam are the photographs taken by the media and news agencies. Collecting these images and analyzing the recorded fractures and displacements of the dam reveal the failing mechanism. The breach of the dam resulted from failing to sliding, which had been developed in three stages. This conclusion is consistent with the observed movements of the dam deduced from a persistent scattered radar interferometry deformation analysis conducted between 2003 and 2010.*

Reference: Garai J., and Kovács I. (2025). *Images Collected from the Internet Reveal the Failing Mechanism of the Tailing Dam Breach at Kolontar, Hungary*. International Journal of Geoengineering Case Histories, Vol.8, Issue 1, p.64-81. doi: 10.4417/IJGCH-08-01-04

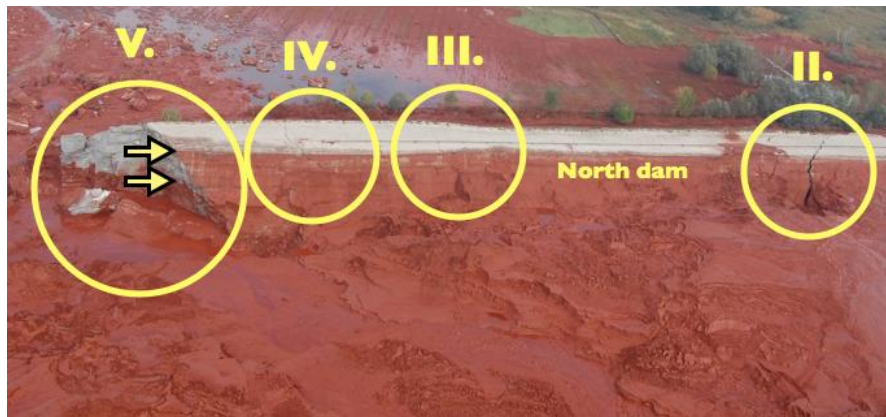
At Location V, the mark of the red sludge on the fracture (Figure 8) is lower than the original one, which indicates that this fracture occurred after the breach, when the sludge level in the reservoir was already lowered.

Figure 8. Photo showing fracture Locations II-V. The red mark of the sludge on the open surface of the fracture at Location V is shown. This mark is much lower than the original level in the reservoir, indicating that this fracture was formed after the breach, when the sludge level was significantly lower. (Source: <http://toleducation.org/achievements/red-legacy/>.)

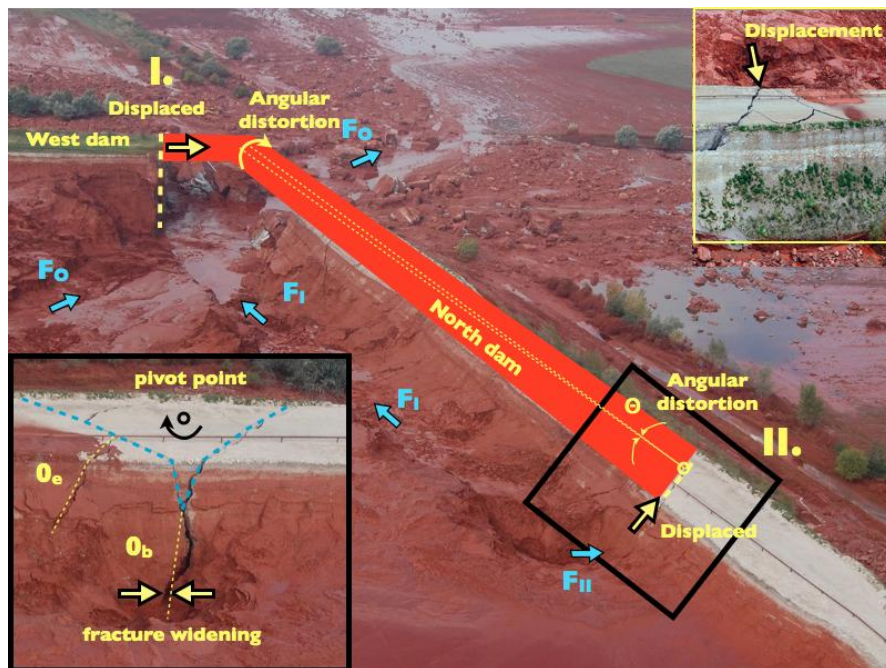
Displacements outward from the reservoir at Locations I and II of the western part of the North dam had been identified (Figure 9). The dam remained intact between these two locations; it is reasonable to assume that the entire dam section between them had been displaced. The displacements at the two ends of the failed dam section are different, which induced an angular distortion on the failed section. This distortion can be identified from the widening of the fracture at Location II (see Figure 9) and from the position of the detached pipe at Location II (see Figure 10). Thus, the failed section of the dam between Locations I and II has been displaced, and an angular distortion has been induced (Figure 9).

Figure 9. The failed section of the North dam is shown in red. This entire section had been displaced outward from the reservoir. Angular distortion also occurred from the bigger displacement at Location I. The widening of fracture 0_b supports the angular distortion. The channels created by the outflow are visible on the surface of the red sludge. The identified flow directions (F) are shown. (Sources: <http://www.hungarianambiance.com/2011/09/possibility-of-act-of-terrorism-cant-be.html> and <https://phys.org/news/2011-04-wildlife-largely-absent-red-sludge.html#nRlv>.)
