Images Collected from the Internet Reveal the Failing Mechanism of the Tailing Dam Breach at Kolontar, Hungary

Reference: Garai J., and Kovács I. (2025). *Images Collected from the Internet Reveal the Failing Mechanism of the Tailing Dam Breach at Kolontar, Hungary*. International Journal of Geoengineering Case Histories, Vol.8, Issue 1, p.64-81. doi: 10.4417/IJGCH-08-01-04

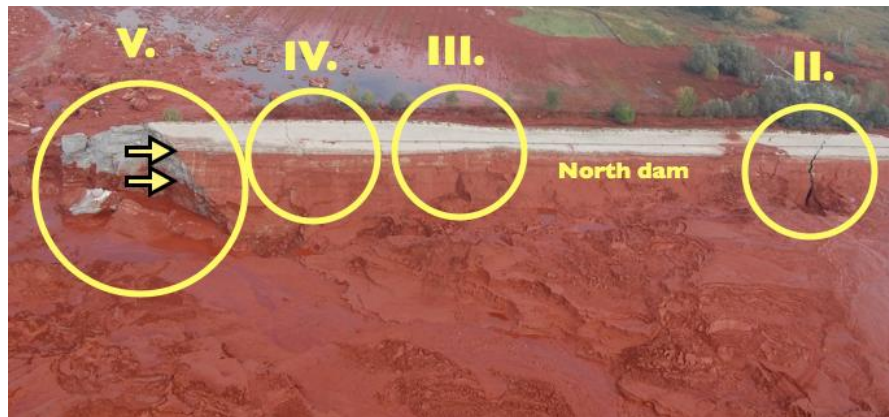
At Location V, the mark of the red sludge on the fracture (Figure 8) is lower than the original one, which indicates that this fracture occurred after the breach, when the sludge level in the reservoir was already lowered.

Figure 8. Photo showing fracture Locations II-V. The red mark of the sludge on the open surface of the fracture at Location V is shown. This mark is much lower than the original level in the reservoir, indicating that this fracture was formed after the breach, when the sludge level was significantly lower. (Source: <http://toleducation.org/achievements/red-legacy/>.)

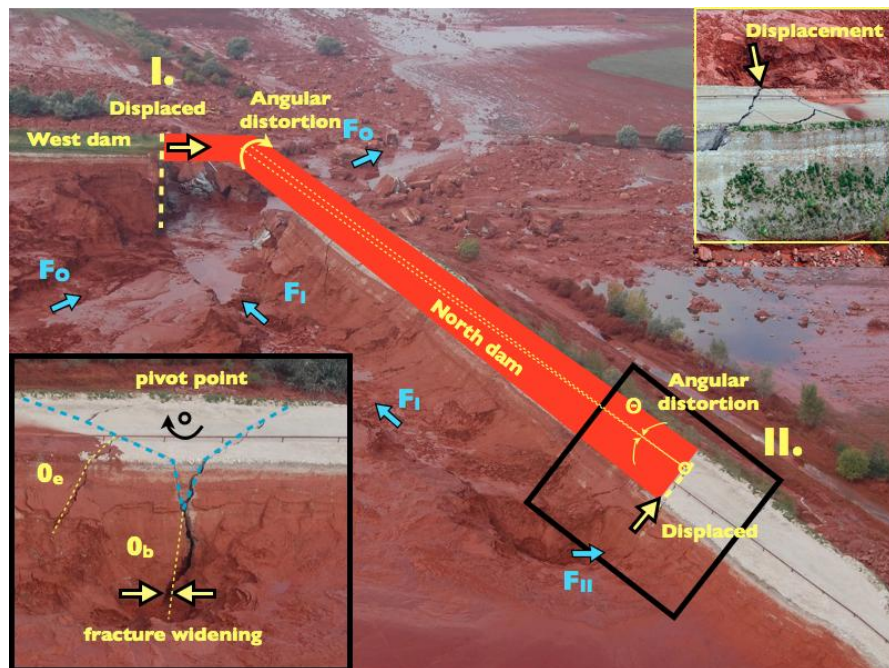
Displacements outward from the reservoir at Locations I and II of the western part of the North dam had been identified (Figure 9). The dam remained intact between these two locations; it is reasonable to assume that the entire dam section between them had been displaced. The displacements at the two ends of the failed dam section are different, which induced an angular distortion on the failed section. This distortion can be identified from the widening of the fracture at Location II (see Figure 9) and from the position of the detached pipe at Location II (see Figure 10). Thus, the failed section of the dam between Locations I and II has been displaced, and an angular distortion has been induced (Figure 9).

Figure 9. The failed section of the North dam is shown in red. This entire section had been displaced outward from the reservoir. Angular distortion also occurred from the bigger displacement at Location I. The widening of fracture 0_b supports the angular distortion. The channels created by the outflow are visible on the surface of the red sludge. The identified flow directions (F) are shown. (Sources: <http://www.hungarianambiance.com/2011/09/possibility-of-act-of-terrorism-cant-be.html> and <https://phys.org/news/2011-04-wildlife-largely-absent-red-sludge.html#nRlv>.)
