Images Collected from the Internet Reveal the Failing Mechanism of the Tailing Dam Breach at Kolontar, Hungary

ABSTRACT: *The failure of the red sludge tailing dam at Kolontar in 2010 was the most severe environmental disaster in the history of Hungary. The official investigations are confidential because the legal case has not been closed. The publicly accessible information from the breach of the dam are the photographs taken by the media and news agencies. Collecting these images and analyzing the recorded fractures and displacements of the dam reveal the failing mechanism. The breach of the dam resulted from failing to sliding, which had been developed in three stages. This conclusion is consistent with the observed movements of the dam deduced from a persistent scattered radar interferometry deformation analysis conducted between 2003 and 2010.*

Reference: Garai J., and Kovács I. (2025). *Images Collected from the Internet Reveal the Failing Mechanism of the Tailing Dam Breach at Kolontar, Hungary*. International Journal of Geoengineering Case Histories, Vol.8, Issue 1, p.64-81. doi: 10.4417/IJGCH-08-01-04

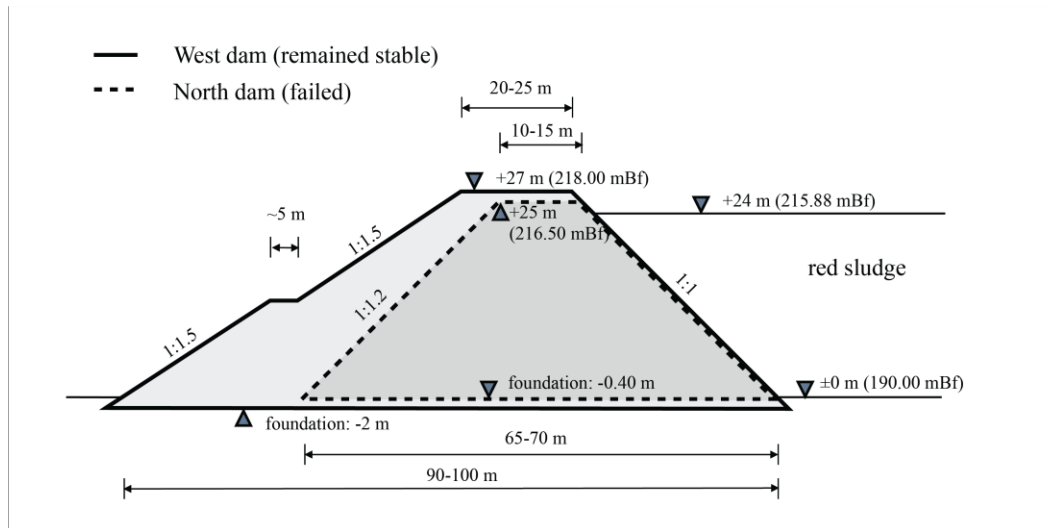
Figure 3. The cross sections of the North and West dams (Farkas et al., 2013). The Northern dam primarily was designed to separate two reservoirs. The cross section of the dam therefore is significantly smaller in comparison to the West dam, which was designed to support the sludge pressure of the reservoir.

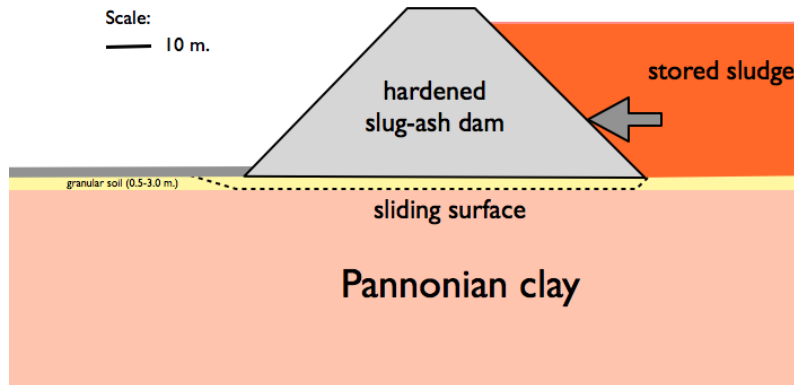
The granular soil (sandy gravel) under the dams, with its weight and its bearing capacity at the toe of the dam, increased the resistance against sliding. Thus, the failure of the dam occurred where the thickness of the granular soil is the smallest (Ndagijimana, 2019). This conclusion is consistent with the failed section of the dam, where the granular layer was the

thinnest (0,5 m) under the dam (Farkas et al., 2013). The dams with a bigger cross section had additional weights, which prevented the sliding failure, even though the resistance against sliding was nearly exhausted.

Figure 18. Schematic cross section of the soil profile and sliding surface of the failing is shown. The high pH and the cation exchange weakened the internal friction of the clay on the surface of the layer. The increasing horizontal pressure of the sludge on the dam led to the sliding failure of the dam along this weak resistant layer. The weight of the granular layer and its bearing capacity at the toe of the dam increased the resistance against sliding. Thus, failure of the dam occurred where the thickness of the granular layer was the thinnest.
