Reconstruction of Konstantinovsky Palace in a Suburb of Saint Petersburg

ABSTRACT: This article describes a complex approach to the condition survey and design executed as part of the remedial works on Konstantinovsky palace in the suburb of Strelna (Saint Petersburg)--one of the most beautiful historic monuments of 18th century Russia. The palace was almost completely destroyed in the 1940s. In 2000 the decision was made to reconstruct the palace, and the project for palace reconstruction was developed. The project was completed in 2003. The following important stages of the project are discussed in this paper: palace condition survey and site investigations, analyses of the palace retaining structures, design project of palace reconstruction, and phases of the remedial works.

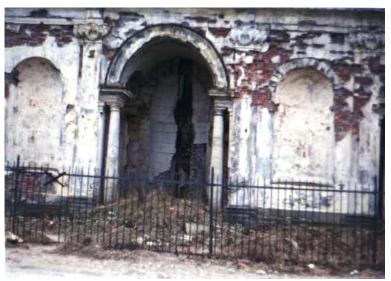
Figure 7a. Dilapidated structures of the palace: grotto.

- 1. Foundations of the dilapidated retaining walls were constructed of bricks. The foundations were no longer capable of being classified as a structure. There was imminent danger of crushed brickwork movement with formation of local bulges.

- 2. The entire brickwork structure was soaked in water, causing dilapidation through cycles of freezing and thawing.
- 3. There were no foundations of the transverse walls of the cellars. Footing was level with the cellar's floor. Decomposed timber pile heads supported the transverse walls.

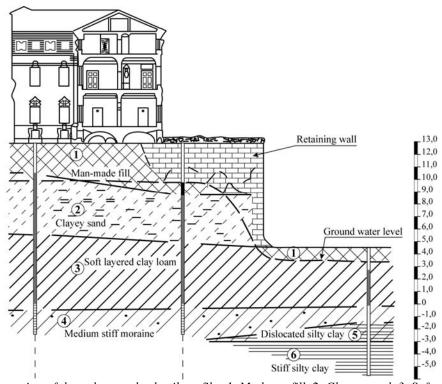
Figure 8. Cross-section of the palace and subsoil profile: 1. Made-up fill, 2. Clayey sand, 3. Soft varved clay loam, 4. Medium-stiff moraine clay loam, 5. Dislocated stiff Cambrian silty clay, 6. Stiff silty Cambrian clay.

As attested by site investigation in the park, underneath 1 m of fill there is a 3-m layer of soft varved clay loam, underlain by medium stiff moraine clay loam (Fig. 8). Still deeper, at the level of around 14.0 m (absolute -1.3 m), there are medium stiff and stiff deep Cambrian clays.
