Rockfall and Subsidence on Mumbai-Pune Expressway

ABSTRACT: *Mumbai-Pune, India's first expressway, which crosses the mountainous and rugged Deccan Trap Province, suffered from a large amount of rockfall and major landslides in 2003 and 2004. A significant number of accidents and fatalities have occurred on the expressway as a result of such events. On the basis of frequency and magnitude of the recorded incidences of rockfall, seventeen critical areas of the road have been deemed in need of investigations and mitigation. One of the problematic areas that suffered from rockfall and subsidence is at km 41 on the expressway, adjacent to a tunnel (Adoshi). This location has been chosen for detailed study. This area extends for 500 m along the expressway, and the embankment has subsided by 2 to 3 m along the entire length. Based on the geological, geomorphologic and geotechnical investigations, causative factors for rockfall and subsidence at this location have been established. This paper presents the field investigations, probable causes, stability analysis and remedial measures for controlling the subsidence and rock fall.*

Reference: Kumar, K., Prasad, P.S., Mathur, S., Kimothi,

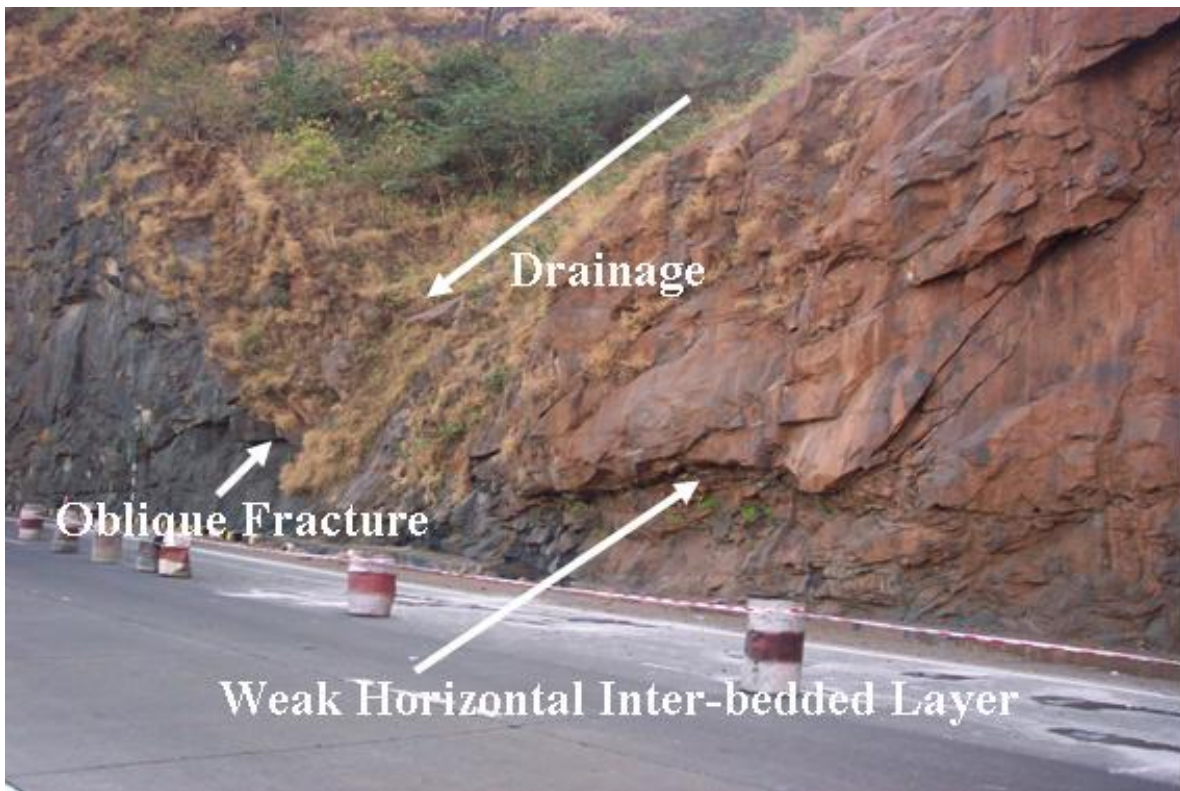
Figure 6. Intersection of oblique and sub-horizontal fractures.

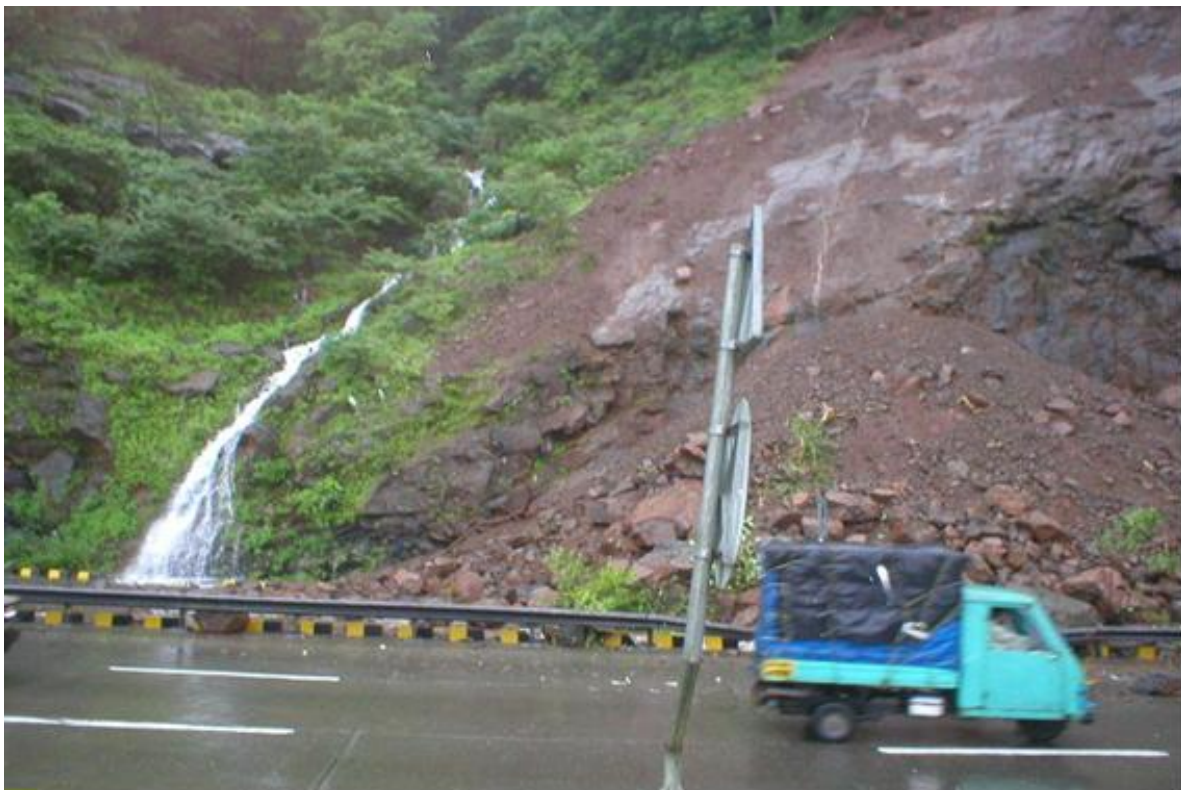
The slope is well covered by trees. The uphill slope has good catchment, and the rainwater generally drains out through the natural streams on both flanks of the slide. A considerable quantity of water also flows down the middle of the slope, above the affected portion. Near the crown there are a number of loose stone blocks, which rest on the slope. These may facilitate blocking and infiltration of more water into the slope during rains. The crown consists of a thin soil cover of a few centimeters to about one-third of a meter in thickness, below which lies 1–2-meter thick weathered and jointed basalt. This layer of weathered and jointed basalt, along with the thin overburden, fails along a smooth sheet joint surface and falls on the expressway through the adjoining vertical cut slope (Figure 2). This vertical cut of about 40 m in height has many joint intersections separating the blocks of the basaltic layer (Figure 5). A stream, guided by the intersection of one of the oblique and sub-horizontal fractures (Figure 6), remains dry except during the monsoon months when it serves as one of the main draining streams (Figure 7). A significant amount of water drains from the above catchment area.

Figure 7. Significant water drainage during a monsoon.

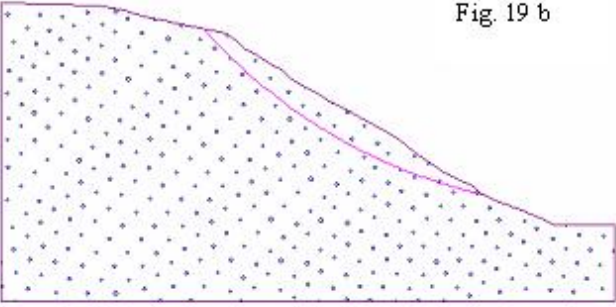
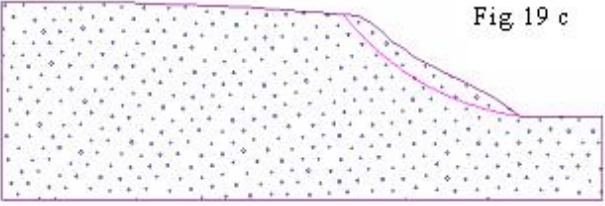
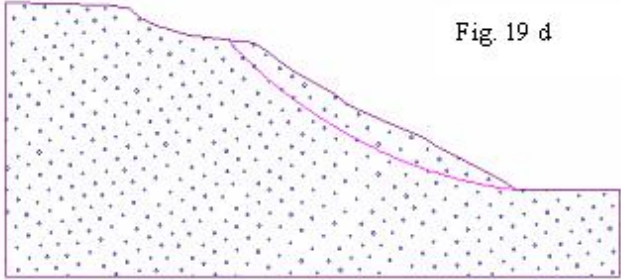
Figure19. Slope stability of subsidence portion.

Soil samples were collected from the field. In-situ density of the embankment was measured using the core cutter method. The bulk density of the embankment is 17 kN/m^3 . The shear strength parameters of the embankment soil are $c'=3 \text{ kPa}$ and $\phi'=30^\circ$. The subsidence portion is around 500 m in length. The cross sections A – A, B – B, C – C and D – D were chosen for every 125 m as shown in Figure 18. Stability analysis of the embankment slope was analyzed by using GEO 4 software (Figure 19). The factor of safety of the embankment was analyzed using Bishop's and Peterson's methods. These results are presented in Table 1. The factor of safety at cross sections A – A and B – B is less than 1.25, which is considered critical by both the code of Indian standards and the US Army Corps of Engineers (IRC: 75, 1979 and EM 1110- 2-1902, 2003).

S.No	Cross Section	Factor of Safety	
		Bishop Method	Peterson Method
1	A – A	1.17	1.14
2	B – B	1.14	1.11
3	C – C	1.38	1.34
4	D – D	1.46	1.42
