Quarry-Induced Slope Instability at a Broadcasting Transmission Plant near Valcava, Lombardia, Italy

ABSTRACT: Since 2006, a broadcasting tower and ancillary buildings on the top of a hill adjacent to a large, active limestone quarry, in northern Italy near the village of Valcava, has been heavily damaged by ground deformation due to slope instability. In 2005, the quarry began to work the slope toward the broadcasting plant, releasing bedding planes that affected the tower site: a number of fractures occurred in the warehouse and in the ground around it, that grew particularly during significant rainfalls. In October 2006 a landslide occurred in the quarry area, close to the broadcasting site. In order to understand what induced the fracture process in the buildings and define a support system to stabilize the broadcasting site, a detailed geotechnical survey and a number of numerical slope stability analyses were carried out. One of the main goals of the paper is to underline the effectiveness of the numerical analyses to understand the instability phenomena when they are particularly complex. Furthermore, by using a reliable numerical model with a good understanding of site geo

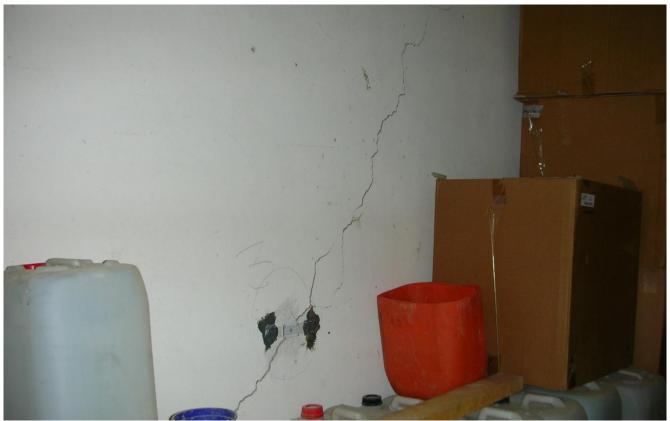
In 2005, quarry operations initiated at the slope toward the broadcasting tower. In May 2006, tension cracks developed in the ground at the top of the hill and many cracks appeared in the walls and floor of the building (Figures 2 and 3). The cracks were parallel to the slope face, suggesting a downward movement of the slope. In October 2006, after two days of medium-high intensity rains, a landslide with a volume of about 27000 m³ occurred in the pit (Figure 4 and 5) at a distance of about 45 m below the warehouse area (Figure 6) and the cracks in the warehouse and in the ground increased, the latter reaching openings of some centimeters. The intense rains of the winter 2006 quickened instability phenomena (Barbero et al., 2008).

Figure 2. Wall damage inside the warehouse.

As crack opening and spreading are important signs of the instability evolution, crack gauges were placed across the larger cracks observed in the warehouse and a continuous monitoring of lengths and openings was performed. Unfortunately, no measurements are available for the cracks that appeared outside the warehouse (tension cracks in Figure 6). The cracks in the warehouse appeared to become more frequent toward the slope in the landslide direction, suggesting that the down slope movement of the rock mass affects the foundation of the warehouse.

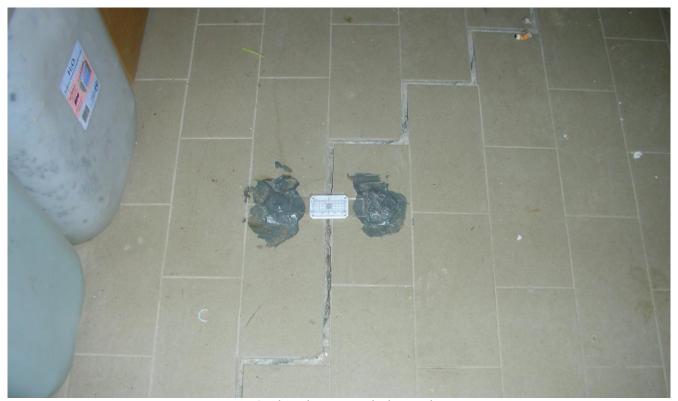
Figure 3. Floor damage inside the warehouse.

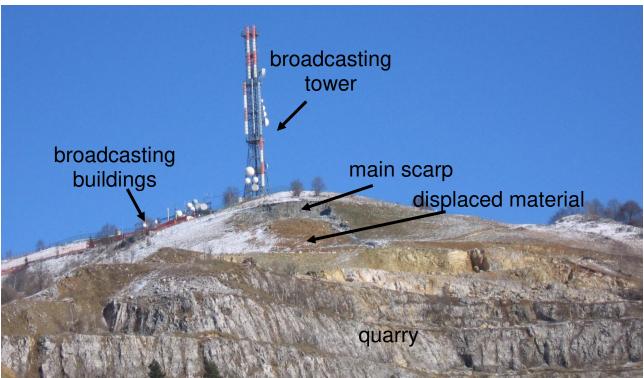
Figure 4. The landslide in the pit area.

- 3. Fault A marks the eastern boundary of the landslide in the pit area. This involves a 30 m slope height and has a crown length of about 35 m;
- 4. In the west side of the edge and in the toe of the landslide, many opened cracks were observed, suggesting that the instability phenomenon is not completed yet and potential landslide progression toward the plant is possible;

- After the event, the landslide was entirely covered by a layer of sprayed-on concrete. In the edge of the landslide, many tension cracks developed with openings of a few centimeters in width. These confirmed that the slope is still moving.

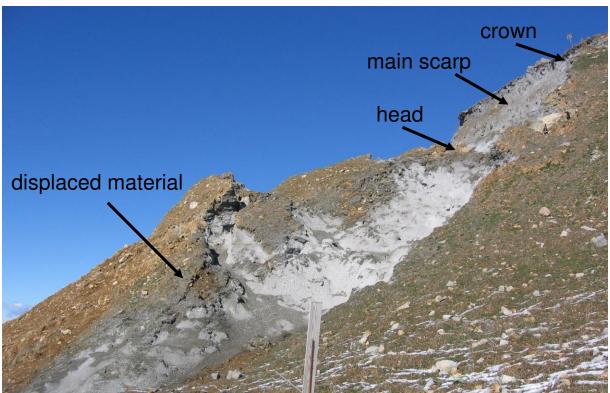
Figure 5. Top of the landslide.

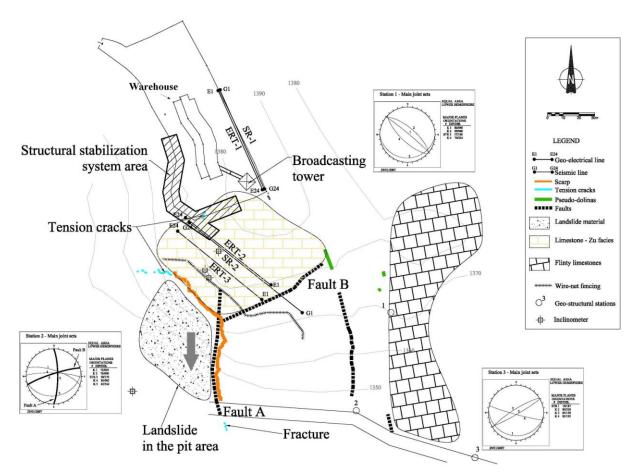
- 2. A second fault is present in the slope area (fault A in Figure 6) which intersects the fault B causing strong cataclasis in both facies, with a remarkable reduction of the rock mass quality;

The geological-geostructural survey was performed in three structural stations (shown in Figure 6). Four main discontinuities sets were found to characterize the rock mass (stereographic projections in Figure 6): 10°-15° down slope dipping bedding planes, two sub-vertical sets that can be potential tension cracks and a set parallel to fault B.

Figure 6. Map of the unstable area and results of the geotechnical survey.

The results of the field surveys have shown that many natural weakness elements affect the site. Fault A marks the east boundary of the landslide. Its intersection with fault B (Figures 6 and 7) induces heavy fracturing in the limestone to significant depths contributing to the instability of the area. The downslope dipping bedding planes predispose the slope to sliding and the two sub-vertical sets of discontinuities can become preferential paths for water percolation.

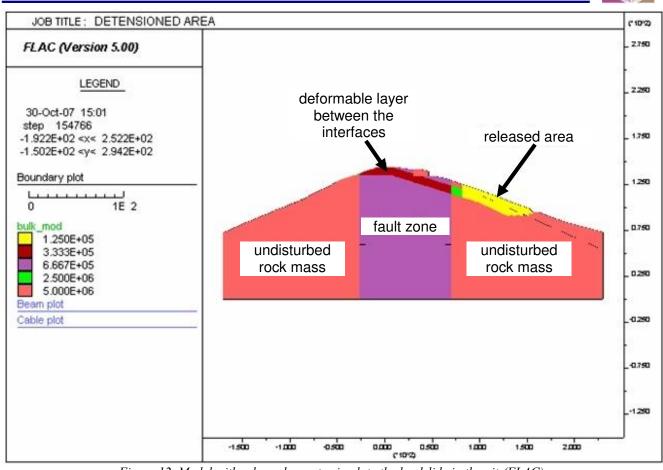
The slope behavior after the landslide in the pit area was simulated. It was assumed that the landslide induced a stress release in the slope beside it, between 1345 m and 1375 m above sea level with down slope displacements. For this purpose, a 20 m thick layer of the rock mass (equal to the estimated depth of the landslide) has been relieved between 1345 m and 1375 m above sea level. In order to simulate the progressive failure along the critical layer, the deformability and strength properties of the corresponding elements were progressively reduced (Table 6 and Figure 12).

The results show an important displacement increase in the upper part of the slope. The displacements in the warehouse area are appreciable only in the case of water table at 5 m from the level of site (Figure 13). A wide area in the disturbed rock mass reaches the plastic boundary for every hydraulic scenarios. From this, it is possible to reconstruct the slope's stress-strain history. The cuts in the pit area induced a progressive instability in the area immediately below the broadcasting plant, with downwards displacements that started in the pit cut and spread towards the warehouse. The landslide in the pit area quickened the instability phenomenon that worsened with heavy rain falls, leading to considerable displacements in the warehouse area.

Figure 12. Model with released area to simulate the landslide in the pit (FLAC).

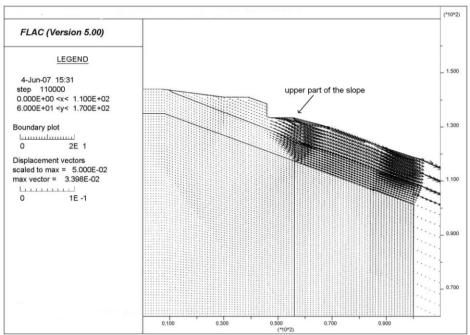
Figure 13. Numerical results: displacements in the upper part of the slope.

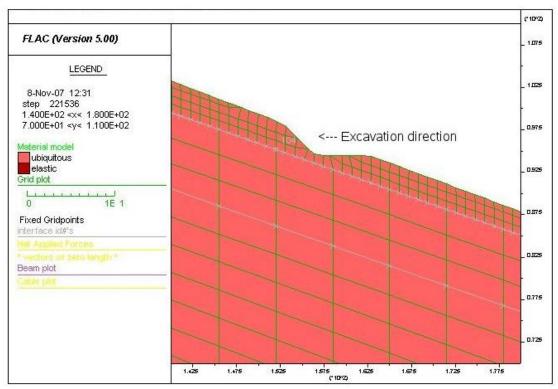
The obtained results pointed out that, with the extension of the pit area, the displacements in the upper part of the slope increase. Close to the warehouse they become in the order of a few centimeters. In particular, the displacements become considerable when the excavation involves the deformable layer.

The results allow to assert that a progression of the mining activity toward the broadcasting plant would induce its instability. For this reason, it can be considered as a triggering cause of the slope movement. As such, it should not to be authorized.

Figure 14. Model for the progression of the mining activities analysis.

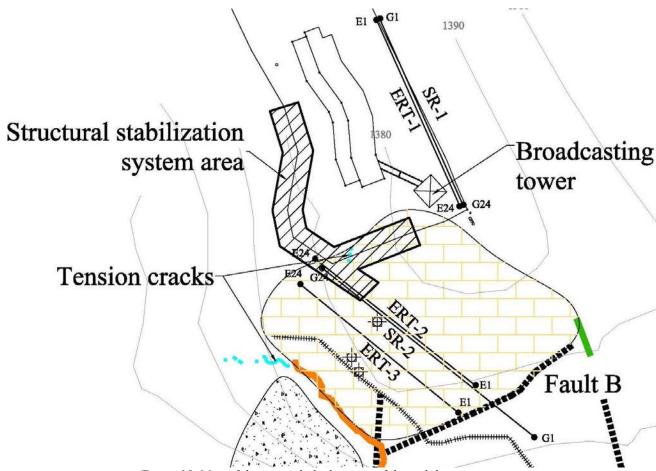
Figure 15. Map of the site with the location of the stabilization system.

In order to confine the strain effects of the stress release induced by the landslide, the broadcasting site has to be isolated from the unstable slope. For this purpose, a structural stabilization system in the warehouse square was suggested (Figure

15 and 17). It was conceived to be a bulkhead consisting of 27 m long micropiles reinforced with steel pipes, 139.7 mm of diameter and 10 mm thick. The micropiles are connected at their head level by a reinforced concrete beam. The bulkhead extends as shown in Figure 15 and is anchored in the head to the undamaged rock mass by means of 28 m long four strands steel anchors, at center distance of 3 m and with a down dipping of 25°. During the construction of the bulkhead, any karst cavities will be filled.
