Embankment Failure in Residual Soils at Nivsar, Ratnagiri

ABSTRACT: The Nivsar Yard embankment was constructed by the Konkan Railways in 1994. Near the station building, the 22m high embankment runs parallel to the Kajali River for a stretch of about 100m. This stretch has experienced failure and settlement related problems since the record-breaking July 2005 rainfall. Corrective ground improvement measures were implemented immediately after the monsoon. However, these measures were inadequate because the failure surface reappeared during the following monsoon. The failure surface mirrored the shape and size of the failure observed in 2005. Since then after nearly every monsoon, the embankment has moved despite precautionary measures taken by the railway to arrest the movement. The hydrogeological and geotechnical properties which affect slope stability are first discussed. The stability of the embankment is then evaluated at 5 sections drawn along the slope. Two cases are considered. In the first case, the stability of the unreinforced slope is calculated. In the second case, calculations are done using the slope reinforced with soil nails and micropiles installed in 2005 and 200

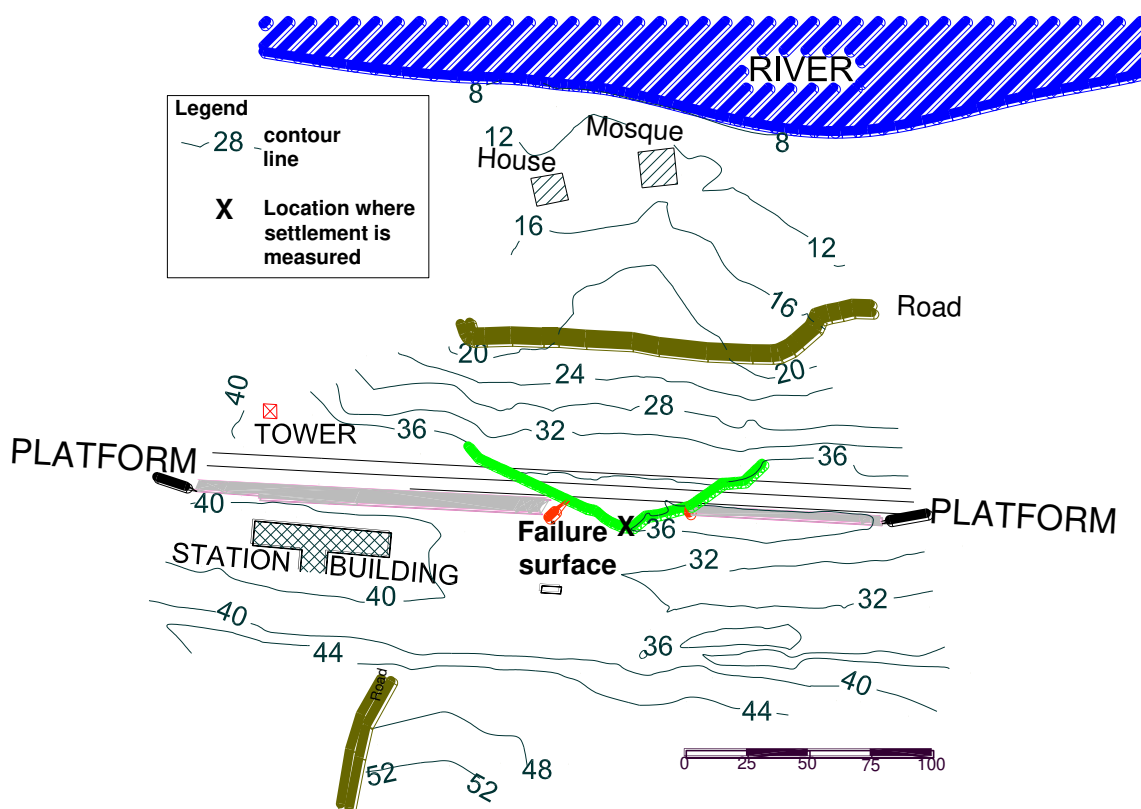
site until the year 2005. In that year, cracks in the embankment developed between chainage km 218.8 and 218.9 following record-breaking rainfall. Heavy rain occurred for 3 days between July 24th and 26th. Cracks opened up to 20mm width over a period of 15 to 20 days. During the same time, the slope settled by more than 150mm. The total settlement was about 550mm towards the end of the 2005 monsoon. At the end of this period, the cracks took shape of a parabola with its vertex close to the station platform. The parabola sloped downhill for about 100 to 120m towards the river. Figure 2 shows the extent of the slope failure observed in 2005.

Figure 2. Failure at Nivsar Yard Embankment

Soon after the observed failure, and when the 2005 monsoon was over, soil nails and micro-piles were installed to prevent further damage to the embankment. Table 1 shows details of the ground improvement works undertaken at the site in 2005. However, the 100mm wide and 130m long crack reappeared during the 2006 monsoon. As in the previous year, the crack encompassed all 3 railway lines, including the main line. The shape and size of the crack mirrored the shape and size observed following the 2005 monsoon. The embankment settled throughout the 2006 monsoon reaching a high value of 2930mm at the station platform.

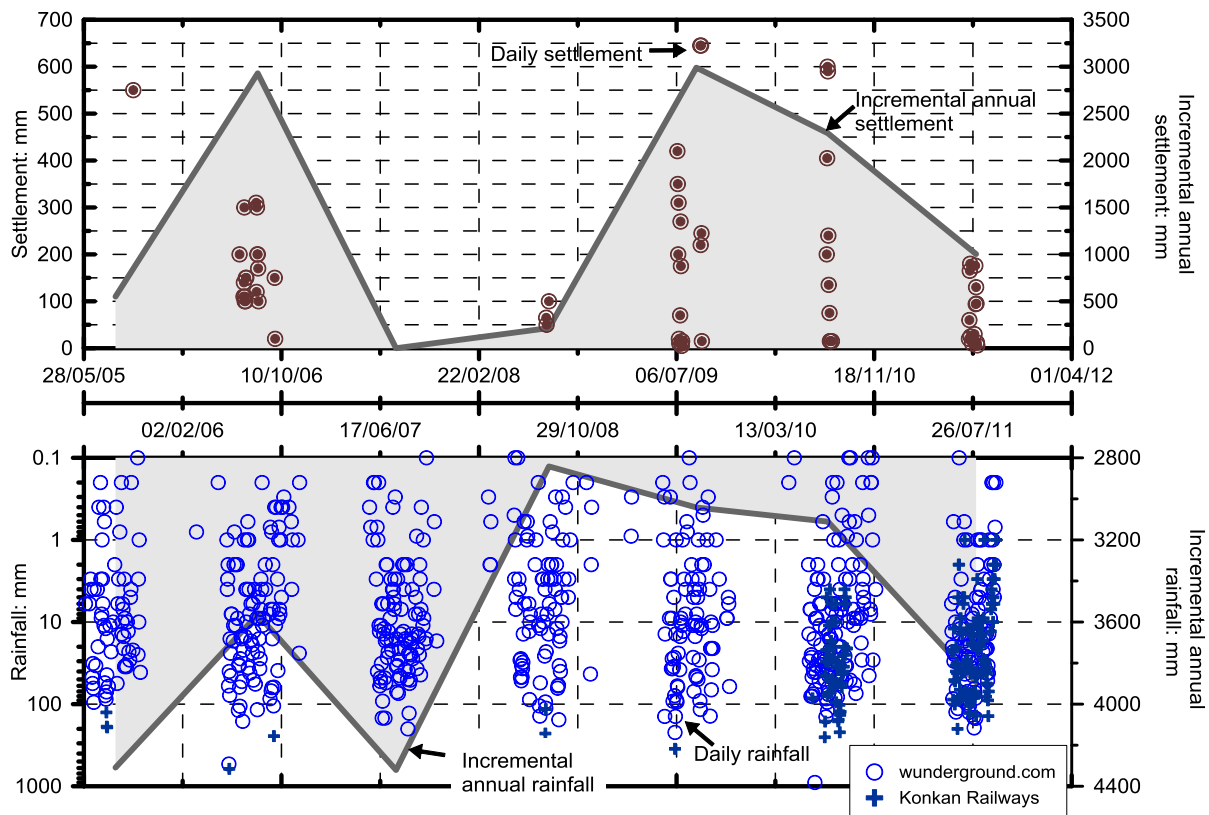
Figure 3 shows the recorded settlement of the embankment from the year 2005. The settlement was measured at top of the embankment near the station platform and its location is shown in Figure 2. Figure 3 also shows the record of rainfall in this region. The rainfall record was obtained from the web pages of <http://www.wunderground.com/> and from the data maintained by Konkan Railways. A clear trend between the magnitude of rainfall and slope movement can be observed in Figure 3. For instance, rainfall of over 200mm per day was invariably followed by more than 100mm settlement every year except during the 2007 and 2008 monsoons. The embankment did not move during the 2007 monsoon. Movement occurred only after more than half of the 2008 monsoon was complete. It appears that the stabilisation work completed before the onset of the 2007 monsoon was insufficient and effective only for a year, before losing effectiveness during the 2008 monsoon. It is likely that the slip planes redeveloped along the original failure surface during the 2008 ground failure. All effects of the soil improvement vanished before the onset of the 2009 monsoon, resulting in rapid movement of the embankment towards the river. The failure cracks that developed in 2009 are shown in Figures 4a-c. Figures 4a and b show the top few meters of the micro-piles that were exposed because of the steady soil-flow down the hill, and Figure 4c shows the transverse cracks observed along the road.

Figure 3. Settlement and rainfall record at Nivsar Yard Embankment.

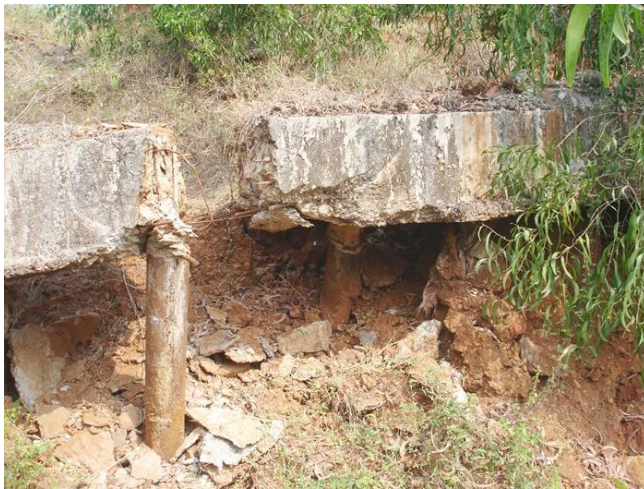
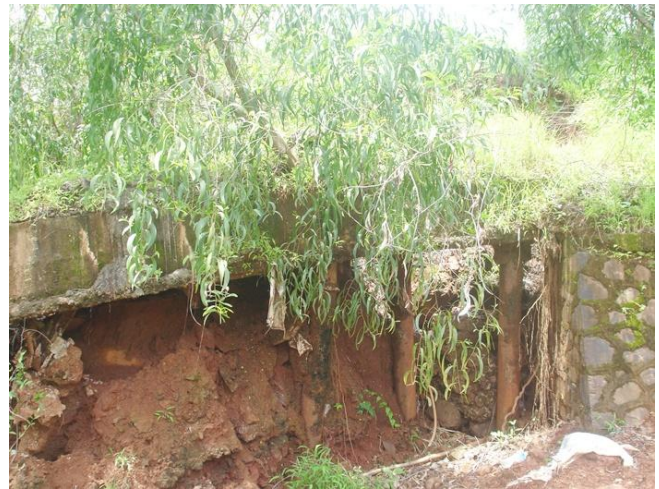
Figures 4a-c. Failure of micropiles and curtain grouting: (a) and (b) Exposed pile foundation; and (c) Location of transverse cracks along the road (curtain grouting was conducted around this location).

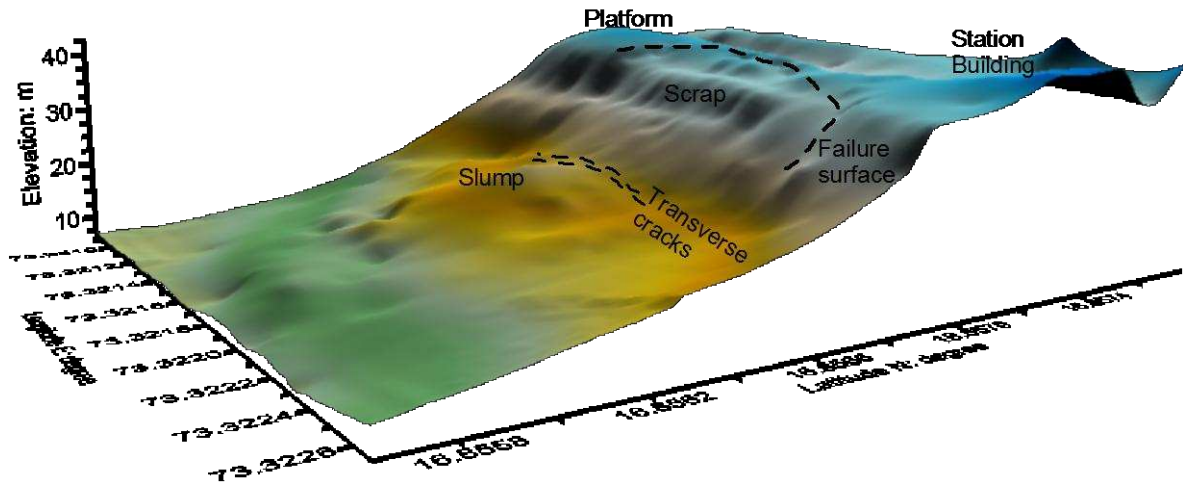
Figure 5 shows the map of the failure surface at the Nivsar Yard Station. In the figure, the latitudes and longitudes were obtained from the local coordinates using the WGS84 method (Chen and Hill 2005). The location of the slump, transverse cracks, and the failure surface are marked in the figure. The position of the transverse cracks was obtained by superimposing the observations made in Figure 4c onto Figure 5. All of the above, and the location of slope-reversal and scarp shown by the tilted trees and the cracked brick walls in Figure 6, suggest that they are parts of a landslide event.

Figure 5. Three dimensional view of the failure surface at Nivsar Yard Station.

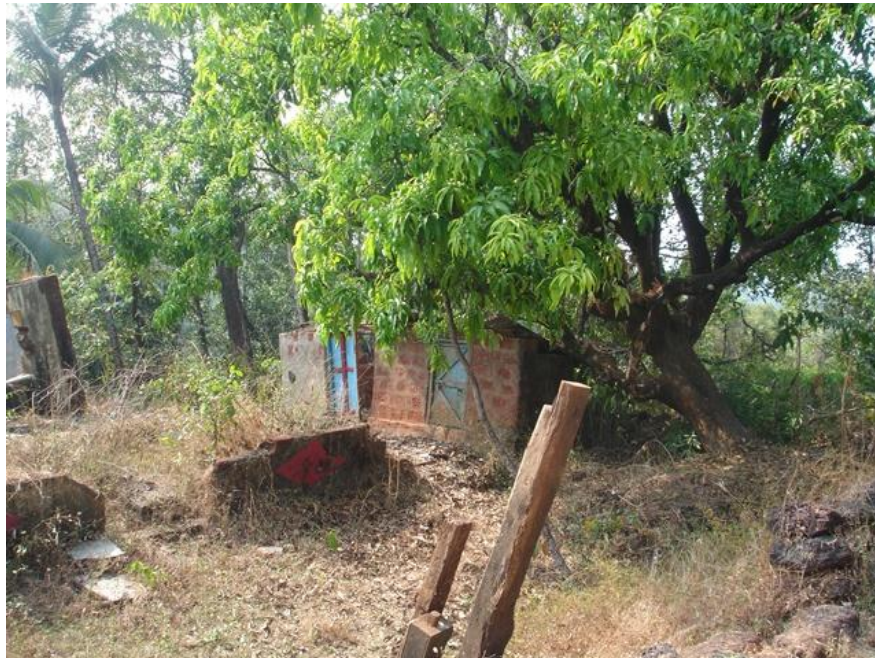
Figure 6. Tilted trees and cracked brick walls observed along the slope.

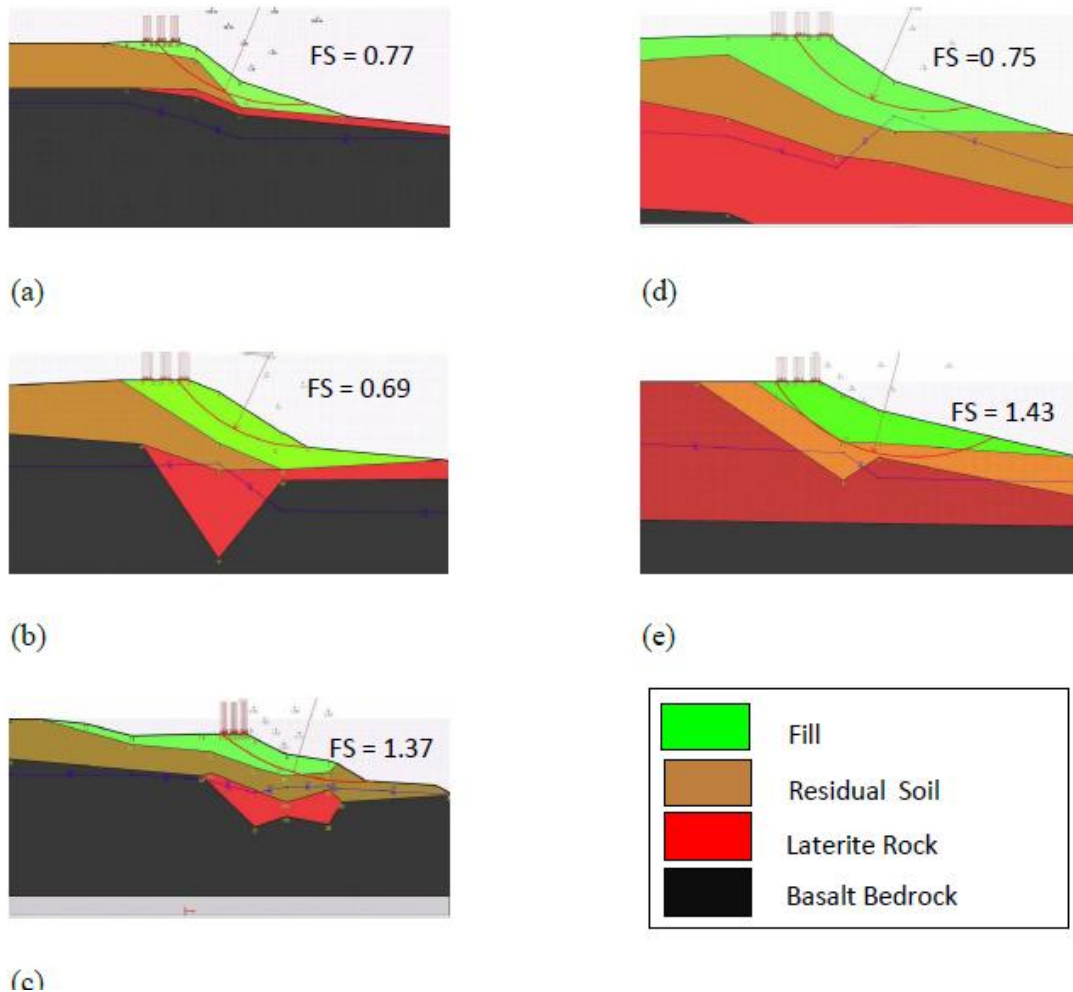
Figures 11a-e show the minimum safety factor and the location of the critical circle in sections A-A to E-E for the dry season. It is surprising to note that the minimum safety factor in 3 out of 4 sections is less than one, despite the fact that the slope was known to be stable and did not show any distress during the dry season. These sections are A-A, B-B and D-D in the figures. Figures 11a to 11e also show that the ground water level is below the critical failure circle in all 4 cases. Therefore, even if it is argued that the hydrological conditions which led to the 2005 failure and those measured in 2010 and 2011 may not be the same, it is unlikely that the position of the water table could influence the stability of the slope during the dry season.

Figures 11a-e. Safety factor during dry season with original parameters for section: (a) A-A; (b) B-B; (c) C-C; (d) D-D; and (e) E-E.

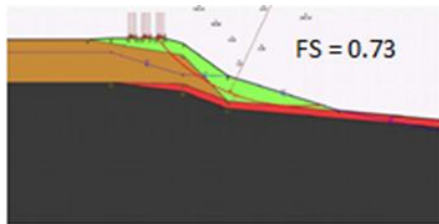
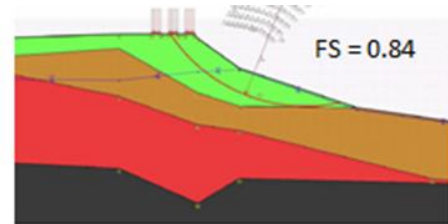
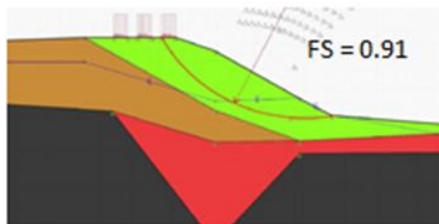
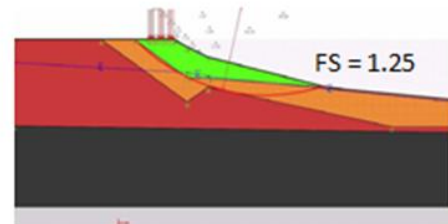
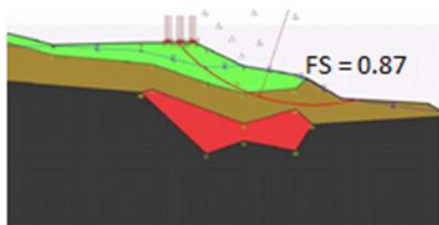
Figures 12a-e. Safety factor during wet season with modified parameters for section: (a) A-A; (b) B-B; (c) C-C; (d) D-D; and (e) E-E.

Figures 12a to 12e show the minimum safety factor and the location of critical circles in sections A-A to E-E for the wet (monsoon) season. In all the figures, the critical slip circle passes through the toe of the embankment, which is similar to the observations made at the site (see Figure 5). Similarly, the top of the circle in Figure 12c intersects the rail tracks and lie close to point X in Figure 2. The safety factor of all the 5 sections for the dry and the wet seasons are compared in Table 8. As can be seen, the safety factor reduced to less than one with the rise in ground water table in all sections, except in section EE. Figure 12e shows that only section E-E was stable during the wet season. This section was far beyond the failure zone shown in Figure 7. Regardless of the above observation, it is plausible that factors such as deep-rooted trees present at the site may have affected the safety factor. All the same, the effect of vegetation on the slope stability cannot readily be incorporated within this simplistic framework (Bernhardt et al. 2011).

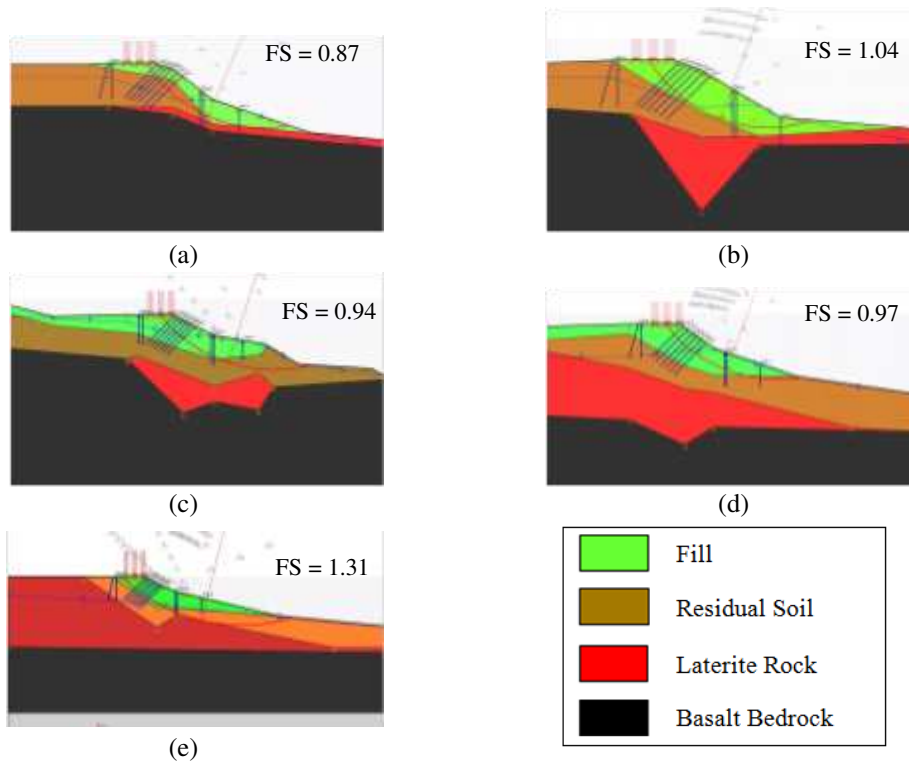
Soil nails and micropiles were installed in November 2005. These reinforcements failed and could not arrest the slope movement during the 2006 monsoon. Subsequently, two new rows of micropiles installed in January 2007 also failed during the 2008 monsoon. It was therefore appropriate to also study the stability of the 2006 and 2008 reinforced slope failures. In this analysis, the location, diameter and spacing of the reinforcement elements were taken from Table 1. Ground conditions and the slope geometry were identical to those used in the previous case. Figures 14a-e and 15a-e show the minimum safety factors and the location of critical circles in sections A-A to E-E for the 2006 and 2008 wet (monsoon) season, respectively. As can be seen, the safety factor is less than one in sections A-A, C-C and D-D for both years, indicating that the soil nails and micropiles installed in November 2005 and January 2007 were indeed inadequate to resist the slope movement. It is also interesting to note from Figures 12a-e and 14a-e to 15a-e that the reinforcement has little influence on the shape and size of the critical slip circle.

Figures 14a-e. Safety factor and critical slip circle during wet season with November 2005 ground improvement scheme for section: (a) A-A; (b) B-B; (c) C-C; (d) D-D; and (e) E-E.

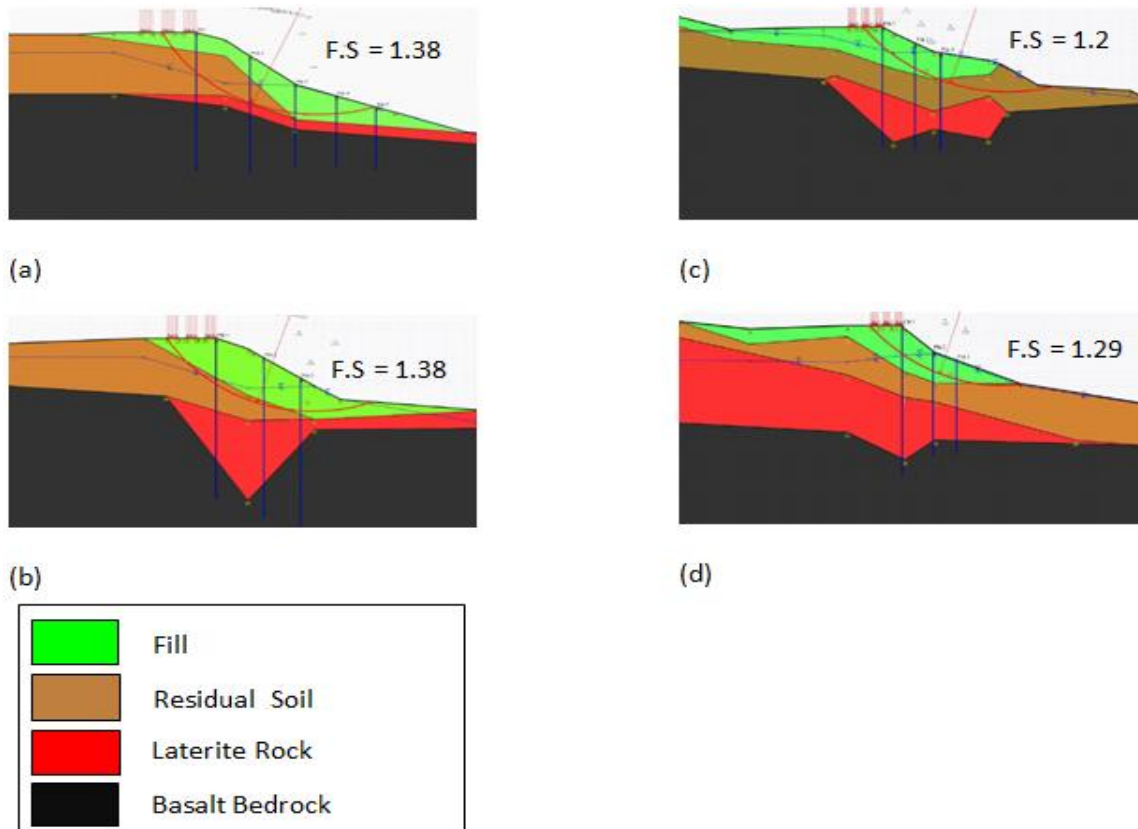
Figures 17a-d. Safety factor during wet season with proposed contiguous bored pile for section: (a) A-A; (b) B-B; (c) C-C; and (d) D-D.

One possible solution to enhance the stability of the slope was with the use of large diameter piles to retain the (failed) soil mass. In this case, safety factors of sections A-A to E-E were also deduced by assuming that the slope was reinforced with single or multiple rows of contiguous bored pile wall constructed parallel to the platform. Figure 16 shows the schematic layout of the proposed bored pile wall. The 1.2m diameter piles terminated below the slightly-to-moderately weathered basalt rock because of which sections B-B and C-C had long piles to provide adequate anchorage (Table 3). Table 9 shows the location and length of the piles used in the analysis. Figures 17a-d show the minimum safety factor and the location of critical circles in sections A-A to D-D for the wet season when the slope is reinforced with contiguous bored pile wall. As can be seen, the minimum safety factor increased up to 1.2 and 1.38 with the use of contiguous bored pile wall.

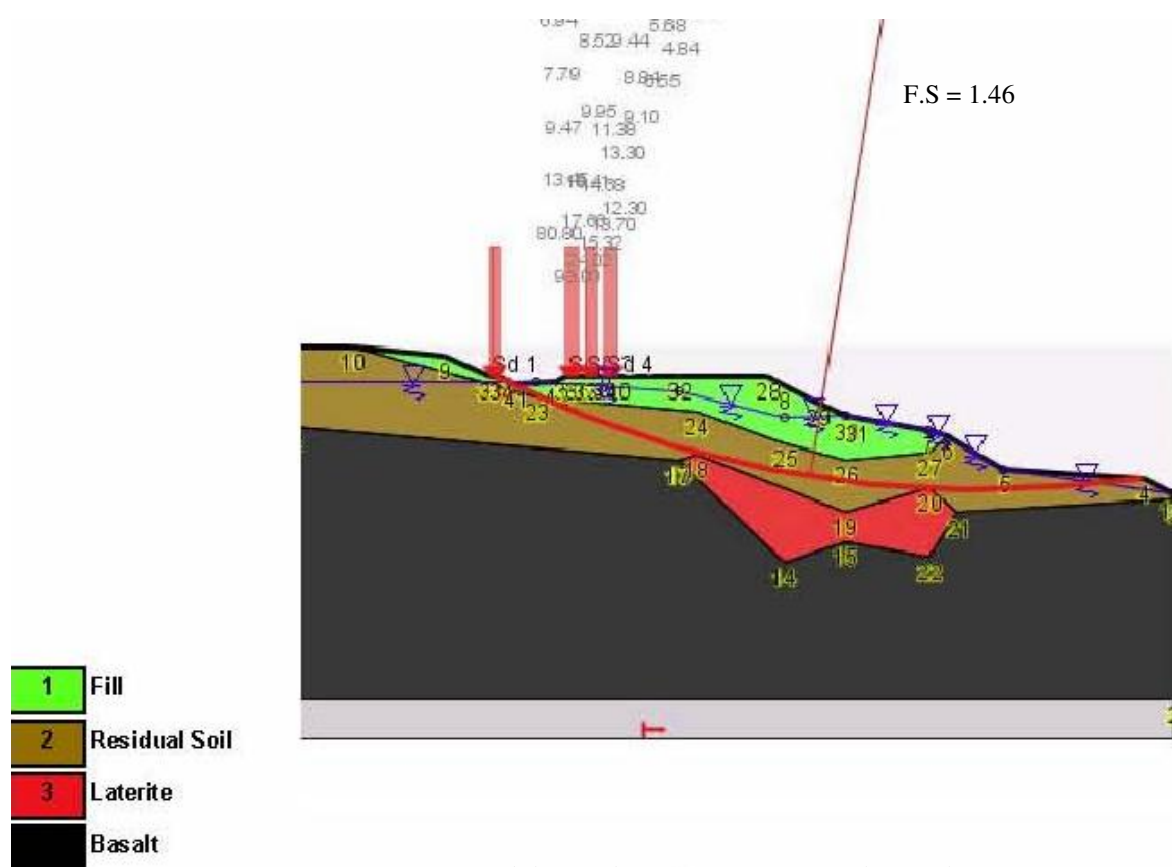
Figure 19. Stability analysis of Section C-C with new alignment.

more than 1.4. The slope was therefore considered to be safe and unlikely to fail under the new loads. This new alignment has been implemented since 2011. It has been constructed at less than 20 percent of the cost incurred to improve the ground. The railways have also removed the speed restriction at Nivsar which has resulted in additional savings during the monsoon.

The cost to use the bored pile wall was over 200 million Indian Rupees (US\$ 3.6 million) and appeared to be prohibitive. As an alternative to this design, the old rail alignment was removed and replaced by a new alignment. The new alignment consisted of 3 loop-lines and 1 main-line. Figure 18 shows section C-C along with the location of the new alignment. In this section, the top left side of the hill was slightly levelled to accommodate the main line and the loop lines. Section C-C was chosen because the new alignment was closest to the failure surface at this section. The horizontal distance from the vertex of the failure surface and the 4 lines was 16m, 21.3m, 26.2m and 46.4m, respectively. The stability of the slope was then reinvestigated using the computer program Talren-4 (Terrasol 2005). As in the previous case, all the lines were loaded by 125 kN/m². This assumption was unduly conservative in absence of strict guidelines (RDSO 2003b). Nonetheless, it permitted trains with more overtaking opportunities on the passing-loops. The ground water level was modeled using the highest RL recorded in Table 5. The failure circles are shown in Figure 19. As can be seen, the minimum safety factor is
