The May 25th 2011 Railroad Embankment Failure in Ann Arbor, Michigan, As a Means for Teaching Geotechnical Engineering

Dimitrios Zekkos, Associate Professor, Department of Civil and Environmental Engineering, University of Michigan, Ann Arbor, Michigan, USA; email: zekkos@geoengineer.org

Reference: Zekkos, D., Athanasopoulos-Zekkos, A., Grizi, A., and Greenwood, W. (2016). *The May 25th 2011 Railroad Embankment Failure in Ann Arbor, Michigan, As a Means for Teaching Geotechnical Engineering*. International Journal of Geoengineering Case histories, Vol.3, Issue 4, p.234-245. doi: 10.4417/IJGCH-03-04-03

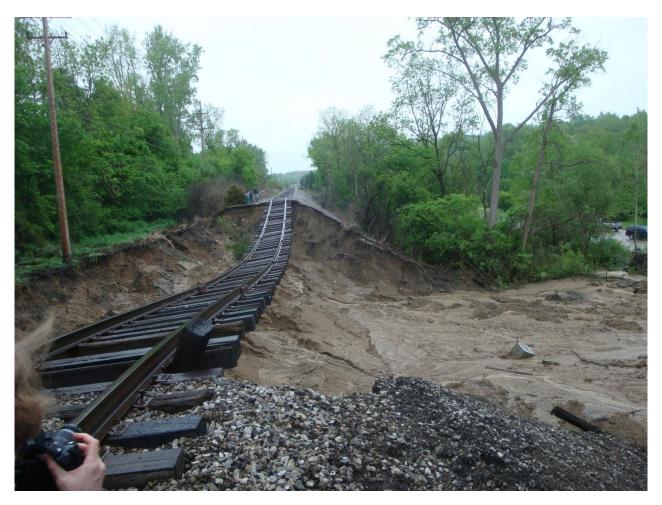
Figure 1. View of the railroad embankment failure looking East.

The failure surface appears to engage the entire railroad embankment that is supported on naturally sloping native ground. A 30-m long section of the embankment along the railroad axis slid, and the sliding mass moved a significant distance downslope, removing a number of trees that had grown in the downslope side of the embankment between the railroad embankment and Plymouth Rd. The interpreted failure surface per field observations is shown in Fig. 5 and 7 and is in the vicinity of the contact between the native ground and the embankment fill, but appears to be restricted within the embankment fills and not involve the native soils.

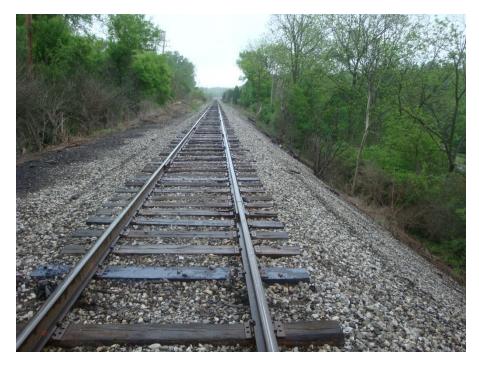
Figure 3. View of intact portion of the embankment immediately to the East of the failure area. One can see that the uphill part of the embankment (left) is supported by natural ground that is at a much higher elevation than the downhill part of the embankment (right).

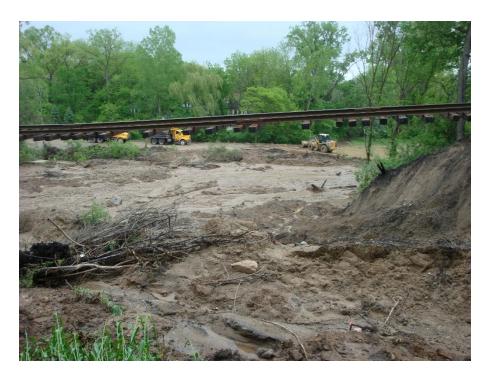
- (a) Shutdown of the railroad for an extended period of time;
- (b) Closure of Plymouth Rd for two days; and
- (c) Flooding and debris deposition on the downslope side of the embankment that damaged a public park southwest of Plymouth Rd and deposited additional sediments in a natural stream, as shown in Fig. 4.

Figure 4. View of the conditions downhill of the failure showing deposition of debris and water. Trucks and dozer are operating on Plymouth Rd. and flooded area further back is a flooded public park.

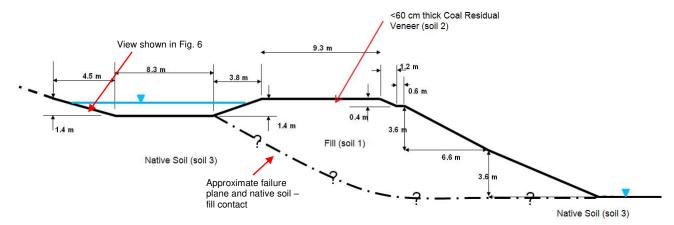
The embankment is constructed partially on a naturally sloping ground and has a total height of 7.6 m as shown in Fig. 5. Its crest, that supports the railroad lines, has a width of 9.3 m. The embankment fill consists of two layers. The main layer (Fill Soil 1) is a silty sand (SM). A surficial layer of very small thickness is also present and consists of coal ash residuals (Soil 2). The natural soil that underlays the embankment is a sandy clay of low plasticity (CL) that geologically is described as very dense glacial deposits (Native Soil-Soil 3).

Figure 5. Cross-section of the railroad embankment at the location of the failure.

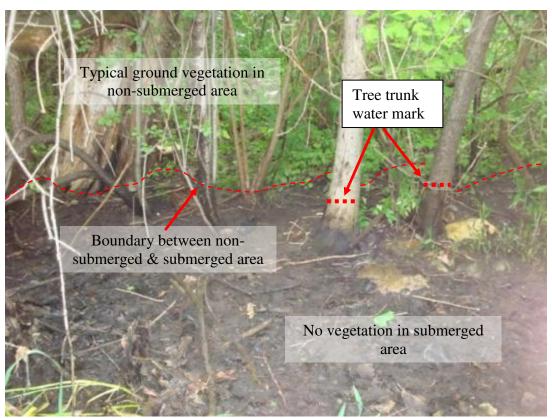
During the site visit, it was observed that the failure location was at a local natural depression that was receiving and accumulating surface water from a wider area. After careful inspection, the authors hypothesized the existence of seasonal ponding water. The surface soil on the uphill side of the embankment was very wet with vegetation that is typical of marshes, such as reeds. Next to the embankment where the water appeared to nearly permanently ponding and below trees there was no vegetation (see web-based supporting information titled "Photos and "Videos"). These conditions were found to be unique compared to other locations along the axis of the embankment. In addition, the level of water could be clearly seen as a watermark on the trunks of trees, as shown in Fig. 6. Based on these observations it was evaluated that the depth of the ponding water could have reached up to 120 cm. Local residents confirmed the existence of ponding water adjacent to the embankment. In fact, it appears that a neighbor used to feed visiting ducks at that location. Retention of ponding water was not part of the original embankment design. It is important to note that ponding water existed for at least some

period of time prior to failure. However, the spring of 2011 was particularly wet and probably more water accumulated compared to previous years. It is also not entirely clear whether a clogged storm drain existed in that location.

Figure 6. Area previously covered by ponding water and water mark on tree trunks.

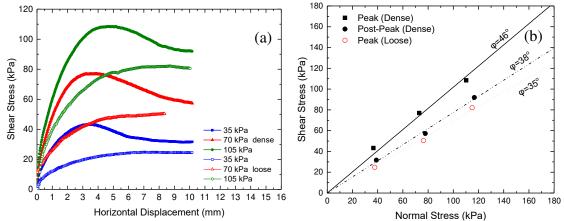
Figure 9. Direct shear results at nominal vertical stresses of 35 kPa, 70 kPa, and 105 kPa on reconstituted specimens of Soil Layer 1.

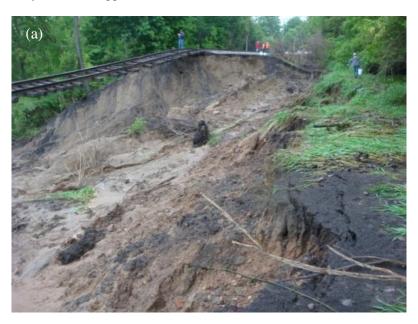
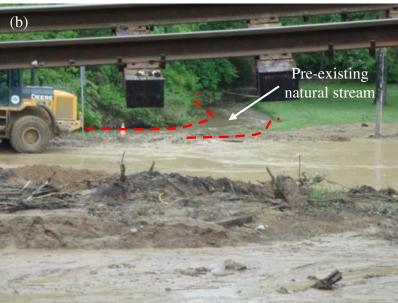
Soil Layer 2: This embankment layer is restricted to the top few cm from the surface and is essentially coal ash residuals that are black in color and can be clearly seen in Fig. 10. The fines are non-plastic and represent only 6.8% of the total mass of the soil, whereas the gravelly size particles are equal to 29.6%. It is classified per USCS as well-graded gravelly sand with silt (SW-SM). This soil layer is not expected to have played a significant role in the failure since it is of very small thickness and restricted at the surface only. Thus, more comprehensive testing to characterize its properties was not conducted.

Figure 10. View of the failure from the crest of the failure surface where (a) the left-in-place embankment is shown; (b) the mass of soil with large amount of water is shown at the toe of the failure reaching the pre-existing natural stream.

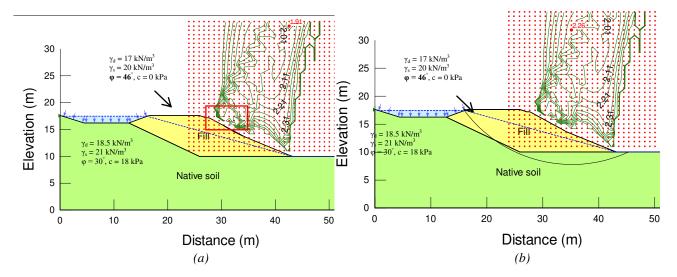
Following site characterization and the assessment of the embankment and failure surface geometry, stability and seepage analyses were conducted using the software programs SEEP/W and SLOPE/W (Geostudio, 2007) and the Spencer method of analysis (Spencer 1967). For stability assessment, parametric analyses were also conducted for reasonable variations of soil properties, as well as variations of the water depth of the ponding water (60 – 120 cm) that is reasonably well documented based on the field observations. These parametric analyses are critical in assessing the impact of uncertainties in the results. The parametric stability analyses indicate that even for the highest ponding water depth, the factor of safety remains significantly higher than one, i.e., it varies between 1.4-1.9 (for friction angles equal to 38° and 46° respectively) for a shallow failure surface that is restricted within the embankment, and is shown in Fig. 11a within the red box. Note that although the failure planes shown are "classic" numerical failure surfaces of purely frictional material with zero cohesion, even for low cohesions of 1-3 kPa, the observation that shallow failure surfaces are most critical remains valid. Higher values of factor of safety that vary between 1.5 and 2.3 were calculated for deeper failure surfaces that intersect the native soil (soil layer 3). Example results of the analyses are presented in Fig. 11.

Figure 11. Indicative results of embankment stability analyses for hydrostatic pore pressures. (a) showing lowest Factor of Safety (FS) of 1.91 for shallow failure planes (in the red box); (b) showing indicative FS of 2.26 for a failure plane that intersects the native soils.

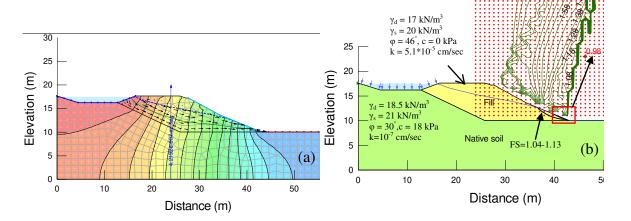
Subsequently, seepage analyses were conducted using the estimated hydraulic conductivities. As described earlier, the natural soil has significantly lower hydraulic conductivity than the embankment soils. Thus, the analyses indicate that when the ponding water depth increases, the exit gradients at the toe of the embankment become high, and vary between 0.48 and 0.78, which are dangerously high and close to critical gradients (~0.9). The stability analyses using the calculated hydraulic pressures, indicate failure of the embankment with factors of safety around one, as shown in Fig. 12. Note that this is not surprising as the seepage analysis gives a more realistic pore pressure profile (Fig. 12a) than that of an arbitrarily assumed piezometric surface (e.g., Fig. 11) with the flow concentrating more on the higher hydraulic conductivity soil. The results, indicate that the failure is caused by the high pore pressures that may even cause piping. The numerical results, are supported by the following interesting field observation: The reeds in the ponding water area adjacent to the embankment were found to be bent sideways and positioned horizontally with a direction that was pointing with great accuracy to the exact location where the ponding water initially drained quickly, as shown in Fig. 12.

Figure 12. Indicative results of combined (a) seepage and (b) stability analyses using seepage analyses results

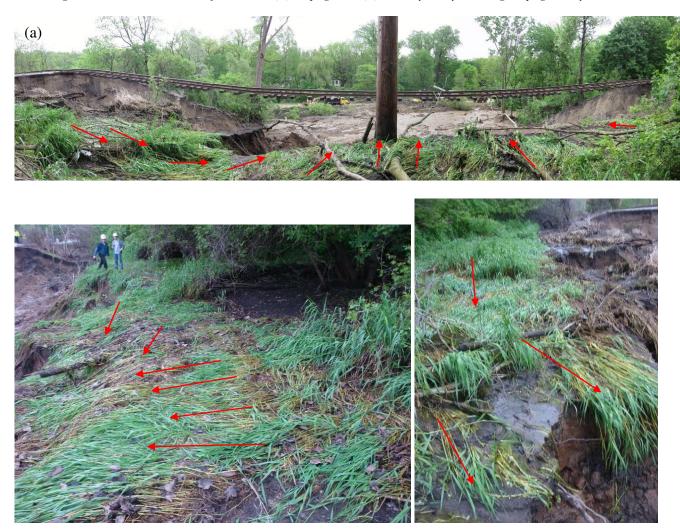
Figure 13. View of the failure and the reeds uphill of the embankment. The arrows are parallel to the direction of the fallen reeds that bent and broke during the abrupt emptying of the ponding water and fell on the ground with their orientation pointing to the initiation point of failure. (Fig. 13a by Karl Jansen, ceephotos.com)
