# Remediation of The Pissouri Landslide in Cyprus

**ABSTRACT:** During the winter of 2001-2002, a landslide of 80.000 m<sup>3</sup> was activated and moved downslope at the Northeast outskirts of the Pissouri village in Cyprus (Limassol prefecture), displacing a section of a country road that was crossing the upper part of the sliding mass and destroying three newly built residences. This paper presents the geologic and hydrogeologic regime of the landslide and its implication on the landslide's mobilization. Geotechnical site investigation and post failure monitoring, in conjunction with slope stability back analysis formed the basis for the study of the slide and subsequently guided the remediation strategy. Various possible interventions to stabilize the slope and allow the safe reconstruction of the displaced road have been investigated and compared considering both economic and environmental criteria. The performance of the remediation measures has been studied in terms of stability safety, using numerical models previously calibrated via back analyses. Observations made during the execution of the stabilization works provided additional data verifying and supplementing the o

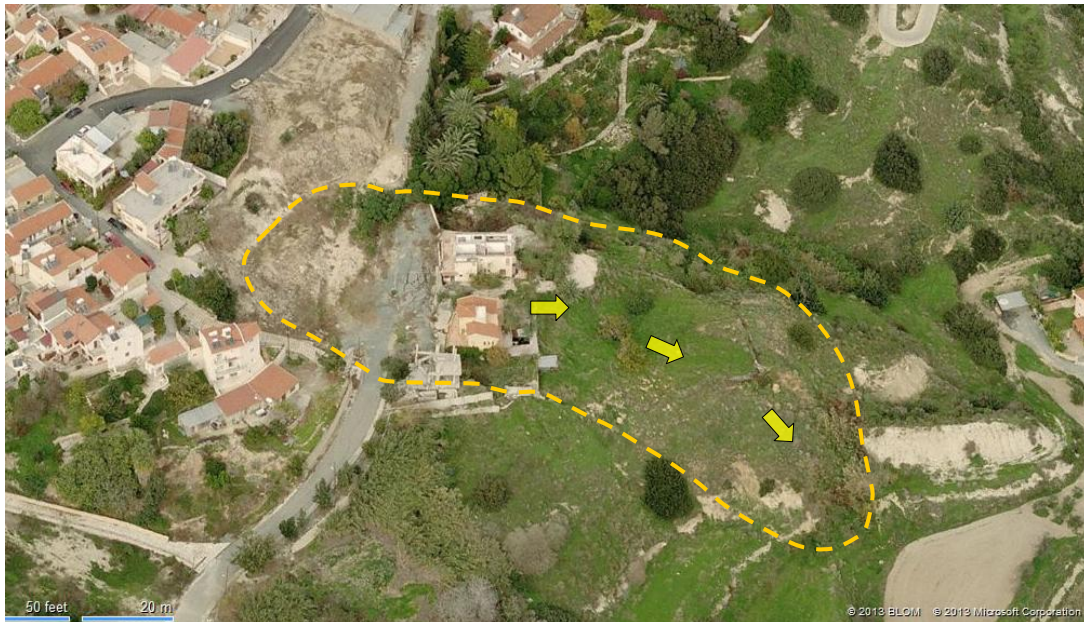
of the build-up area, approximately 80,000 m<sup>3</sup> of ground mobilized and moved 0.5 m to 1.0 m downslope. The landslide distorted a section of a country road which was crossing the upper part of the slide and three residential buildings built adjacent to it. It continued to move the following years, at low rates during the dry seasons and at an accelerating rate during the wet seasons. With an average movement rate of 3 cm per month the landslide displacement accumulated up to 3.00 m – 3.50 m during the next 10 years. The landslide was immediately followed by water springing at the toe of the sliding mass, and continued the following years to seasonally gush out water and mud, pinpointing the significance of groundwater seepage through the sliding mass to its mobilization. An aerial view of the landslide, the distorted road and the damaged buildings is presented in figure 1, which can also be seen on the photographs of figure 2.

*Figure 1. Aerial view of the Pissouri landslide. Dashed line indicates the border of the sliding mass. Notice the distorted road and the damaged residential buildings resting on the sliding mass.*

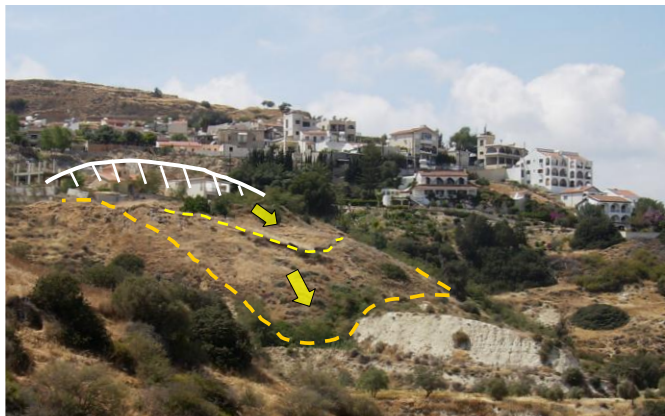
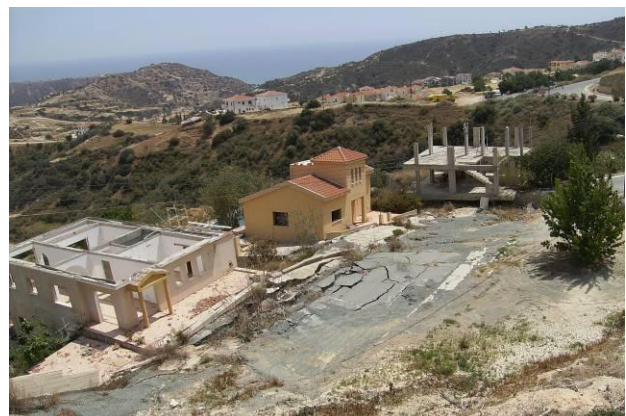
*Figure 2. Left: Northward view of the Pissouri landslide. Dashed line marks the border of the sliding mass. Back scarp is also marked. Right: The distorted road and damaged buildings resting at the upper part of the sliding mass.*

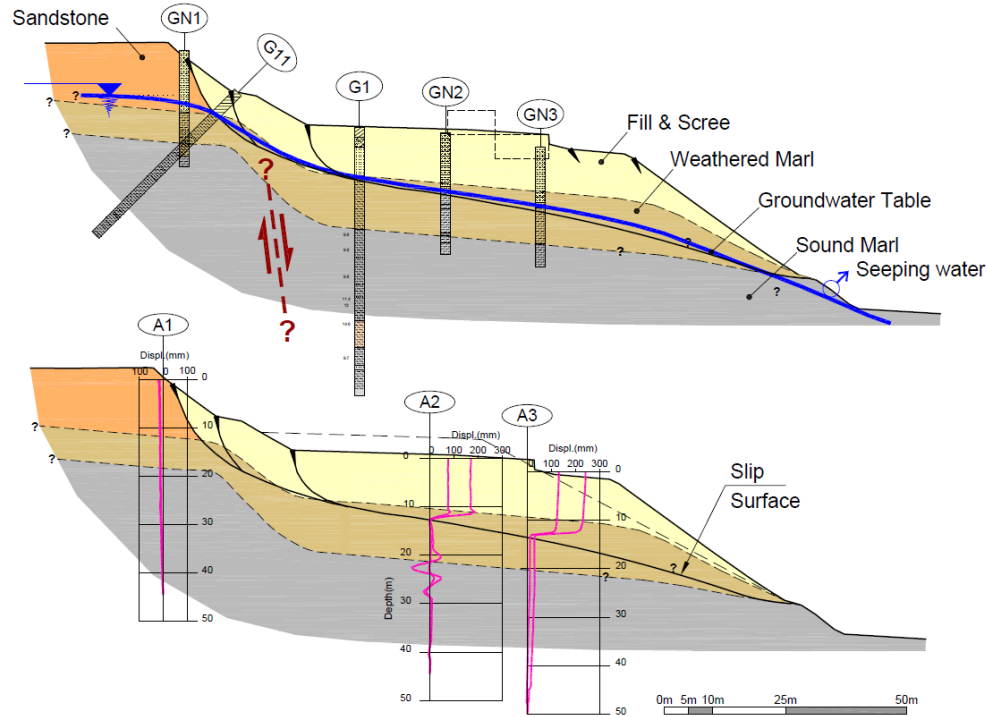
Figure 5. Geotechnical section along the sliding mass. Top: Exploratory boreholes Stratigraphy and ground water table  
Bottom: Inclinometer readings and location of slip surface.

The slip surface was located by combining the monitoring data from the two inclinometer tubes (A2 & A3) installed within the sliding mass and the careful mapping of slope breaks and cracks, visible on the ground (in some cases), on the cracked pavement of the distorted road, the houses and the paved ground around them. The third inclinometer tube which had been installed further upslope did not show signs of movement (as shown in figure 5) and allowed the identification of the back scarp of the slide with confidence.

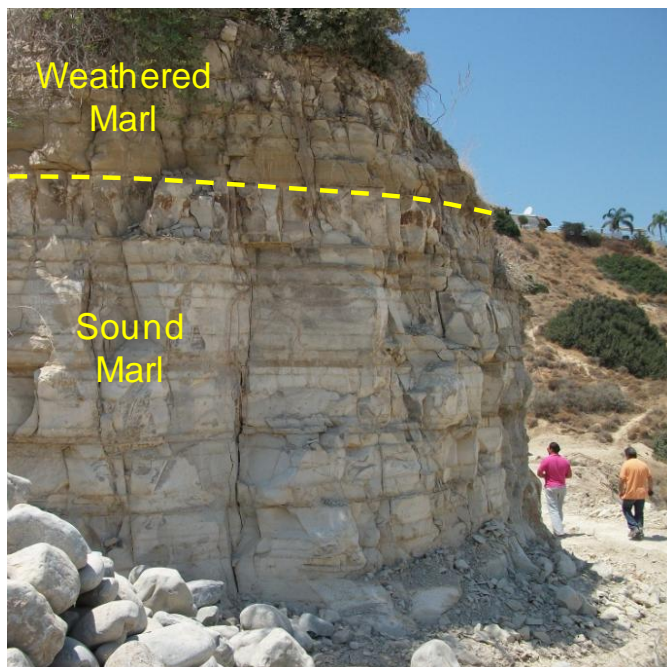
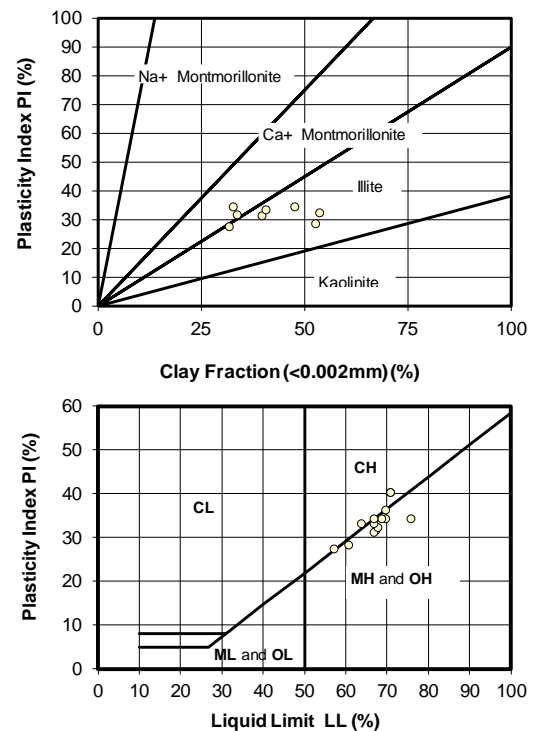
The bedrock is a low strength yellowish calcareous marlstone ( $UCS \approx 10$  MPa), fairly undisturbed, but marked by a medium to thick bedding (10 - 100 cm) dipping with a low angle to south-southeast. Stress relief lead to the development of sub-verical joints and fissures and water circulation gradually resulted to the development of a capping weathered crust. Weathering is associated with oxidization and decalcification of the marlstone, the gradual increase in pore volume (further promoting seepage) and subsequent intact strength degradation to that of a stiff soil. In the landslide site the thickness of the weathered marl crust is 5 to 10 meters and the material was encountered in places disturbed and sheared by the landslide movement. The succession of sound and weathered marl is depicted on the photograph of Figure 6, where the weathered material is noted by the distinct brownish color and its intense fissility. Soil samples obtained from the weathered zone are classified as CH-MH with a plasticity index (PI) ranging from 20% to 35% and clay fraction (CF) between 30% and 60%. Natural water content of the weathered marl does not exceed 30% and the material is generally stiff with SPT values ranging from 25 blows/ft to refusal. Typical classification test results from this zone are also presented in Figure 6.

Figure 6. Left: Typical appearance of the bedded calcareous marl and the overlying weathered crust.  
Right: Typical soil classification test results performed on samples retrieved from the weathered marl zone.

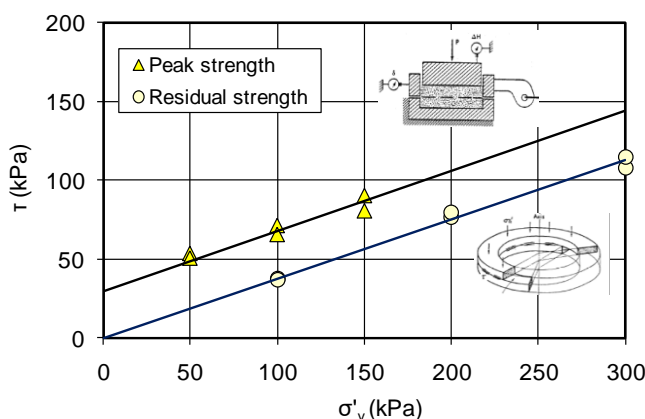
The shear strength parameters of the weathered marl, where the slip surface eventually developed, was investigated in the laboratory by means of a few slow (drained) shear box tests, which averaged to  $c'=30$  kPa and  $\phi'=21^\circ$  as shown in figure 7. Residual shear strength parameters, were obtained from ring shear tests (Broamhead ring shear apparatus) which yielded values of  $c_r'=0$  and  $\phi_r'=21^\circ$ . The values of the residual angle of shearing resistance determined directly by the ring shear tests are compared with the dataset presented by Skempton (1985) (Figure 8) and are found to be in the upper bound of the scatter. This is probably due to the fact that the particular ring shear tests were carried out on fairly silty samples (classified as MH) and not on clayey ones.

Figure 7. Shear box and ring shear test results on soil samples from the weathered marl horizon. Peak strength  $c'=30$  kPa,  $\phi'=21^\circ$ . Residual strength  $c_r'=0$  kPa  $\phi_r'=21^\circ$ .

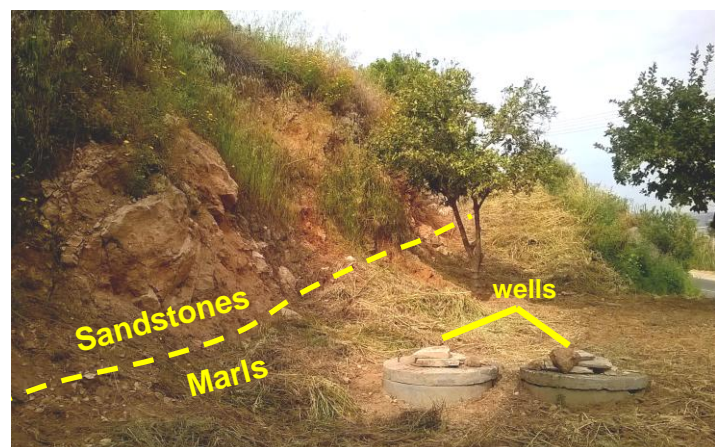
Figure 11. Wells collecting groundwater springing out freely in the sandstone-marl contact area were located a few hundred meters south of the landslide area.

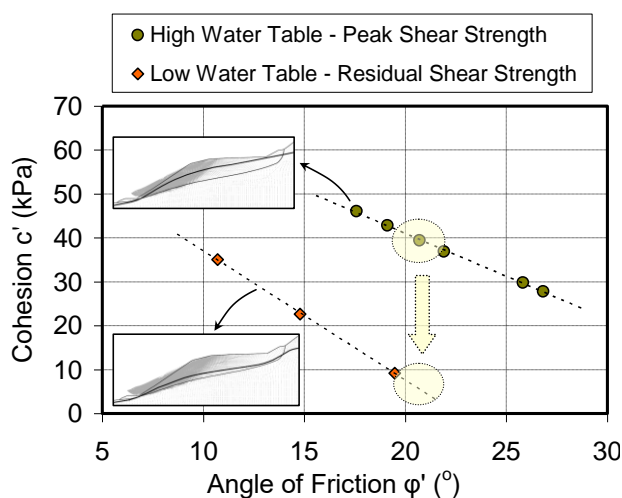
These analyses manifested the fact that an elevated water table can mobilize the weathered marl crust with operational shear strength parameters close to the peak values, as they were determined by the shear box tests performed on the soil samples. They also show that the slide remained mobile after water table lowering, (dry season) if the operational strength values of the weathered marl crust at the failure surface were close to the residual strength values, determined by the ring shear tests. It is concluded that most likely we deal with a new slide, which was brought in the verge of failure due to gradual loading of the upslope area with scree and manmade fill and the gradual progression of the weathering process. The development of high water pressures triggered an already mature slide, which continued to be active even during the dry seasons due to the drop of the shear strength values from peak to residual.

Figure 14. Back analyses results. Estimated mobilized shear strength parameters for a higher and lower water table coincide with the transition of shear strength values from peak to residual.

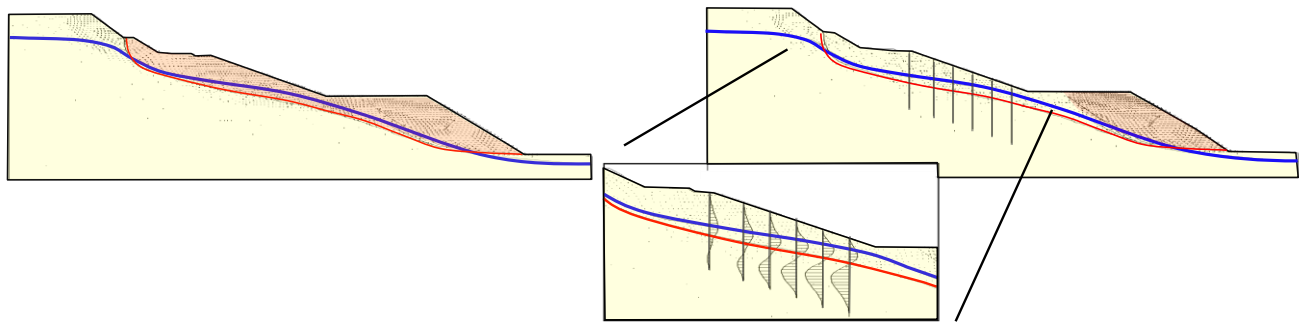
The construction of the toe buttress and the trimming of the upslope area of the landslide, lead to sufficient factors of safety ( $FOS=1.6$ ) under normal conditions (low water table, static conditions), which though drop to low values with an elevated water table and very low values under seismic conditions. It was also observed that these low factors of safety are associated with mobilization of the entire sliding mass. The dowelling effect of the bored piles isolates and stabilizes the upper part of the sliding mass, while the lower part may remain more critical but still with sufficient  $FoS$ . Figure 17 depicts the critical sliding mode with and without the dowelling piles. In this case the raised water table yield a  $FOS = 1.6$  and the seismic analysis a  $FOS=1.15$ .

*Figure 17. Stability analysis of the remediated slope. Left: Without the stabilization piles the entire sliding mass mobilizes as a single body. Right: With the addition of the piles the toe buttress is more critical.*

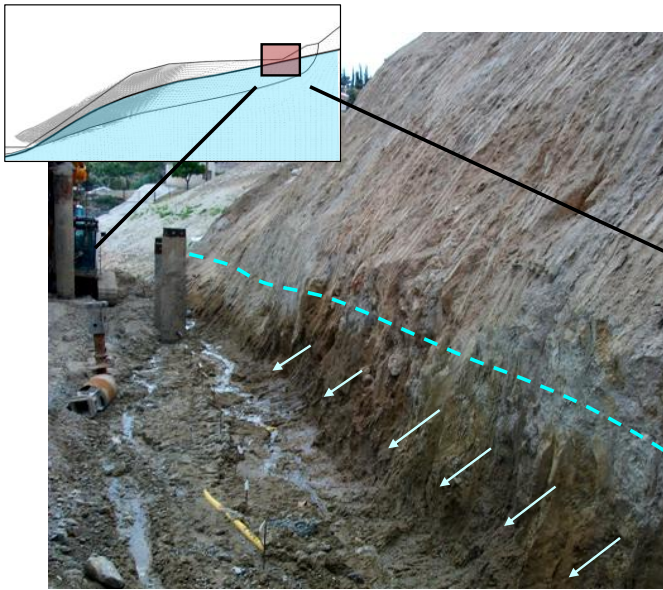
Figure 20. Water seeping out of the marl at the landslide back scarp

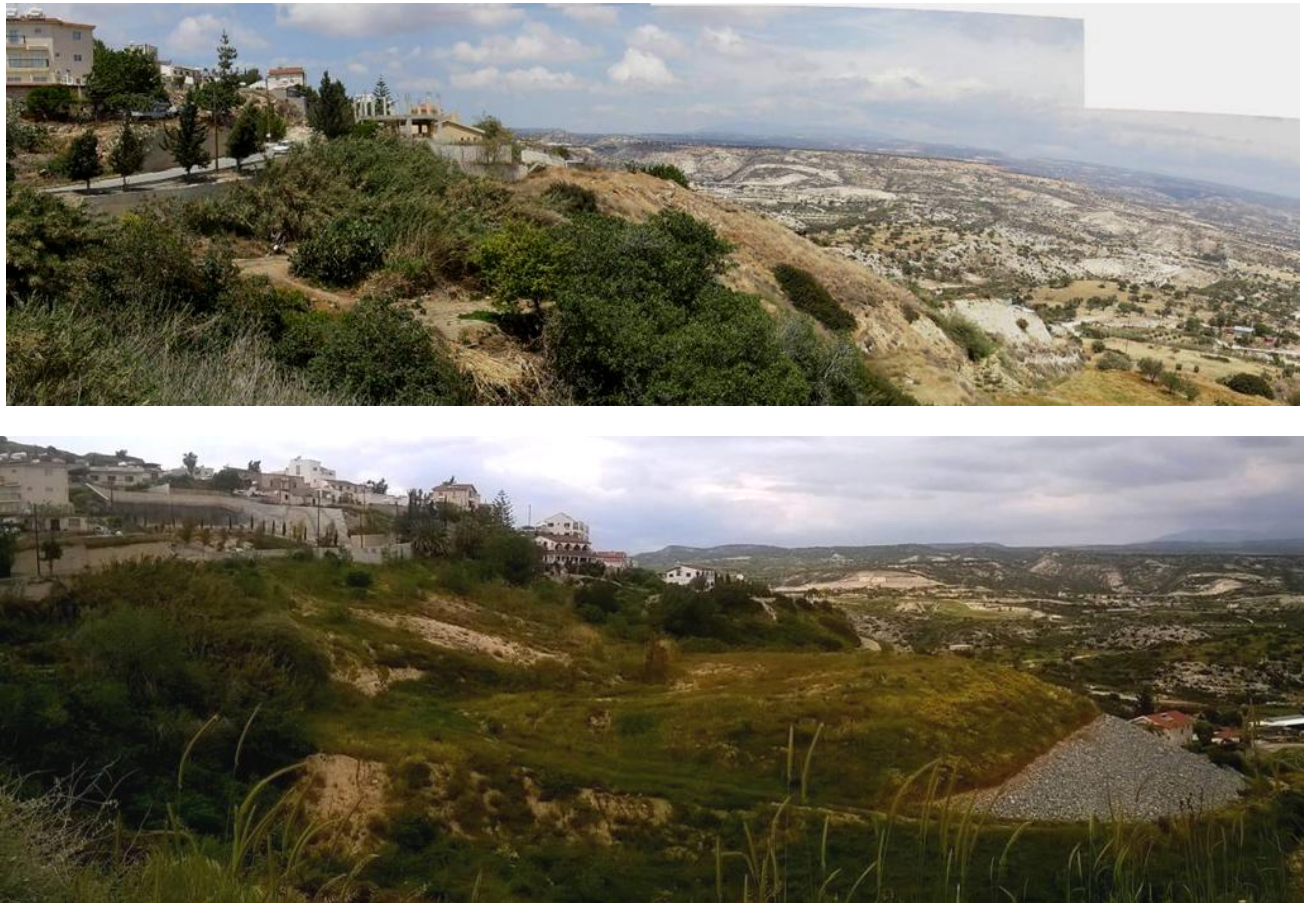
*Figure 23. The landslide area before (top) and after (bottom) the stabilization works.*
