A Large Scale Landslide in a Coal Mine in Marly Formations: Evaluation, Analysis and Rehabilitation

ABSTRACT: This paper describes a large scale landslide in a coal mine in Servia area in Kozani, Greece, which occurred in February 2011. The landslide, of ~250m width and ~350m length, took place in marly lacustrine sediments. The main factors for the manifestation of the landslide were a temporary interruption of works, the existence of a specific weak surface, the clayey nature and the sensitivity of marl to environmental agents, the action of water and the large slope height. Due to the magnitude and the position of the failure, a geotechnical solution was proposed that involved rearrangement of ground masses. The proposed solution led to successful rehabilitation and unimpeded continuation of the exploitation process.

Reference: Prountzopoulos, G., Fortsakis, P., Marinos, V. and Marinos, P. (2016). *A Large Scale Landslide in a Coal Mine in Marly Formations: Evaluation, Analysis and Rehabilitation*. International Journal of Geoengineering Case histories, Vol.4, Issue 1, p.29-45. doi: 10.4417/IJGCH-04-01-03

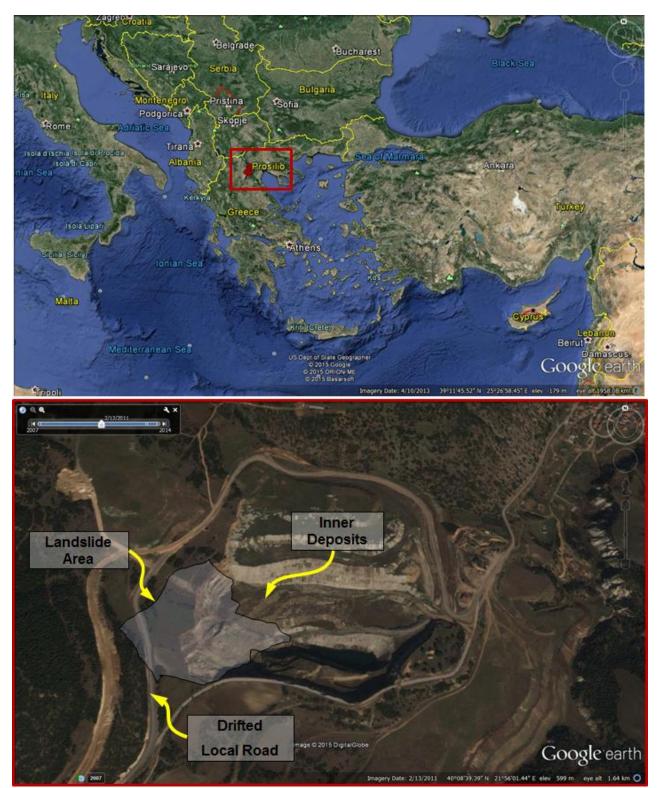
Figure 1 includes a demarcation of the position of the landslide, together with an aerial photo of the coal mine, only few days before the landslide. The landslide area, the local road affected by the landslide and the initially placed deposits for lateral retaining action to the mine slope are indicated on the satellite photo.

Figure 1. Position of landslide (up – red pin insite the red rectangle) and aerial photograph of the coal mine 2 weeks before the landslide (down). The area that was later occupied by the landslide is indicated with the transparent shape.

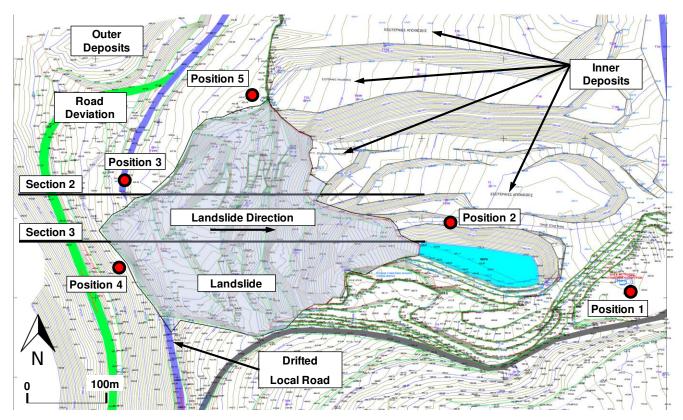
Figure 2 shows a plan view of the landslide area, with demarkation of the main features of the incident, as mentioned or referred to in the present paper. After examination of historical, geometrical and geotechnical data provided by the exploitation contractor, in-situ inspections and evaluation of the available information, it was concluded that the factors that played an important role in the initiation and triggering of sliding movement and the evolution of the landslide were:

Figure 2. Topographic mapping (plan view) of the coal mine after the landslide with demarkation of some key features

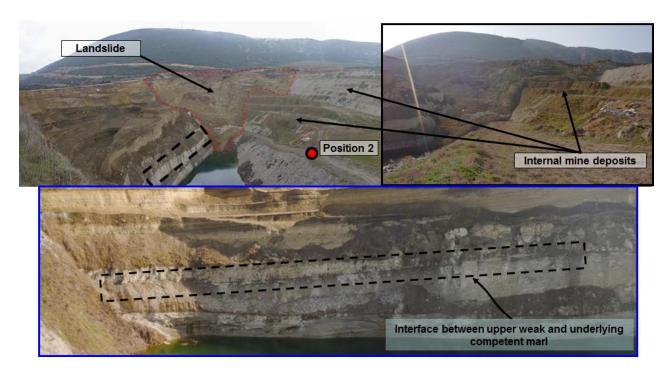
Figure 3 illustrates a general aspect of the landslide from its E and NE side (Positions 1 and 2 in Figure 2) and a view of the contact surface between the weak and the competent marl, which played a major role in the landslide manifestation. Figure 4 illustrates various aspects of the landslide and its main features.

Figure 3. Aspect of the coalmine and the landslide from Position 1 (upper left), the landslide from Position 2 (upper right) and the contact surface between the weak and the competent marl (bottom)

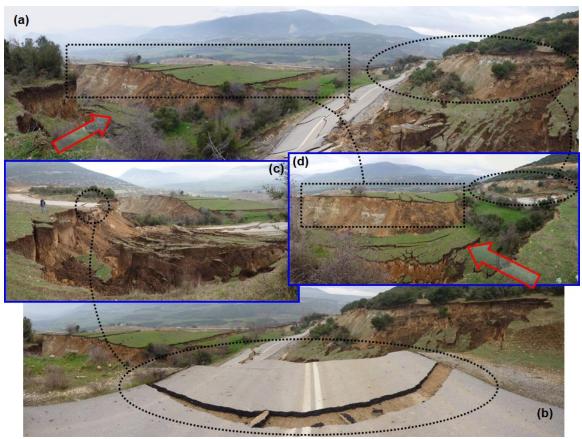
Figure 4. Aspect of the landslide from Position 3 (a & b), Position 4 (c) and Position 5 (d), the landslide crest (oval shape in a & d), the block that moved almost monolithically downstream (rectangle in a & d) and the mass that sank behind the block (arrow in a & d).

To evaluate the stability conditions of the landslide before any intervention, it was assumed that the critical failure surfaces either pass through the total failure envelope of the event, or through zones where significant shearing and relative movements were observed between "intact" parts of the marl formation, such as the zone downslope of the large scale trench that is shown in Figure 4.

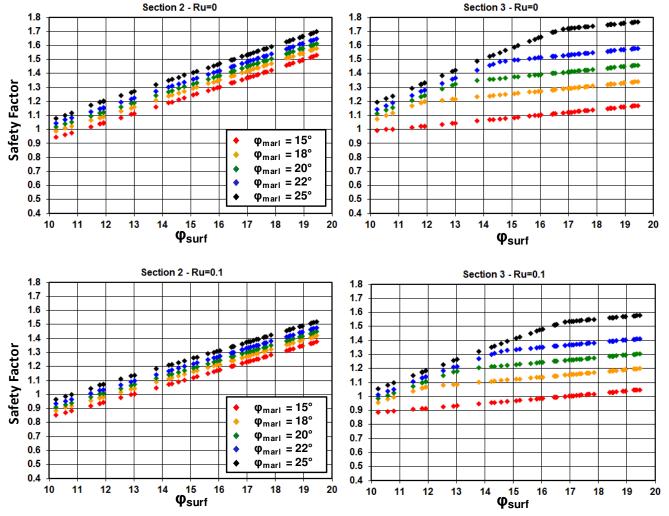
- 2. Values of the safety factor for values of pore pressure ratio R_u =0-0.1 generally lie above unity for both Sections analyzed (see Figure 6), especially for $\phi_{surf} > 13^{\circ}$ and were therefore excluded. This result was actually anticipated, since water seemed to have had a major role in the landslide triggering.

Figure 6. Variation of safety factor for different values of φ_{marl} and φ_{surf} for R_u =0.0 (up) and R_u =0.1(down), as computed for Section 2 (left) and Section 3 (right)

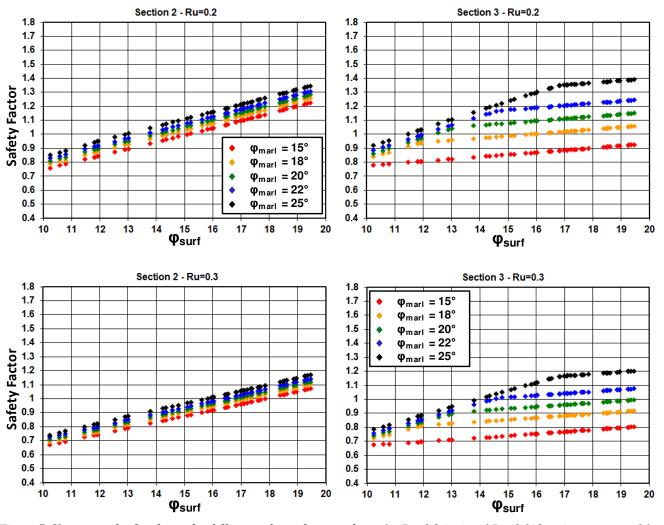
Figure 7. Variation of safety factor for different values of φ_{marl} and φ_{surf} for R_u =0.2 (up) and R_u =0.3(down), as computed for Section 2 (left) and Section 3 (right)

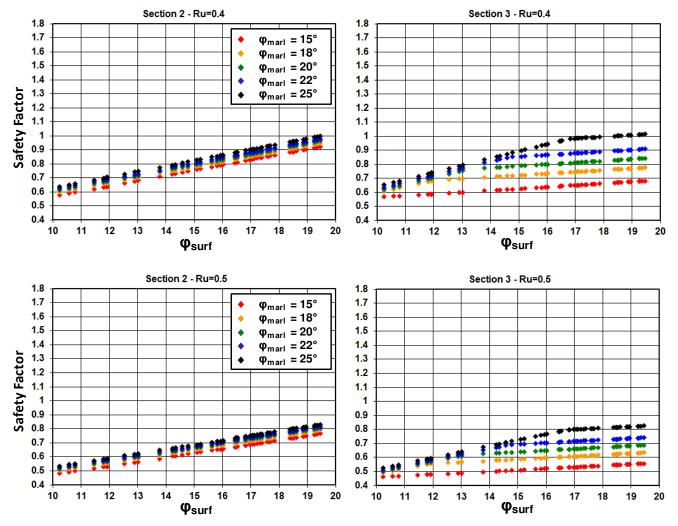
- 3. Values of the safety factor for values of the pore pressure ratio R_u =0.4-0.5 were generally well below unity for both analysis Sections (see Figure 8), especially for ϕ_{surf} <17°-18° and were not considered likely. Values of the safety factor for ϕ_{surf} >18°, given the nature of the specific surface and the fact that are assumed to refer to residual strength, were not considered reasonable.

Figure 8. Variation of safety factor for different values of φ_{marl} and φ_{surf} for R_u =0.4 (up) and R_u =0.5(down), as computed for Section 2 (left) and Section 3 (right)

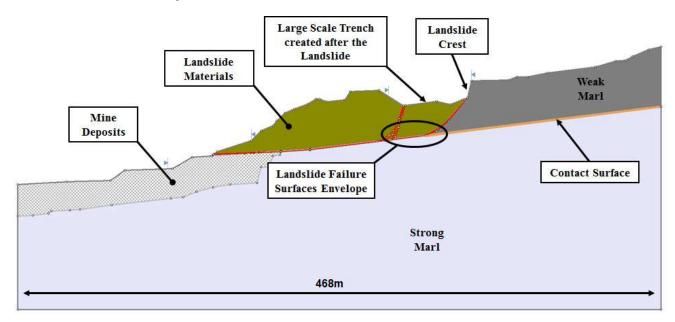
Figure 9. Analysis Section 2 after the landslide

The relevant analyses yielded results of the safety factor between 1.06 and 1.11, which were considered marginal, given the possible further deterioration of the shear strength of the materials involved in the slides, due to ongoing movements, especially during the rainy season in the area. Specifically, analyses of Section 2 resulted in a minimum value of the safety factor equal to 1.11, whereas the corresponding minimum value from Section 3 was 1.06. Analyses with free selection of surfaces by the software were not performed, as these would yield unrealistically low values of the safety factor (considerably <1), under the assumption that the total mass included in the landslide envelope had been downgraded to its residual strength (zero cohesion and low friction), which was not the case due to monolithic, undisturbed blocks existing within the slid mass. The fact that the resulting safety factor values were rational, i.e. marginally larger than unity, indicating a temporarily stable situation after a main landslide event, enhanced our confidence in the assumptions that were made.

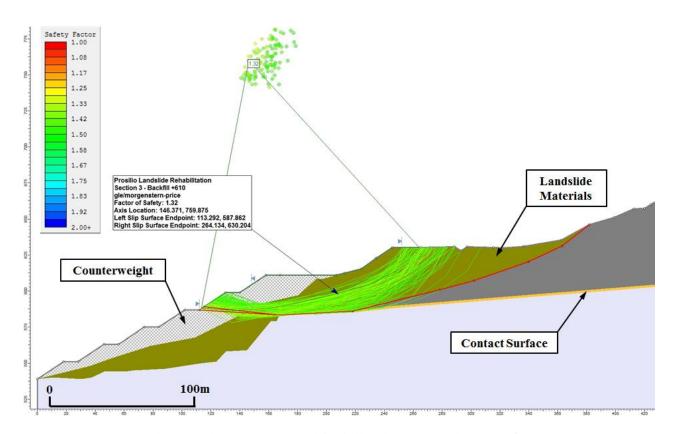
Figure 11. Analysis Results for Section 3 with backfill at the toe up to elevation +610 (F.S. = 1.32)

- 1. Placement of non commercial deposits at the toe of the landslide up to an elevation approximately 25 m above the contact surface between the upper weak and the undelying competent marl (~+610 m absolute evelation), significantly increased the safety factor. Specifically, considering the envelope of the landslide or surfaces along obvious large scale movements within the total landslide mass as potential failure surfaces, the computed values of the safety factor ranged between 1.52 and 1.63. Assuming that any failure surface within the total landslide envelope was possible (a quite conservative approach, since residual shear strength parameters were assigned in the analysis model) the safety factor ranged between 1.32 and 1.56. These values, even with the second, conservative approach, were considered adequate.

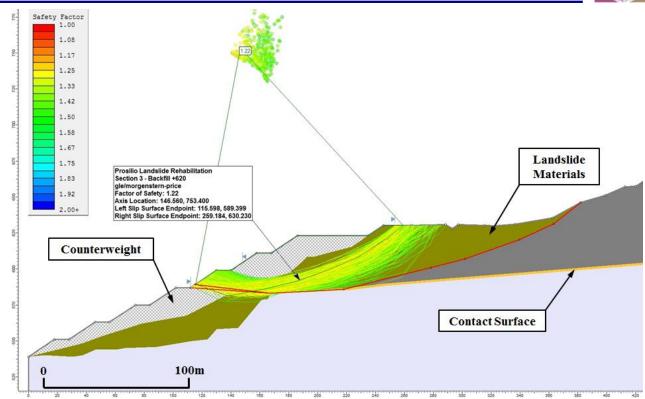
Figure 12. Analysis Results for Section 3 with backfill at the toe up to elevation +620 (F.S. = 1.22)

- 2. Placement of non commercial deposits at the toe of the landslide up to an elevation approximately 35 m above the contact surface between the upper weak and the undelying competent marl (~+620 m absolute evelation), did not significantly differentiate the safety factor. Specifically, considering the envelope of the landslide or surfaces along obvious large scale movements within the total landslide mass as potential failure surfaces, the computed values of the safety factor ranged between 1.56 and 1.70. Assuming that any failure surface within the total landslide envelope was possible, the safety factor ranged between 1.22 and 1.57. Therefore, it was shown that the additional placement up to the specific level was only to facilitate the landslide removal and exploitation procedures and was not necessary for the stabilization of the landslide. In fact, locally, due to the existing geometry and morphology of the landslide, this additional placement could somehow reduce the available safety factor, as part of the deposits would actually increase the sliding moment for certain potential failure surfaces (pose additional loading to the landslide see Figure 12 above).

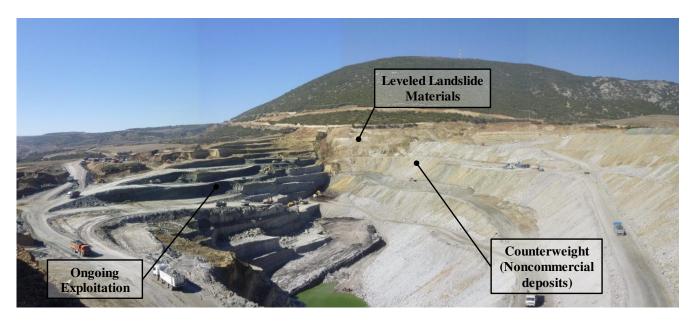
Figure 13. Aspect of the coal mine area after completion of counterweight construction and leveling works (March 2012).

The proposed rehabilitation scheme was successfully applied in order to stabilize the landslide before any intervention to its mass. The operation of the coal mine has continued without significant instability incidents ever since. The following figures show an aerial photo of the coal mine area and an aspect of the same from within the mine area, after completion of landslide counterweight construction and leveling of the landslide materials.

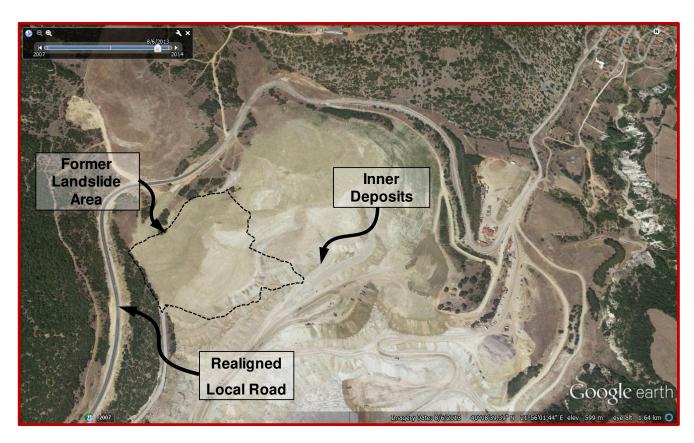
Figure 14. Aerial photo of the coal mine area after completion of counterweight construction and leveling works.
