## A High Rock Cut Stabilization in Muscat City, Oman

**ABSTRACT:** A large road box cut was constructed in hilly terrain of Muscat city, Oman, in an area underlain by the geologically complex Sahtan and Mahil formations comprising of limestone, dolomite, sandstone and siltstone with interbedded soft calcareous mudstone. The rockmass contains a large number of small scale faults, shear zones, minor folds and solution cavities. The maximum height of the cut was 50 m with slope angle of 1V:0.25H, and intermediate benches generally 3 m wide. To control vibrations in the urban neighborhood located nearby and avoid damage to the rockmass, a very cautious and time consuming excavation approach was adopted using rock breakers. The excavation work was completed in 2010. Oman has a hyper-arid environment with scarce rainfall for many months. However, occasionally the area is hit by intense rainstorms. During Cyclone Phet and accompanying rains in June 2010, part of the cut slope failed with a downslope movement of about 800 m<sup>3</sup> of massive rock. This necessitated a post-excavation re-evaluation of the cut slope, which culminated in design modifications, and construction of long te

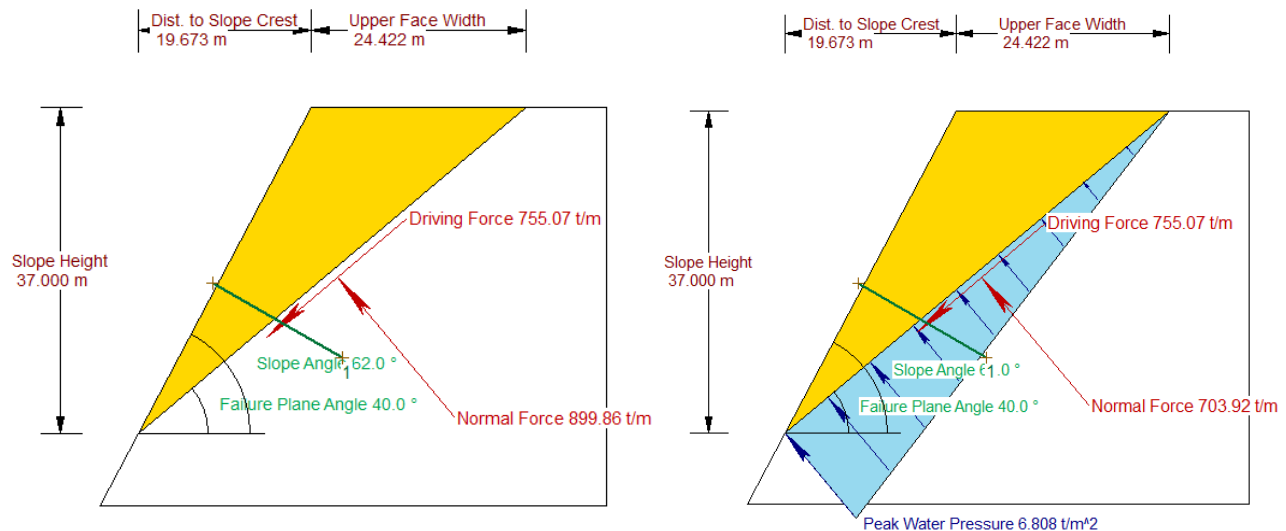
*Figure 9. The driving and resisting forces against the calculated FOS 1.12 and 1.01 for dry and wet slope (15 m water head) respectively.*

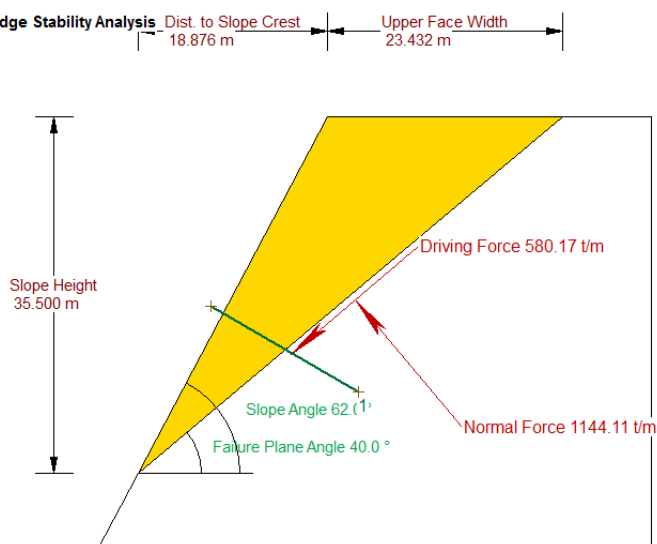
Figure 11. Factor of Safety (FOS) in dry condition with 3360 KN/m external force applied through designed cable anchors.

After several trials using different applied normal stresses on the failure plane, seven strand anchors of 1200 KN working load at 2.5 x 2.5 m grid (3400 KN/m) for a 35 m high slope were selected. The results of factor of safety using the 1200 KN anchors on the deep sliding planes are presented in Figures 11 to 14 and are summarized in Table 3.

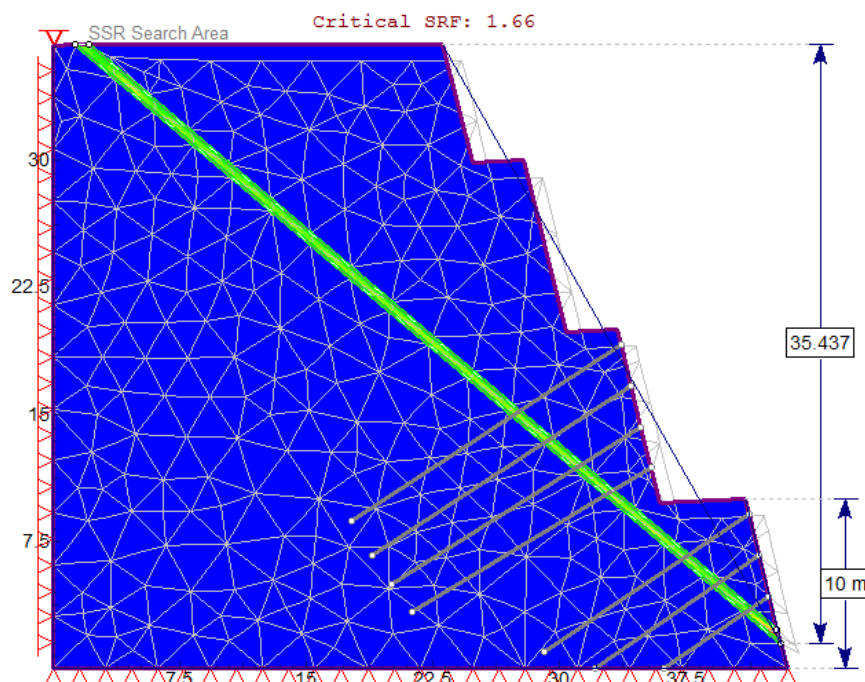
Figure 13. Deformed Mesh for the SRF =1.72 (in dry conditions) for which no FEA convergence occurred. The critical SRF for which the FEA satisfied the condition of equilibrium with 7 strand anchors of 1200 KN (2.5 x 2.5 m grid) is 1.66 as shown.

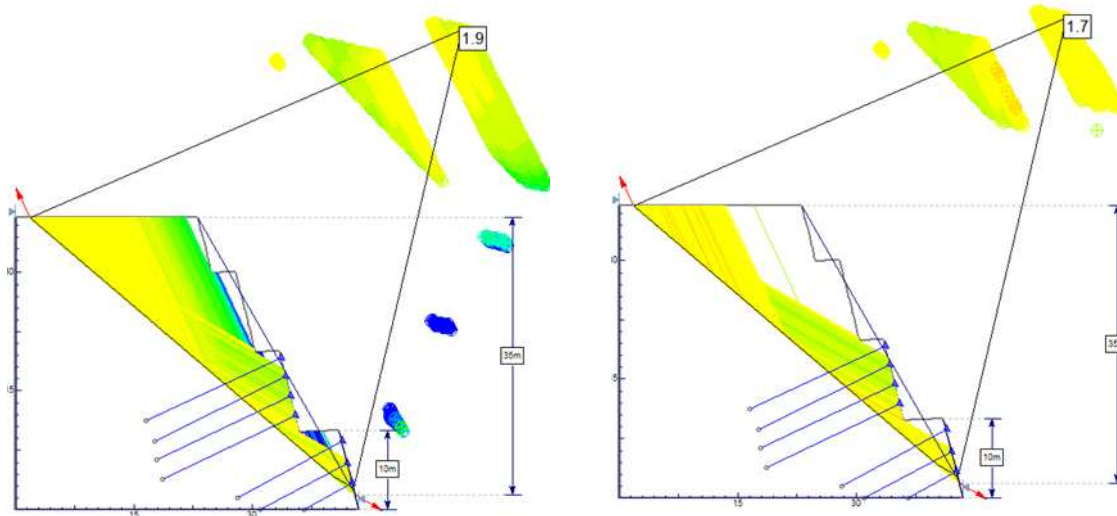
Figure 14. FOS with 7 x 1200 KN anchors in dry condition using Bishop (left) and Morgenstern-Price (right) methods.

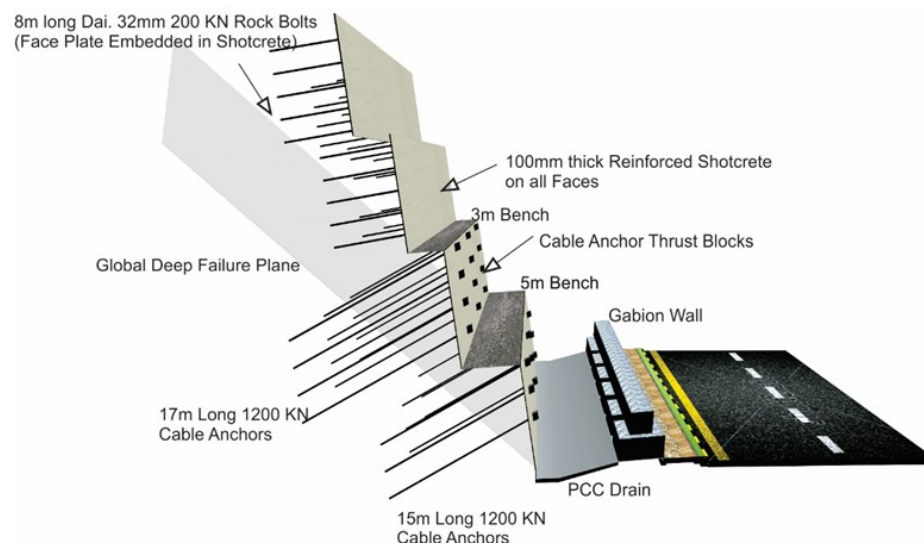
Figure 15. 3D Conceptual arrangement of reinforcing elements at both the 20 m terminus of 500 m long left slope of Box Cut #1.

It was therefore concluded that the ends of box cut #1 were most vulnerable as at these locations large and deep seated failures were kinematically possible, whereas in the middle of these slopes, only shallower failures would be possible, the unstable wedges being confined at both ends. It was therefore decided to reinforce only the terminus of the 500 m long vulnerable slope with 1200 KN cable anchors. Other intermediate and cut faces above the cable anchored slopes were, however, reinforced with 200 KN rock bolts to control the comparatively smaller scale failures. The rock bolt heads were tensioned on steel plates resting on epoxy cement base. For long term durability, the steel plates were embedded in the shotcrete. The anchor heads of high capacity cable anchors were installed on specially constructed reinforced concrete anchor blocks. A typical arrangement of the reinforcement pattern at cut slope ends is shown in Figure 15.

The arrangement of stabilization measures shown in Fig. 15 were implemented and are performing satisfactorily for the last six years.
