Uplift of an Underground Tank in Northern Malabar Region, India

ABSTRACT: An underground reinforced concrete tank was constructed for a project in the southwest region of India. The tank was 90 m x 35 m in plan and 7.3 m deep resting on partly filled-up and partly native soil. During the peak monsoon, a sudden uplifting of the base slab by about 300 mm and subsequent failure of the foundation raft and a partition wall was observed. Laboratory testing was executed and hydrogeological survey was carried out using ground penetrating radar, seismic refraction and infiltrometer testing, and an analytical study was carried out to identify the root cause of the tank uplifting. Based on this study, it was observed that the uplifting and structural failure was essentially due to the peculiar land terrain and soil properties and the development of excess hydraulic head below the bottom of the tank. After considering different options, the rectification measures were carried out by provision of dewatering wells along the tank periphery to release the excess hydrostatic pressure and stabilize the foundation raft. The structural repair of the top of the foundation raft and partition wall was c

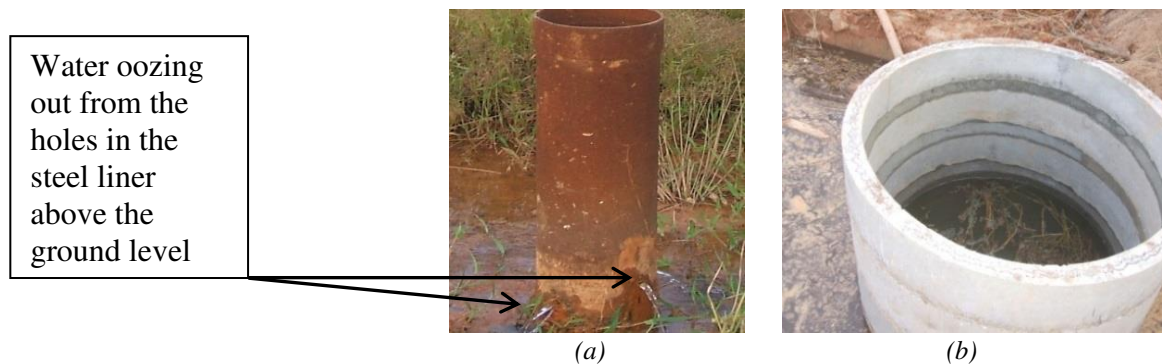
Figure 3. Groundwater level in (a) borehole with steel liner and (b) ring well

In the meantime, when the tank filling was ongoing and the rainfall intensity reduced, the boreholes with steel liner were drilled along the tank periphery and a 1.2 m diameter and 4 m deep ring well was also dug near the tank. The groundwater was observed to be coming out from the perforations in steel liner above the ground level due to high hydraulic head (Fig. 3a). The water level in an open well was also observed to be at the ground level (Fig. 3b).

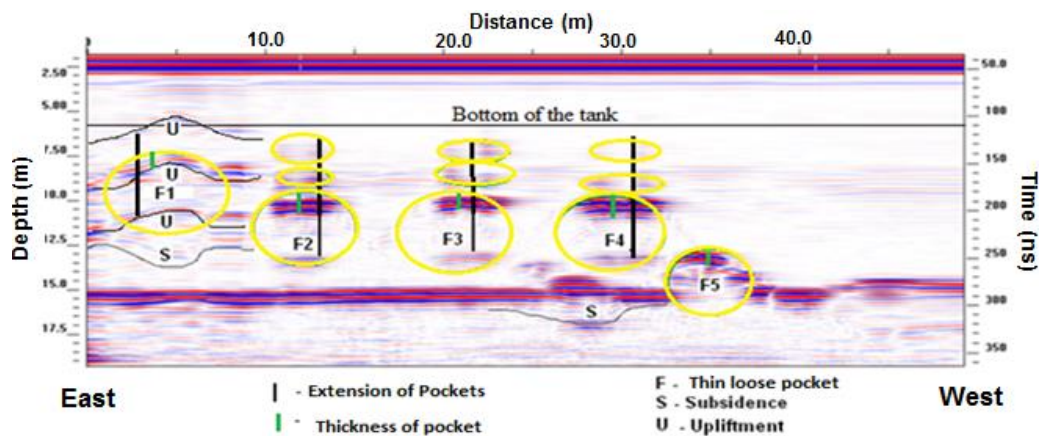
A phase inversion occurred at the concrete and void interface as indicated by a negative amplitude preceding a positive amplitude (see Fig. 8, 9 and 10). The amplitude of the GPR data is represented by red, blue and white colors. Red coloured areas represent a positive reflection and blue coloured areas represent a negative reflection while white areas represent distinct reflected areas, typically indicative of a dielectric uniformity within a given medium.

Loose pockets in the substrata were observed along the East-West direction beneath the tank bottom. The horizontal length of loose pockets below the bottom of the tank (F1 to F5) are observed to be varying between 0.5 m to 5.5 m at different locations. (see Fig. 7). The vertical thicknesses of the loose pockets are approximately 0.5 m each.

Figure 7. GPR3 profile collected using a 200 MHZ antenna inside the tank along East - West direction by placing antenna inside the floating body.

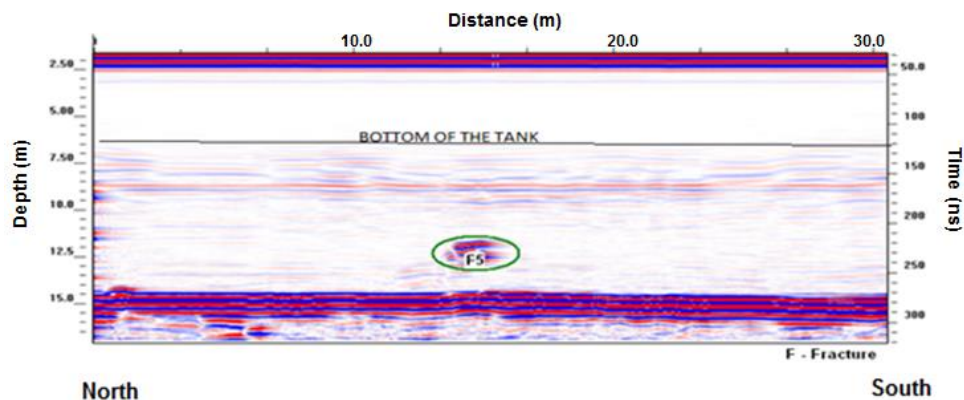
Fracture F5 is visible at the depth of 12.5 m in the profile along North-South direction (shown in Fig. 9). High amplitude reflections at 7.5 m depth are interpreted as rock formations and very high amplitude thick reflections encountered at depth of 14.5 m are interpreted as hard bedrock.

Figure 9. GPR4 profile collected using a 200 MHZ antenna inside the tank along North - South direction by placing antenna inside the floating body.

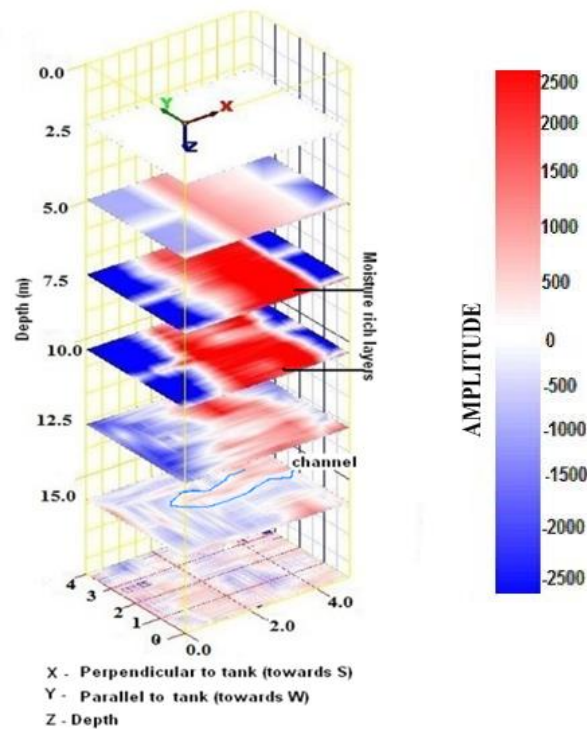
3D data near the tank clearly indicates the clay rich strata at the depth of 2.5 m below ground level and the moisture is more concentrated at the depth of 7.5 m to 10 m from ground level (see Fig. 10). This visualization assisted in confirming the presence of water channels between the well and the tank.

Figure 10. 3D view of the grid from GPR2 near the tank, data collected with 2 m interval at X axis and 1 m interval at Y axis. X is the direction perpendicular to the tank; Y is direction parallel to the tank and Z is the depth of penetration of the GPR2 antenna, i.e., 20 m.
