# Post-2017 Hurricane Season Assessment of Civil Infrastructure Impacts on Beach and Near-Beach Environments

**ABSTRACT:** *This paper presents an overview of observations and preliminary measurements of coastal infrastructure in the aftermath of Hurricanes Harvey and Irma in 2017. Two teams mobilized by the Geotechnical Extreme Events Reconnaissance (GEER) Association were sent to document perishable data along the Texas coastline (Port Aransas, Holiday Beach, East Matagorda Peninsula, and Follets Island) and Florida Keys (Simonton Beach, Sombrero Beach, and Coco Plum Beach). Significant damage from sediment overwash and road undercutting was observed at beach access paths and roads that transect dune fields. It was also observed that beach access points weaken the line of coastal defense provided by dunes, vegetation, and structures. The lessons learned from these field reconnaissance missions indicate that longshore non-uniformity in the dune system should be well-documented. Measurements of the geometry of beach access pathways and dunes, including the height, width, length, and vegetation coverage, should be collected prior to recovery of the system post-storm.*

Reference: S

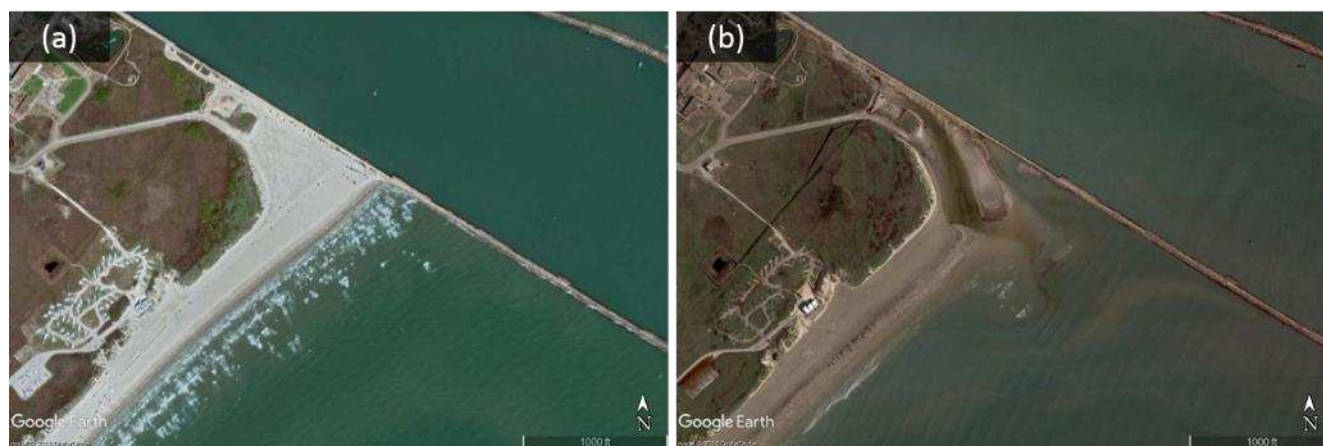
Southwest of the jetties that protect Port Aransas Pass, several paths transect the dune system to provide beach access to Port Aransas. The closest of these beach access points at the end of East Cotter Avenue experienced severe undercutting and paralleled a newly-formed eroded runnel that extended from the road, around a large dune, to the beach (Figure 3). This breach was observed to start at a small culvert under East Cotter Avenue, extend northwest toward the jetty, follow the jetty for approximately 120 m (394 ft), then turn southwest toward the GoM. At the beginning of the breach, a maximum undercut depth of 0.4 m (1.2 ft) was measured on the west side of East Cotter Avenue (Figure 4). The toe of the large dunes between the jetty and East Cotter Avenue and at the end of the beach access road were severely eroded (Figure 5). A scarp measuring approximately 0.9 m (3 ft) was observed and a thick wrack line of debris was deposited at the toe of the scarped dune. This location, along with several other beach access points in Port Aransas, provides evidence that these transects through the dune system provide a pathway for flow channelization, resulting in increased erosion.

Figure 3. (a) Pre-storm satellite imagery (imagery date February 22, 2017) and (b) post-storm satellite imagery (imagery date August 29, 2017) show the eroded runnel created during Hurricane Harvey near Port Aransas Pass (location  $27^{\circ}50'6.39''\text{N}$ ,  $97^{\circ}2'50.56''\text{W}$ ). Map data: Google Earth, Digital Globe.

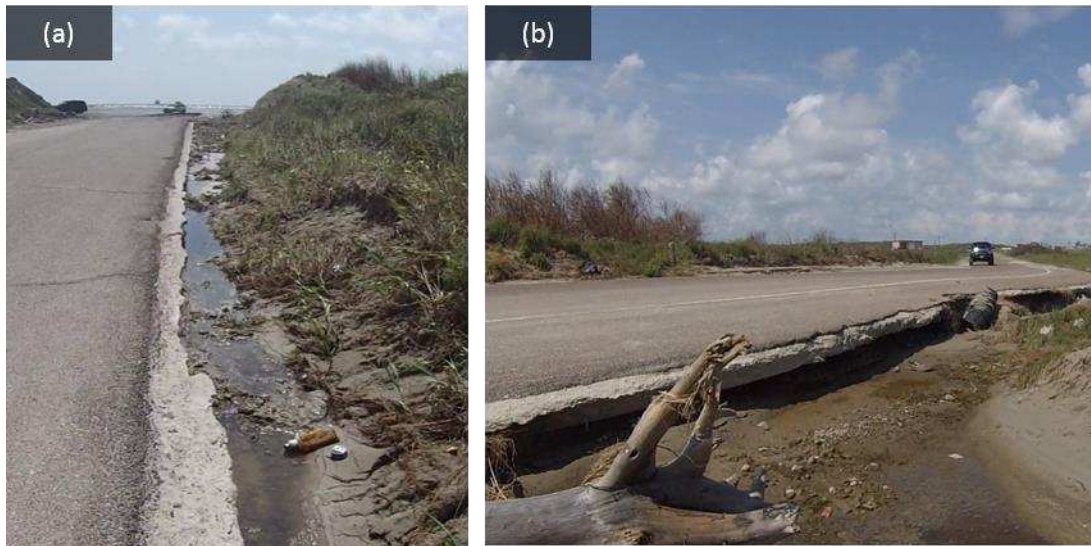
*Figure 4. (a) Road undermining due to erosion and scour was observed on both sides of East Cotter Avenue, and (b) a 0.4 m undercut was measured at the beginning of a newly formed breach (collected September 3, 2017; location 27°50'8.53"N, 97°2'55.00"W).*

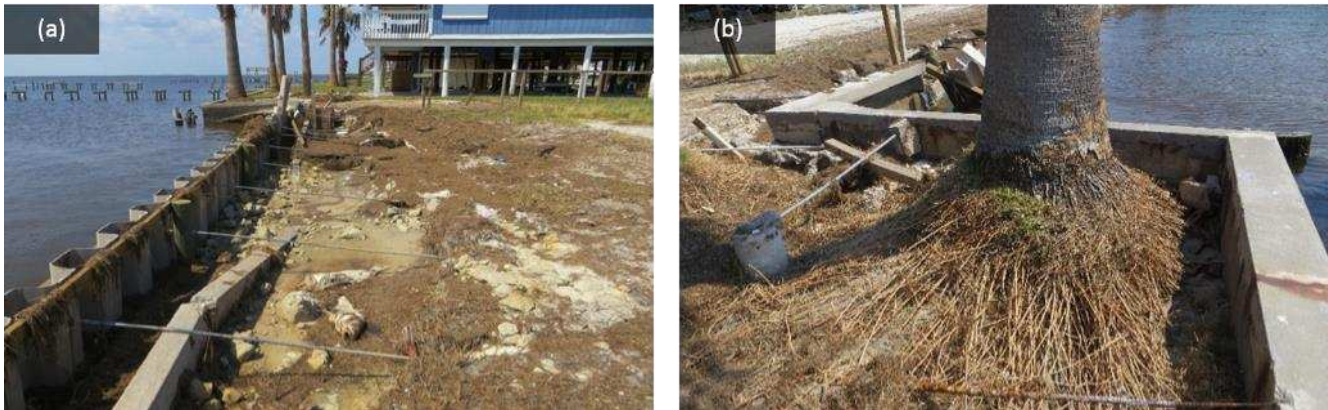
During the reconnaissance survey, houses in Holiday Beach were found heavily damaged by wind and bay surge, particularly those located on the bayfront street that parallels the canals. Anchored bulkhead retaining walls constructed along the bayfront property line were overtopped during Hurricane Harvey and severely eroded on their backsides, exposing supporting steel rods (Figure 6a). Scouring around trees and other fixed obstacles was also observed (Figure 6b). Although Holiday Beach is located on Copano Bay and is not subject to GoM wave action, the damage due to hydrodynamic forces in this region was extensive. Observations show the bulkhead was overtopped during Hurricane Harvey, leaving fish and other debris on land. As the water levels retreated, sediment appeared to be transported from the backside of the bulkhead and around the base of fixed objects, leaving these structures damaged and in need of repair. The condition of the bulkheads and service life

maintenance prior to Hurricane Harvey remain unknown, and it is unclear if it affected the damage observed during the survey.

*Figure 6. (a) Supporting steel rods were exposed after storm surge retreat scoured the backside of a bulkhead, and (b) scour was also observed around other fixed objects (collected September 3, 2017; location 28°10'11.24"N, 97°1'2.03"W).*

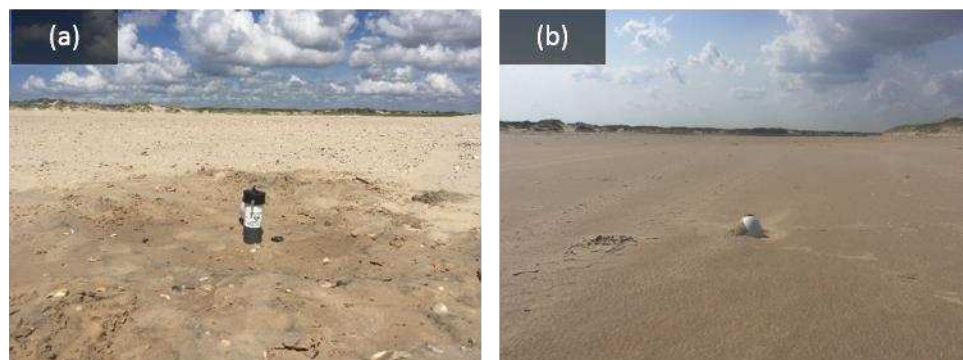
The infilled storm cut through East Matagorda Peninsula hydraulically connects GoM and bay surface waters only during elevated storm water levels. During Hurricane Harvey, the maximum water surface elevation at the backshore (GoM side of the cut) was 1.8 m above Mean Sea Level (MSL) and 1.0 m above MSL at the back-barrier location (bay side of the cut) as measured by rapid response field measurement units containing pressure transducers. The dunes at this site were not overtopped. Surface hydraulic connection through the cut lasted for approximately six hours. During this time, up to 0.50 m (1.6 ft) of GoM sediment was deposited in the backshore (back-barrier) region of the cut as a result of onshore-directed transport of sediment eroded from the shoreface by hurricane wave action. Figure 7 shows before and after photos of the backshore area on the GoM side of the cut, clearly indicating the accretion that occurred at this location. The cut serves as a roadway to access the back-barrier areas and is an example of what can happen to shore-perpendicular gaps in the dune line during hurricane impact.

*Figure 7. (a) Pre-storm (collected August 23, 2017) and (b) post-storm observations (collected August 30, 2017) of the backshore area fronting the East Matagorda cut where 0.5 m of sediment accretion was observed (location 28°36'43.57"N, 95°56'24.88"W).*

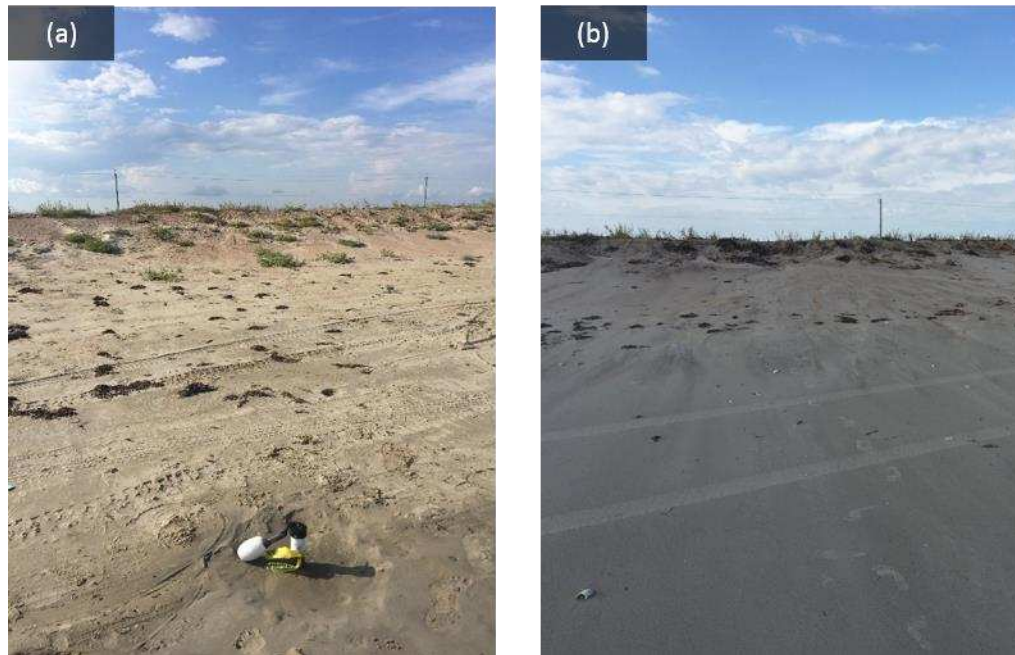
The recently nourished, relatively longshore uniform beach on Follets Island experienced dune collision and re-grading of the beach profile by storm surge and waves, but was not overtopped or severely overwashed as observed in other study locations discussed herein (Figure 8). Significant erosion of the dune line was observed due to heavy rainfall. A shore-parallel ridge-runnel system was observed in the foreshore (Figure 9a). At the beach access point from Bluewater Highway, sediment

Figure 8. (a) Pre-storm (collected August 24, 2017) and (b) post-storm observations (collected August 31, 2017) of the dune show regrading of the beach profile and washout from heavy rainfall on the dune peak (location  $29^{\circ}1'27.93''\text{N}$ ,  $95^{\circ}11'24.93''\text{W}$ ).

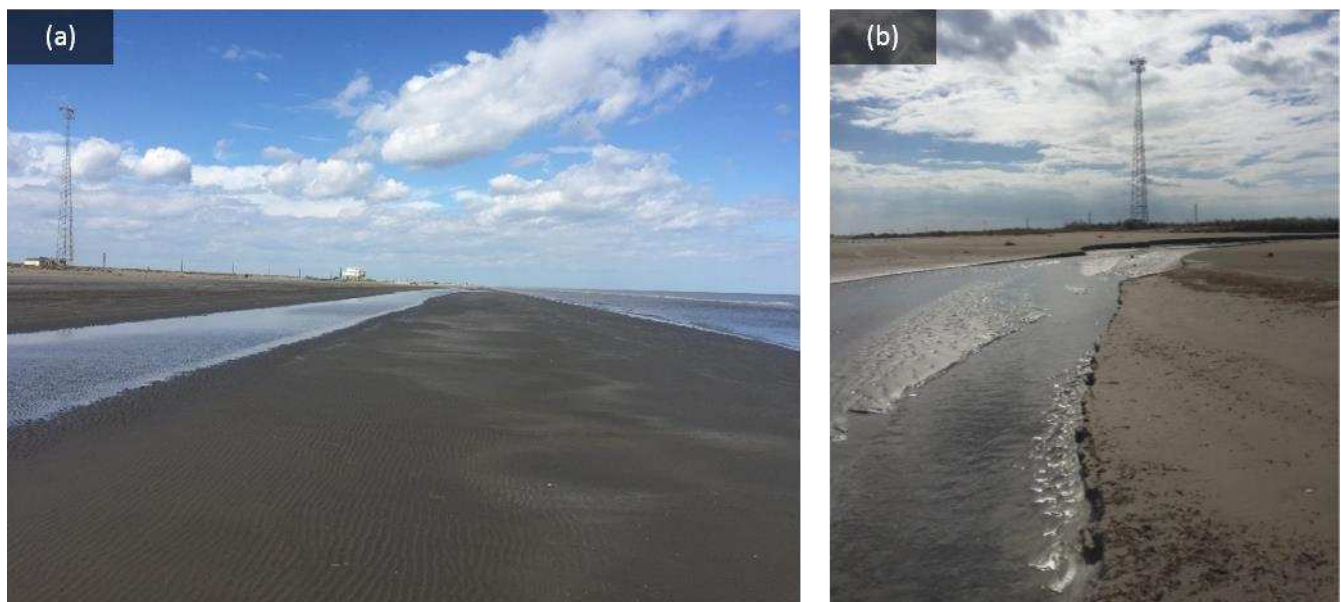
deposits were observed on the road (257R) and a channel was formed connecting the flooded backbarrier region to the beach along the eastern and western flanks of the dunes (Figure 9b). This study location on Follets Island shows the protection afforded by dunes against storm flooding, but it also demonstrates damaging erosion along the sides of roadways. It also highlights that beach access points can serve as a funnel as rainwater and storm surge retreat, allowing the channelization of sediment transport.

Figure 9. (a) A ridge-runnel system formed parallel to the shore, and (b) a channel was eroded from the beach access point to the GoM (location  $29^{\circ}1'27.93''\text{N}$ ,  $95^{\circ}11'24.93''\text{W}$ ).

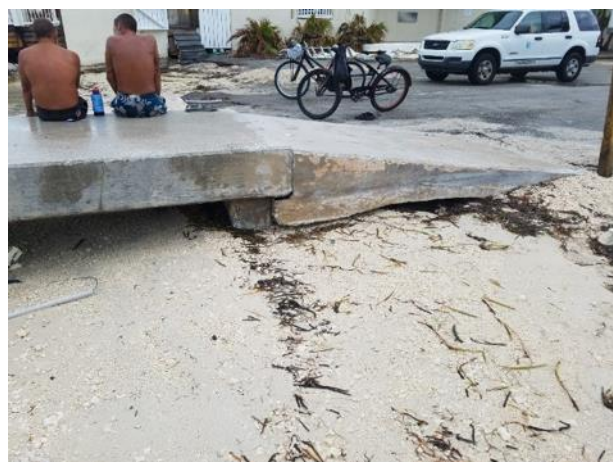
Figure 11. A concrete structure located on the eastern edge of Simonton Beach was undermined due to scour around the structure (collected September 27, 2017; location  $24^{\circ}33'43.32''\text{N}$ ,  $81^{\circ}48'20.22''\text{W}$ ).

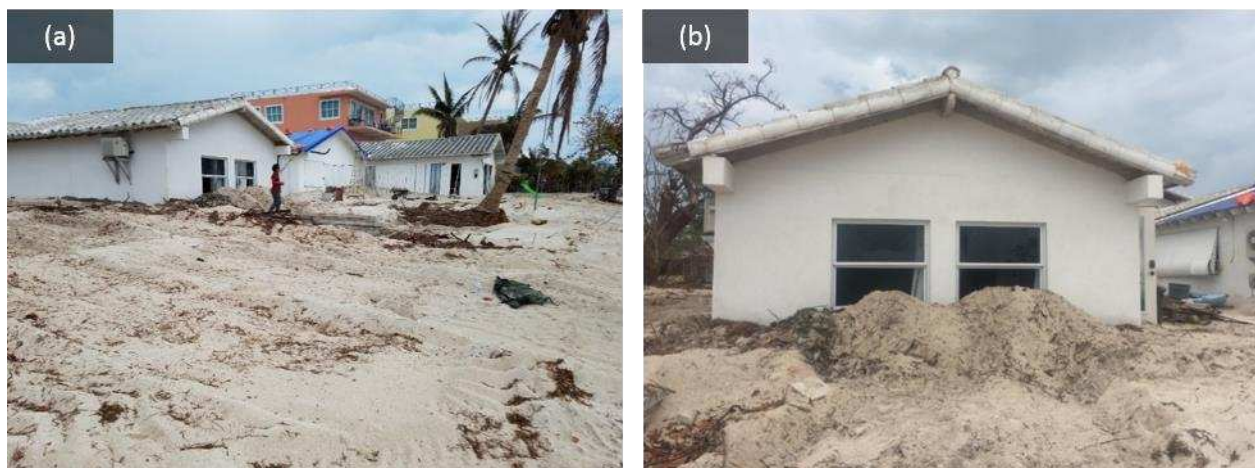
Figure 13. (a) Large volumes of sediment were deposited around houses and other structures and (b) buried them with approximately 1 m of sand, reaching the bottom of window sills (collected September 26, 2017; location  $24^{\circ}41'31.52''\text{N}$ ,  $81^{\circ}4'56.31''\text{W}$ ).

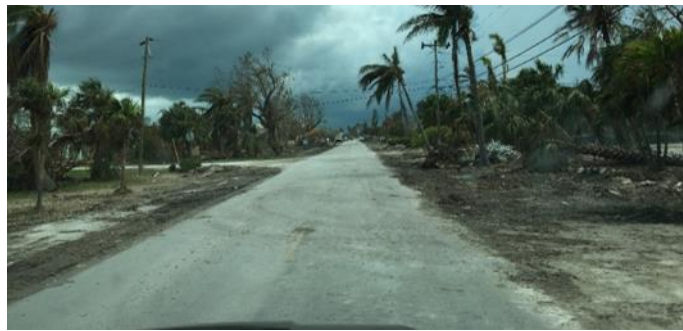
On Coco Plum Drive, evidence of wind and inundation by storm surge was observed from the debris deposited onto the roadway (Figure 17). At Coco Plum Beach Park, large volumes of sediment were transported from the beach, narrowing its

*Figure 17. Sand and debris were deposited on Coco Plum Drive (collected September 26, 2017; location 24°43'34.52"N, 81°0'36.53"W).*
