Bridge Abutment Remediation – A Case Study

Reference: Sundaram, M., Sugawara, J. and Sivakumar, S. (2022). Bridge Abutment Remediation – A Case Study. International Journal of Geoengineering Case Histories, Volume 7, Issue 4, pp. 1-7, doi: 10.4417/IJGCH-07-04-01

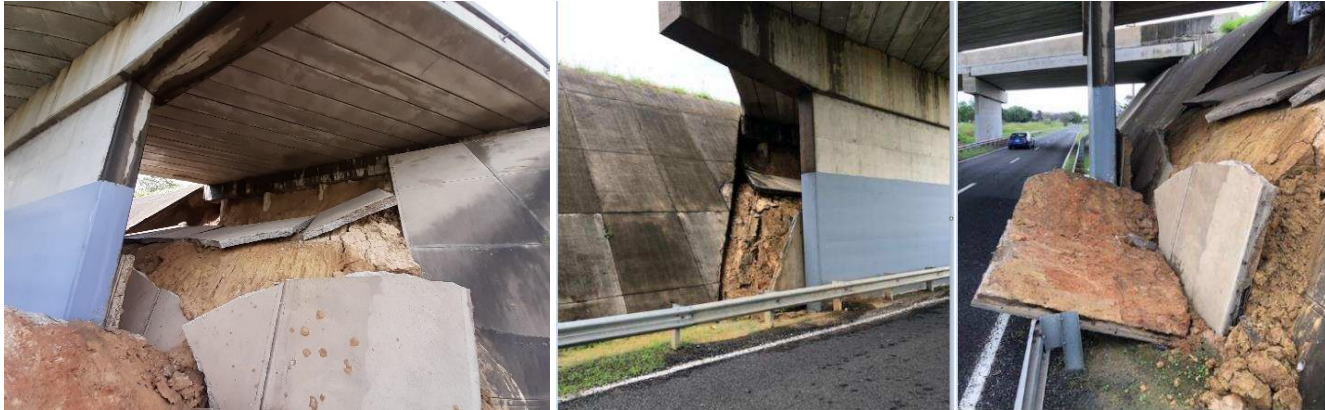
Figure 2. Abutment condition after failure.

In November 2021, after a downpour, fill material from the crest of the abutment started to move, causing the concrete panels to slip and buckle, and to eventually topple onto the pier below and the guard rails. About 50 cubic meters of material failed from the abutment (Figure 2). However, the bridge pier prevented further movement of the fill material, containing it within the toe of the slope.

A total of 112 millimeters of rainfall was experienced in the month prior to the failure, which was almost double the mean annual rainfall. An additional 30 millimeters fell on the day of failure. The failed material was saturated and fluidized near

the surface. A seepage line was identified two meters below the headstock and was visible to about six meters from edge of the abutment. It is likely that water infiltration from pavement edges may have saturated the abutment fill behind the panels. Therefore, the main cause of the failure is thought to be excessive pore water pressure buildup behind the panels, perched water within the embankment, blockage of weepholes, and softening of the fill material from infiltrated stormwater.

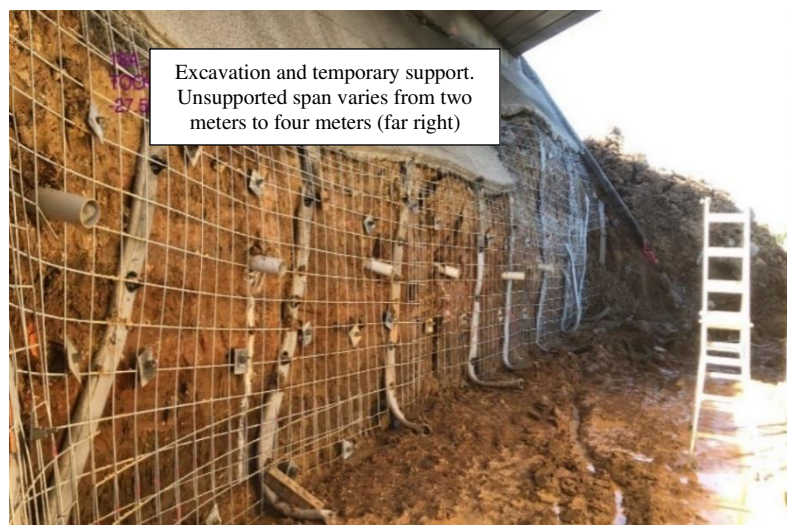
The excavation, anchor installation, and shotcrete application progressed well for the first three rows of anchors, after which, the contractor inadvertently excavated to full depth not following the support sequences specified in the design drawings. This resulted in the exposure of the slope face between 2-4 meters high without full protection. Consequently, approximately, 0.5 meter thick soil movement occurred behind the highest exposed face (Figure 6) with displacement of 250 millimeters in shotcrete below the headstock. On the same day, 13 millimeters of rainfall exacerbated the movement. Additional rows of anchors and steel mesh were installed to stabilize the movement. As a precautionary measure, the highway speed was also reduced to 60 kilometers per hour to minimize any vibration-induced movements. Surveillance was also increased to ensure safety was not compromised. The rate of the movement reduced after the installation of additional support measures and ceased two days after shotcrete application was completed (Figure 7).

Figure 6. Excavation completed to formation level. The abutment is supported with percussion anchors and reinforced shotcrete. Note larger unsupported span on the far right.

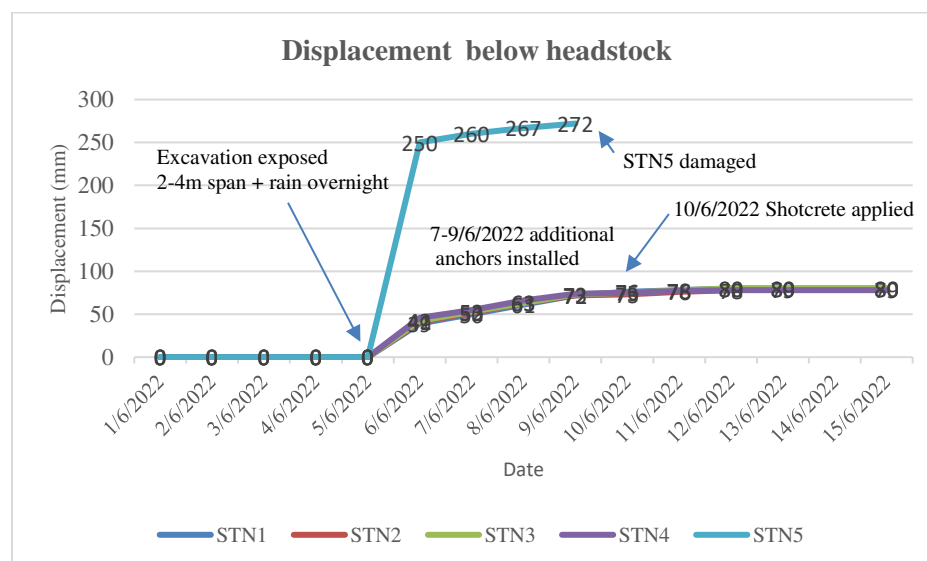
Figure 7. Displacement (mm) in shotcrete below headstock. Station 5 (STN5) located on far right. Displacement ceased two days after shotcrete application.
