Emergency Bridge Scour Countermeasure in Marin County, California, United States

ABSTRACT: *The Lucas Valley Road Bridge over Miller Creek in Marin County, California was identified as scour critical in August 2017. Within four months (just before the rainy season in California), structural, hydraulic, and monitoring countermeasures were installed at the bridge. Structural countermeasures included lowering the foundation at Pier 2. Hydraulic countermeasures included rock riprap around Piers 2 and 3 to inhibit local pier scour and a series of criss cross weirs downstream to inhibit downstream head cutting. Monitoring countermeasures included a stage gage installation to monitor water surface elevation, a sonar device installation at the upstream and downstream ends of Pier 2 to monitor local pier scour and rock riprap movement, and sensitive tilt-meters to monitor movement of the bridge to give the local agency sufficient time to close the bridge prior to potential bridge collapse. This paper will focus on the case study of why the bridge is scour critical, and describe the countermeasures proposed to protect the safety of the travelling public.*

This paper presents the results of

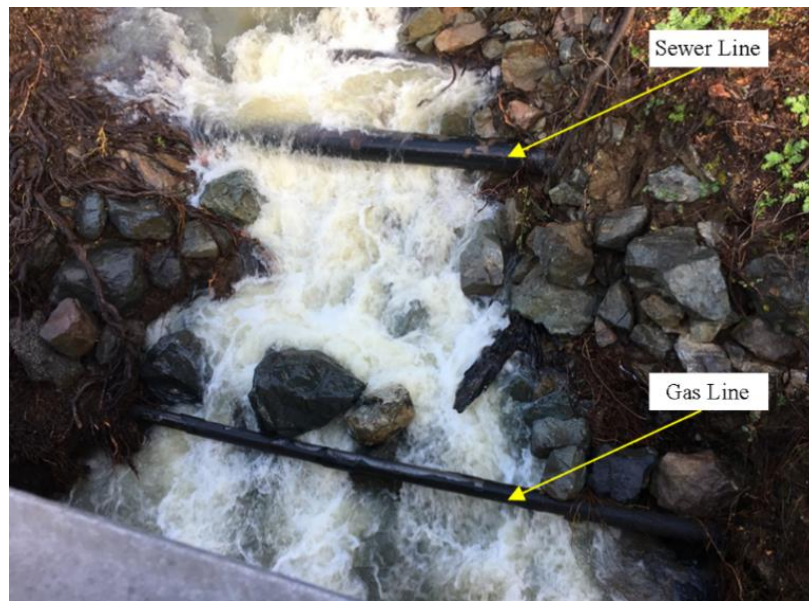
Bridges in the United States are inspected every two years. Bridges coded by the California Department of Transportation (Caltrans) with unknown foundations are required by the Federal Highway Administration (FHWA) to have a scour Plan of Action. The author first visited the bridge site under contract to the County of Marin in January 2017 with an interdisciplinary team of engineers including structural, geotechnical, and hydraulic engineers. Water was flowing rapidly upstream of the bridge due to a head cut through the bridge that had undermined the bridge foundations as well as exposed a sewer and gas line upstream of the bridge. The undermining of the bridge foundations subjected the bridge to potential collapse and the undermining of the utility pipes subjected them to impact loading from rocks and hydraulic forces from rapid water as shown in Figure 1.

Figure 1. Looking upstream from the existing bridge at the undermined pipes (January 2017).

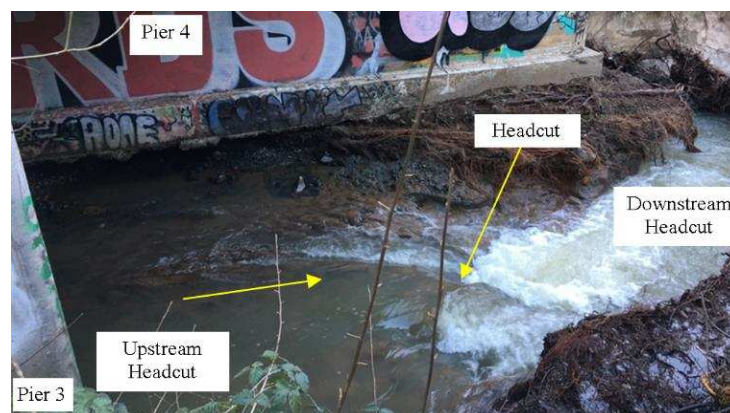
The rapid water made it difficult to determine the actual pile exposure, as shown in Figure 2 during the January event. Figure 3 shows that the piles were exposed 0.6 to 1 meter after the water subsided.

Figure 2. Looking at Pier 4 (Span 3). A 0.6 meter to 1.2-meter-high head cut in Span 3 moving upstream toward Piers 3 and 4.

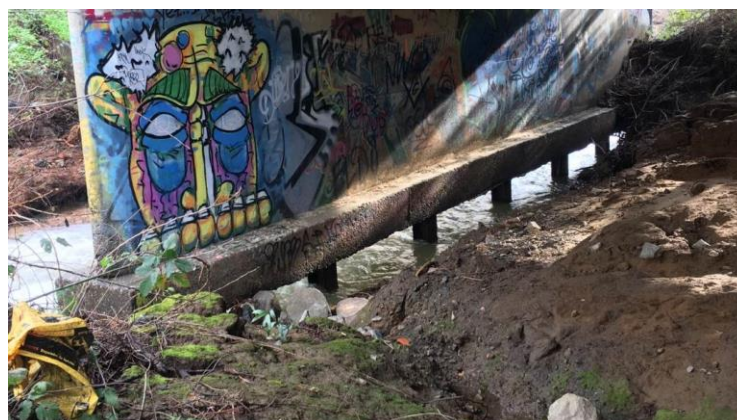
Figure 3. Upstream of head cut looking at Pier 3. Approximately 0.6 to 1 meter of pile are exposed below the bottom of the footing.

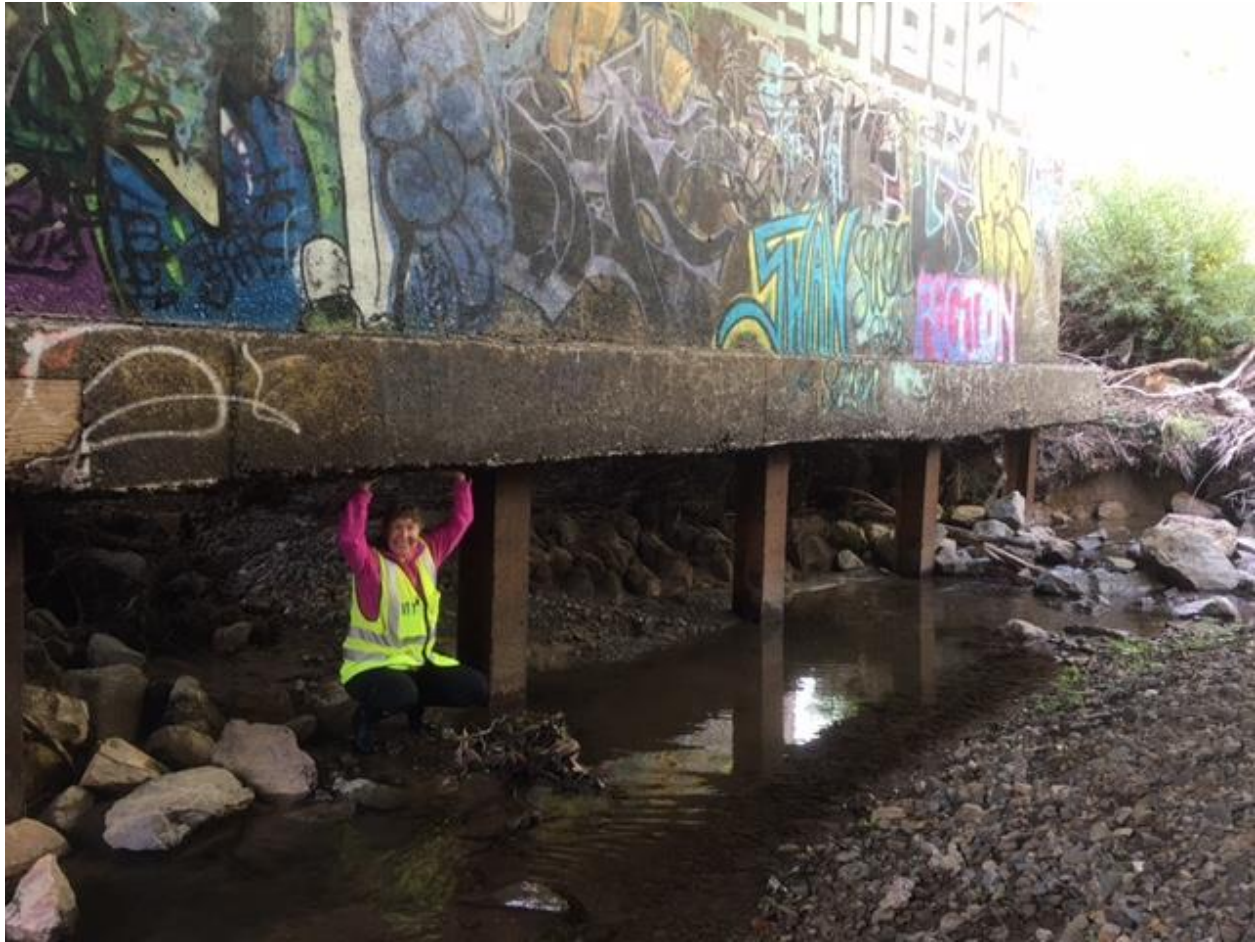
The active head cut downstream caused 0.6 to 1 meter of pile exposure under Pier 3, as shown in Figure 4.

Figure 4. Looking upstream at Pier 3 pile exposure with author (November 2017).

The pile exposure at Piers 3 and 4 required scour countermeasures to stabilize the bridge and prevent bridge collapse during a significant storm or seismic event. The chosen structural countermeasure solution was to install structural countermeasures by lowering the pier foundations, as shown in Figure 8 and Figure 9. The structural solution included excavating a portion of the bridge foundation, placing steel plates, and backfilling with concrete to mitigate the undermined pile cap and exposed piles. Work progressed from downstream to upstream so that only a portion of the undermined channel was fully exposed at any one time in order to maintain the structural integrity of the bridge and to maintain traffic on the bridge.

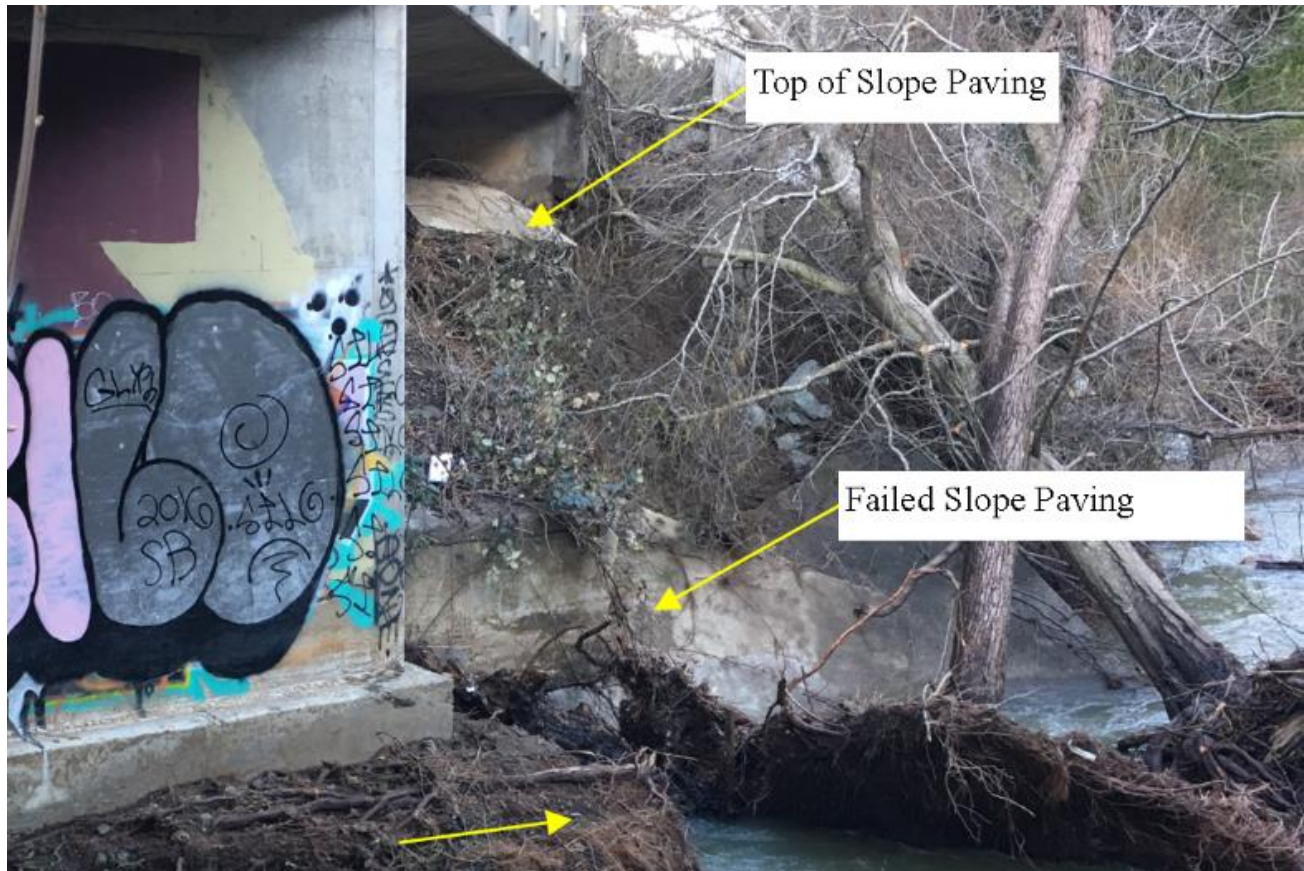
In 2001, the bridge inspection report changed the ELI code to a “3,” meaning “scour is significant enough to warrant a structural analysis of the bridge.” The ELI code remained the same until 2015, when the ELI manual was updated, and the scour code was removed. With this change in methodology, a direct comparison of the scour codes before 2015 and after 2015 cannot be made. The 2001 report also noted the Abutment 5 slope paving was breaking away from the main slab. This condition remained the same throughout the 2015 report. The field review in 2017, however, showed that the slope paving had failed on the downstream side of the bridge and had fallen downstream into the channel, as shown in Figure 5.

Figure 5. Slope paving at Abutment 5, which is undermined and has fallen into the creek.

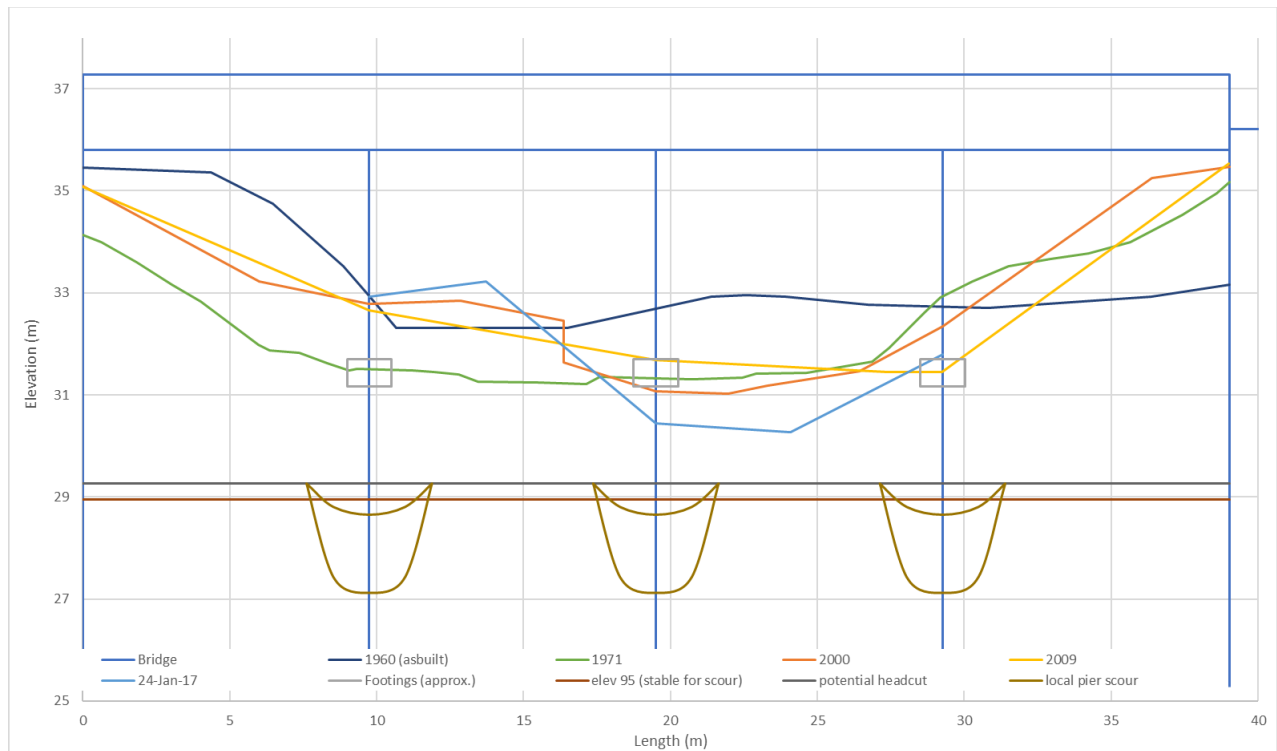
To determine historical patterns of channel aggradation or degradation, the available channel cross-sections between the oldest available section (1961) and the most recent section (2017) were reviewed. As shown in Figure 6, the channel thalweg had lowered from elevation 31.7 meters in 1961 to elevation 30.2 meters in 2017, a rate of 0.03 meters per year. Assuming a 75-year bridge life, an additional 0.6 meters of degradation could occur at the bridge.

The author and her colleagues documented the pile exposure which had increased dramatically since the previous bridge inspection before the January 2017 storm event. A Technical Memorandum (TM) was submitted to Caltrans less than a week after the field review in order to document the scour history, showing that the scour challenges at the bridge began in 1984 and continued until the last report available (in 2017) from 2015. The existing bridge scour was computed using the methodology outlined in HEC-18 (Arneson et al., 2012) and is shown graphically in Figure 6.

Figure 6. Channel cross sections over time at the upstream face of the existing bridge.

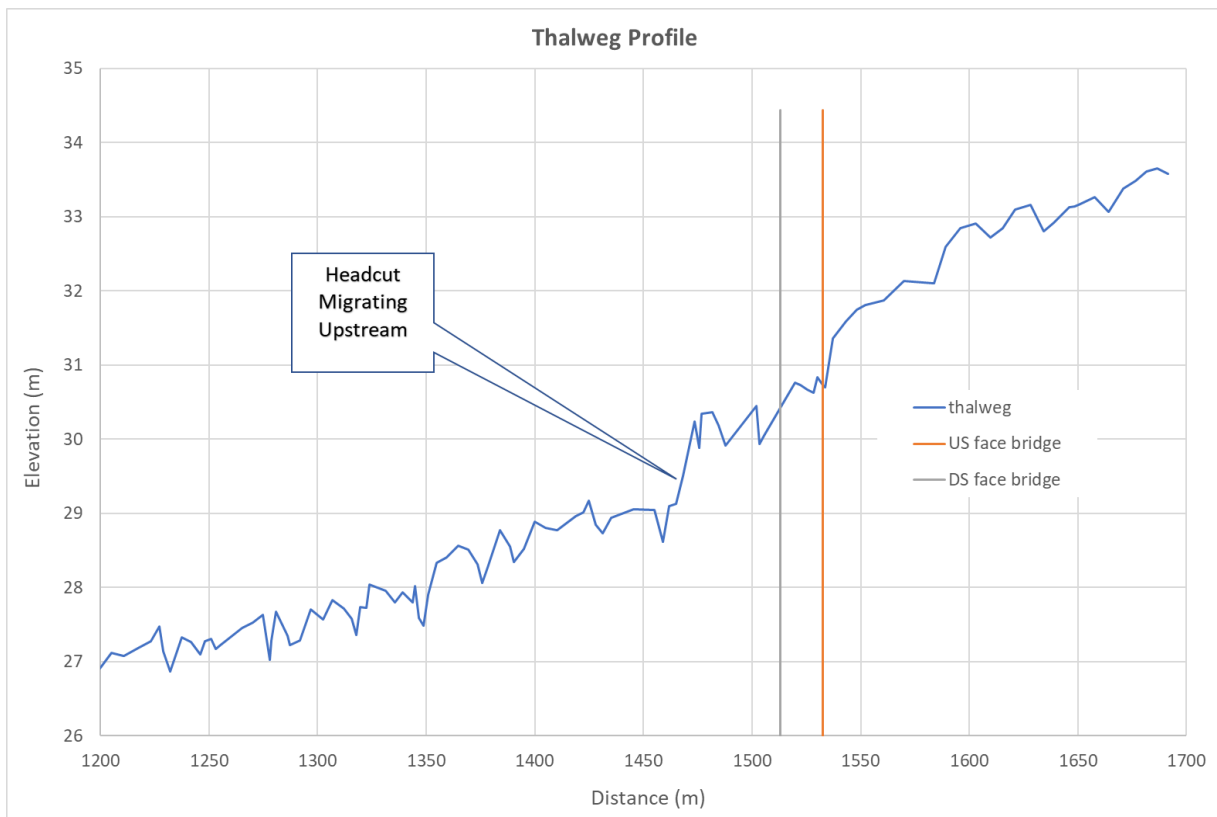
The thalweg was surveyed in November 2017 from approximately 150 meters upstream of the bridge to 900 meters downstream of the bridge, as shown in Figure 7. Upstream of the bridge, the channel slope was approximately 2% while downstream it was 0.6%. Approximately 60 meters downstream, the thalweg drops 1.2 meters, as shown in Figure 7. It was anticipated that this discontinuity could headcut upstream to the bridge and it was likely that the headcut could travel upstream during the next storm, even causing an additional 0.6 to 1.2 meters of piles exposure at Pier 3 and undermining Pier 4.

Figure 7. Thalweg profile from 11/2017 survey data.

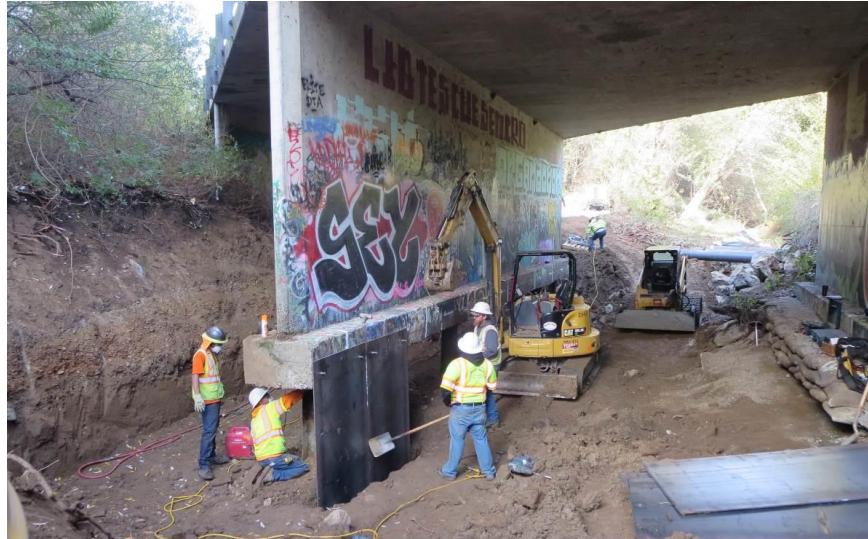
Figure 8. (left) Looking upstream at Pier 3 pier footing construction (beginning construction, December 9, 2017).

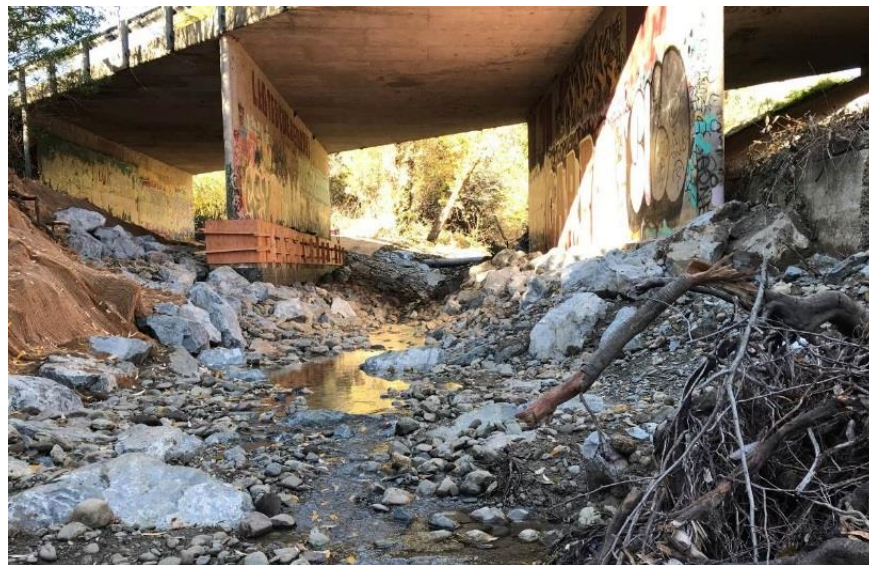
Figure 9. (Right) Looking upstream at Pier 3 and Pier 4 (during construction, December 20, 2017).

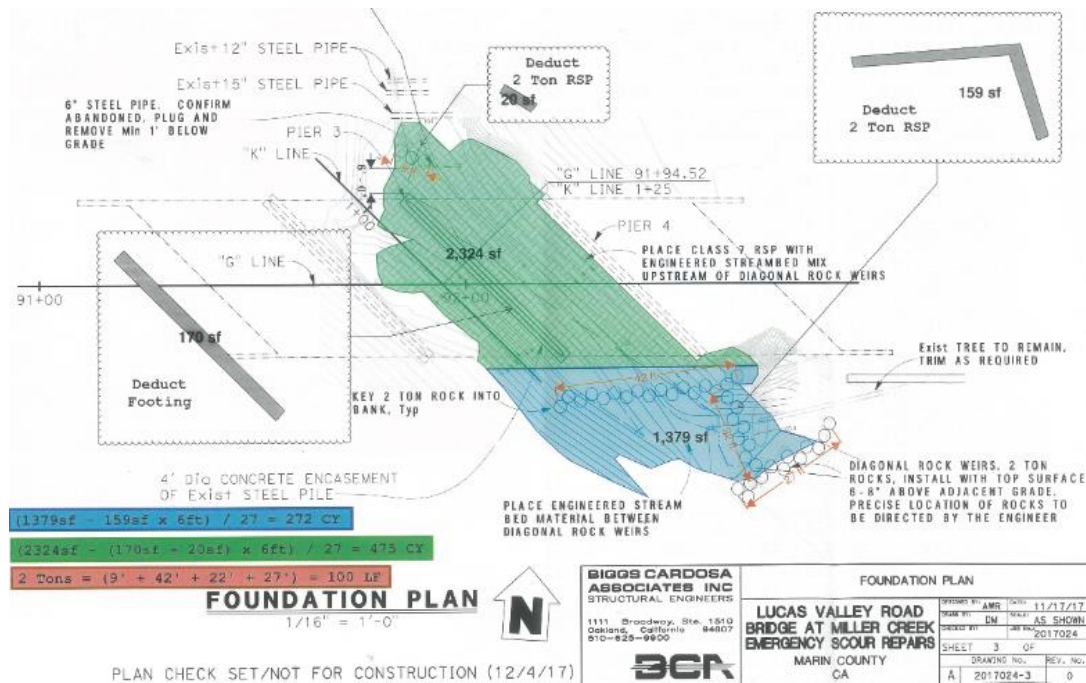
Figure 10. Layout showing 2-ton rock and criss cross weirs.

As an additional hydraulic scour countermeasures, rock riprap (highlighted in green on Figure 10) was installed along the piers to inhibit the local pier scour, and criss cross weirs were installed downstream of the rock riprap (highlighted in blue on Figure 10). The criss cross weirs were installed to help meet the grade requirements from the environmental regulatory agencies at the downstream project limits, which would allow fish to migrate through the project and inhibit the anticipated channel headcutting from reaching the bridge.

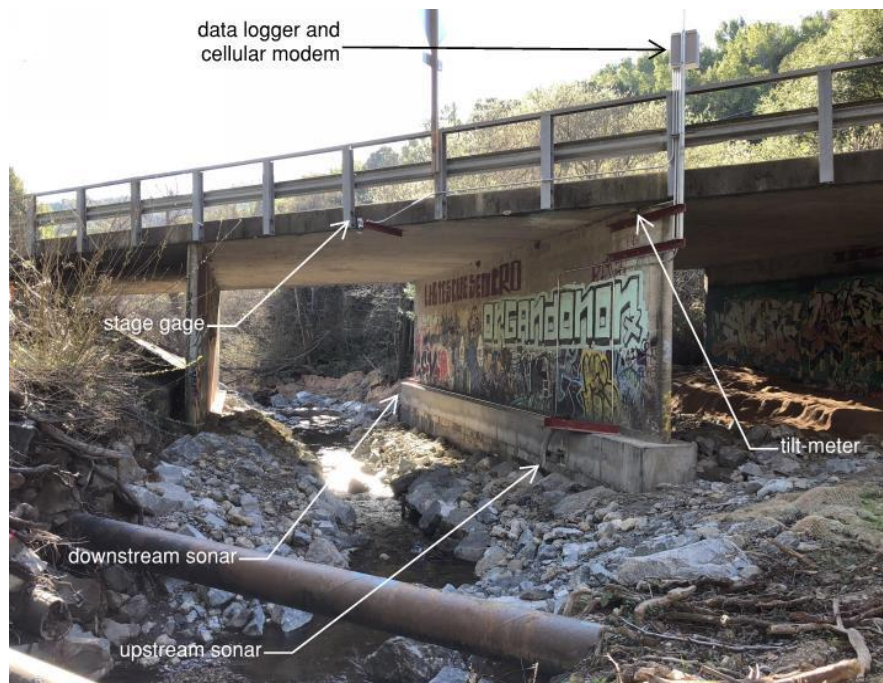
Figure 11. Looking downstream at Piers 3 and 4 (after monitoring device installation, February 2018).

Finally, scour monitoring devices were installed to (a) monitor water stage, (b) monitor scour at the upstream and downstream limits of Pier 3, and (c) monitor movement of the bridge with a very sensitive tilt meter, as shown in Figure 11 and Figure 12. Available results from the initial monitoring are shown in Figure 13 following the installation in January 2018. These results show the bridge moves a small bit due to thermal changes as the sun rises and sets each day. If dramatic rotation caused by the undermining of the piers were to occur, the tilt meters would send a signal to the County, allowing them to close the bridge to traffic prior to bridge failure.

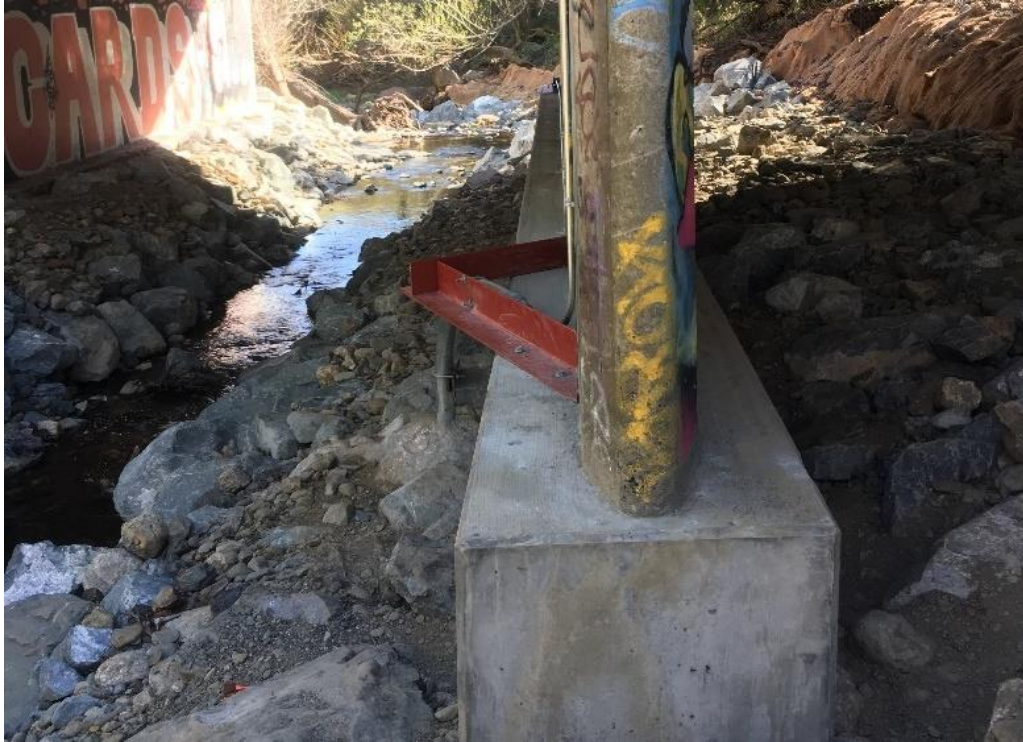
Figure 12. Closeup looking downstream at Pier 3 sonar device.

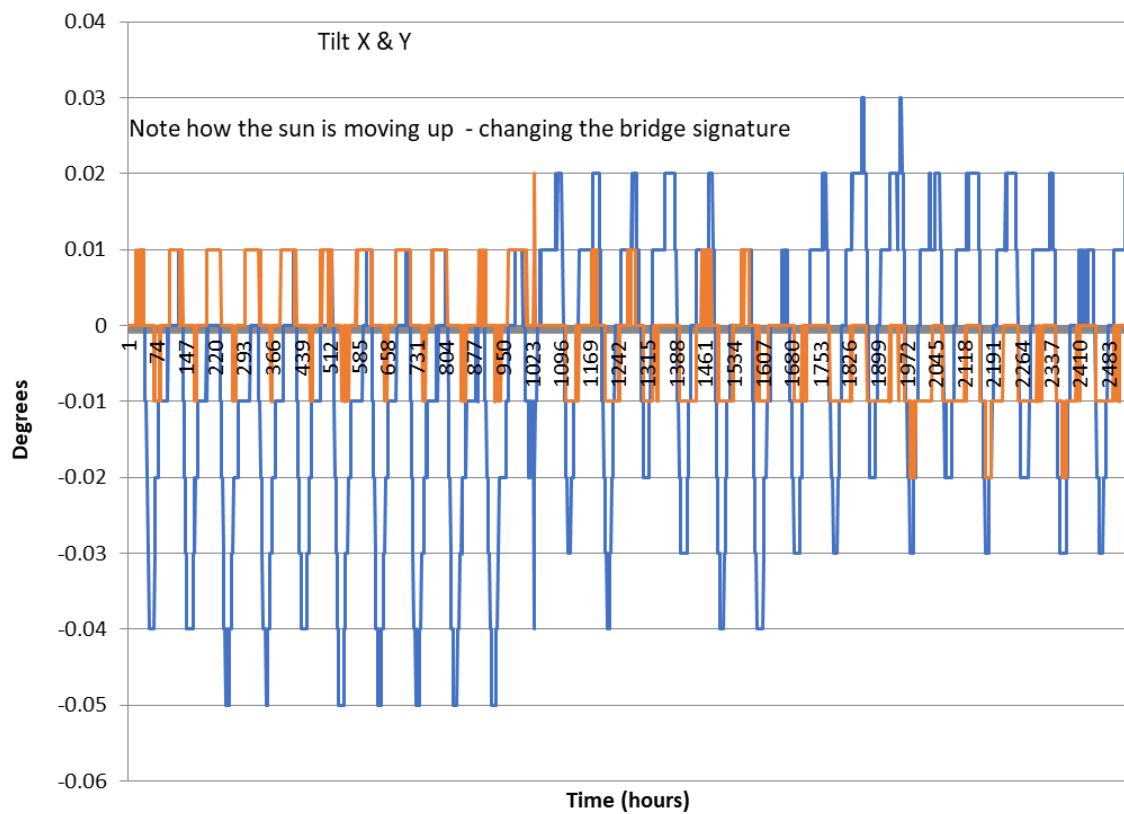
Figure 13. Tilt meter readings in degree
