# Images Collected from the Internet Reveal the Failing Mechanism of the Tailing Dam Breach at Kolontar, Hungary

**ABSTRACT:** *The failure of the red sludge tailing dam at Kolontar in 2010 was the most severe environmental disaster in the history of Hungary. The official investigations are confidential because the legal case has not been closed. The publicly accessible information from the breach of the dam are the photographs taken by the media and news agencies. Collecting these images and analyzing the recorded fractures and displacements of the dam reveal the failing mechanism. The breach of the dam resulted from failing to sliding, which had been developed in three stages. This conclusion is consistent with the observed movements of the dam deduced from a persistent scattered radar interferometry deformation analysis conducted between 2003 and 2010.*

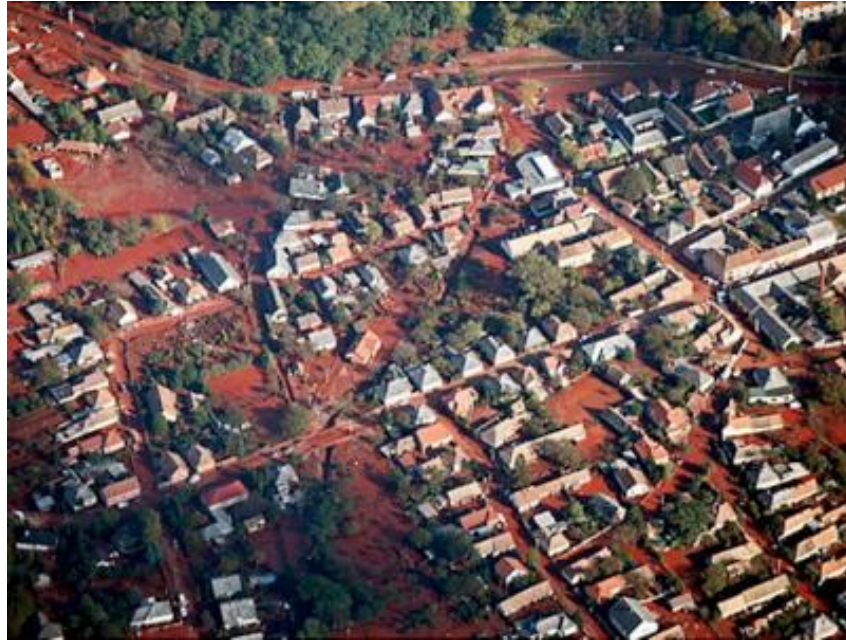
The failure of the dam occurred on October 4th around noon. The dam broke over a 50 m length, resulting in the release of 1 million  $\text{m}^3$  of highly basic sludge (Figures 1, 2). The flood of sludge killed 10 people and another 286 were injured (Banvolgyi, Gy., 2010).

*Figure 1. The scale of the disaster: the highly toxic sludge flooded the neighboring villages in the valley of Torna. (Source: <http://www.nydailynews.com/news/world/bodies-found-hungary-toxic-red-sludge-seeped-danube-river-article-1.188733>.)*

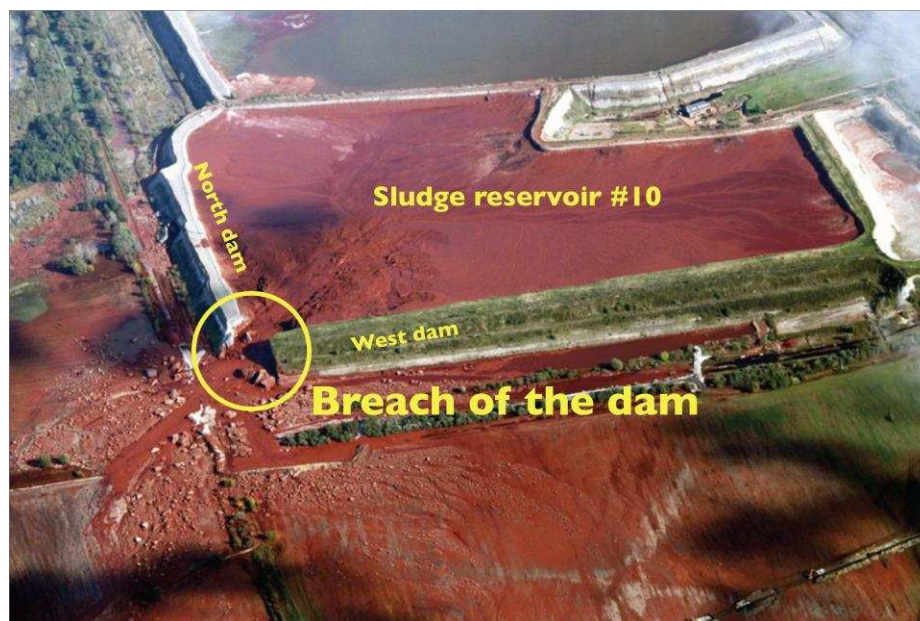
*Figure 2. Aerial photo of the breach of the tailing dam. (Source: <https://www.ndtv.com/world-news/hungarys-toxic-sludge-spill-as-big-as-gulf-oil-leak-435094>.)*

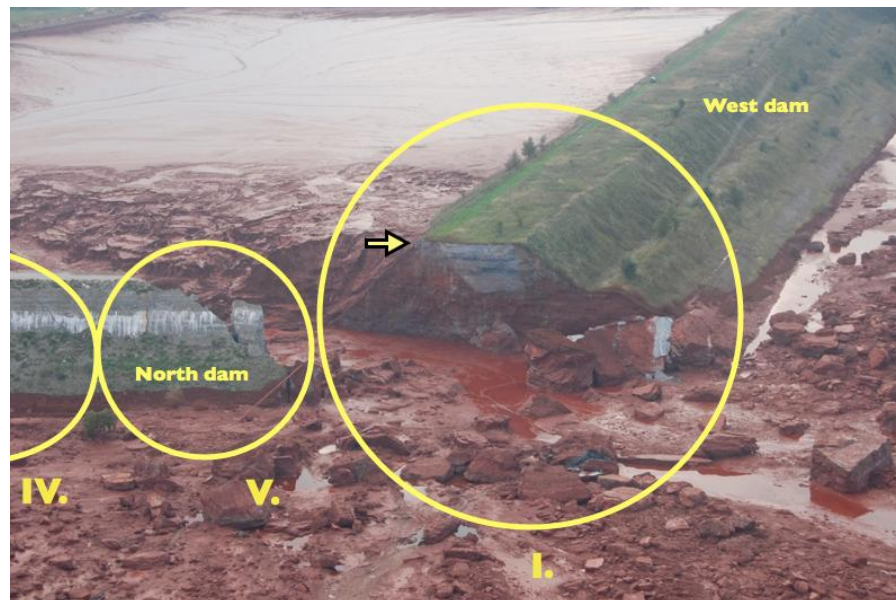
Investigating the collected photos, five fracture locations had been identified. These locations are numbered I-V and shown in Figures 7 and 8. The entire dam section, between fracture Locations I and II, have been displaced. The section between Locations I and V is missing because it had been washed out by the outflow of the sludge. At Location I, the mark of the sludge on the surface of the exposed fracture shows that the displacement occurred at the breach (see Figure 7).

Figure 7. Photo showing the fracture Locations I, IV, and V. The red mark of the sludge on the open surface of the fracture at Location I is the same as the original sludge level. Thus, this fracture occurred right at the breach of the dam before the sludge level decreased in the reservoir.

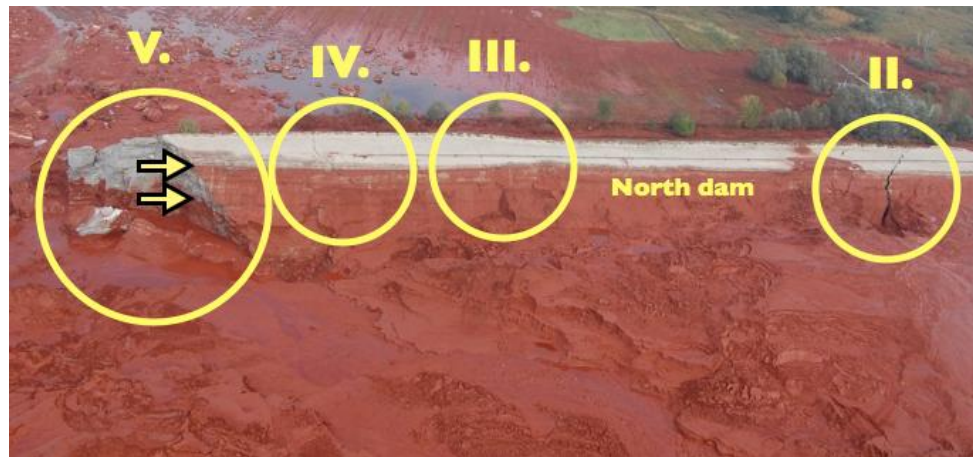
At Location V, the mark of the red sludge on the fracture (Figure 8) is lower than the original one, which indicates that this fracture occurred after the breach, when the sludge level in the reservoir was already lowered.

Figure 8. Photo showing fracture Locations II-V. The red mark of the sludge on the open surface of the fracture at Location V is shown. This mark is much lower than the original level in the reservoir, indicating that this fracture was formed after the breach, when the sludge level was significantly lower.  
(Source: <http://toleducation.org/achievements/red-legacy/>.)

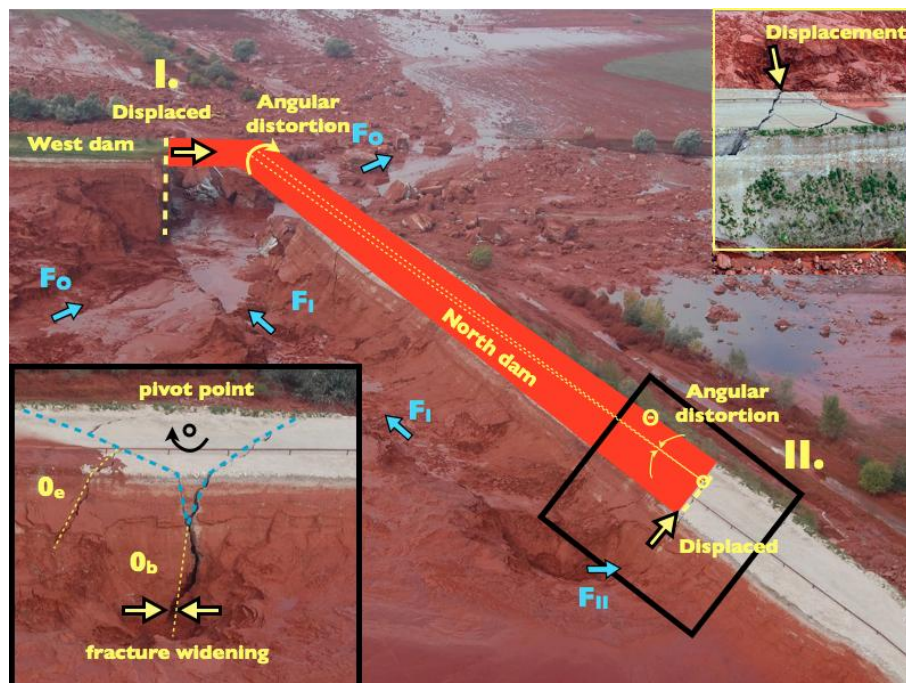
Displacements outward from the reservoir at Locations I and II of the western part of the North dam had been identified (Figure 9). The dam remained intact between these two locations; it is reasonable to assume that the entire dam section between them had been displaced. The displacements at the two ends of the failed dam section are different, which induced an angular distortion on the failed section. This distortion can be identified from the widening of the fracture at Location II (see Figure 9) and from the position of the detached pipe at Location II (see Figure 10). Thus, the failed section of the dam between Locations I and II has been displaced, and an angular distortion has been induced (Figure 9).

Figure 9. The failed section of the North dam is shown in red. This entire section had been displaced outward from the reservoir. Angular distortion also occurred from the bigger displacement at Location I. The widening of fracture  $0_b$  supports the angular distortion. The channels created by the outflow are visible on the surface of the red sludge. The identified flow directions ( $F$ ) are shown.  
(Sources: <http://www.hungarianambiance.com/2011/09/possibility-of-act-of-terrorism-cant-be.html> and <https://phys.org/news/2011-04-wildlife-largely-absent-red-sludge.html#nRlv>.)

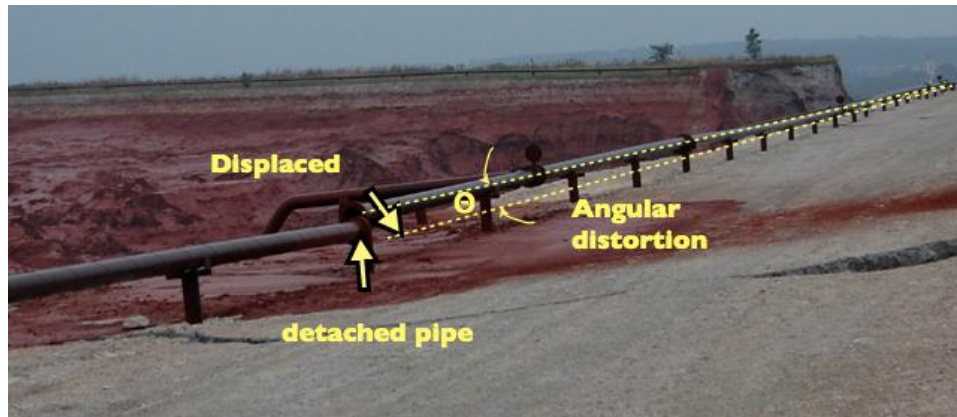
Figure 10. The angular distortion of the failed section of the dam can be seen from the position of the displaced broken pipe. On the failed part of the dam the pipe moved towards the reservoir despite the outward movement of the failed dam section. This indicates that the displacement resulting from angular distortion exceeded the outward displacement of the dam.

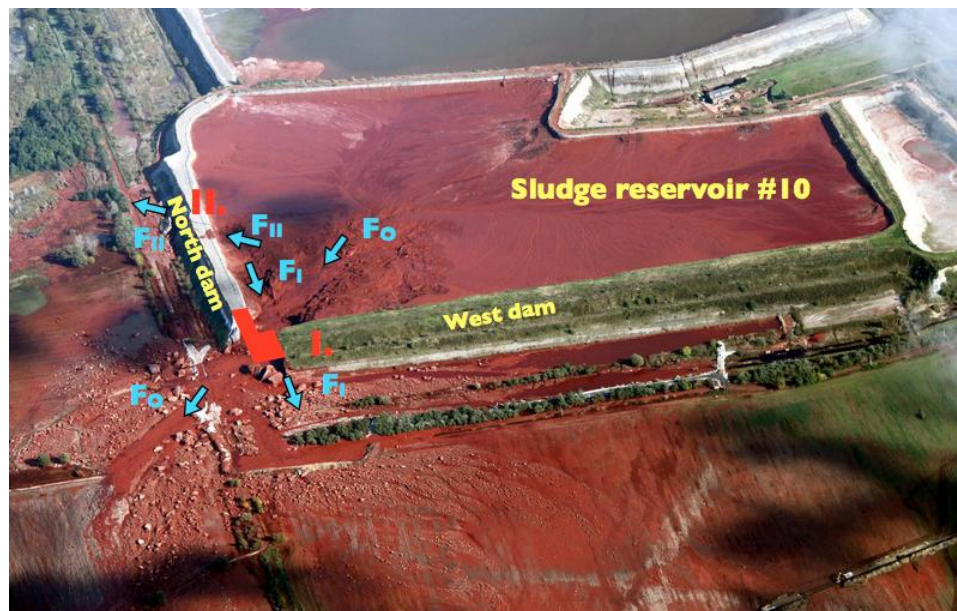
The directions of the flow can be identified by a visual inspection of the surface of the red sludge in the reservoir on the photos. Three channels have been identified from the photos (Figure 11). These channels are also marked on Figure 9. It is obvious that the identified directions of the flow points to the directions where the failed dam section has been detached and the openings occurred. It is assumed that a smaller opening created the narrower channel, while the wide channel relates to wider or bigger opening.

Figure 11. Based on the created flow channels in the red sludge, the flow directions were reconstructed. The initial flows  $F_1$  and  $F_2$  occurred at Locations I and II, pointing toward the direction of the existing fractures.

The direction of flow  $F_1$  changed to  $F_0$  when the western part of the North dam had been washed away, creating a big opening. (Source: <https://www.ndtv.com/world-news/hungarys-toxic-sludge-spill-as-big-as-gulf-oil-leak-435094>.)

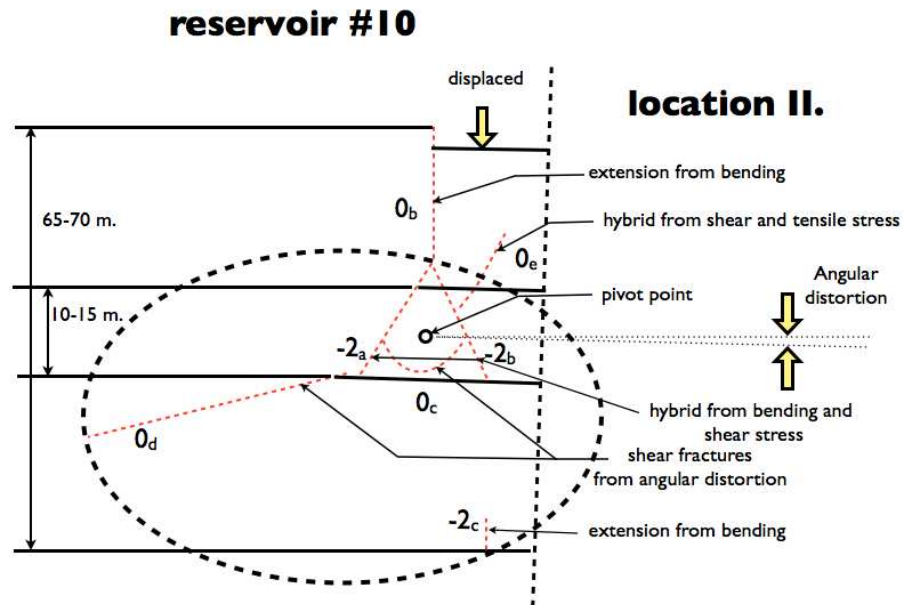
Location II is in the middle of the North dam. The fracture pattern is quite complex. Based on the fracture pattern, it can be identified that the fractures  $-2_a$  and  $-2_b$  relate to bending (Figure 6). The tension side of the bending was the outer side of the reservoir. However, on this side (outward from the reservoir), shear fractures  $0_c$  and  $0_d$  are also present, indicating compression stress on the same side (Figures 4 and 5).

Figure 13. The identified fractures at Location II are shown. Dashed circles mark fractures, formed from compression and tension in the same location. The coexistence of the extension and shear fractures in the same location can only be possible if the stress conditions changed in time.

| location # | fracture # | type of failure | cause of failure |
|---|---|---|---|
| II | -2 <sub>a,b</sub> | hybrid | bending and shear stress |
| II | 0 <sub>b</sub> | extension | tensile stress from bending |
| II | 0 <sub>e</sub> | hybrid | shear and tensile stress |

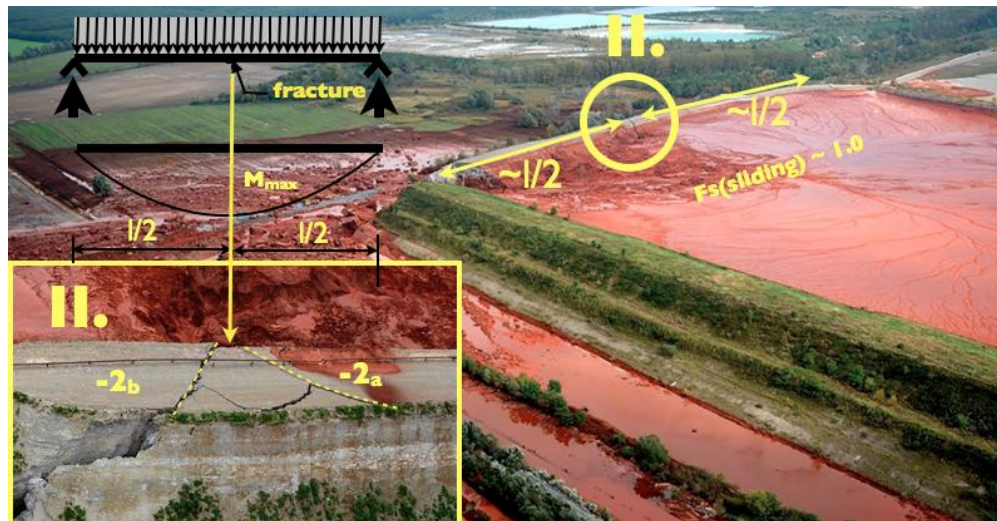
The coexistence of compressional and tensional stresses at the same side of the dam is possible only if the stress conditions changed in time. At the breach, displacement and angular distortion occurred. These movements should develop compression stress on the outward and tensile stress in the inward side and shear stress. The bending related fractures  $-2_a$  and  $-2_b$  are not consistent with the stress condition at breaching, which indicates that these fractures  $-2_a$  and  $-2_b$  were already present when the breach occurred. The fracture pattern  $-2_a$  and  $-2_b$  is an indicative of failing from bending (Figure 6), which developed from the pressure of the red sludge acting from the reservoir site on the dam. The bending related fracture pattern is further supported by the location of the fractures, which is in the middle of the North dam, where the maximum bending moment should occur in a beam subject to uniform load (Figure 14).

Figure 14. Location II is at the middle of the North dam, where the bending moment has its maximum under uniformly distributed load. The fracture pattern (Figure 6) and the location suggest that these fractures (-2<sub>a</sub> and -2<sub>b</sub>) occurred from the bending. These fractures were formed before the breach of the dam.

The allowable angular distortion in buildings is 1/300 (Skempton and MacDonald, 1956). In masonry or concrete structures, fractures start to develop when the angular distortion exceeds this value, which might be too conservative for the dam because its material is not as rigid as these building materials. Using this conservative value on the approximately 500 m long dam, many decimeters of displacement in the middle of the dam were required to develop these fractures. Thus, the dam suffered a very significant deformation before the breach. The displacement occurred in the horizontal direction, indicating that, at the time of the fracture formation, the resistance against sliding was already exhausted. The developed fractures (-2<sub>a</sub> and -2<sub>b</sub>) reduced the bending moment at Location II close to zero, and the dam did not fail.

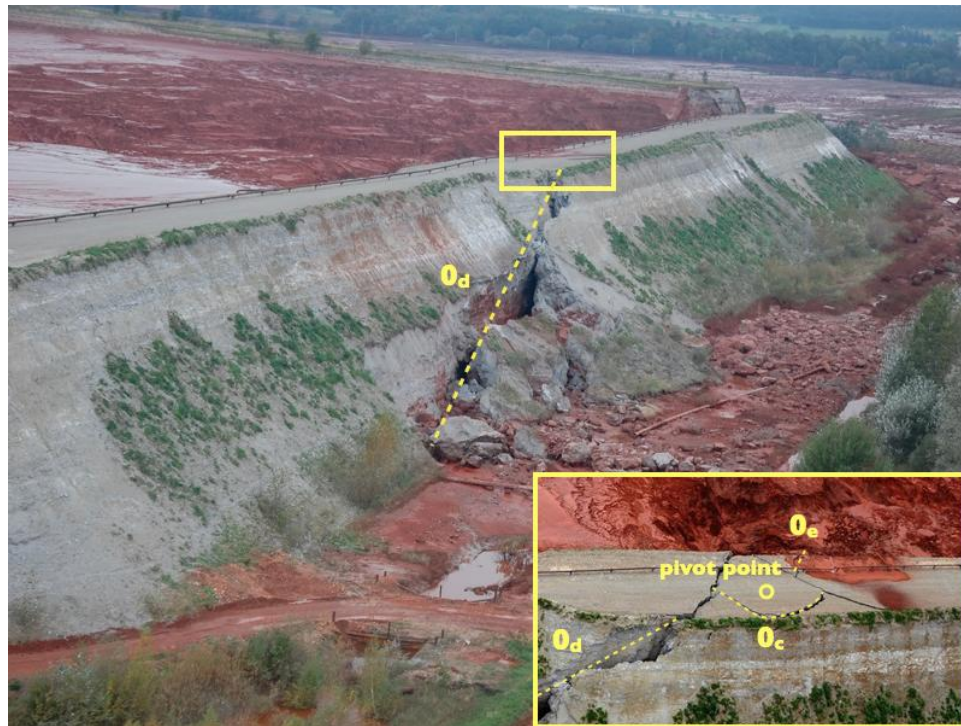
The last straw leading to the breach of the entire dam section was when the tensional resistance of the West dam was exhausted. The dam, whose sliding resistance had already been exhausted, had been detached at fracture 0<sub>a</sub> and the dam moved outward from the reservoir, activating the preexisting bending fractures at Location II. The displacement also induced an angular distortion which generated tensile and shear stresses on the reservoir side, resulting in fractures 0<sub>b</sub> and 0<sub>c</sub> respectively. The angular distortion of the dam produced compression stress at the outward site of the reservoir, which resulted in the development of shear fractures 0<sub>c</sub> and 0<sub>d</sub> on the outward side of the dam (Figure 15). The detachment occurred along the extension fracture (0<sub>b</sub>) (Figure 9), and the preexisting fracture -2<sub>a</sub> (Figure 14). Fracture 0<sub>c</sub> (Figure 9) is a hybrid fracture caused by extension (angular distortion) and shear stresses (displacement).

Figure 15. Shear fractures ( $0_c$  and  $0_d$ ) caused by compressional stress at Location II are shown. These fractures were formed at the breach, resulting from the angular distortion of the failed dam section. On the opposite (reservoir) side, at the same time, extension fracture  $0_b$  occurred (Figure 9), extending the existing fracture of  $-2_b$ . (Sources: <https://www.nbcnews.com/slideshow/toxic-red-sludge-floods-towns-near-budapest-39514793>; <http://www.hungarianambiance.com/2011/09/possibility-of-act-of-terrorism-cant-be.html>).

| location # | fracture # | type of failure | cause of failure |
|---|---|---|---|
| II | 0 <sub>c,d</sub> | shear | compression from angular distortion |

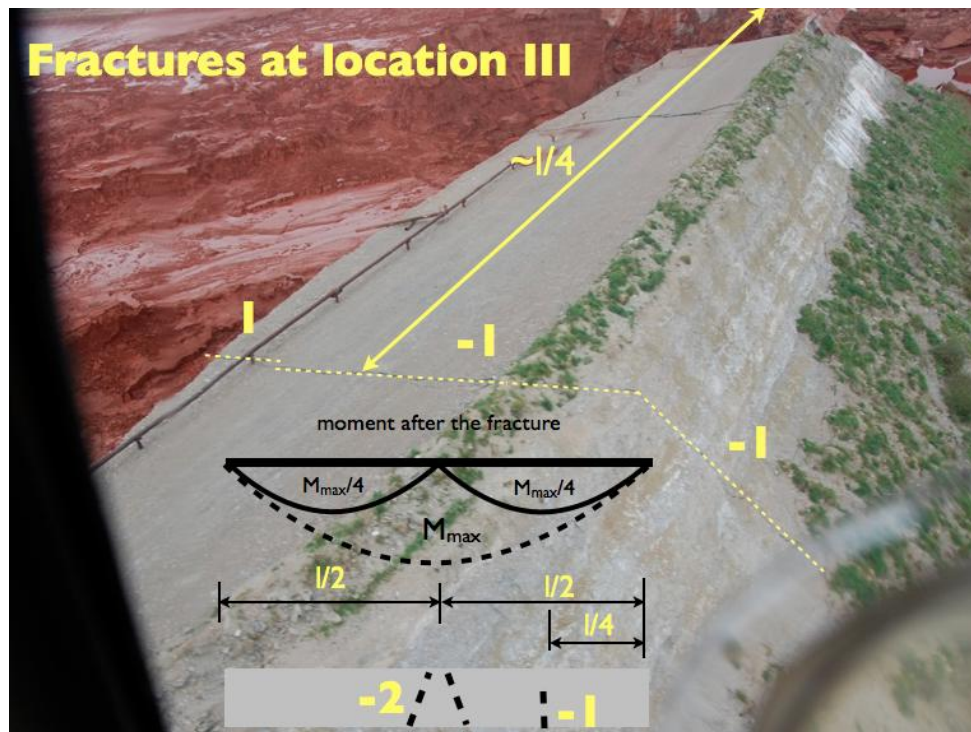
There are two independent fractures (1 and -1) perpendicular to the axis of the North dam. Based on the fracture direction, it is concluded that these fractures are the result of tensile stress acting in the direction of the axis of the dam (Figure 4). Both of these fractures resulted from bending, but there is a time gap between their occurrences. Following the development of fractures  $-2_{a,b}$  at Location II, the maximum bending moment shifted from the middle of the dam to 1/4 of the length of the dam, which is where Location III is (Figure 16). The tensile strength relating to the bending moment of sludge pressure caused fracture -1 at the outward side of the dam. This failure occurred before the breach of the dam. At this weakened cross section, the angular distortion occurring at the breach and the additional flow pressures after the breach led to the development fracture 1 on the opposite side.

Figure 16. The location and the shape of fracture -1 is shown. Both the location and the shape of the rupture indicate that the failing was caused by bending. Following the formation of fractures -2 at Location II, the maximum moment was formed at Location III, resulting in the fracture of -1.  
(Source: <http://www.hungarianambiance.com/2011/09/possibility-of-act-of-terrorism-cant-be.html>.)

| location # | fracture # | type of failure | cause of failure |
|---|---|---|---|
| III | -1 | extension | tensile stress from bending |
| III | 1 | extension | tensile stress from bending |

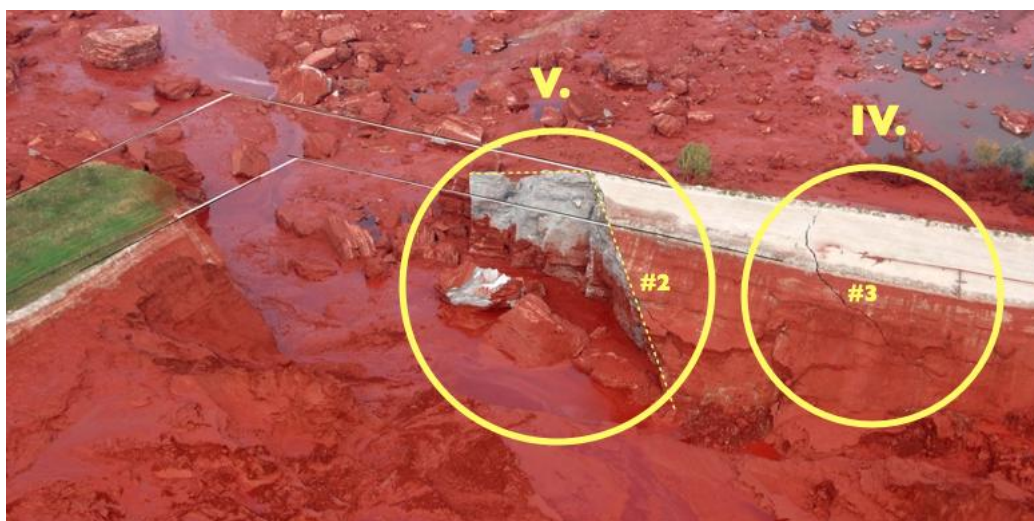
The fracture pattern of these sites shows hybrid failure (Figure 17).

Figure 17. The fractures at Locations IV and V are hybrid fractures caused by the outflowing pressure of the red sludge and the additional settlement. These fractures occurred after the breach of the dam and they have no relevance to the failing of the dam. (Source: [https://commons.wikimedia.org/wiki/File:Ajka\\_accident\\_d7df9fea08\\_b.jpg](https://commons.wikimedia.org/wiki/File:Ajka_accident_d7df9fea08_b.jpg).)

If the fractures at Locations IV and V existed before the breach, then the transformation of the force and the torque would be very limited beyond these locations. Elimination of the torque would not allow the development of the angular distortion beyond Location IV or V. Thus, these fractures at Locations IV and V were formed after the breach. The mark of the red sludge on the surface of fracture 2 also shows that this failing occurred after the breach when the level of the red sludge was reduced from its original elevation (Figure 8). The widening of fracture 3 towards the top of the dam indicates that additional angular distortion in the vertical direction occurred, most likely resulting from the outflow of the sludge, which washed out the soil below the dam section at the opening. The settlement of the dam section led to the development of the extension fracture 4. All fractures at Locations IV and V had been developing after the breach of the dam; therefore, these fractures have no relevance to the breach. The list of all the fractures, as well as the type and the cause of the respective failure, is given in Table 1.

| location # | fracture # | type of failure | cause of failure |
|---|---|---|---|
| IV | 2 | hybrid | compression from the sludge and tensile stress from settling |
| IV | 4 | extension | tensile stress |
| V | 3 | hybrid | compression from the sludge and tensile stress from settling |

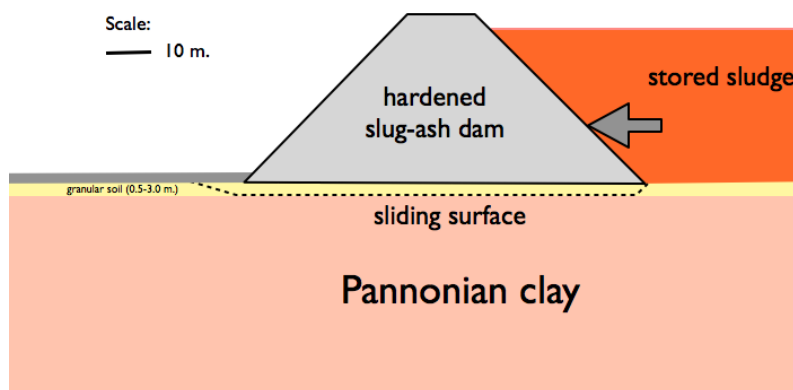
The granular soil (sandy gravel) under the dams, with its weight and its bearing capacity at the toe of the dam, increased the resistance against sliding. Thus, the failure of the dam occurred where the thickness of the granular soil is the smallest (Ndagijimana, 2019). This conclusion is consistent with the failed section of the dam, where the granular layer was the thinnest (0.5 m) under the dam (Farkas et al., 2013). The dams with a bigger cross section had additional weights, which prevented the sliding failure, even though the resistance against sliding was nearly exhausted.

Figure 18. Schematic cross section of the soil profile and sliding surface of the failing is shown. The high pH and the cation exchange weakened the internal friction of the clay on the surface of the layer. The increasing horizontal pressure of the sludge on the dam led to the sliding failure of the dam along this weak resistant layer. The weight of the granular layer and its bearing capacity at the toe of the dam increased the resistance against sliding. Thus, failure of the dam occurred where the thickness of the granular layer was the thinnest.
