# Leaning Tower of Pisa: Behaviour after Stabilization Operations

**ABSTRACT:** It is well known that the foundations of the Leaning Tower of Pisa were stabilised using the method of underexcavation to reduce the southward inclination of the Tower by about 10 percent in combination with controlling the seasonally fluctuating water table beneath the north side. Having been closed to the public since early in 1990, the Tower was re-opened in December 2001. The paper summarises the response of the Tower during the period of implementation of the stabilisation works. Monitoring of the movements of the Tower has been continuing and the observations obtained since 2001 are presented. It is shown that over the six years between 2003 and 2008 the induced rate of northward rotation of the Tower has been steadily reducing to less than 0.2 arc seconds per year. Similarly the rate of induced settlement of the centre of the foundation has been steadily reducing and is approaching the background rate of settlement of the Piazza. Piezometer measurements close to the north side of the foundation shows that the drainage system has been successful in stabilising the groundwater levels beneath the n

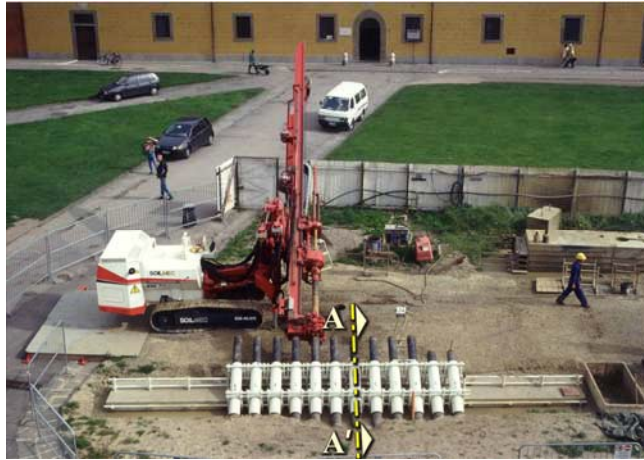
Figure 9. Holes for preliminary underexcavation.

In August 1998 the Committee agreed to carry out limited soil extraction from beneath the Tower with a view to observing its response. This preliminary underexcavation was to be carried out over a limited width of 6m north of the Tower using twelve bore holes lined with 219mm diameter casings (Fig. 9). On 9th February 1999, in an atmosphere of great tension, the first soil extraction took place. The Tower slowly began to rotate northwards. When the northward rotation had reached about 80 arc seconds by early June 1999 the preliminary soil extraction was stopped. Northward rotation continued at a decreasing rate until October 1999.
