Estimation of the Hydroconsolidation Susceptibility of the Anthropogenic Fill of the Historical Center of Thessaloniki, Greece

KEYWORDS: hydroconsolidation, anthropogenic historical fill, collapse settlement, oedometer simulation, Thessaloniki's Metro

Reference: Hatzigogos, N.P.T., Makedon, T.K., Tsindaris, G.E., Tsotsos, S.C. and Christaras B.C. (2016). *Estimation of the Hydroconsolidation Susceptibility of the Anthropogenic Fill of the Historical Center of Thessaloniki, Greece*. International Journal of Geoenvironmental Engineering Case histories, Vol.4, Issue 1, p.46-56. doi: 10.4417/IJGCH-04-01-04

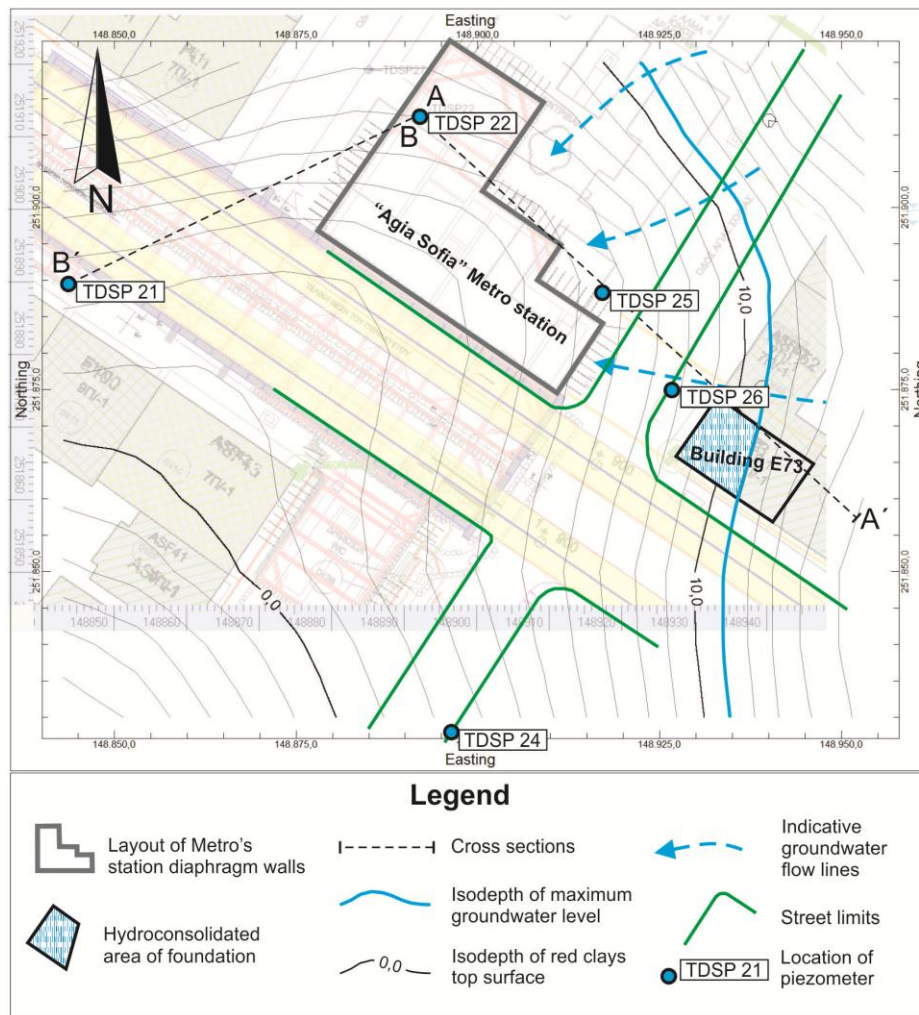
Figure 5. Map of the investigation area with the isodepths of the red clays.

The data used in the analysis were obtained by exploration boreholes that were drilled for Thessaloniki's Metro in the study area. Based on these data the historical fill has a local thickness of 9-10 m whereas the Quaternary deposits that are encountered only at the western part of the study area overlying the red clays have a thickness of 3 m. This stratigraphy forms a perched water table in the historical fill as shown in Figures 5 and 6, with an underground flow direction NE-SW that follows the morphology of the red clays. The underground flow is oriented by a backfilled underground flow network formed on the red clays that were in the past, before urbanization, the surface level formation. Figure 5 shows a map of the isodepth curves of the red clays formation which is the natural boundary of the historical fill. The groundwater level presents insignificant seasonal changes due to the existing structure that prohibits surface water percolation. As a result an unsaturated zone of significant thickness is created above the groundwater table and the geo-materials of this zone have not sustained any wetting during the past.
