# Geotechnical and Structural Challenges over an Active Landslide

**ABSTRACT:** The construction of the steel arched Tsakona Bridge, designed to overpass an active landslide, required several temporary projects. Auxiliary steel towers were used for the erection and welding of the arch segments. Most of them had to be founded in the body of the sliding mass. An automated instrumentation and monitoring system was installed on site providing early warning to the engineers in charge in case large displacements were measured. The real-time recording data provided valuable information about the landslide movements. These monitoring results defined the geotechnical and structural design criteria for the deep foundation of the temporary towers. Several 2D and 3D geotechnical and structural models were created to evaluate the sliding effect on the foundation components, finalize their dimensioning and calculate the required reinforcement. The procedure followed for the design of the temporary deep foundation is described based on the criteria devised using the monitoring system, emphasizing on the continuous feedback between the geotechnical and structural design teams. Several key structu

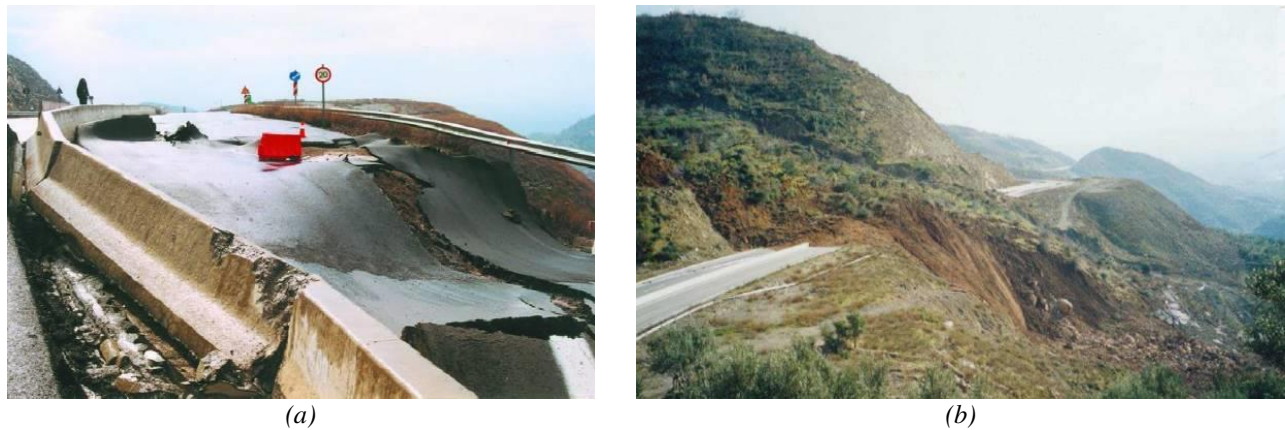
Figure 1. The Tsakona landslide (February 2003) (EMEK S.A (2015)) (a) large settlements on the road pavement (b) massive soil movement (Fikiris et al. (2001)).

The highway to the city of Kalamata in southern Peloponnese crossed through an old landslide, which was reactivated in January 2003 after a period of heavy rainfalls, leading to a major catastrophic slide. The triggered landslide is one of the largest that have occurred in Greece, the consequences of which are shown in Figure 1. Horizontal and vertical displacements of the sliding mass up to 100 m and 40 m, respectively, were measured, causing a soil mass movement of about 6,000,000 m<sup>3</sup> of flysch colluvia and manmade deposits, extended in a large area of 400 m upslope and 700 m downslope of the highway (Belokas 2013, Belokas and Dounias 2016). Among several options studied for the rehabilitation of the National Highway, bridging over the landslide was selected as the most cost-efficient and technically feasible solution (Fikiris et al. 2011). The steel arched Tsakona Bridge, sketched in Figure 2, was decided to be constructed over the sliding mass, which moved downslope at an average rate of about 1.5-2.0 mm/month. This rate was increasing significantly during the periods of intense rainfalls, exceeding for short periods of time the value of 30 mm/month (projected rate of movement).

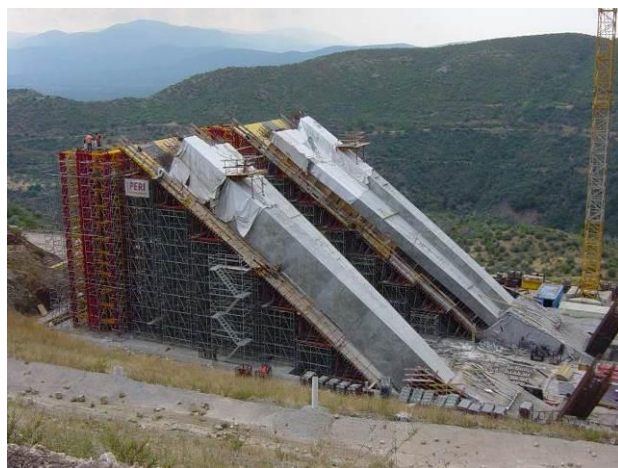
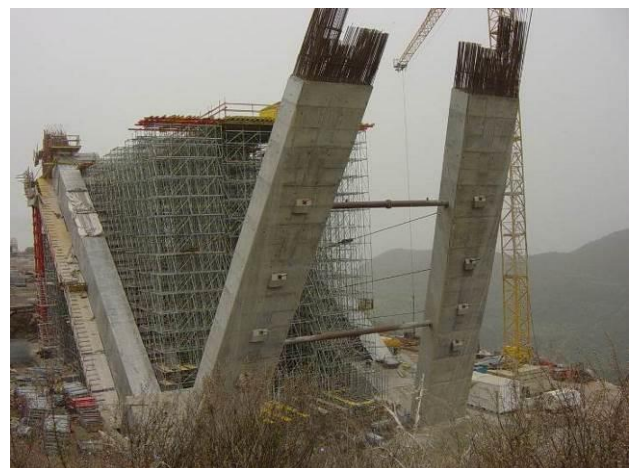
Figure 9. Construction of the (a) curved struts and (b) straight struts of the bridge pier.

The main body of the V-shaped pier consisted of two pairs of supporting struts. The southern struts were curved, following the parabolic geometry of the arch. The northern ones were designed as straight elements on the same inclined plane, converging towards each other. For the construction of the curved struts, scaffolding towers were used, anchored on slabs on the ground. For the straight struts a self-climbing formwork system was mobilized. Temporary horizontal bracings along the transverse direction kept the straight struts in place. At the same time, temporary tendons were utilized to suspend these struts from the completed curved ones, providing the necessary stability to the unfinished V-shaped pier (Figure 9). Before the construction of the curved struts, the two MT towers were installed to support their top ends. They were designed to provide bearing capacity of 12000 kN and 16500 kN each, under static and seismic load combination, respectively. Their foundation consisted of pile-groups penetrating the stable bedrock, connected with pile caps. Ground anchors were also foreseen, as mitigation measure to be activated in case large movements were observed during construction (Figure 10). A special arrangement was provided on the top of the MT towers to compensate any contingency movement within the loose soil above the bedrock as well as the elastic deformations of the auxiliary towers and the deformation due to temperature fluctuations. This arrangement included two (2) elastomeric bearings and four (4) lifting jacks for each tower. Continuous accurate surveying of the level of the bearings and vertical adjustments through the jacks were ensuring the fixed vertical position of the support during construction, until the complete functionality of the arch was achieved.

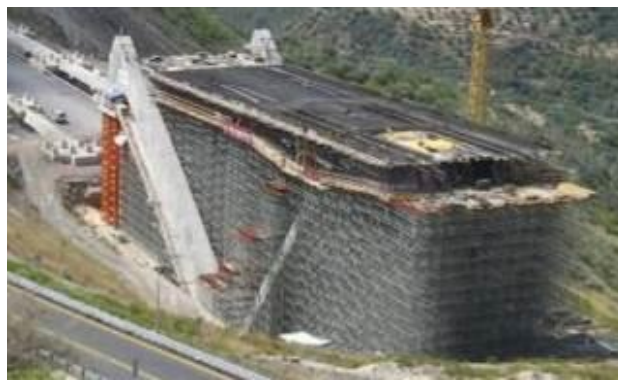
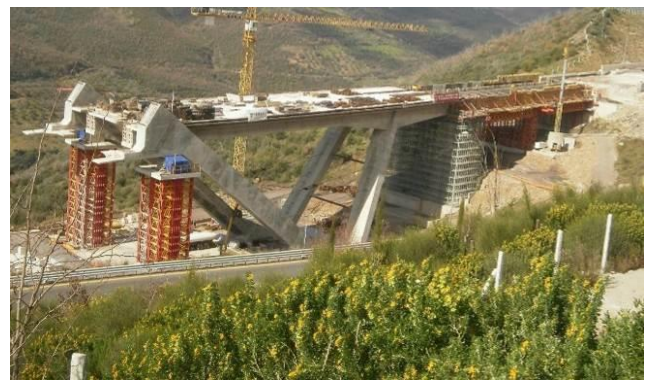
Figure 11. Construction of (a) the 55 m and (b) the 75 m access parts of the bridge prestressed concrete deck.

The 130 m prestressed concrete part of the bridge consisted of two parts, one 55 m long closing the V shape of the bridge pier and the other 75 m long between the straight struts of the pier and the northern abutment, as shown in Figure 11. The first part was poured on scaffolding anchored on the struts of the pier and ground slabs, while for the second one heavy duty bridge-type scaffolding was used, founded with piles on adverse surface morphology conditions, but on a stable ground (Figure 11). The construction of the bridge was completed with the steel arch part. The arch system with a span of 260 m and a rise of 45 m, consisted of two vertical steel arches, one for each branch of the Highway, connected with K-type bracings, all pre-fabricated. Segments of 12 m long were assembled and welded on the ground slabs or the bridge corridors, creating larger pieces of 36 m, which were in turn lifted to position with the heavy lifting system mounted on the temporary steel towers and welded at height. Shelter booths were seated at the top of the towers providing protection from the wind and the rain for the welding procedure of the arch segments (Figure 12a). The bridge was completed with the erection of the composite deck (Figure 12b), which was fully suspended from the arches with the use of hangers (Stathopoulos et al. 2014a, 2014b).

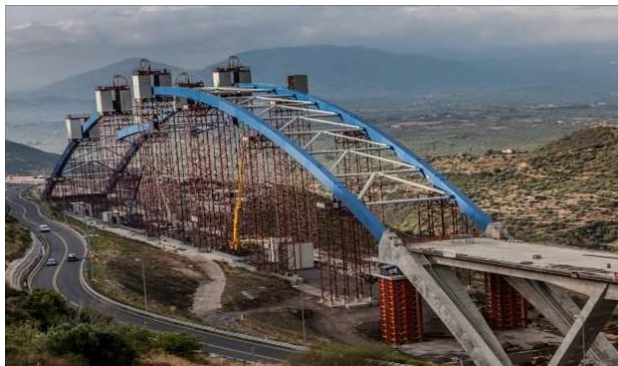
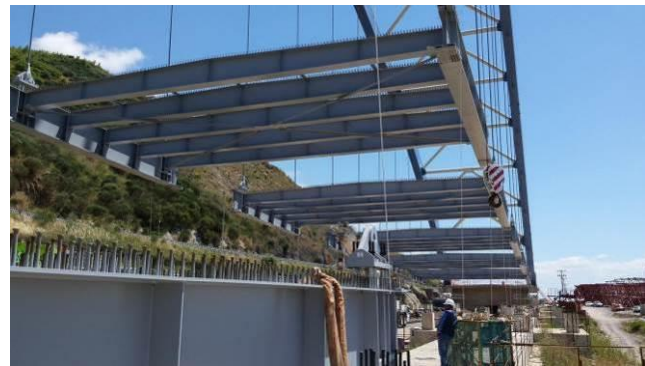
Figure 12. Assembling, erection and welding of (a) the arch segments using the auxiliary steel towers and (b) the composite deck segments.

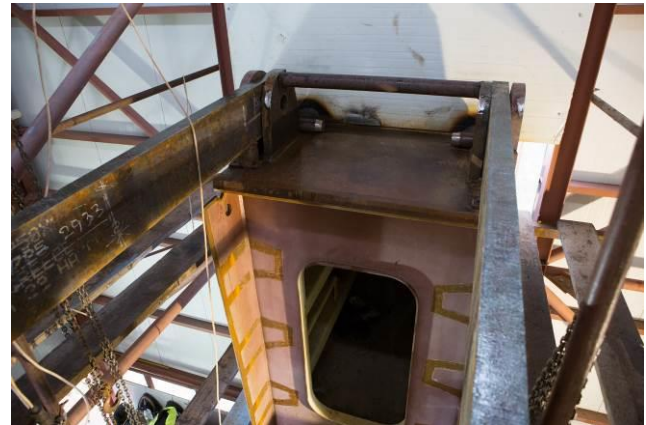
Figure 13. Connection arrangement for fixing the crown gap between the arch parts to weld the key segment (a) drawing (b) implementation.

The length of the crown gap changed during a 24 hours cycle up to 4 cm, because of the high temperature differences, rendering difficult the welding of the key segment. The gap was fixed to a firm distance to allow the welding of the last “tailor made” piece of the arch, using steel plates and pins. Four connections were designed (Figure 13) to sustain a total tensile and compressive force between the constructed parts of the arch equal to 10000 kN, caused by a mean temperature difference of  $\pm 15^{\circ}\text{C}$ .

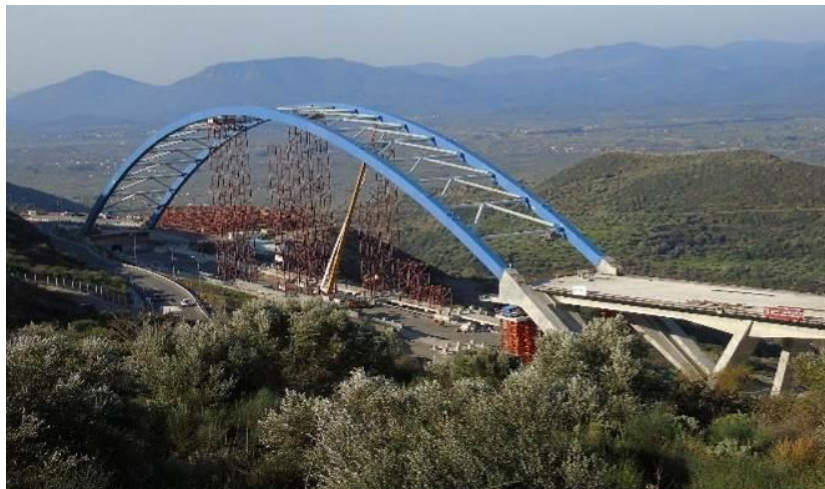
Figure 14. Removal of the temporary towers.

Other crucial issues were related with gradual removal of the arch supporting towers (Figure 14), as well as the total release of the bridge and the removal of the last supporting structure, the MT towers.

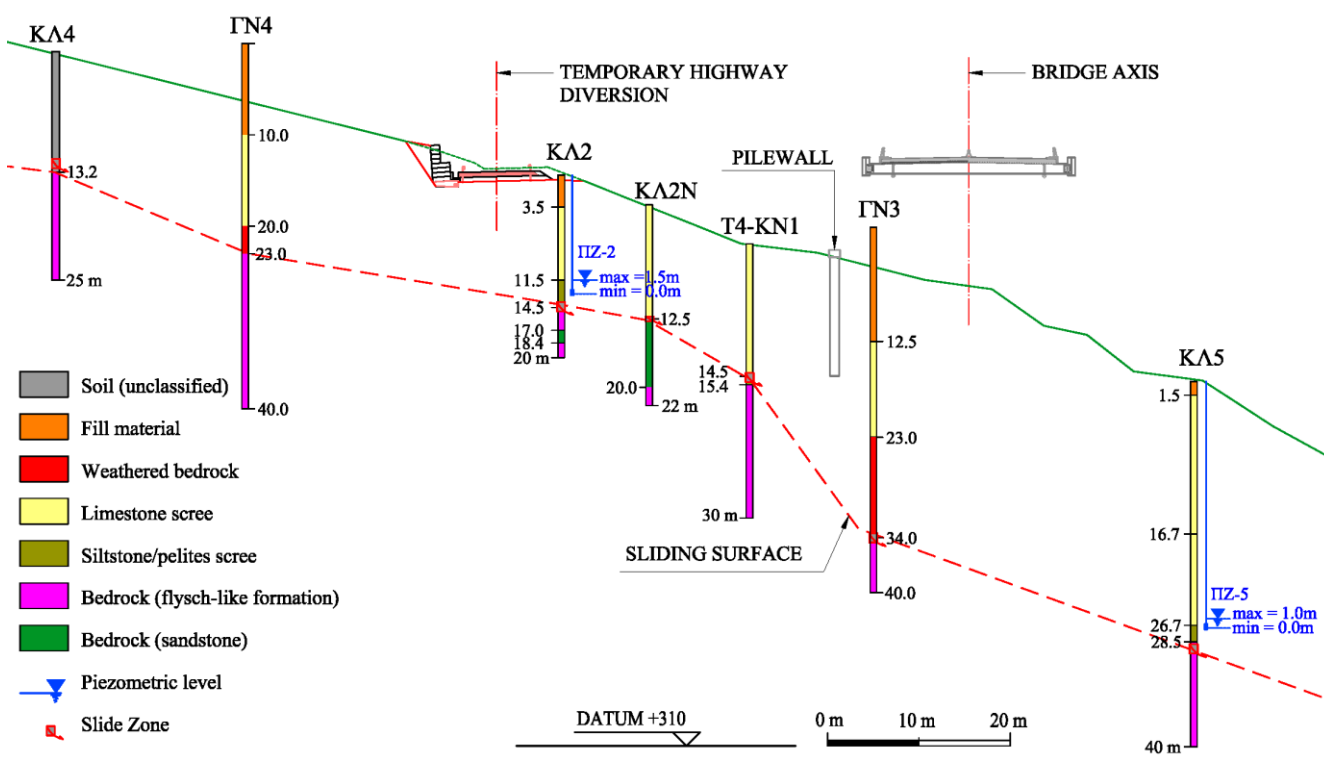
Figure 16. Section in between Piers Ii2 and Ii3 showing the position of the geotechnical instruments with respect to the bedrock surface.

In order to explore and deal with an active landslide, which presented very small margins of safety against failure, a network of geotechnical instruments that recorded the movements of the sliding mass and water levels was installed in the 2001-2012 period, comprising optical targets, inclinometers and piezometers. In January 2013, in view of the forthcoming high-risk construction works, a complementary fully automated instrumentation scheme was designed and implemented that continuously recorded, monitored and updated a database (Seferoglou and Chrysohoidis 2016). The instruments were located at key depths within the sliding mass and at positions near structural elements. The new instrumentation system consisted of four (4) in-place inclinometer chains in boreholes KA2, KA3, KA4 and KA5 (later relocated to KA2N, KA3N and KA5N), three (3) electrical piezometers (PIZ-2, PIZ-3 και PIZ-5) close to the boreholes KA2, KA3 and KA5 and a rain gauge (pluviometer). These instruments, along with the conventional ones, provided all the necessary information about the movement of the sliding mass and its impact on the structures. The arrangement of all instruments in plan-view is illustrated in Figure 15, while a characteristic section between piers Π2 and Π3 is shown in Figure 16, pointing out the position of the geotechnical instruments with respect to the bedrock surface.

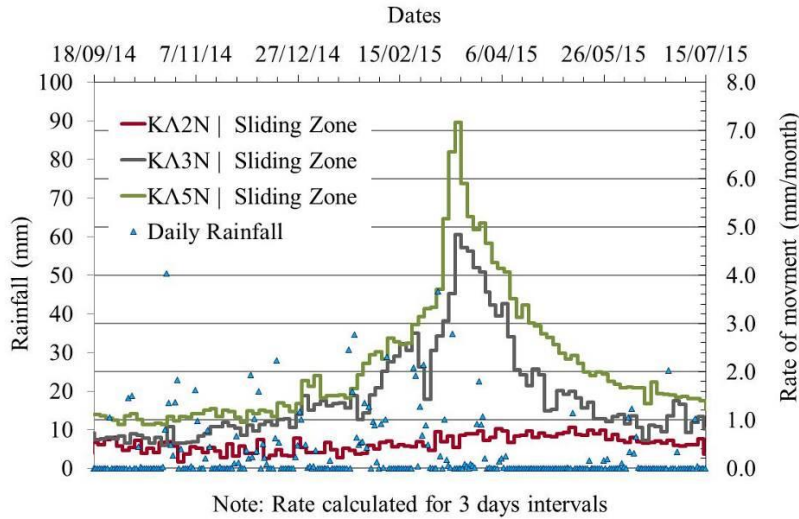
Figure 20. Diagram of slide movement rate with respect to rainfall.

- The rate of the sliding movement varied seasonally depending on rainfall, as shown in Figure 20. The rate picks are concentrated in the months of February and March, reflecting major rainfall incidents as well as the accumulation of rainfall along the whole rainy season (November-March). The influence of heavy rainfalls in the piezometric levels can be seen in Figure 21.

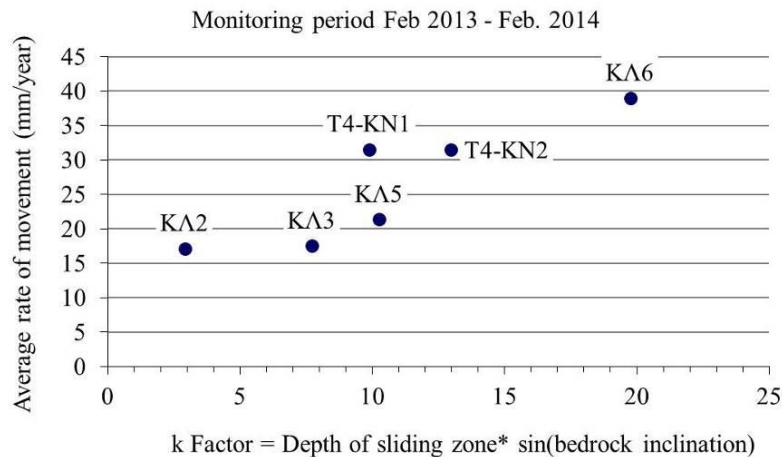
Figure 22. Rate of movement for different locations of the slide zone.

- Differences in the movement rate were noted among the monitoring locations, as concluded from Figure 22 and Table 2. The depth of the sliding zone, as well as the inclination of the bedrock, which differed significantly across the landslide mass, were the basic parameters that influenced the rate of movement. The empirical factor  $k$  ( $=\text{depth} \cdot \text{inclination}$ ) was calculated to define the dependence of the slide rate on the depth and the inclination of the sliding surface at various landslide locations. As expected, the graph of Figure 22 illustrates a strong positive correlation between the mentioned geometrical factors on the landslide velocity (the slide rate increases with depth and bedrock inclination).

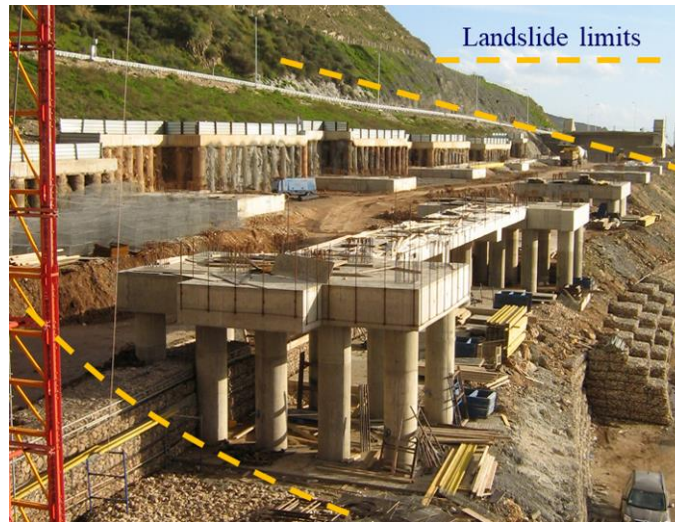
Figure 23. Assembling line of the right branch.

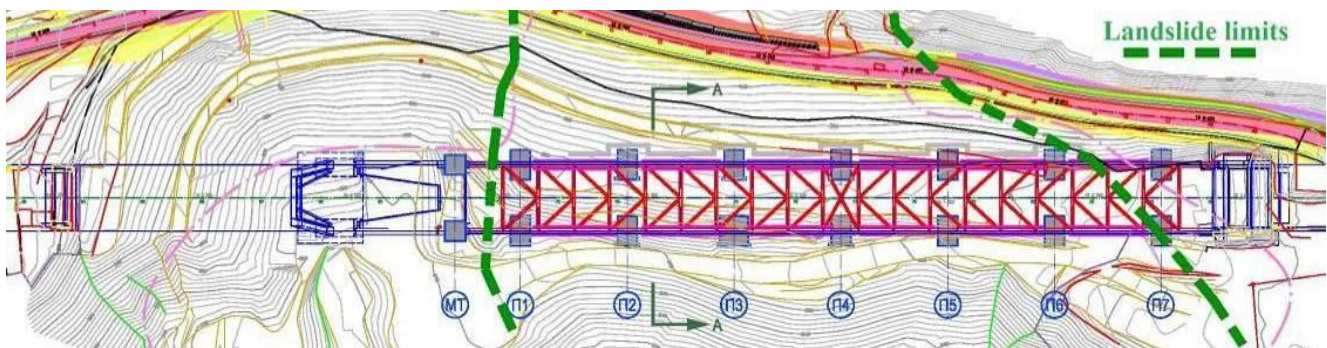
Figure 24. Location in plan view of the characteristic transverse view A-A.

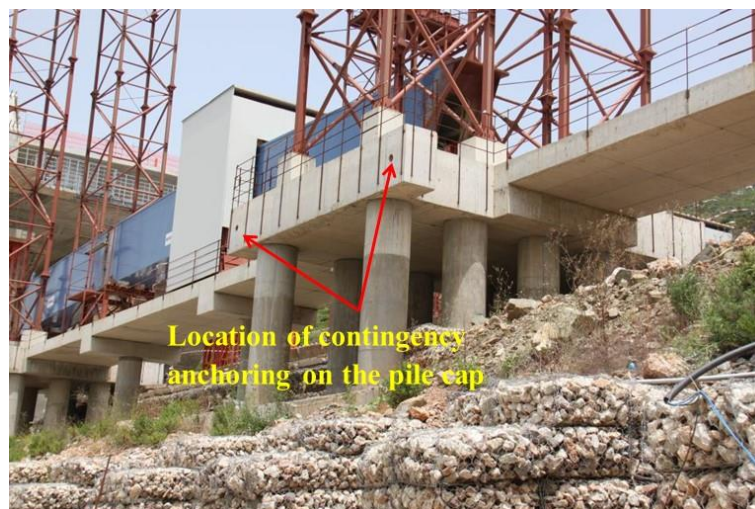
Figure 34. Contingency plan for anchoring of the pile caps.
