## St. Isaac Cathedral (St. Petersburg, Russia): A Case History

**ABSTRACT:** *St Isaac's Cathedral in St. Petersburg was completed in 1858 after 40 years of construction; it is today the fourth largest domed Cathedral in Europe. The underlying soil is a relatively soft saturated sediment and carries this 3155 MN structure that is 100 meters high with an imprint of 92 m by 100 m. It is founded on a 7.5 m thick mat of granite and limestone blocks resting on relatively short timber piles of different lengths. The Cathedral has progressively experienced significant deformation including differential settlement causing cracks in the pillars and tilting of the porticoes. The paper summarizes the available geotechnical engineering and engineering geology aspects of the soil on which the Cathedral is built as well as classical issues such as foundation ultimate capacity and settlement analysis through simple calculations and numerical simulations. It also includes some less classical issues such as the influence of microbial activity on the behavior of the Cathedral through the changes the microbes and their activity create in the engineering properties of the soil and in the groundwater

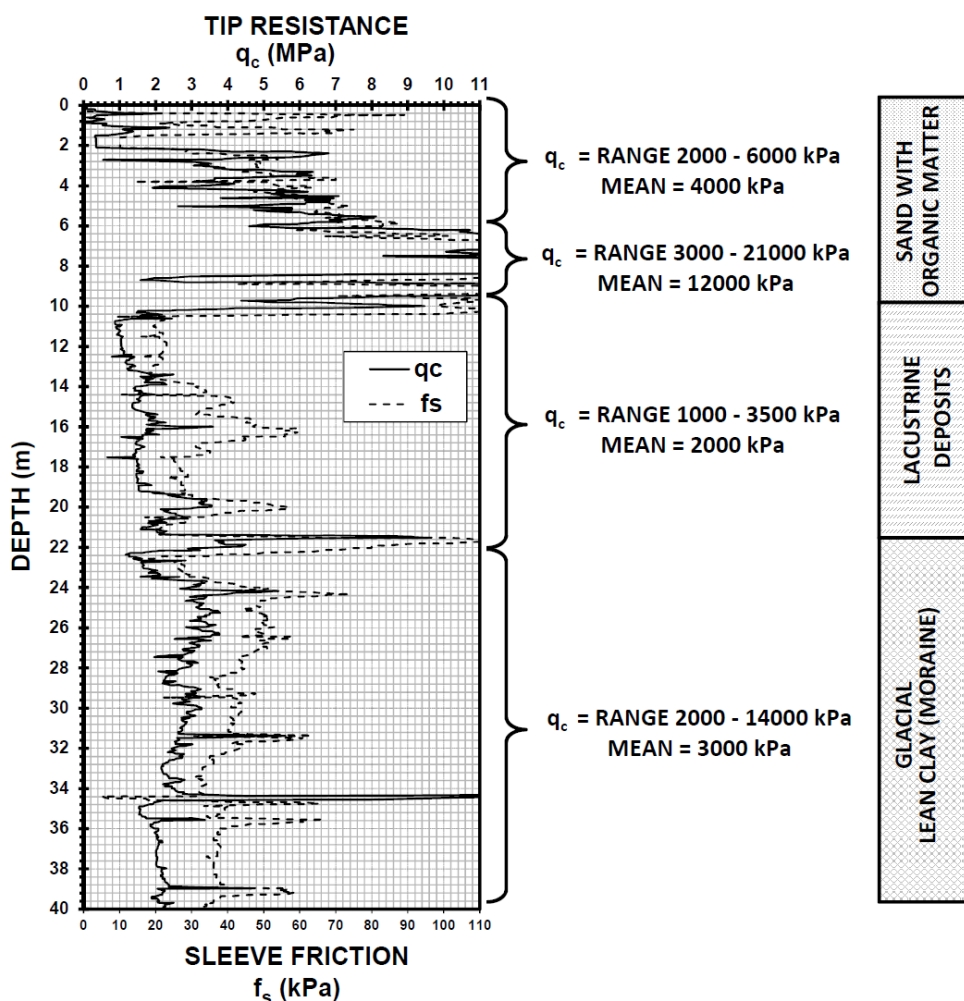
Figure 4. CPT profile near St. Isaac Cathedral.

Using Fig. 4 and a lower-bound cone tip resistance of 1500 kPa together with a cone bearing capacity factor of 0.35 (Briaud, 2013) the bearing capacity is 615 kPa. This is much higher than the bearing capacity based on the Skempton (1951) equation and when compared to the applied pressure of 415 kPa gives a much more reassuring factor of safety against bearing capacity failure of  $615/415 = 1.48$ . The low bearing capacity based on the undrained strength from the samples may be due to sample disturbance. Indeed, the cone  $N_k$  factor linking the undrained shear strength of the cone tip resistance is back-calculated to be about 50; this is unusually high.

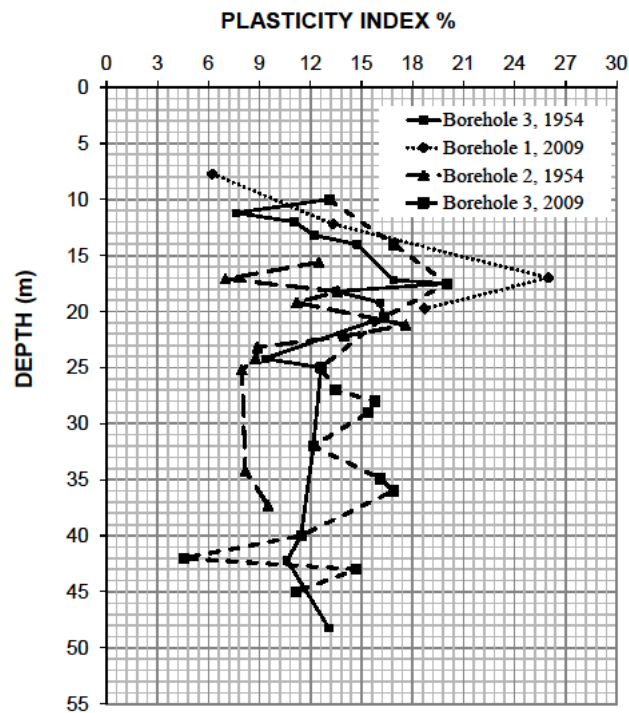
Figure 8. Variation of plasticity index versus depth at different locations.

Soil properties were obtained in 1954 and 2009 and are combined in the following figures. The natural water content is presented in Fig. 7 and the plasticity index in Fig. 8. Fig. 7 indicates that there is no clear trend in the evolution of the water content with time and that the largest water contents occur in the layer of silty sand with peat at a depth about 3-5 meters and in the varved clay at the depth of 15-20 meters. Fig. 8 indicates that the varved clay at a depth of 15-20 meters exhibits the highest plasticity.

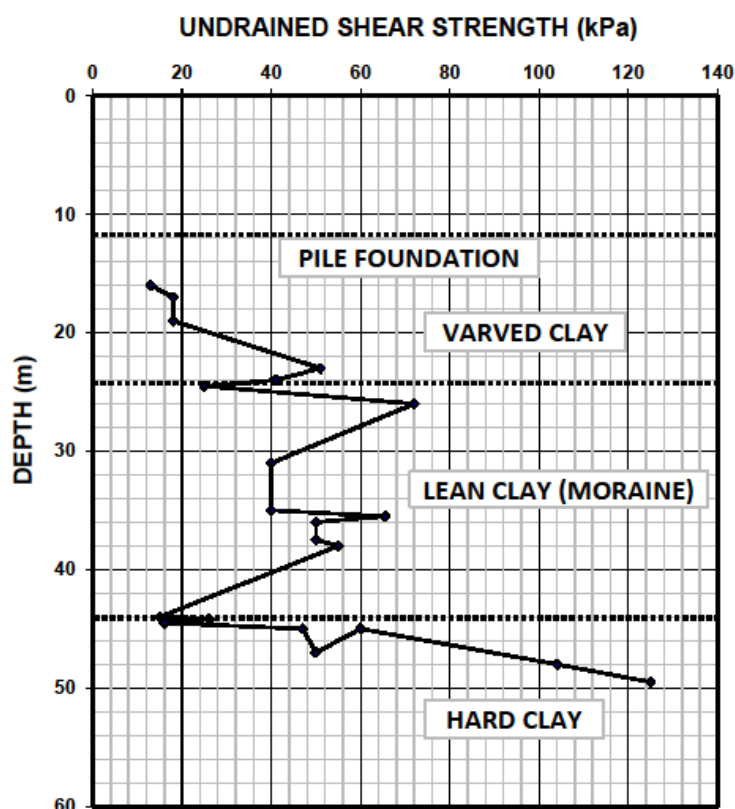
Figure 10.  $s_u$  profile versus depth.

The shear strength properties, cohesion and angle of internal friction, available from the archives of 1954 are limited to direct shear test results (Table 3). In 2009, unconsolidated undrained triaxial tests were performed. The undrained shear strength ( $s_u$ ) vs. depth profile obtained from these tests is shown in Fig. 10. Figs. 11 and 12 show the deviator stress vs. normal strain for some of the tests; the samples failed mostly in general deformation mode (barrelling) rather than along a single plane of failure. As indicated by the stress strain curves, the varved lacustrine clay underlying the pile foundation is very soft with  $s_u$  values between 18 and 20 kPa. The glacial clayey soil below the varved clay is a bit stronger with values in the range of 25 to 72 kPa. The Vendian clay below that glacial soil has  $s_u$  values which vary with depth from 18 kPa at the top of the layer to 125 kPa at depth. This significant variation could be due to the micro-fissures present in the upper zone of that clay layer which weaken the global strength.

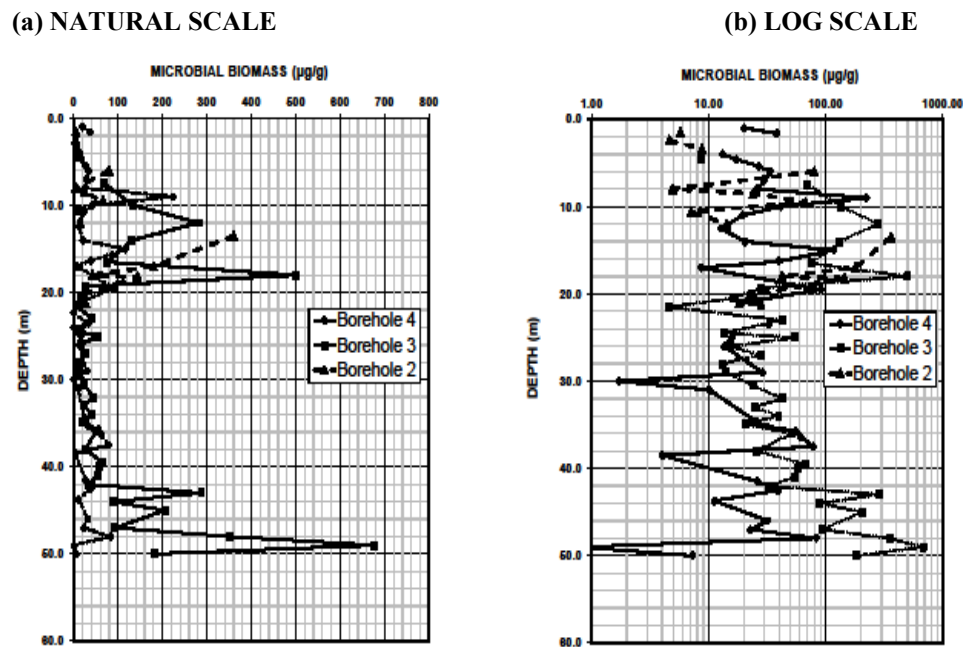
Figure 14. MM in soil vs. depth (2009 data): (a) natural scale, (b) decimal log scale.

for some St. Petersburg soils by Dashko and Shidlovskaya (2015). The microbial mass and biofilms create slippery substances which coat the particle contacts and facilitate the movement of particles with respect to each other (lower modulus of deformation and lower strength) and clog the pores (lower permeability) (Dashko et al. 2013a, 2015). Indeed, for example, hydrogen sulfide ( $H_2S$ ) as a metabolic product of sulfate-reducing bacteria in anaerobic state and bivalent iron ( $Fe^{2+}$ ) leads to the generation of hydrotroilite  $FeS \cdot nH_2O$  in the form of black and dark grey powder that was observed in all soil samples below the groundwater level. Fig. 14 shows the MM distribution through the soil profile. The peaks of MM at 20 m and 50 m depth correspond to the lacustrine varved clay (up to 500 micrograms per gram) and to the Vendian clay (up to almost 700 microgram per gram).
