## A geocomposite barrier for hydrocarbon containment in the Arctic

**ABSTRACT:** *The paper describes the background and remediation steps that were taken to contain migration of a subsurface hydrocarbon contaminant plume at a site in the Canadian Arctic. A composite liner consisting of a novel fluorine surface-treated high-density polyethylene geomembrane and a geosynthetic clay liner was selected as the short-term (several years) barrier solution. The paper describes the design details, the selection criteria, and the challenges that were overcome to install the barrier system. A complimentary program of site monitoring is underway together with a parallel program of laboratory testing investigating the long-term effects of freeze-thaw, low temperatures, and contact with jet fuel on specimens of the barrier components. Results from site monitoring show that the barrier system is performing as planned three years after installation. Laboratory tests completed to date show that the geosynthetic barrier materials can be expected to maintain acceptably low rates of hydrocarbon diffusion and advection well beyond the original 3-year design life of the barrier system.*

Bathurst, R.

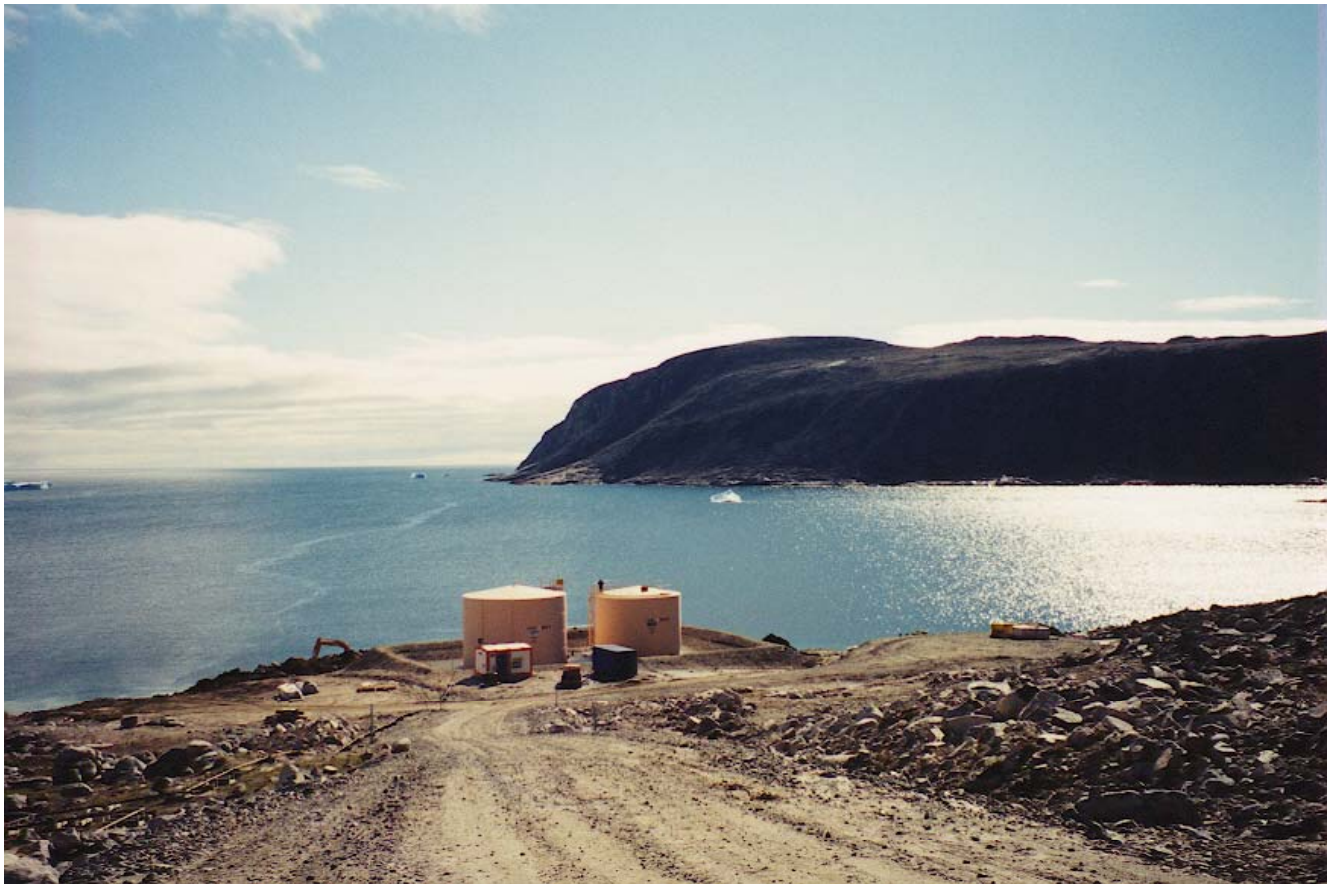
*Figure 2. View looking toward ocean showing existing fuel tanks.*

In 1998, during the initial site assessment of BAF-3, visual inspection of the beach area confirmed the presence of two large petroleum, oil and lubricants (POL) tanks situated within a lined berm area approximately 75 m north of the ocean (Figures 2 and 3). Given that the existing POL tanks had replaced older tanks dating back from the original Brevoort Relay Station (RES-X-1; a DEW Line Rearward Communications Site), the potential for fuel leaked from corroded tanks or spilled during deconstruction activities was investigated. At that time, the collection and analyses of limited soil samples revealed the presence of Arctic diesel (jet fuel) in the sloped area between the tanks and the ocean at levels up to 14,000 ppm total petroleum hydrocarbons (TPH).

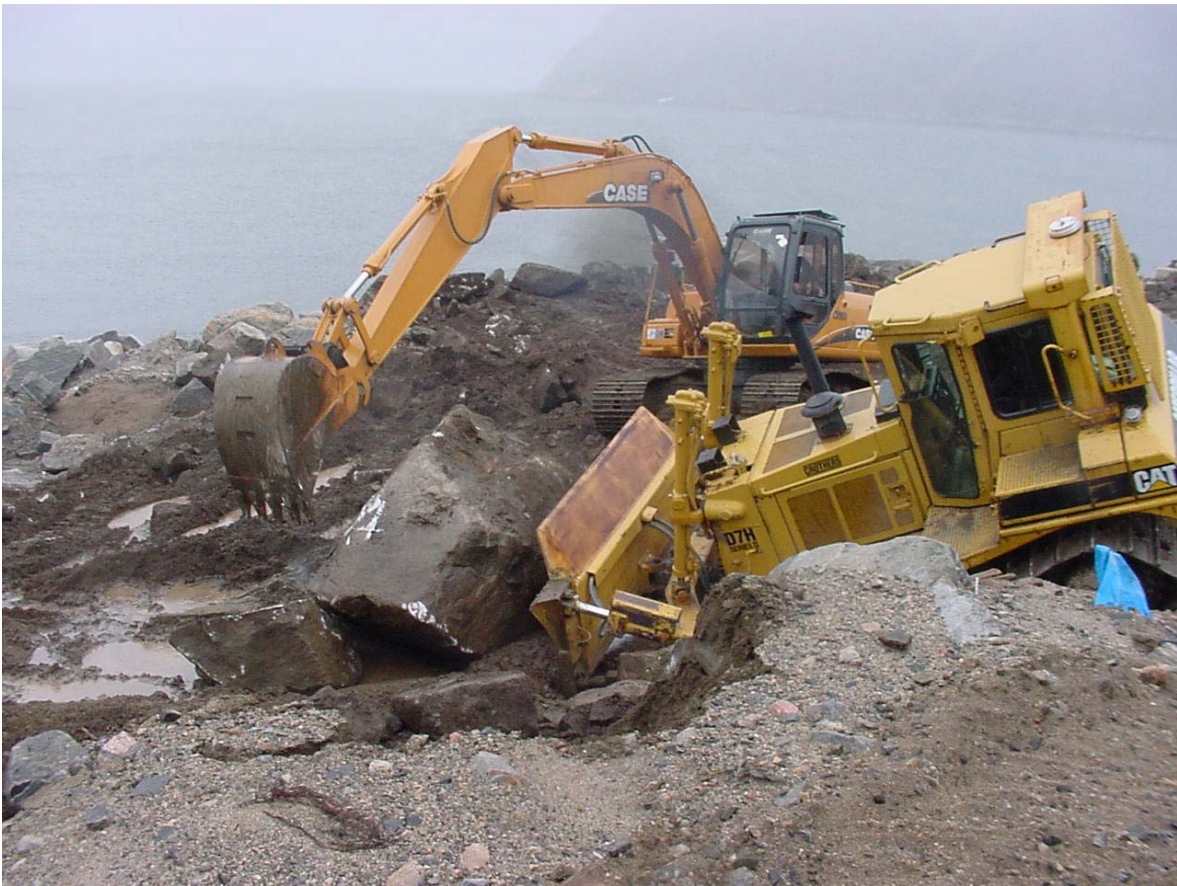
*Figure 4. Photograph illustrating large boulders encountered at east end of trench excavation.*

The barrier system was designed to be placed on the down-slope side of the excavated trench. The decision for a sloped installation was largely dictated by factors such as available manpower and ease of construction. It was recognized that this approach would require more geosynthetic barrier material and excavation than an alternative vertical wall system. However, a vertical trench was not possible because of the presence of large boulders and the possibility of intercepting the groundwater table that could lead to trench wall instability. Photographs of trench excavation illustrating ground conditions at the site are shown in Figures 4 and 5. The groundwater table was not observed during excavation of the trench nor was there visual evidence of free product LNAPL. The ponded water on the permafrost layer in Figure 5 was the result of rainfall runoff.

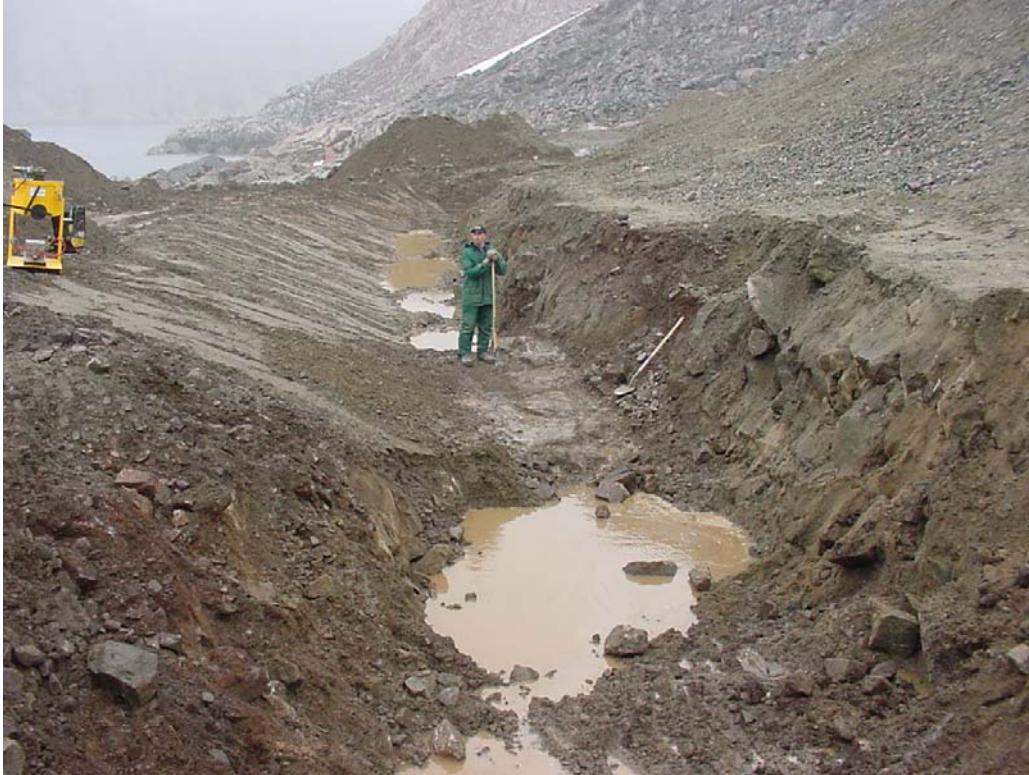
*Figure 5. Photograph of trench excavation illustrating bedrock encountered at trench bottom.*

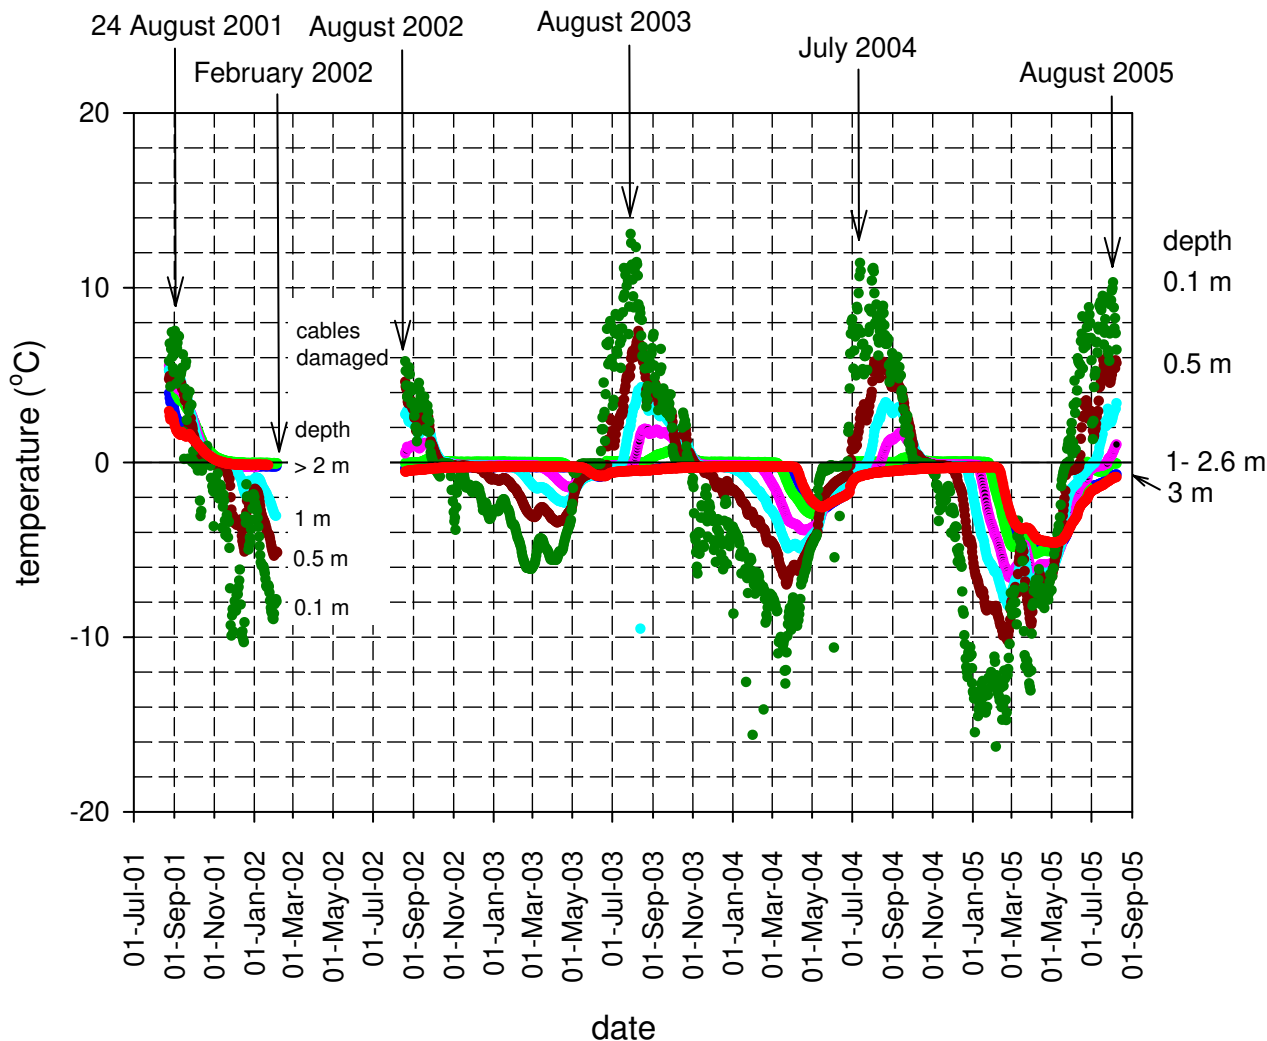
Figure 12. Example temperature-time histories from thermocouples located in Pipe 1 (upstream of barrier).

Temperature-time records from thermocouples placed in one of the instrumentation pipes immediately upstream of the barrier are shown in Figure 12. The gap in the records is due to severing of the cables by wildlife at the site in early 2002. The cables were repaired the following summer. Based on the data available, the ground temperatures at a given depth are lower in the winter of 2004-05 than the preceding winters. For monitoring points below a 2 m depth, temperatures are persistently below freezing based on the data available. This point is explored further by plotting temperature profiles from the same installation corresponding to the time of barrier installation and at selected times during the summers of 2003, 2004, and 2005 (Figure 13). The data show that freeze-back has occurred to an elevation well above the base of the original trench. The piezometers located close to the base of the barrier were frozen and hence measurement of the groundwater table behind the barrier was not recorded.
