# Effect of Dredging and Axial Load on a Berthing Structure

ABSTRACT: Piles and a diaphragm wall of a supported berthing structure on marine soils are loaded both axially and laterally. Axial loads are typically generated by the self weight of the structure and external live loads; lateral loads are typically generated by wave current and seismic loads. These loads are generally considered in the design of berthing structures. However, the lateral force generated by lateral soil movements due to dredging may not be considered or accounted in the design of berthing structures. Hence, a full-scale field study was conducted on a berthing structure to estimate the actual axial load distribution during axial loading and the lateral displacement during dredging. After construction of the berth, it was decided to conduct a full scale axial load test on a single pile and monitor the lateral movements of the berth during and after dredging. This paper describes the load transfer data obtained from a bored cast – in – situ pile socketed 1.5 m into hard rock and the lateral displacement of the berth recorded during and after dredging to a -9.5 m dredge depth.

Muthukkumaran K., Sundaravadive

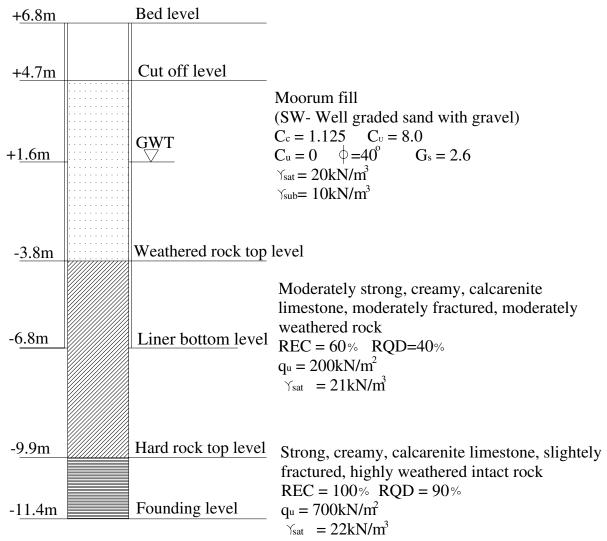
Figure 1. Typical Soil Profile at Pile Load Test Location.

A typical soil profile at the location of pile load test is shown in Fig. 1. The top 10.5 m consist of filled moorum soil, followed by rocky formation. The index and engineering properties of the encountered soils and rock are as follows.

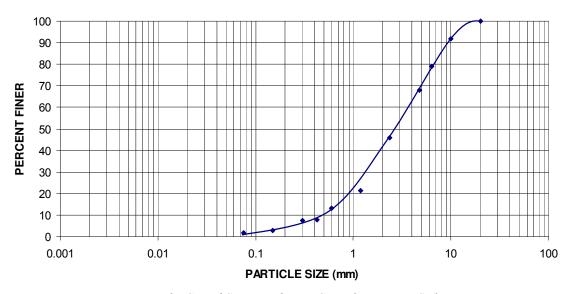
Figure 2. Graind Size Distribution Curve for Moorum Soil.

A typical grain size distribution curve of moorum fill is shown in Fig. 2. The effective particle size  $(D_{10})$  is 0.5 mm, average particle size  $(D_{50})$  is 2.7 mm, Coefficient of Uniformity  $(C_U)$  is 8.0, Coefficient of Curvature  $(C_C)$  is 1.125 and Specific Gravity  $(G_S)$  is 2.6. As per ASTM D-2487, the moorum fill soil is classified as well graded sand with gravel (SW). To obtain the value of angle of internal friction, direct shear tests were conducted on the moorum soil. The average angle of internal friction of the moorum soil was estimated to be  $40^{\circ}$ . Typical direct shear test results are presented in Fig. 3.

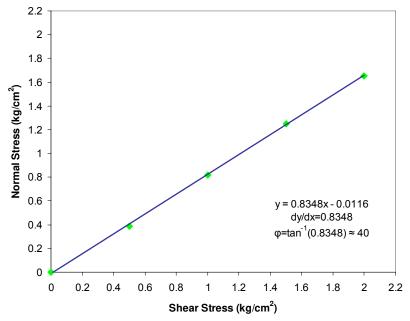
Figure 3. Direct Shear Test Result of Moorum Soil.

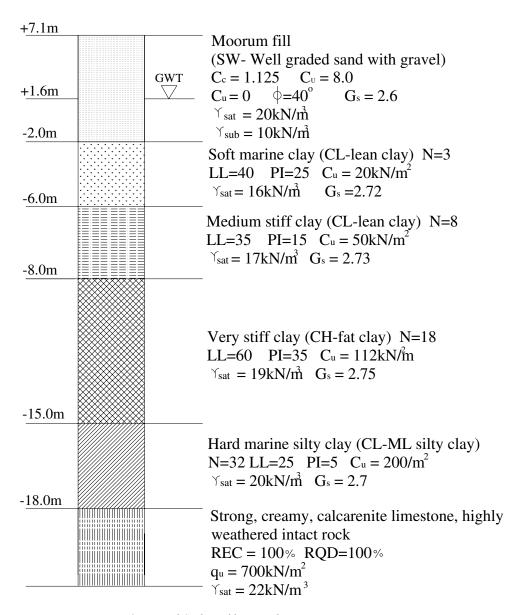
Figure 4. Typical Soil Profile at Inclinometer Test Locations.

Fig. 4 shows the typical soil profile at the pile and diaphragm wall panel locations where the inclinometer was installed. The top soil is moorum fill of 9.1 m thickness followed by 4 m soft marine clay with an average SPT (N) value of 3, followed by 2 m thick medium stiff clay with an average SPT (N) value of 8, followed by 7 m thick, very stiff clay with an average SPT (N) value of 18. The clay is underlain by 3 m thick hard marine silty clay with an average SPT (N) value of 32 which in turn is underlain by strong, creamy, calcarenite limestone, highly weathered intact rock with REC value of 100% and RQD value of 100%. Based on the RQD values, the encountered rock formations are classified as excellent rock. The index and engineering properties of the moorum soil are identical to the pile load test location moorum soil, presented previously. The encountered fine-grained soils index and engineering properties are presented below.

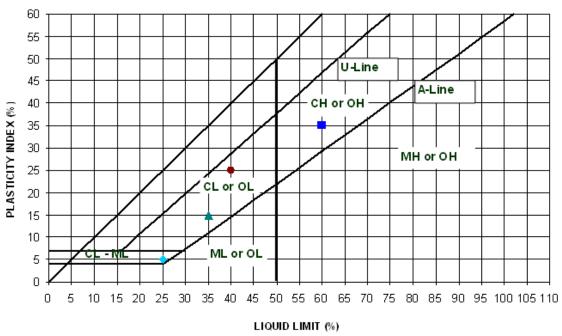
Elevation (m)	Symbol	LL (%)	PI (%)	Passing # 200 Sieve, (%)	USC Classification
-2.0 to -6.0	•	40	25	70	CL (Lean Clay)
-6.0 to -8.0	<b>A</b>	35	15	60	CL (Lean Clay)
-8.0 to -15.0		60	35	80	CH (Fat Clay)
-15.0 to -18.0	•	25	5	40	CL-ML (Silty Clay)

Figure 5. Classification of fine grained soil (ASTM D2487)

To obtain the index and engineering properties of the fine-grained soils, disturbed and undisturbed soil samples were collected at different depths. Liquid limit and plastic limit tests were conducted on the collected soil samples, to classify the soils based on the Unified Soil Classification System (USCS). The classification of the encountered fine grained soils is presented in Fig. 5. The undrained shear strength of the encountered fine grained soils was evaluated by conducting in-situ field vane shear tests in the soft clay soil and unconfined compression tests in the collected undisturbed soil samples. Two vane shear tests were conducted at elevations -2.0 m and -4.0 m. The average undrained shear strength of the layer (elevations between -2.0 m & -4.0 m) was obtained as 20 kN/m². The vane shear computations are presented in the appendix. The unconfined compression tests were conducted on the undisturbed soil samples collected at elevations of -6.0 m, -8.0 m, -11.0 m, -13.0 m, -15.0 m and -17.0 m. The typical unconfined compressive strength variation plot for elevations of -6.0 m, -11.0 m and -15.0 m are shown in Fig. 6a, 6b and 6c respectively. The average undrained shear strength of lean

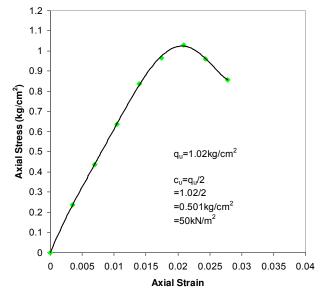
Figure 6a. Unconfined Compression Test Result at -6.0m depth.

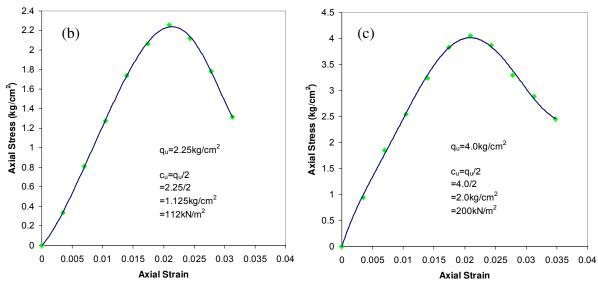
Figure 6b. Unconfined Compression Test Result at -11.0 m depth; 6c. Unconfined Compression Test Result at -15.0 m depth.

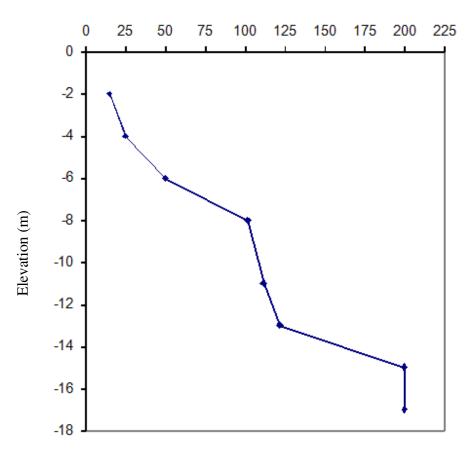
Figure 7. Variation of Undrained Shear Strength with Depth.

clay at elevations between -6.0 m and -8.0 m was estimated as 50 kN/m<sup>2</sup>. The average undrained shear strength value of fat clay at elevations between -8.0 m and -15.0 m was estimated as 112 kN/m<sup>2</sup>. The average undrained shear strength value of silty clay at elevations between -15.0 m and -18.0 m was estimated as 200 kN/m<sup>2</sup>. The undrained shear strength variation with elevation is shown in Fig. 7. The unconfined compressive strength computations are presented in the appendix.

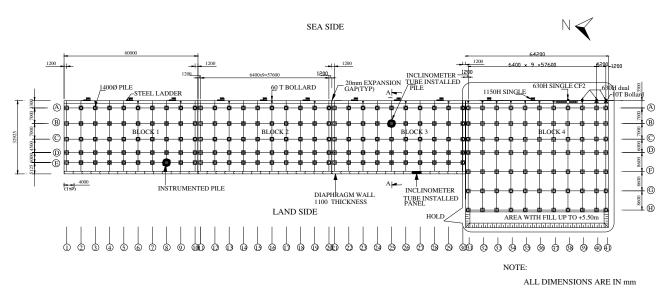
Figure 8. General Layout of Berthing Structure.

The general layout of the berthing structure and a cross section of the berth is shown in Fig. 8 and Fig. 9 respectively. The total length of the berth is 252 m and the width is 33 m. The berth is supported by both piles and the diaphragm wall. The diaphragm wall thickness is 1100 mm and extends to an elevation of -25.7 m. The construction of guide walls for the diaphragm wall is shown in Fig. 10. The diaphragm wall is constructed with the appropriate number of panels and each panel has a length of 5.0 m. Bored cast in-situ concrete piles of 1400 mm diameter are used and the founding elevation is varied between -11.4 m and -22.0 m based on the soil profile. The axial load test pile is terminated at an elevation of -11.4 m and the instrumented with inclinometer pile is terminated at an elevation of -22.0 m. The construction sequence of piles is shown in Fig. 11. The bored cast in-situ concrete piles were constructed using piling gantry. The natural seabed level at the structural location is +0.0 m elevation. To satisfy the berthing facility of the vessel, the ground level is required to be dredged up to an elevation of -9.5 m. The dredging was done in three stages, in each stage 3.0 m thick material is dredged. The inclinometer readings were collected when the water elevation in front of the structure was -3 m (prior to dredging) and -9.5 m (after -9.5 m dredging). Two sets of readings were collected at -9.5 m elevation, one immediately after dredge level reached an elevation of 9.5 m and the other 3 months after the first set of readings to evaluate time effects.

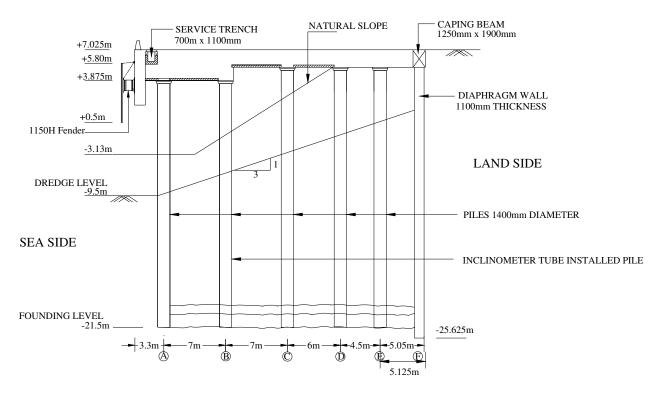
Section A-A Figure 9. Typical Cross Section of Berth.

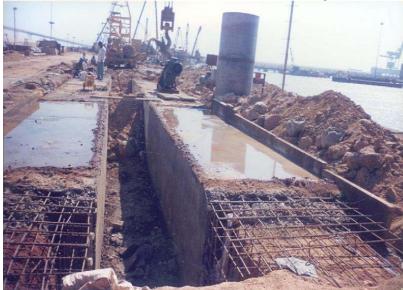
Figure 10. Construction Of Guide Walls For Diaphragm Wall.

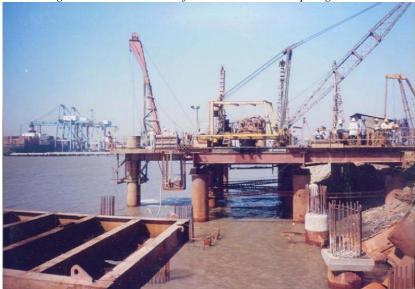
Figure 11. Construction of Piles.

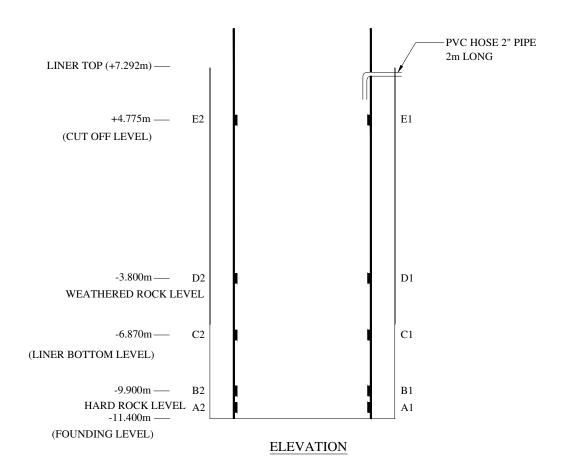
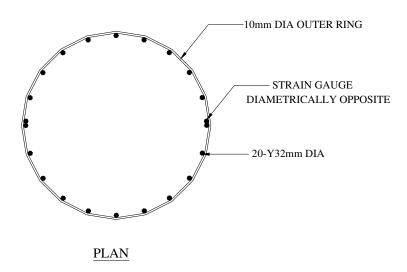
Figure 12. Pile Instrumentation with Strain Gauges.

The test pile is instrumented with electrical resistance type strain gauges. The gauges are attached at five different elevations as shown in Fig. 12. Two diametrically opposite main reinforcement rods are selected to mount the strain gauges. After mounting the gauges, the electric cable from each gauge is safely secured along the reinforcement bar to minimize the possibility of damage by the Tremie pipe during concreting. The cables of the gauges on the same reinforcement rod are bundled together and tied with a plastic wire to the reinforcement rod every 30 cm. The electric cables have a minimum length of 5 m beyond the cut off length to enable connection to the measuring instrument during the load test. All the strain gauges are aligned vertically.

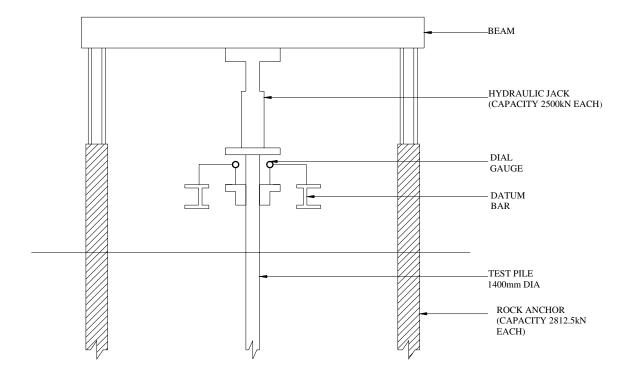
Figure 13. Schematic View of Pile Load Test Arrangement.

For the axial load test, the load applied on the test pile is obtained by the reaction forces from 4 pre-stressed rock anchors. Each anchor has a capacity of 2812.5 kN. The load on the pile is applied via 4 hydraulic jacks each of 2500 kN capacity. The settlement of the pile is recorded by 4 fixed dial gauges located at the same distance from the center of the pile. These dial gauges are installed on two datum bars with immovable support, at a distance of 3.6 m from the edge of the pile. A schematic view of the pile load test arrangement is shown in Fig. 13.

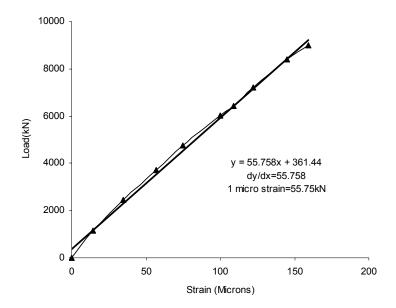
Figure 14. Strain Gauge Calibrations.

load test, the axial strain of the pile at each level was measured by the read out unit for every increment of loading. Strain gauge readings were taken 10 to 15 minutes after the load increment was applied. To estimate the mobilization of axial load along the pile shaft, the measured strain readings were converted to equivalent axial load by using a calibration constant. To obtain the calibration constant, one strain gauge was embedded in a concrete cylinder of 150 mm diameter and 300 mm long. The strain gauge was oriented such that the axis of strain gauge was parallel to the concrete cylinder axis. The cylinder was cured for 28 days and then tested in compression. The strain readings were observed to be almost linear with applied load. Fig. 14 shows the load as a function of strain. From the graph, the calibration constant of 55.75 kN was obtained, 1 micro strain being equal to 55.75 kN load.

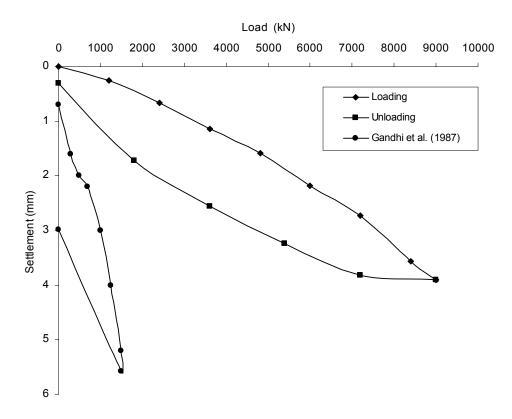
Figure 15. Load Settlement Curve.

The pile was tested up to 1.5 times the design load, i.e., up to 9000 kN. The load settlement curve is shown in Fig. 15. As per IS 2911 (Part-4) 1985, the maximum settlement at working load (1.5 times design load) may not exceed 12 mm. In the present study, the total settlement was 3.9 mm, rebound was 3.6 mm and net settlement was 0.3 mm, indicating that the pile

behaved well and has not reached its capacity. The pile load test results were compared to the Gandhi et al. (1987) pile load test results, which are also shown in Fig. 15. As presented in that paper, the pile load test was conducted on a 6.5 m long and 0.5 m diameter pile. Out of the 6.5 m, 0.5 m are socketed in hard rock strata. The test was conducted at the NALCO project site, Angul in India. The soil profile at this location includes 3.0 m of red soil with an average SPT (N) value 35, followed by yellowish grey weathered rock with SPT (N) values of about 100. Dark grey hard rock is present at 6.0 m below the ground level. The subsurface stratigraphy of the present study area (JNPT, Mumbai) and Gandhi et al. (1987) study area (NALCO project site, Angul) are not the same and thus, the load-settlement response of the test piles is different.

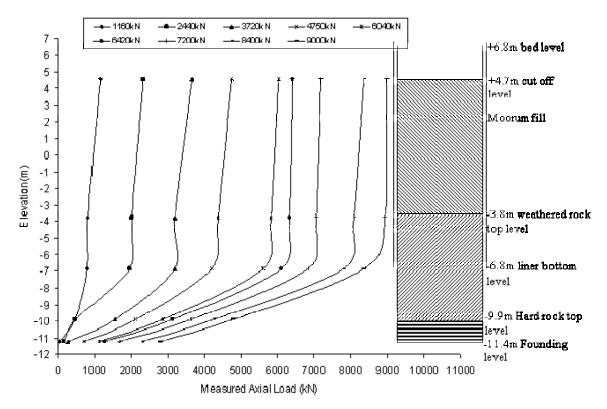
Figure 16. Mobilization of Axial Load.

Fig. 16 shows the load resisted by each soil layer. The maximum load is mobilized from an elevation of -6.87 m to -9.9 m, where the weathered rock is present. The mobilization of frictional resistance is not significant at the top layer of moorum fill. Nearly 4000 kN load is mobilized in the weathered rock, 2000 kN mobilized in hard rock, and 2000 kN mobilized in the moorum fill strata under a total applied load of 9000 kN. Only 1000 kN load is resisted by end bearing by the hard rock.

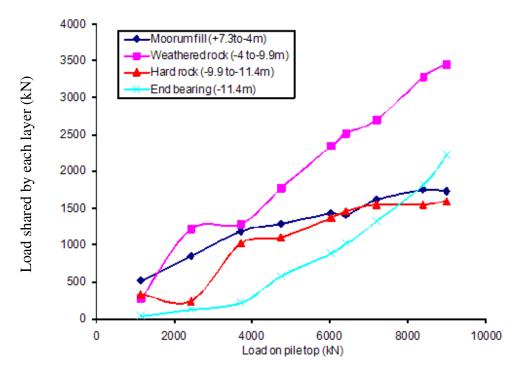
Figure 17. Axial Load Shared by Each Layer.

Fig. 17 shows the load shared by each layer for all applied load increments. For all cases except the load increment of 8400 kN and 9000 kN, the frictional resistance was significantly increased in all soil layers compared to the end bearing resistance. For the test load of 9000 kN, the end bearing resistance was higher than the frictional resistances of the moorum fill and the hard rock. However, the mobilization of end bearing was less than the frictional resistance in weathered rock. Nearly 75% of the load is resisted by friction and 25% of the load is resisted by end bearing. The weathered rock contributed about 20% to 45% of the total pile resistance.

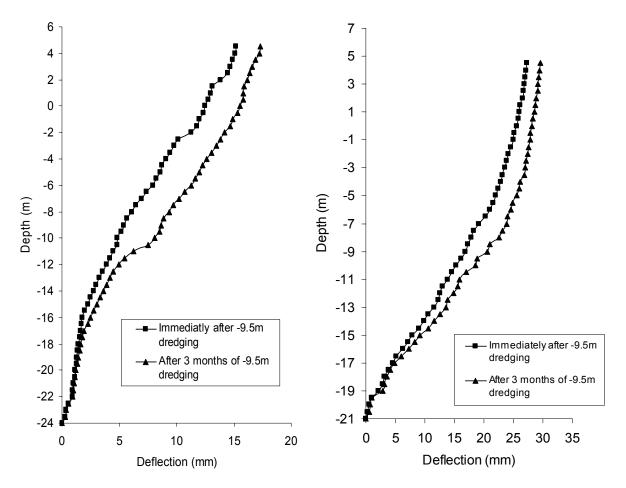
Figure 18. Deflected Shape of Diaphragm Wall.

Figure 19. Deflected Shape of Pile.

After construction of the full berth, the inclinometer readings were collected in 3 stages. First set of readings were taken after construction of the berth and prior to dredging. This reading represents the initial position of the diaphragm wall and pile. The second readings were collected immediately after dredging to an elevation of -9.5 m. The difference between the second and first reading is the deflected shape of the diaphragm wall panel and pile. The third readings were collected 3 months after dredging to an elevation of -9.5 m. The difference between the third and second reading is shown in Fig. 18 and 19.

It can be observed that for the diaphragm wall immediately after -9.5 m dredging, the maximum deflection is 15.2 mm at the level of +4 m, while at the same level the maximum deflection increased to 17.3 mm after three months. The increase in deflection is probably due to the consolidation and associated pore pressure dissipation effects of the soft clayey soil. The same behavior was observed for the pile also. For both the pile and the diaphragm wall the deflection from -16 m elevation and lower is small compared to the upper layers due to the lower hard layers of marine silty clay and rock.
