Effect of Dredging and Axial Load on a Berthing Structure

Muthukkumaran K., Sundaravadivelu R., Gandhi S.R. (2007). *Effect of Dredging and Axial Load on a Berthing Structure*. International Journal of Geoengineering Case histories, <http://casehistories.geoengineer.org>, Vol.1, Issue 2, p.73-88.

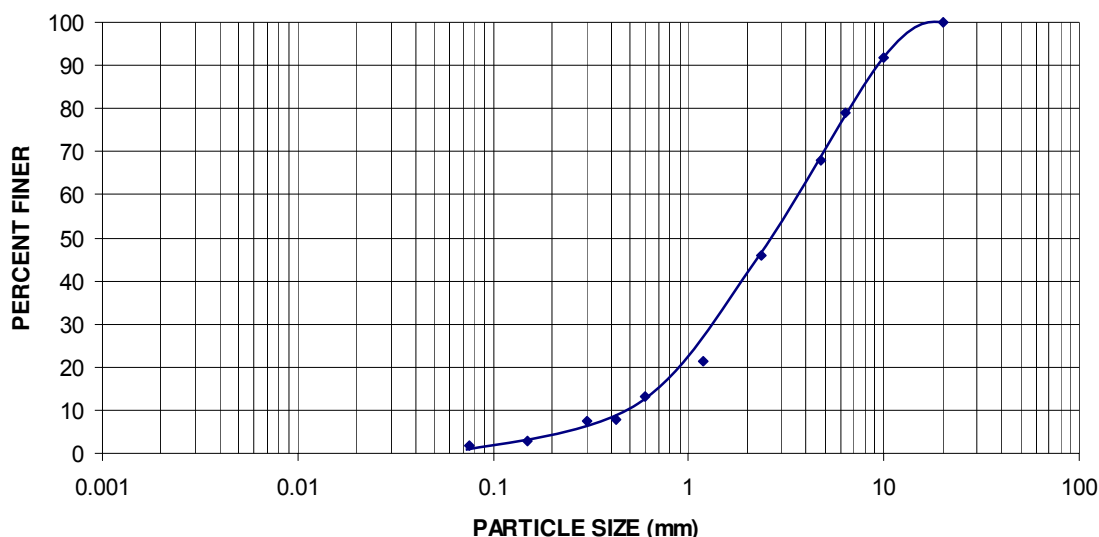
Figure 2. Grain Size Distribution Curve for Moorum Soil.

A typical grain size distribution curve of moorum fill is shown in Fig. 2. The effective particle size (D_{10}) is 0.5 mm, average particle size (D_{50}) is 2.7 mm, Coefficient of Uniformity (C_U) is 8.0, Coefficient of Curvature (C_C) is 1.125 and Specific Gravity (G_s) is 2.6. As per ASTM D-2487, the moorum fill soil is classified as well graded sand with gravel (SW). To obtain the value of angle of internal friction, direct shear tests were conducted on the moorum soil. The average angle of internal friction of the moorum soil was estimated to be 40° . Typical direct shear test results are presented in Fig. 3.

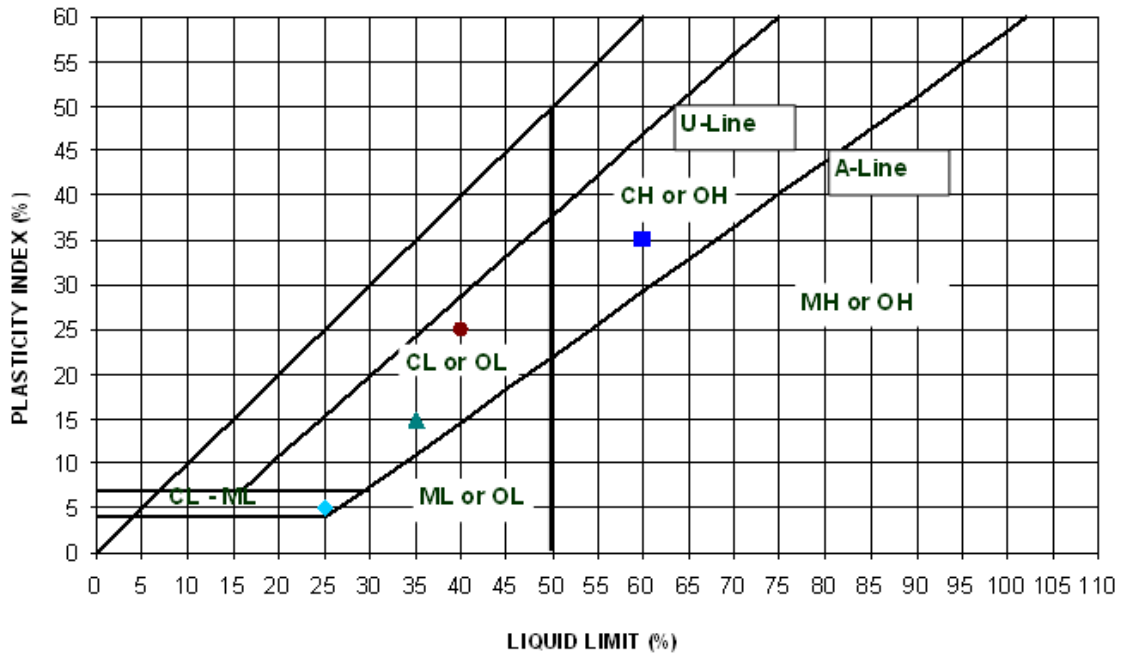
Elevation (m)	Symbol	LL (%)	PI (%)	Passing # 200 Sieve, (%)	USC Classification
-2.0 to -6.0	●	40	25	70	CL (Lean Clay)
-6.0 to -8.0	▲	35	15	60	CL (Lean Clay)
-8.0 to -15.0	■	60	35	80	CH (Fat Clay)
-15.0 to -18.0	◆	25	5	40	CL-ML (Silty Clay)

Figure 5. Classification of fine grained soil (ASTM D2487)

To obtain the index and engineering properties of the fine-grained soils, disturbed and undisturbed soil samples were collected at different depths. Liquid limit and plastic limit tests were conducted on the collected soil samples, to classify the soils based on the Unified Soil Classification System (USCS). The classification of the encountered fine grained soils is presented in Fig. 5. The undrained shear strength of the encountered fine grained soils was evaluated by conducting in-situ field vane shear tests in the soft clay soil and unconfined compression tests in the collected undisturbed soil samples. Two vane shear tests were conducted at elevations -2.0 m and -4.0 m. The average undrained shear strength of the layer (elevations between -2.0 m & -4.0 m) was obtained as 20 kN/m². The vane shear computations are presented in the appendix. The unconfined compression tests were conducted on the undisturbed soil samples collected at elevations of -6.0 m, -8.0 m, -11.0 m, -13.0 m, -15.0 m and -17.0 m. The typical unconfined compressive strength variation plot for elevations of -6.0 m, -11.0 m and -15.0 m are shown in Fig. 6a, 6b and 6c respectively. The average undrained shear strength of lean

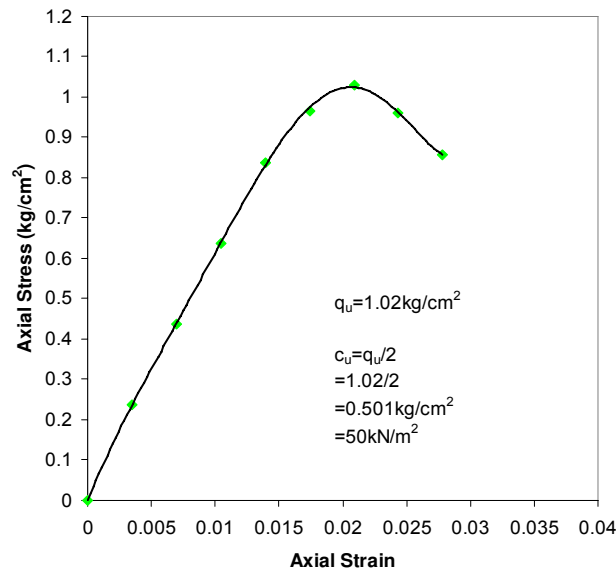
Figure 6a. Unconfined Compression Test Result at -6.0m depth.

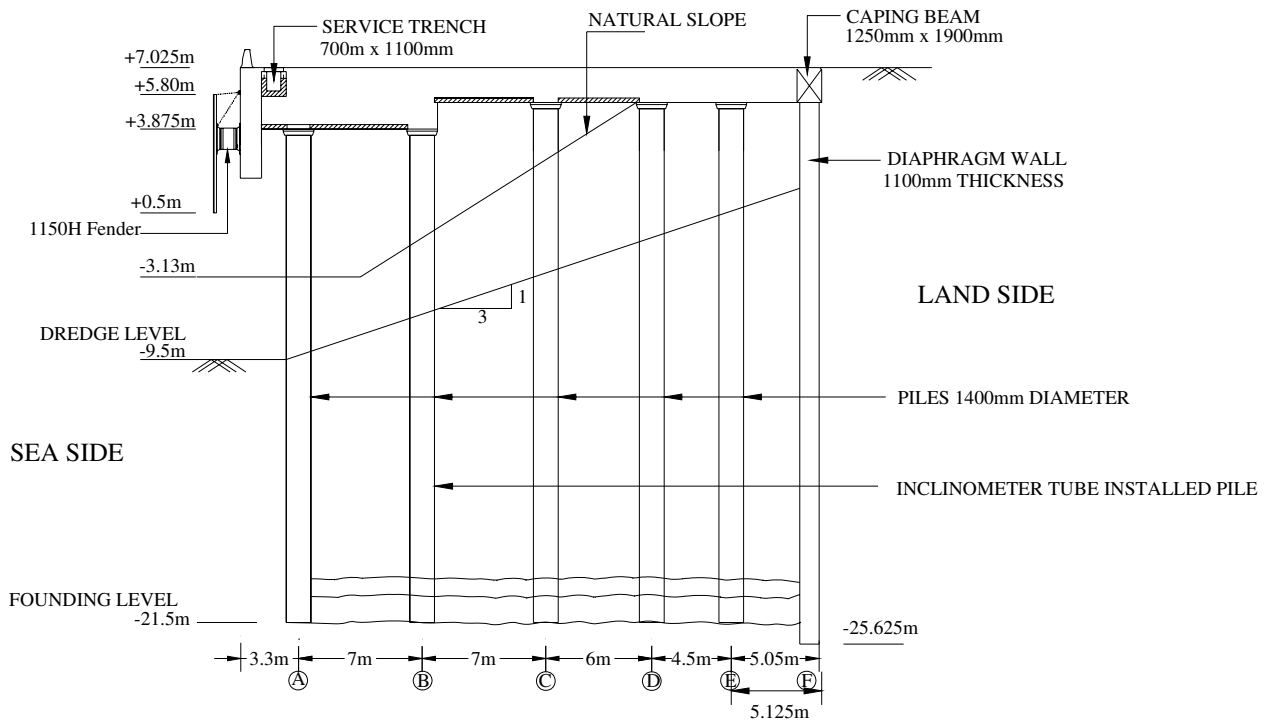
Section A-A
Figure 9. Typical Cross Section of Berth.

The general layout of the berthing structure and a cross section of the berth is shown in Fig. 8 and Fig. 9 respectively. The total length of the berth is 252 m and the width is 33 m. The berth is supported by both piles and the diaphragm wall. The diaphragm wall thickness is 1100 mm and extends to an elevation of -25.7 m. The construction of guide walls for the diaphragm wall is shown in Fig. 10. The diaphragm wall is constructed with the appropriate number of panels and each panel has a length of 5.0 m. Bored cast in-situ concrete piles of 1400 mm diameter are used and the founding elevation is varied between -11.4 m and -22.0 m based on the soil profile. The axial load test pile is terminated at an elevation of -11.4 m and the instrumented with inclinometer pile is terminated at an elevation of -22.0 m. The construction sequence of piles is shown in Fig. 11. The bored cast in-situ concrete piles were constructed using piling gantry. The natural seabed level at the structural location is +0.0 m elevation. To satisfy the berthing facility of the vessel, the ground level is required to be dredged up to an elevation of -9.5 m. The dredging was done in three stages, in each stage 3.0 m thick material is dredged. The inclinometer readings were collected when the water elevation in front of the structure was -3 m (prior to dredging) and -9.5 m (after -9.5 m dredging). Two sets of readings were collected at -9.5 m elevation, one immediately after dredge level reached an elevation of 9.5 m and the other 3 months after the first set of readings to evaluate time effects.

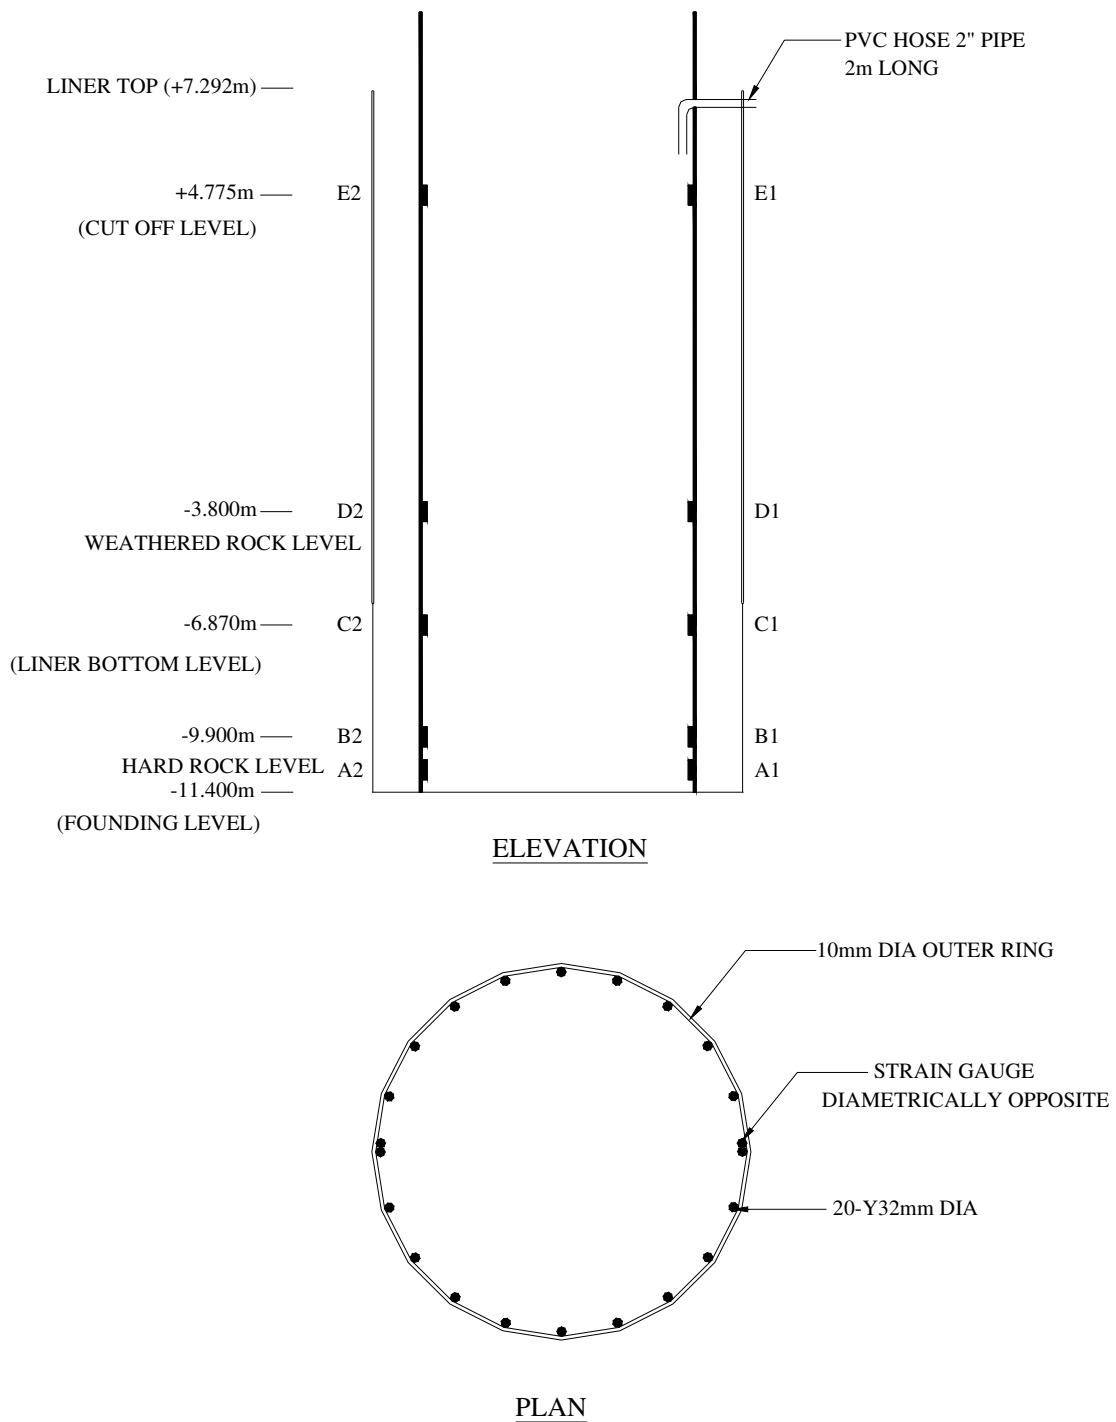
Figure 12. Pile Instrumentation with Strain Gauges.

The test pile is instrumented with electrical resistance type strain gauges. The gauges are attached at five different elevations as shown in Fig. 12. Two diametrically opposite main reinforcement rods are selected to mount the strain gauges. After mounting the gauges, the electric cable from each gauge is safely secured along the reinforcement bar to minimize the possibility of damage by the Tremie pipe during concreting. The cables of the gauges on the same reinforcement rod are bundled together and tied with a plastic wire to the reinforcement rod every 30 cm. The electric cables have a minimum length of 5 m beyond the cut off length to enable connection to the measuring instrument during the load test. All the strain gauges are aligned vertically.

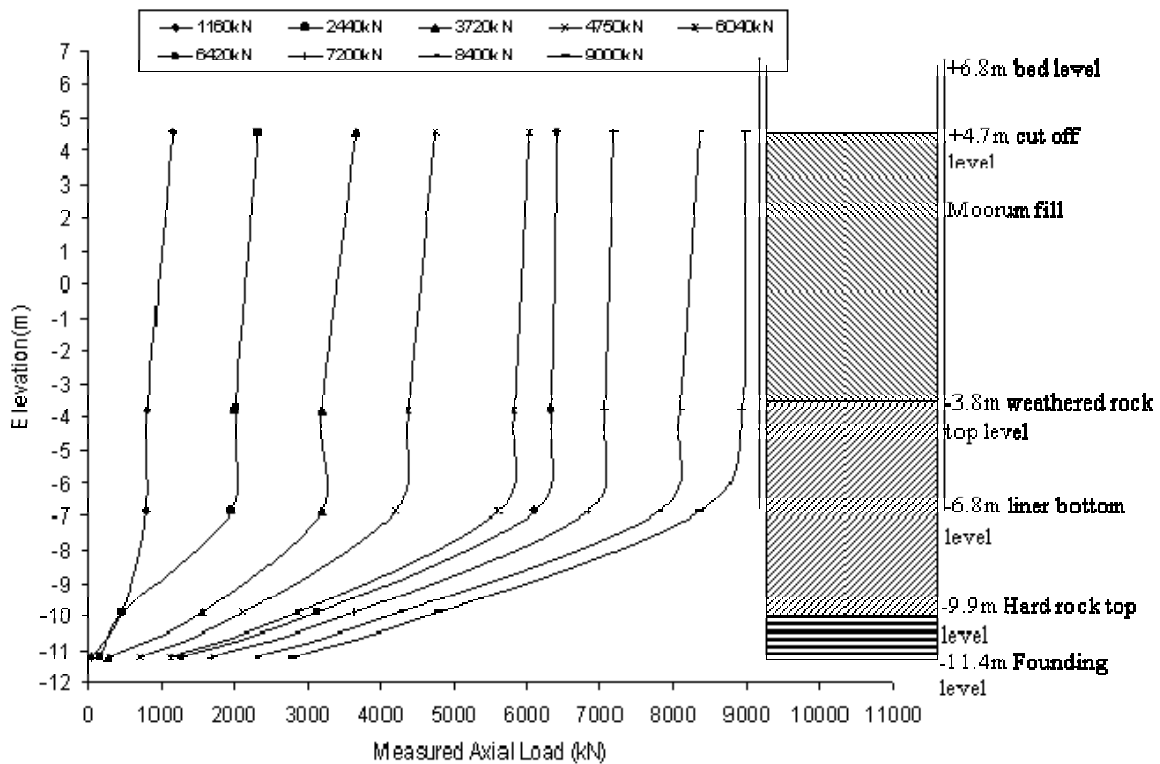
Figure 16. Mobilization of Axial Load.

Fig. 16 shows the load resisted by each soil layer. The maximum load is mobilized from an elevation of -6.87 m to -9.9 m, where the weathered rock is present. The mobilization of frictional resistance is not significant at the top layer of moorum fill. Nearly 4000 kN load is mobilized in the weathered rock, 2000 kN mobilized in hard rock, and 2000 kN mobilized in the moorum fill strata under a total applied load of 9000 kN. Only 1000 kN load is resisted by end bearing by the hard rock.

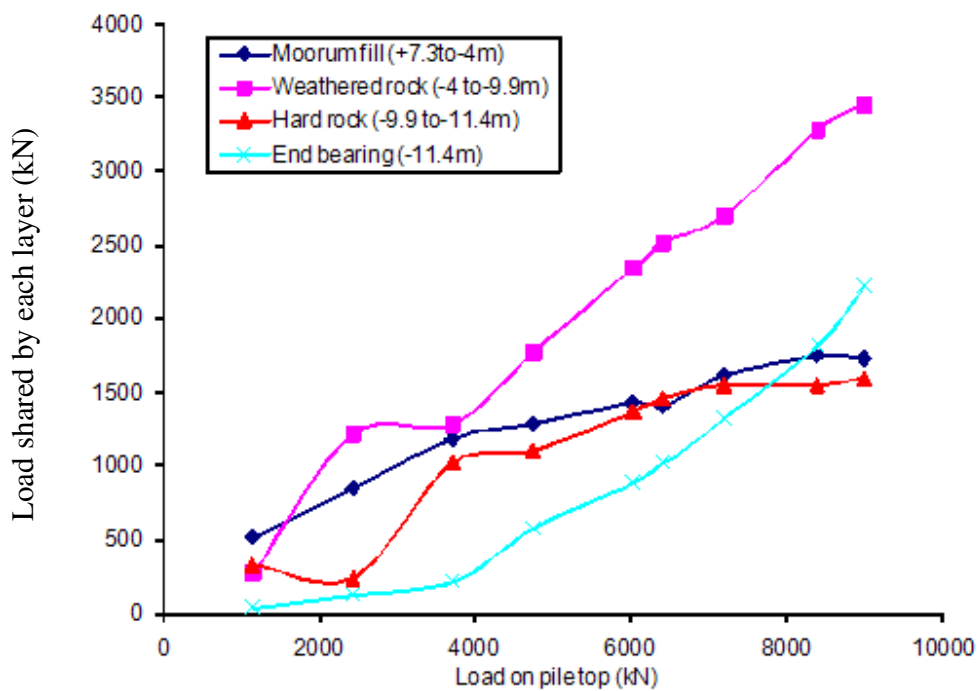
Figure 17. Axial Load Shared by Each Layer.

Fig. 17 shows the load shared by each layer for all applied load increments. For all cases except the load increment of 8400 kN and 9000 kN, the frictional resistance was significantly increased in all soil layers compared to the end bearing resistance. For the test load of 9000 kN, the end bearing resistance was higher than the frictional resistances of the moorum fill and the hard rock. However, the mobilization of end bearing was less than the frictional resistance in weathered rock. Nearly 75% of the load is resisted by friction and 25% of the load is resisted by end bearing. The weathered rock contributed about 20% to 45% of the total pile resistance.
