Effect of Dredging and Axial Load on a Berthing Structure

ABSTRACT: Piles and a diaphragm wall of a supported berthing structure on marine soils are loaded both axially and laterally. Axial loads are typically generated by the self weight of the structure and external live loads; lateral loads are typically generated by wave current and seismic loads. These loads are generally considered in the design of berthing structures. However, the lateral force generated by lateral soil movements due to dredging may not be considered or accounted in the design of berthing structures. Hence, a full-scale field study was conducted on a berthing structure to estimate the actual axial load distribution during axial loading and the lateral displacement during dredging. After construction of the berth, it was decided to conduct a full scale axial load test on a single pile and monitor the lateral movements of the berth during and after dredging. This paper describes the load transfer data obtained from a bored cast – in – situ pile socketed 1.5 m into hard rock and the lateral displacement of the berth recorded during and after dredging to a -9.5 m dredge depth.

Muthukkumaran K., Sundaravadivelu

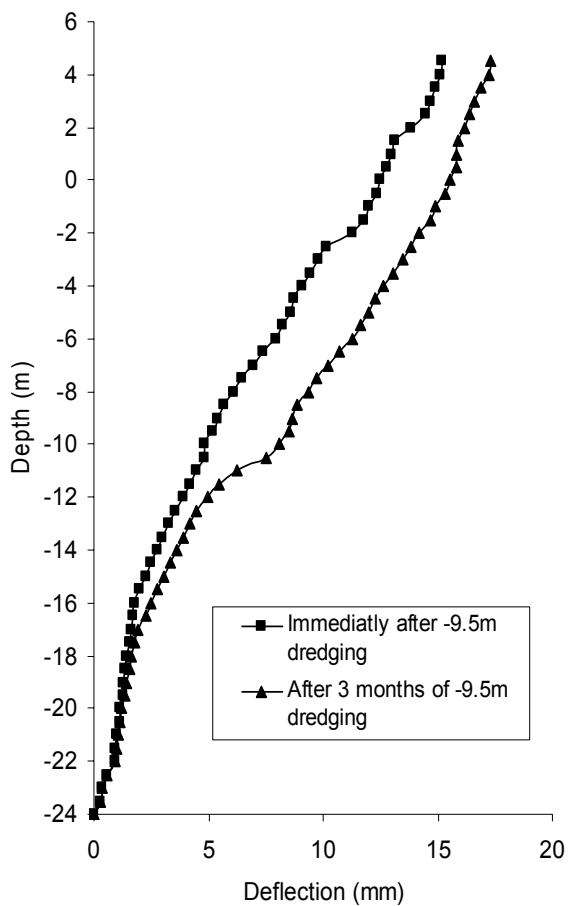
After construction of the full berth, the inclinometer readings were collected in 3 stages. First set of readings were taken after construction of the berth and prior to dredging. This reading represents the initial position of the diaphragm wall and pile. The second readings were collected immediately after dredging to an elevation of -9.5 m. The difference between the second and first reading is the deflected shape of the diaphragm wall panel and pile. The third readings were collected 3 months after dredging to an elevation of -9.5 m. The difference between the third and second reading is shown in Fig. 18 and 19.

It can be observed that for the diaphragm wall immediately after -9.5 m dredging, the maximum deflection is 15.2 mm at the level of +4 m, while at the same level the maximum deflection increased to 17.3 mm after three months. The increase in deflection is probably due to the consolidation and associated pore pressure dissipation effects of the soft clayey soil. The same behavior was observed for the pile also. For both the pile and the diaphragm wall the deflection from -16 m elevation and lower is small compared to the upper layers due to the lower hard layers of marine silty clay and rock.

Figure 18. Deflected Shape of Diaphragm Wall.

- (1) The maximum deflection of 30 mm was measured in the berthing structure after dredging to an elevation of -9.5 m. The permissible lateral movement of the berthing structure was 150 mm and thus the deflections observed were considered small.
- (2) About 87% of the maximum deflection was mobilized at the soft top layers, probably due to the presence of the underlying harder ground materials.
