Effect of Dredging and Axial Load on a Berthing Structure

ABSTRACT: Piles and a diaphragm wall of a supported berthing structure on marine soils are loaded both axially and laterally. Axial loads are typically generated by the self weight of the structure and external live loads; lateral loads are typically generated by wave current and seismic loads. These loads are generally considered in the design of berthing structures. However, the lateral force generated by lateral soil movements due to dredging may not be considered or accounted in the design of berthing structures. Hence, a full-scale field study was conducted on a berthing structure to estimate the actual axial load distribution during axial loading and the lateral displacement during dredging. After construction of the berth, it was decided to conduct a full scale axial load test on a single pile and monitor the lateral movements of the berth during and after dredging. This paper describes the load transfer data obtained from a bored cast – in – situ pile socketed 1.5 m into hard rock and the lateral displacement of the berth recorded during and after dredging to a -9.5 m dredge depth.

Muthukkumaran K., Sundaravadivelu

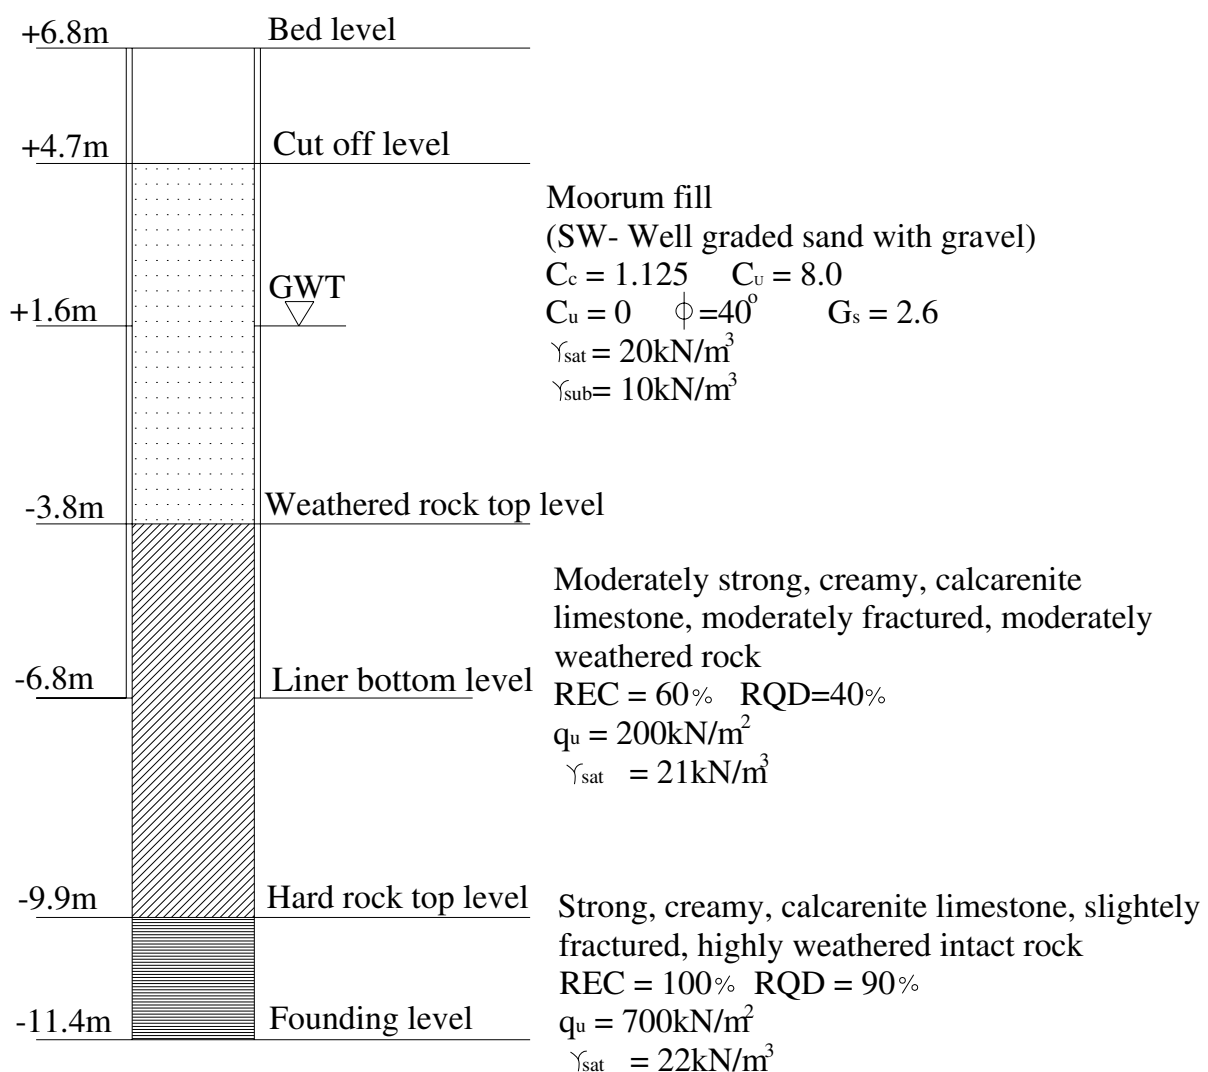
Figure 1. Typical Soil Profile at Pile Load Test Location.

A typical soil profile at the location of pile load test is shown in Fig. 1. The top 10.5 m consist of filled moorum soil, followed by rocky formation. The index and engineering properties of the encountered soils and rock are as follows.

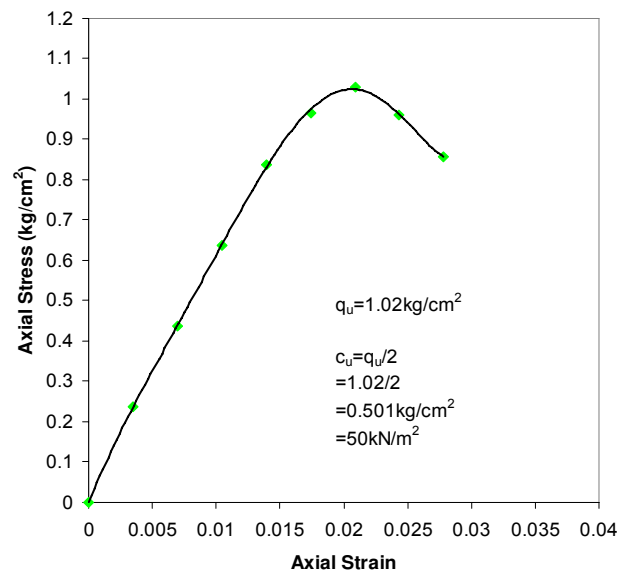
Figure 6a. Unconfined Compression Test Result at -6.0m depth.

To obtain the index and engineering properties of the fine-grained soils, disturbed and undisturbed soil samples were collected at different depths. Liquid limit and plastic limit tests were conducted on the collected soil samples, to classify the soils based on the Unified Soil Classification System (USCS). The classification of the encountered fine grained soils is presented in Fig. 5. The undrained shear strength of the encountered fine grained soils was evaluated by conducting in-situ field vane shear tests in the soft clay soil and unconfined compression tests in the collected undisturbed soil samples. Two vane shear tests were conducted at elevations -2.0 m and -4.0 m. The average undrained shear strength of the layer (elevations between -2.0 m & -4.0 m) was obtained as 20 kN/m². The vane shear computations are presented in the appendix. The unconfined compression tests were conducted on the undisturbed soil samples collected at elevations of -6.0 m, -8.0 m, -11.0 m, -13.0 m, -15.0 m and -17.0 m. The typical unconfined compressive strength variation plot for elevations of -6.0 m, -11.0 m and -15.0 m are shown in Fig. 6a, 6b and 6c respectively. The average undrained shear strength of lean

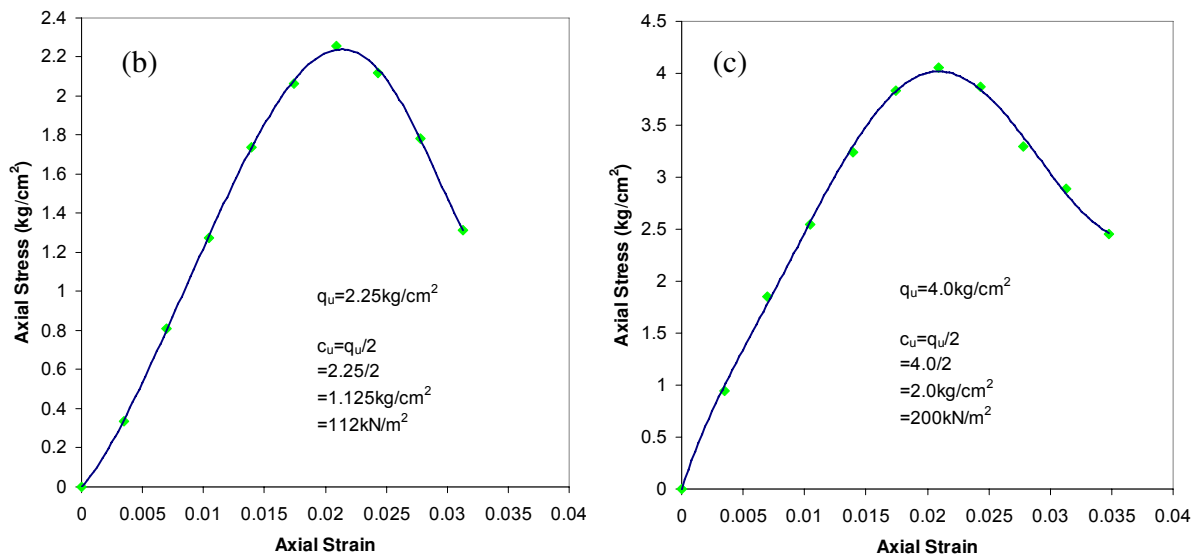
Figure 6b. Unconfined Compression Test Result at -11.0 m depth; 6c. Unconfined Compression Test Result at -15.0 m depth.
