## Effect of Dredging and Axial Load on a Berthing Structure

**ABSTRACT:** Piles and a diaphragm wall of a supported berthing structure on marine soils are loaded both axially and laterally. Axial loads are typically generated by the self weight of the structure and external live loads; lateral loads are typically generated by wave current and seismic loads. These loads are generally considered in the design of berthing structures. However, the lateral force generated by lateral soil movements due to dredging may not be considered or accounted in the design of berthing structures. Hence, a full-scale field study was conducted on a berthing structure to estimate the actual axial load distribution during axial loading and the lateral displacement during dredging. After construction of the berth, it was decided to conduct a full scale axial load test on a single pile and monitor the lateral movements of the berth during and after dredging. This paper describes the load transfer data obtained from a bored cast – in – situ pile socketed 1.5 m into hard rock and the lateral displacement of the berth recorded during and after dredging to a -9.5 m dredge depth.

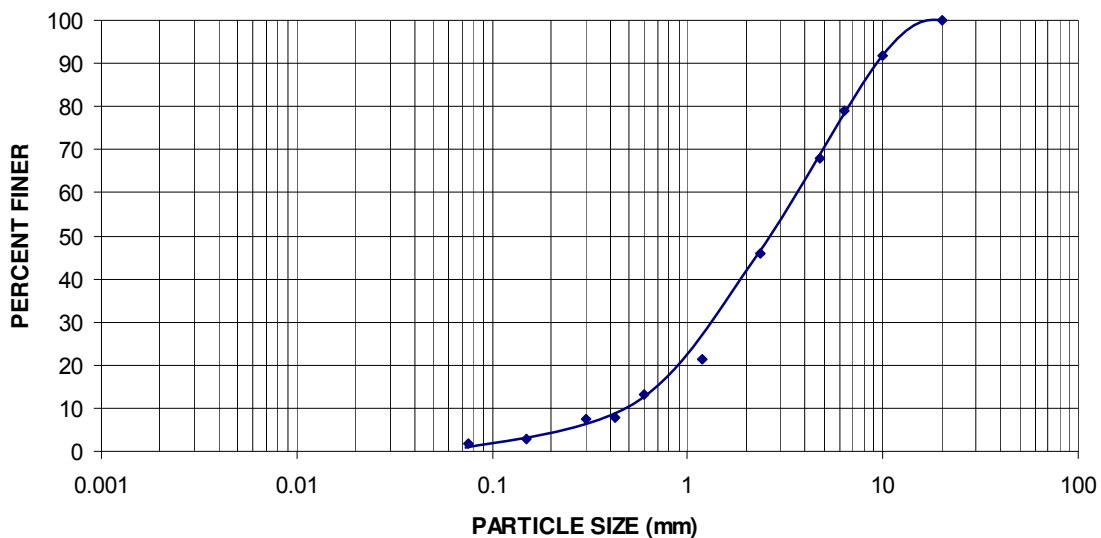
Figure 2. Grain Size Distribution Curve for Moorum Soil.

A typical grain size distribution curve of moorum fill is shown in Fig. 2. The effective particle size ( $D_{10}$ ) is 0.5 mm, average particle size ( $D_{50}$ ) is 2.7 mm, Coefficient of Uniformity ( $C_U$ ) is 8.0, Coefficient of Curvature ( $C_C$ ) is 1.125 and Specific Gravity ( $G_s$ ) is 2.6. As per ASTM D-2487, the moorum fill soil is classified as well graded sand with gravel (SW). To obtain the value of angle of internal friction, direct shear tests were conducted on the moorum soil. The average angle of internal friction of the moorum soil was estimated to be  $40^\circ$ . Typical direct shear test results are presented in Fig. 3.

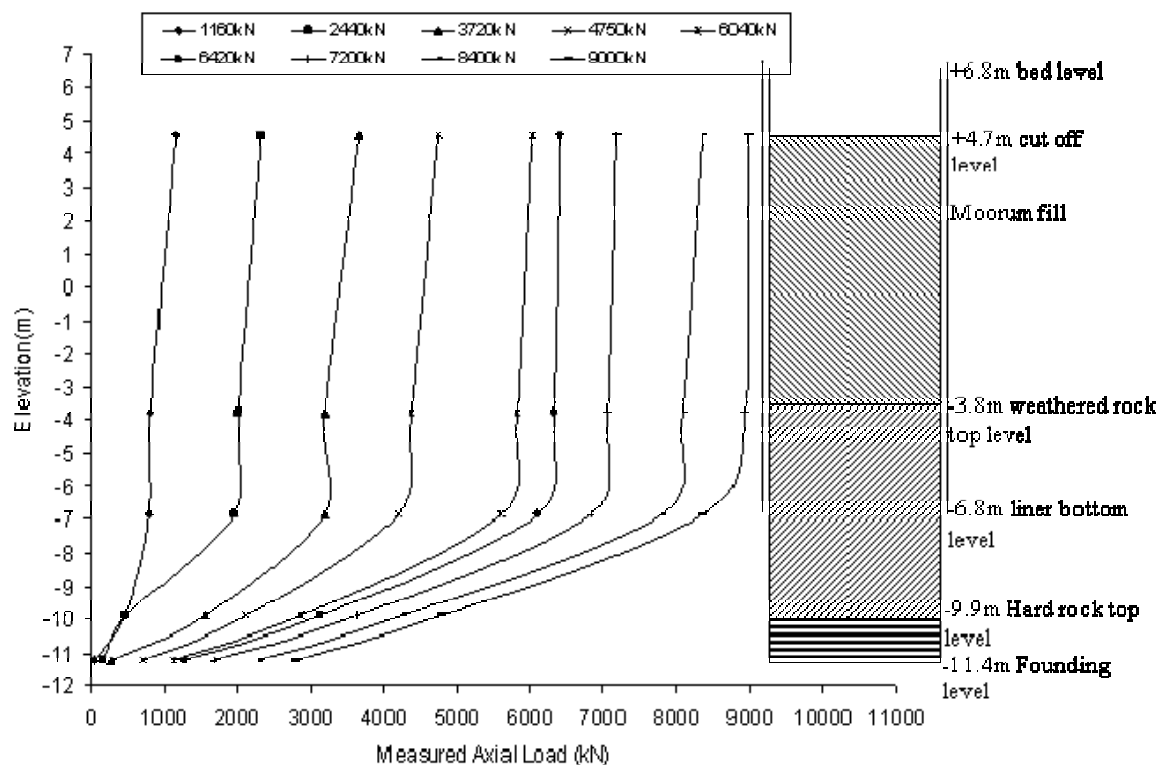
Figure 16. Mobilization of Axial Load.

Fig. 16 shows the load resisted by each soil layer. The maximum load is mobilized from an elevation of -6.87 m to -9.9 m, where the weathered rock is present. The mobilization of frictional resistance is not significant at the top layer of moorum fill. Nearly 4000 kN load is mobilized in the weathered rock, 2000 kN mobilized in hard rock, and 2000 kN mobilized in the moorum fill strata under a total applied load of 9000 kN. Only 1000 kN load is resisted by end bearing by the hard rock.

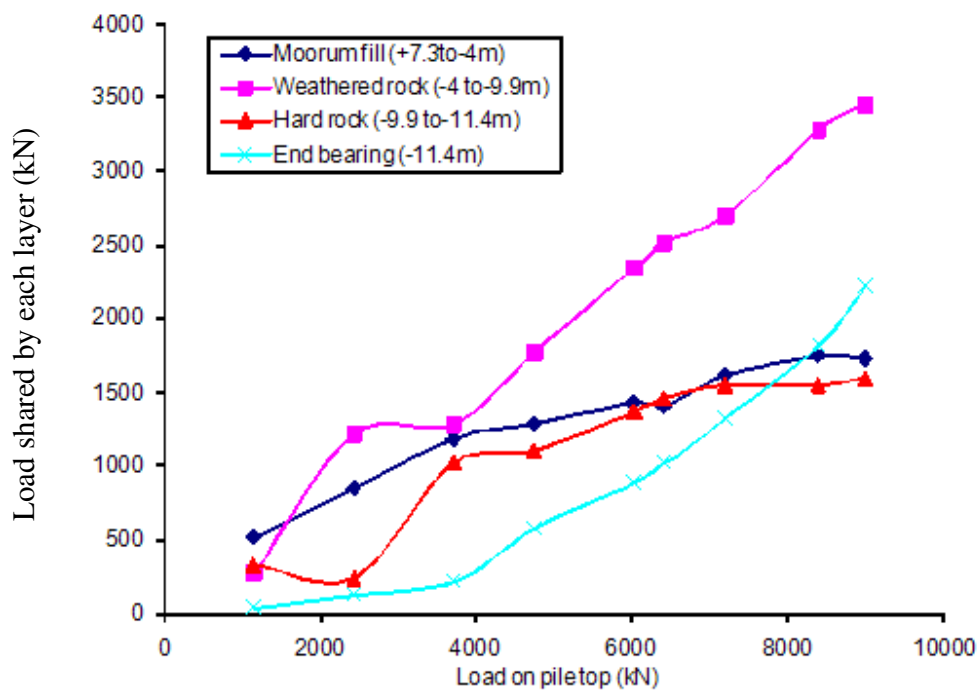
Figure 17. Axial Load Shared by Each Layer.

Fig. 17 shows the load shared by each layer for all applied load increments. For all cases except the load increment of 8400 kN and 9000 kN, the frictional resistance was significantly increased in all soil layers compared to the end bearing resistance. For the test load of 9000 kN, the end bearing resistance was higher than the frictional resistances of the moorum fill and the hard rock. However, the mobilization of end bearing was less than the frictional resistance in weathered rock. Nearly 75% of the load is resisted by friction and 25% of the load is resisted by end bearing. The weathered rock contributed about 20% to 45% of the total pile resistance.
