# Leaning Tower of Pisa: Behaviour after Stabilization Operations

**ABSTRACT:** It is well known that the foundations of the Leaning Tower of Pisa were stabilised using the method of underexcavation to reduce the southward inclination of the Tower by about 10 percent in combination with controlling the seasonally fluctuating water table beneath the north side. Having been closed to the public since early in 1990, the Tower was re-opened in December 2001. The paper summarises the response of the Tower during the period of implementation of the stabilisation works. Monitoring of the movements of the Tower has been continuing and the observations obtained since 2001 are presented. It is shown that over the six years between 2003 and 2008 the induced rate of northward rotation of the Tower has been steadily reducing to less than 0.2 arc seconds per year. Similarly the rate of induced settlement of the centre of the foundation has been steadily reducing and is approaching the background rate of settlement of the Piazza. Piezometer measurements close to the north side of the foundation shows that the drainage system has been successful in stabilising the groundwater levels beneath the n

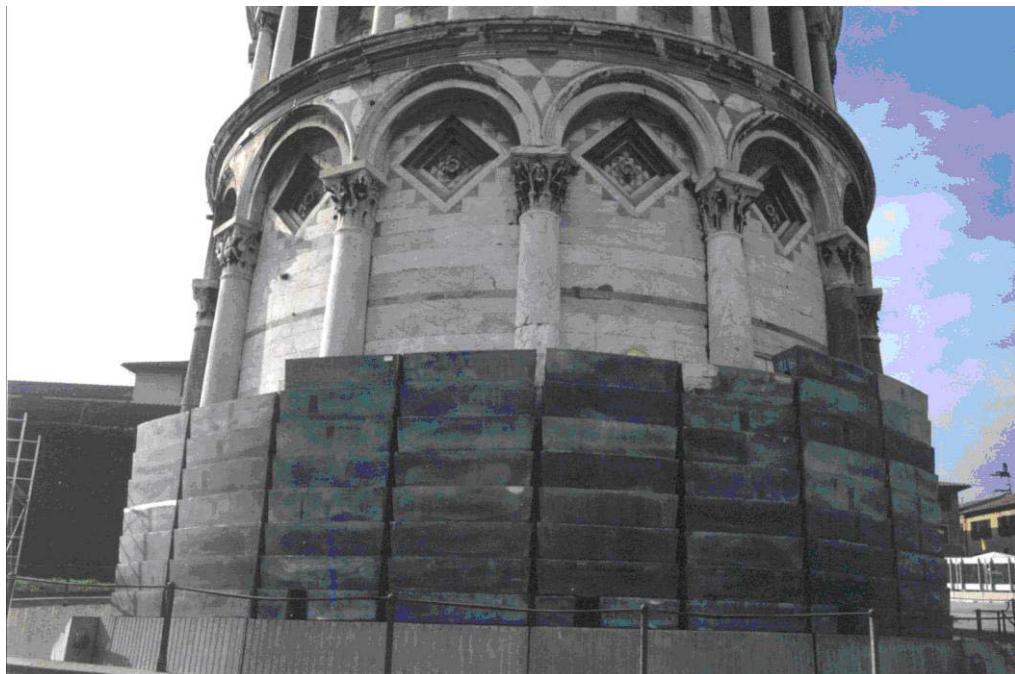
Figure 7. Lead counterweight on the North Side.

Temporary stabilisation of the foundation was achieved during the second half of 1993 by the application of 600t of lead weights on the north side of the foundations via a post-tensioned removable concrete ring cast around the base of the Tower at plinth level, see Fig. 7. This caused a reduction in inclination of about one minute of arc and, more importantly, reduced the overturning moment by about ten percent. In September 1995 the load was increased to 900t in order to control the accelerating southward movements of the Tower during an unsuccessful attempt to replace the unsightly lead weights with temporary ground anchors. This difficult period during the Committee's activity has been called "Black September" and is referred to in Fig.16.

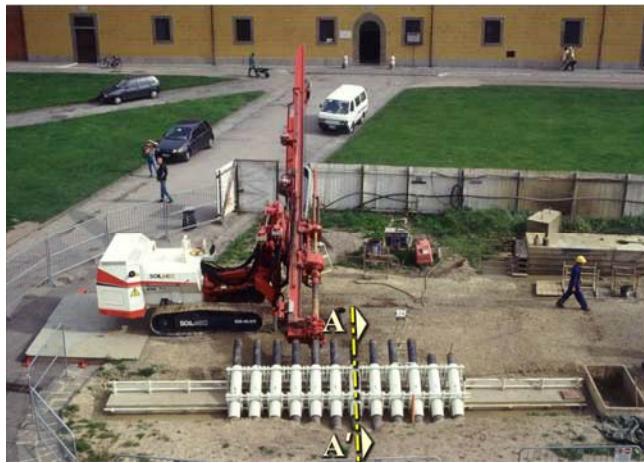
Preliminary underexcavation  
Extraction hole - Section A-A'

Figure 9. Holes for preliminary underexcavation.

In August 1998 the Committee agreed to carry out limited soil extraction from beneath the Tower with a view to observing its response. This preliminary underexcavation was to be carried out over a limited width of 6m north of the Tower using twelve bore holes lined with 219mm diameter casings (Fig. 9). On 9th February 1999, in an atmosphere of great tension, the first soil extraction took place. The Tower slowly began to rotate northwards. When the northward rotation had reached about 80 arc seconds by early June 1999 the preliminary soil extraction was stopped. Northward rotation continued at a decreasing rate until October 1999.
