Seismological and geotechnical aspects of the $M_w=6.3$ L'Aquila earthquake in central Italy on 6 April 2009

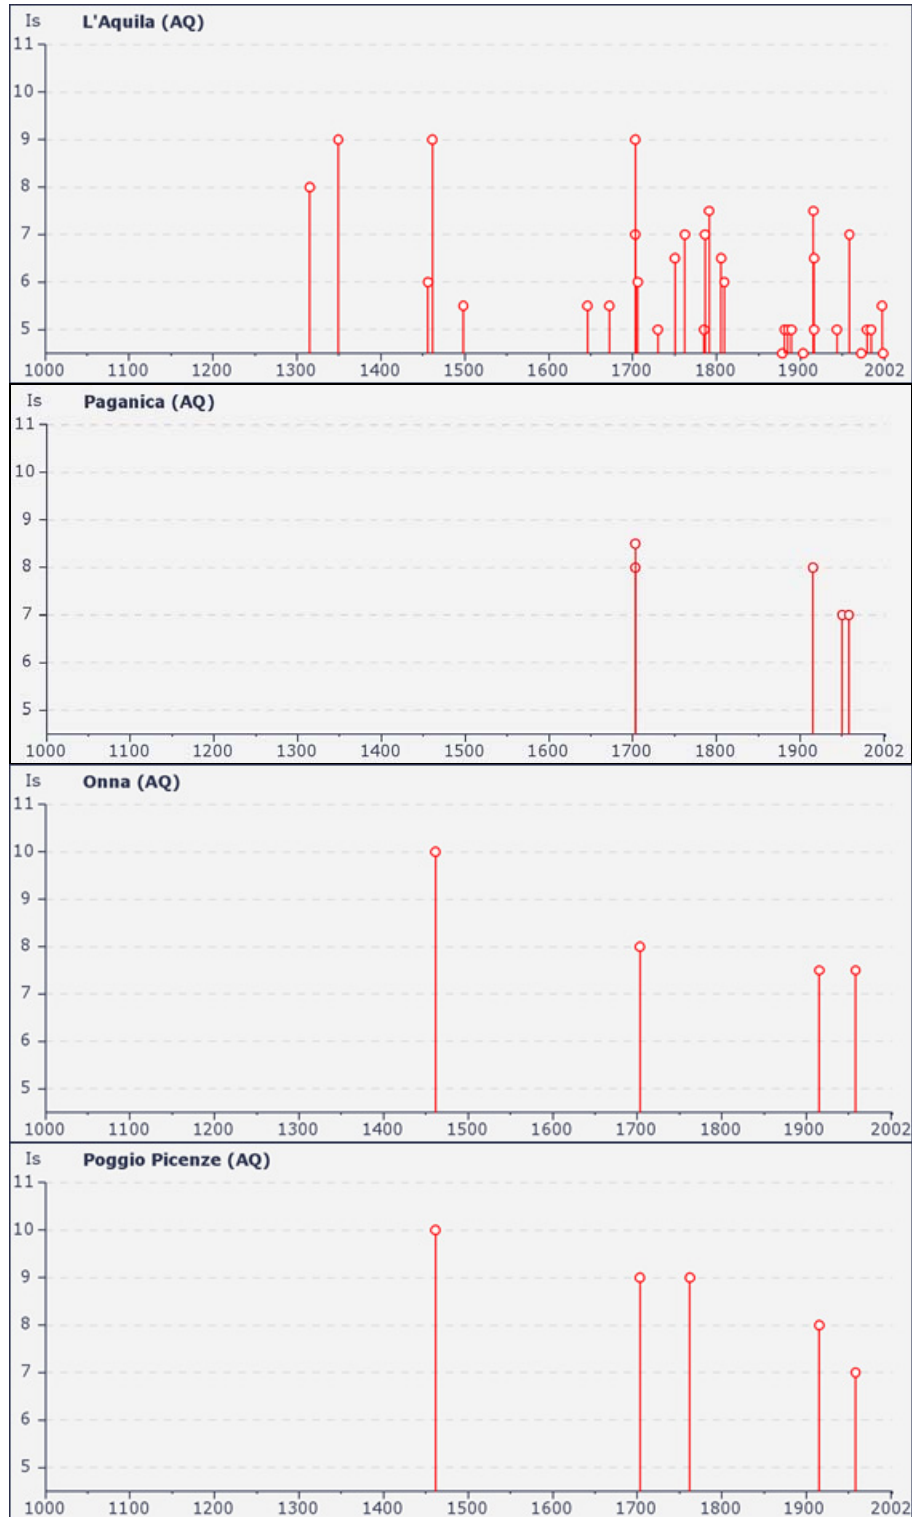
although the two towns are characterized by very similar construction types with “poor” stonework and masonry buildings, San Pio delle Camere (Intensity MCS=V-VI) consistently has much less damage than Castelnuovo (Intensity MCS=IX-X). These different damage levels likely result from variations in local seismic response, primarily due to the lithostratigraphic characteristics of the subsoil in the two areas (details presented in the subsequent section on Damage Patterns).

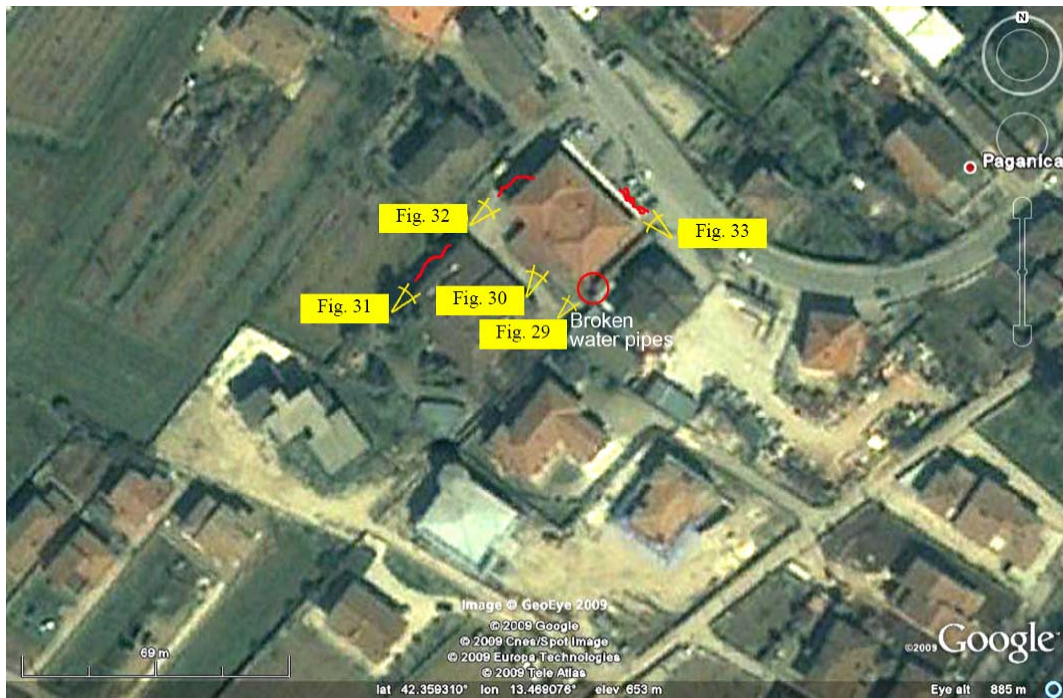
Figure 28. Plan view of Paganica site with marked positions of ground fissures, paved walkway cracks and broken water pipes. Directions of photo shots are indicated by yellow signs.

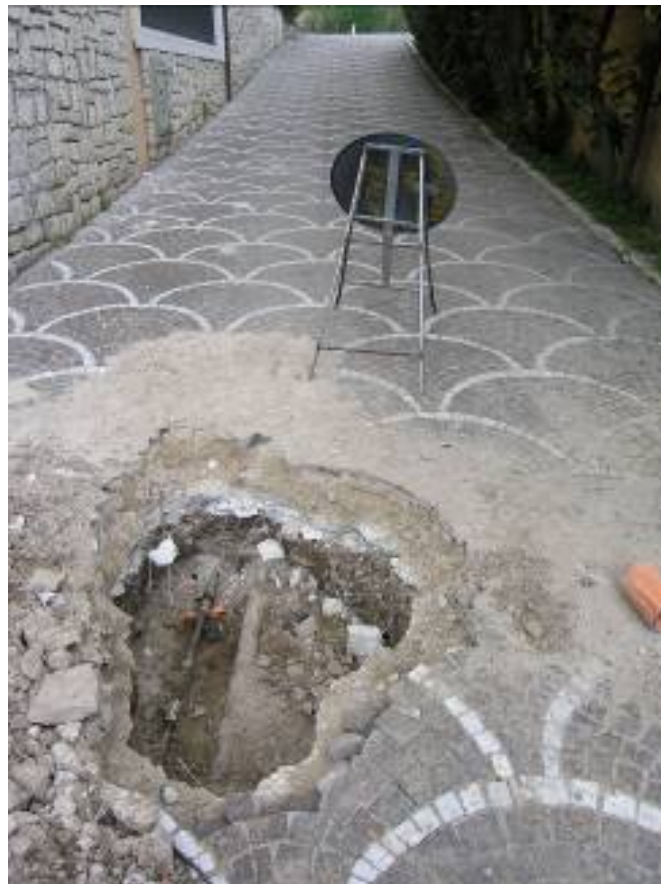
Figure 29. Failure of water pipe. (42.359335°N, 13.468954°E).

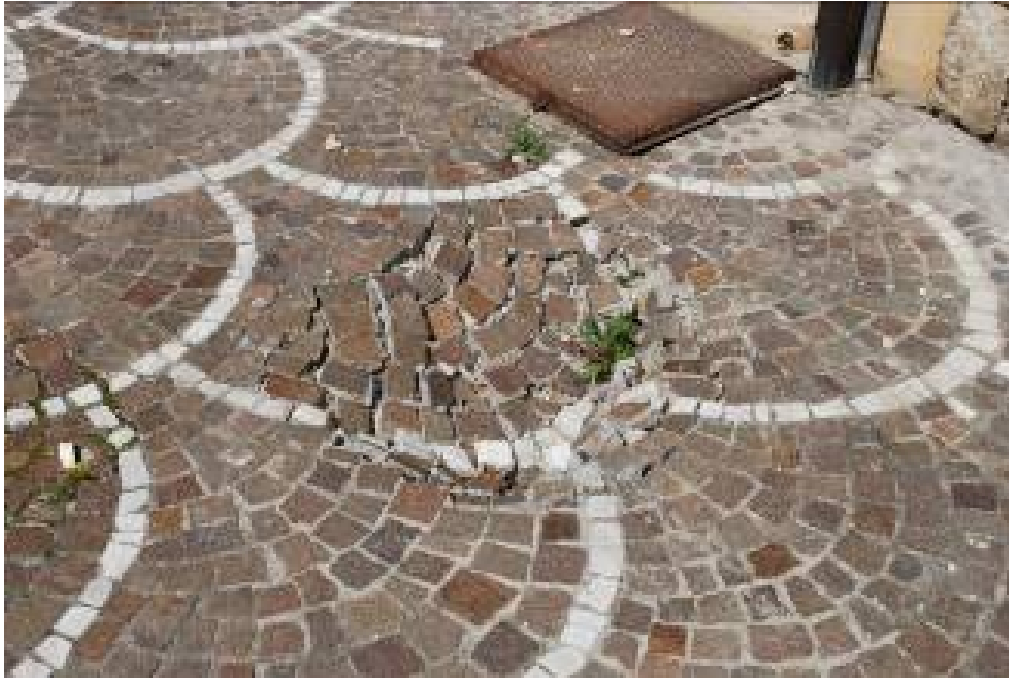
Figure 30. Local settlement close to piping system (42.359335°N, 13.468954°E).

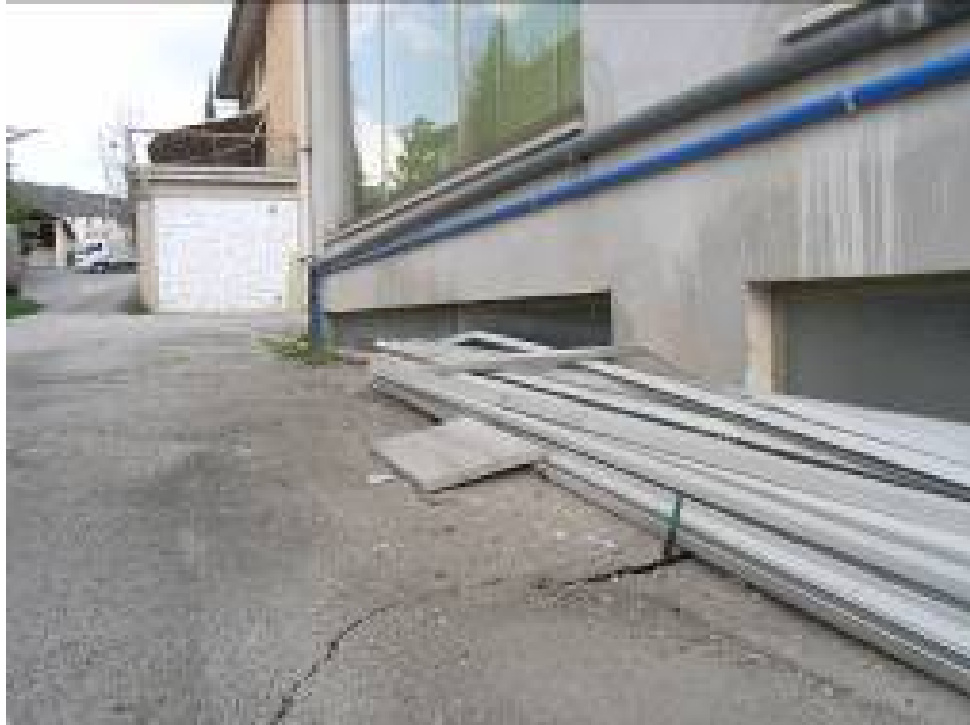
Figure 32. Ground fissures and settlement at the side of the building (42.359817°N, 13.468649°E).

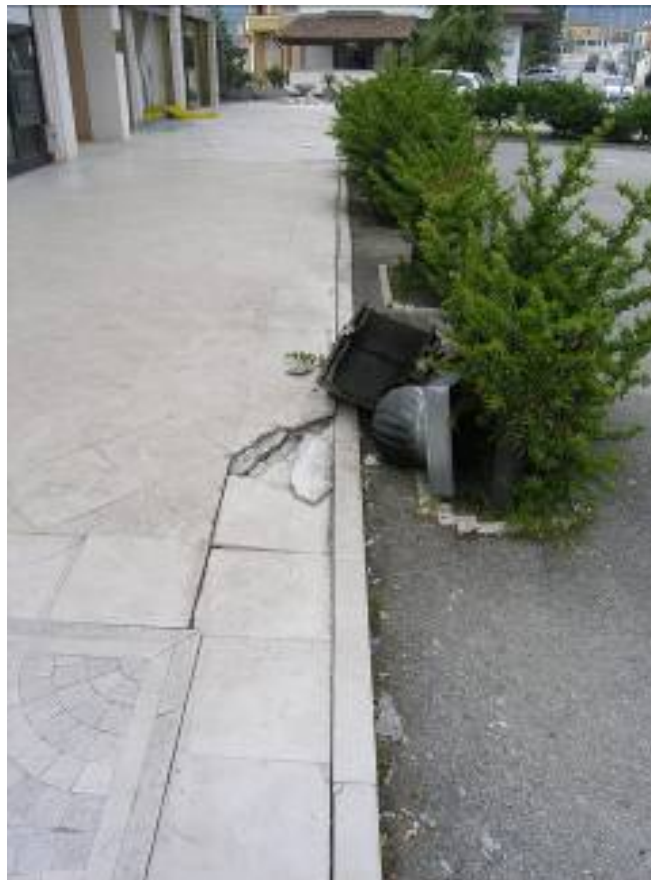
Figure 33. Separation cracks at sidewalk on front of building (42.359335°N, 13.468954°E).

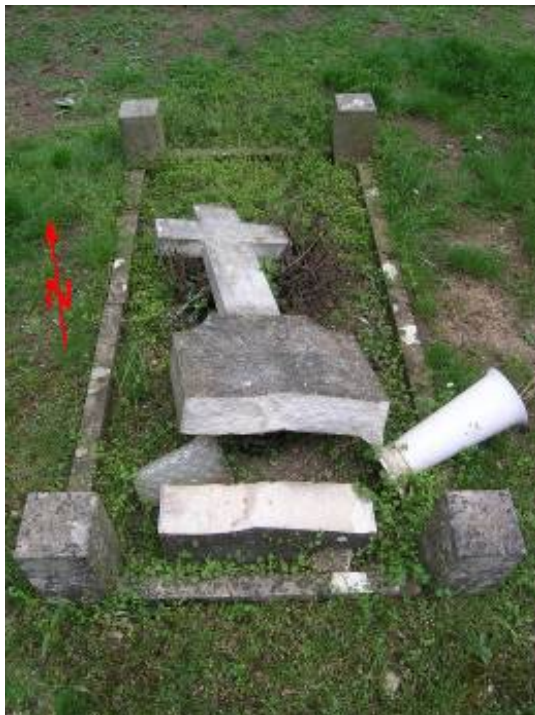
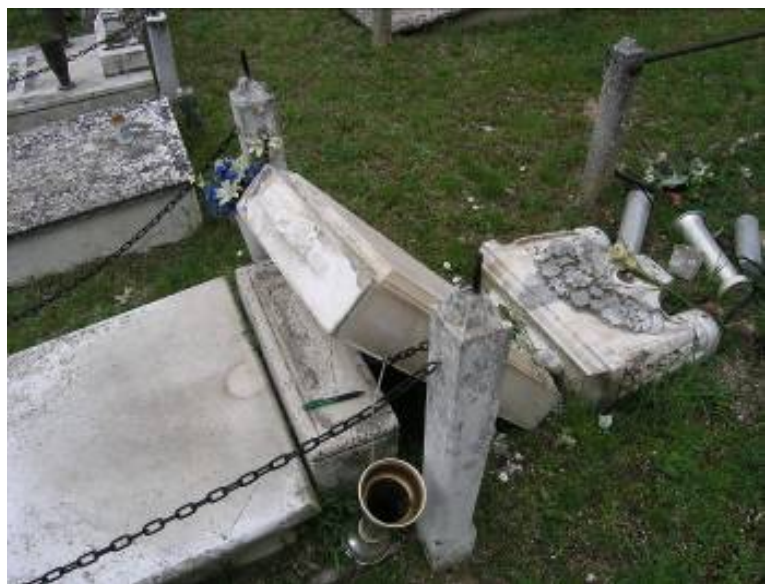
Figure 49. Grave markers breakage.

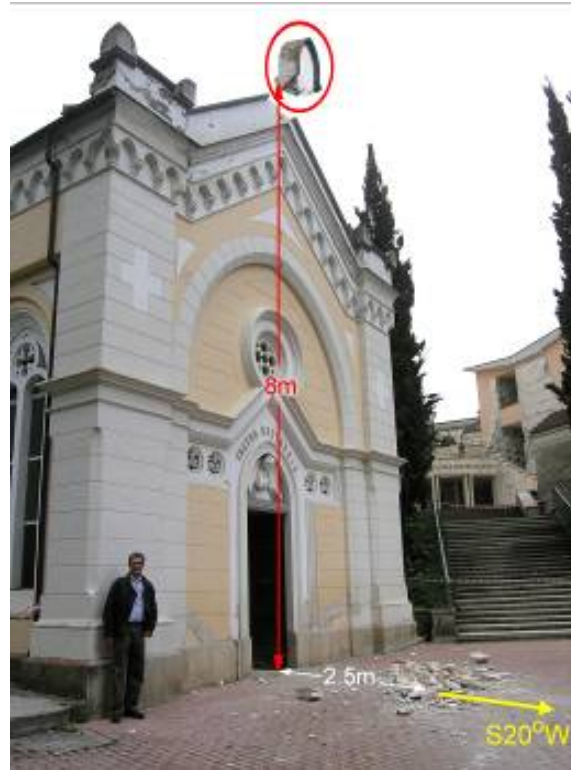
Figure 53. Fall of facade object at mortuary building.

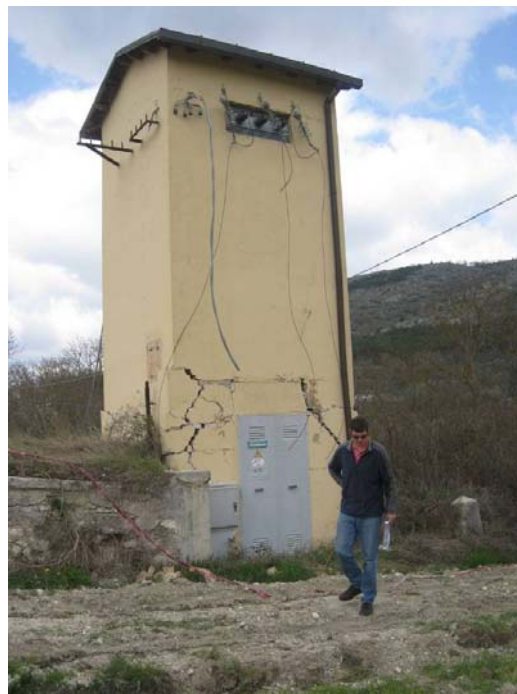
Figure 57. Heavily damaged seismometer station box (not in use at the time of the earthquake, no recording) on the northeast valley beneath the town of Castelnuovo. (42.2982°, 13.6295°).

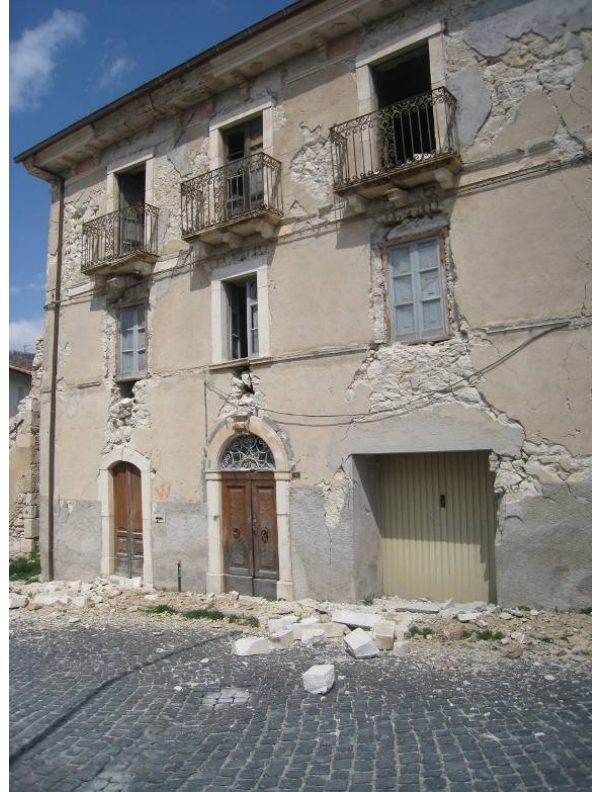
Figure 58. A typical heavily damaged structure in the lower elevation of Castelnuovo. Many structures in the lower elevation neighborhood had less observable damage. (42.2956°, 13.6274°).

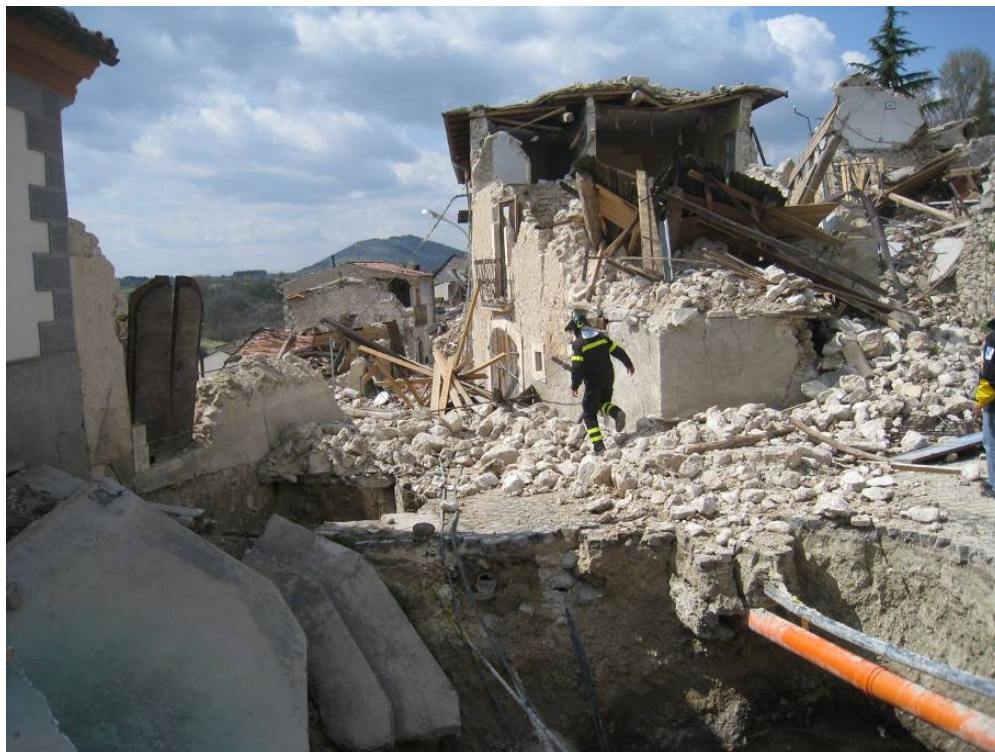
Figure 59. At the highest elevation of the hilltop town of Castelnuovo, almost all of the structures collapsed (D5) or were near collapse (D4). (42.2947°, 13.629°).

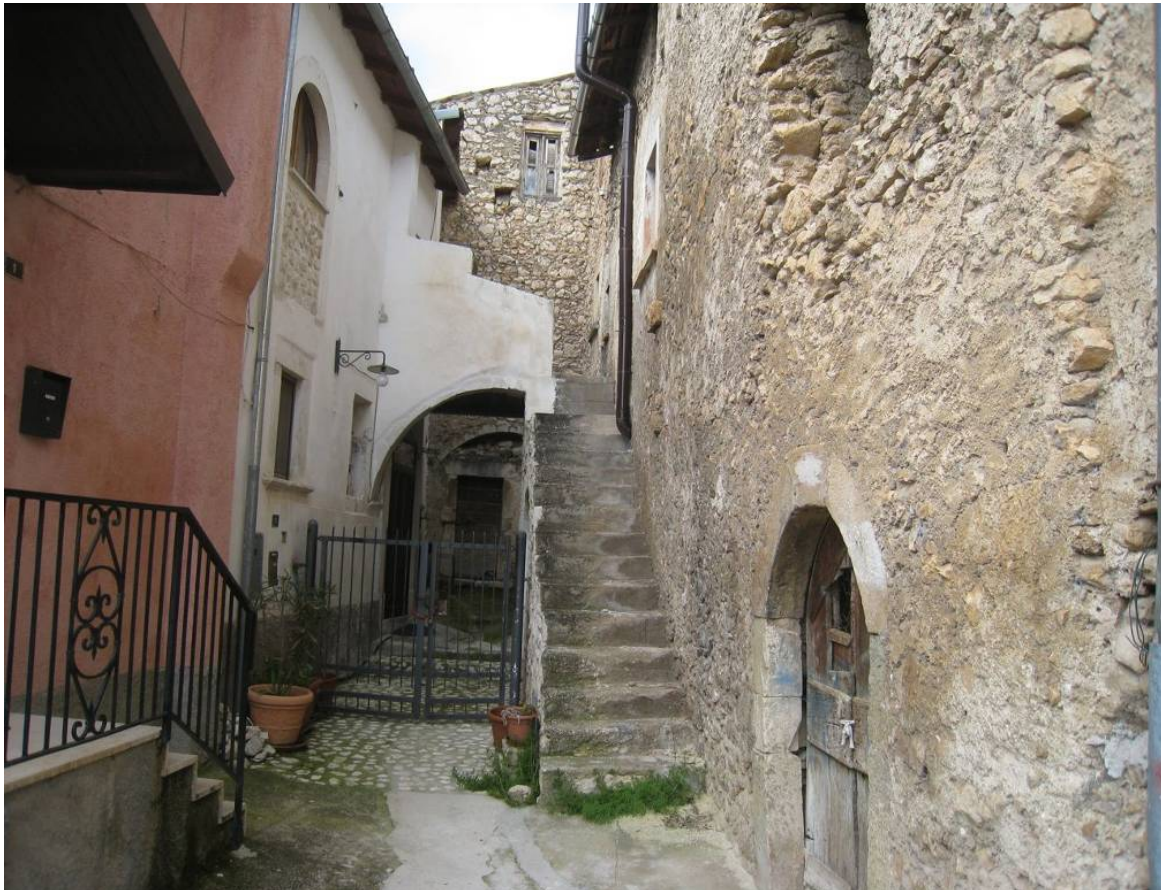
Figure 62. Typical unreinforced masonry structures in the village of San Pio delle Camere suffered no damage (D0), or slight cracking (D1). Structures in this village are similar to those in Castelnuovo. San Pio delle Camere is built on limestone bedrock.

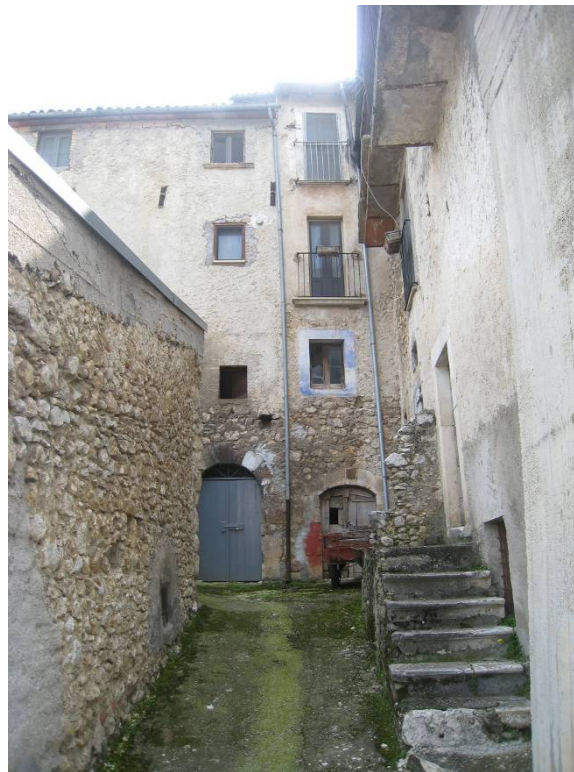
Figure 63. The reconnaissance team observed no damage to the town of Tussio. The town is built on Mesozoic calcareous bedrock (42.2657°, 13.6414°).

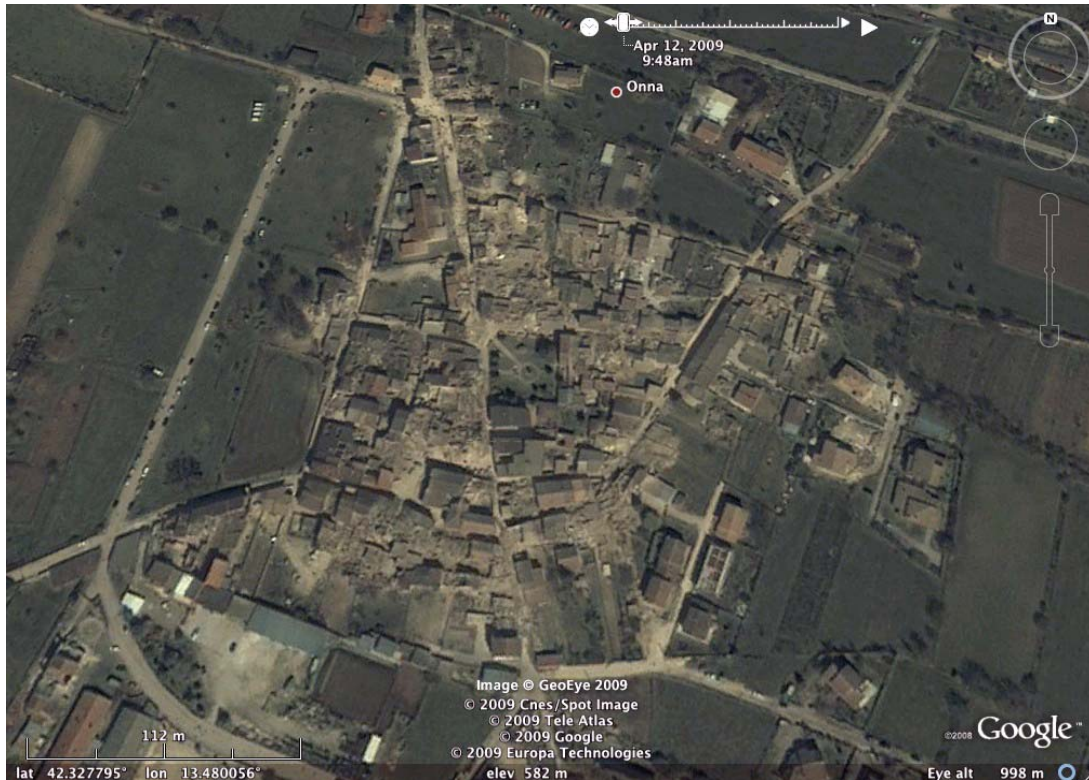
Figure 64. The village of Onna suffered D4–D5 damage in most of the unreinforced masonry structures. Reinforced concrete structures at the margins of the village performed well with only minor damage (D0-D2).

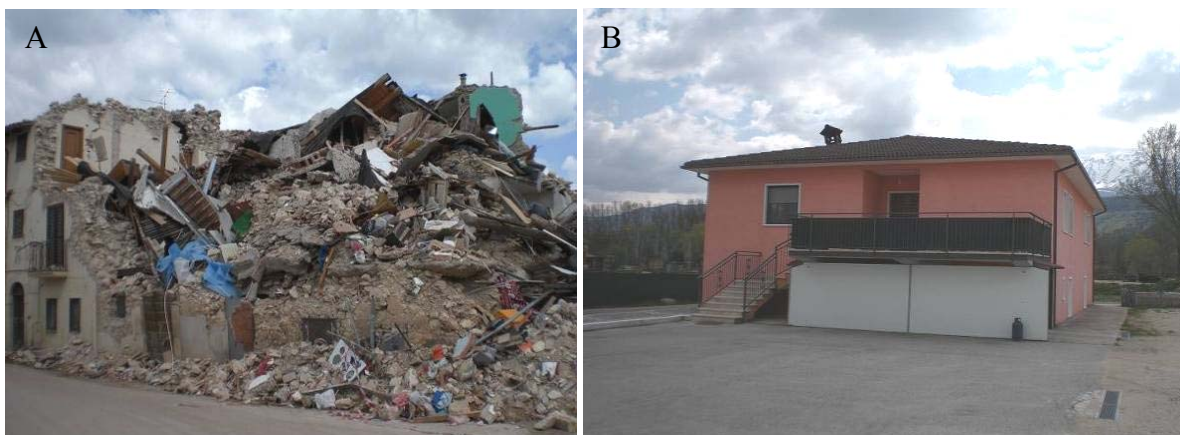
Figure 67. Onna. (A) D5 damage level on masonry building structures, (B) D0 damage on a RC building (except for the tilting of the chimney).

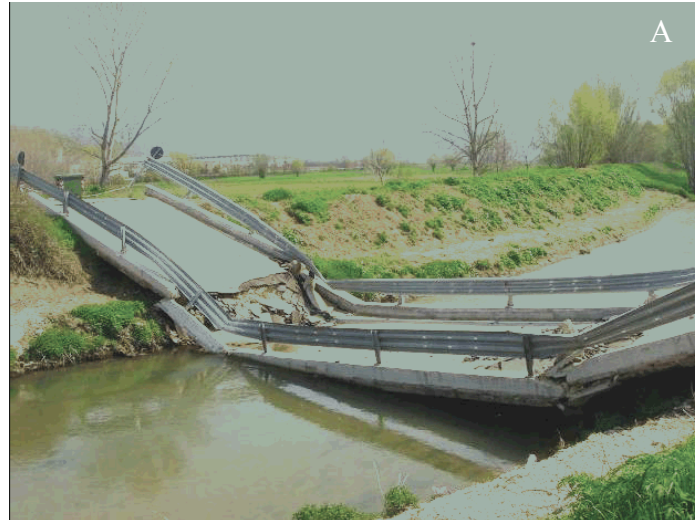
Figure 68. Onna. (A) Collapse (D5).

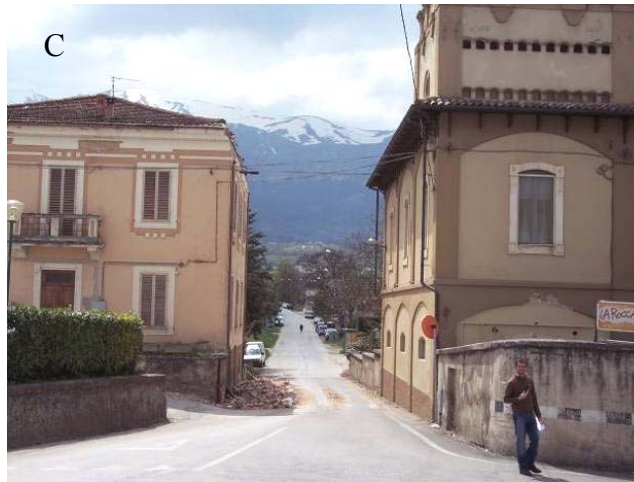
Figure 70. Monticchio. (C) D1 damage (fall of the cornice) on a masonry building.

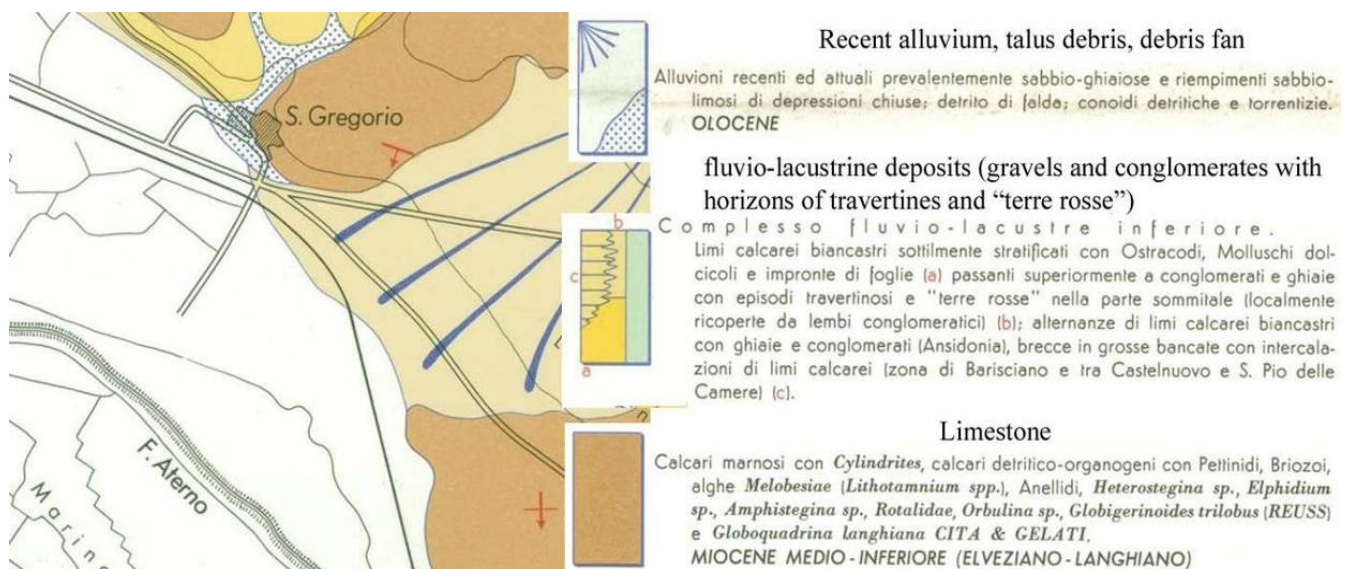
Figure 71. Geological map of San Gregorio (after Bosi and Bertini, 1970).

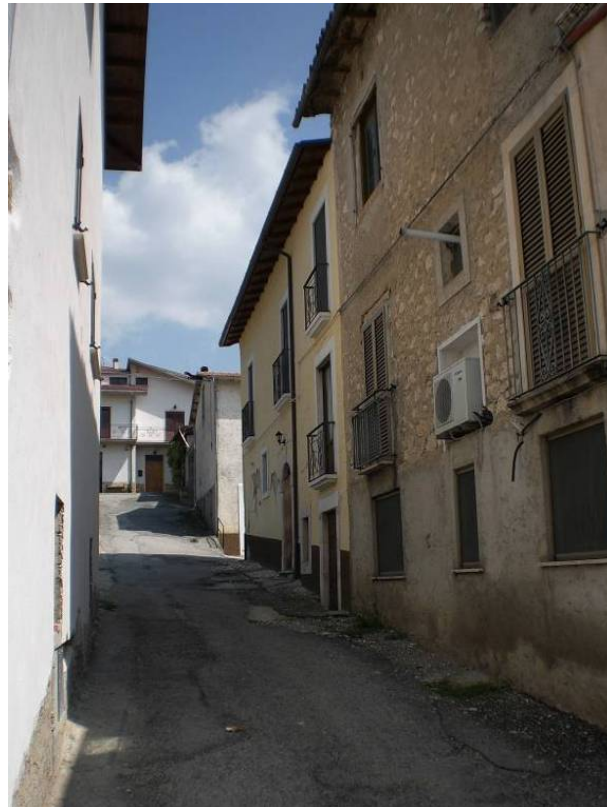
Figure 73. San Gregorio western part: masonry buildings with minor damages.

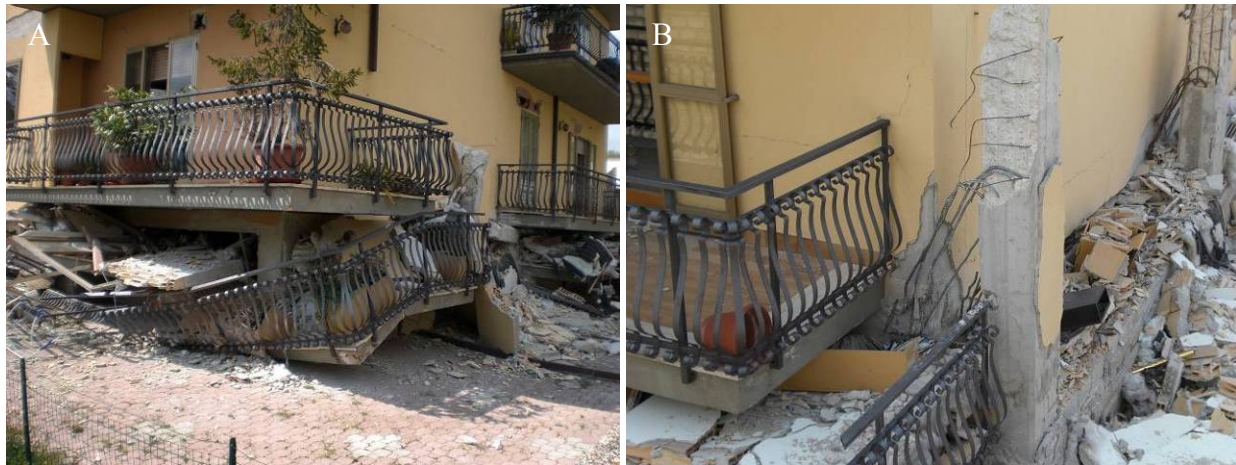
Figure 74. San Gregorio eastern part. (A) RC building “pancake” collapse, (B) Detail of sheared pillars.

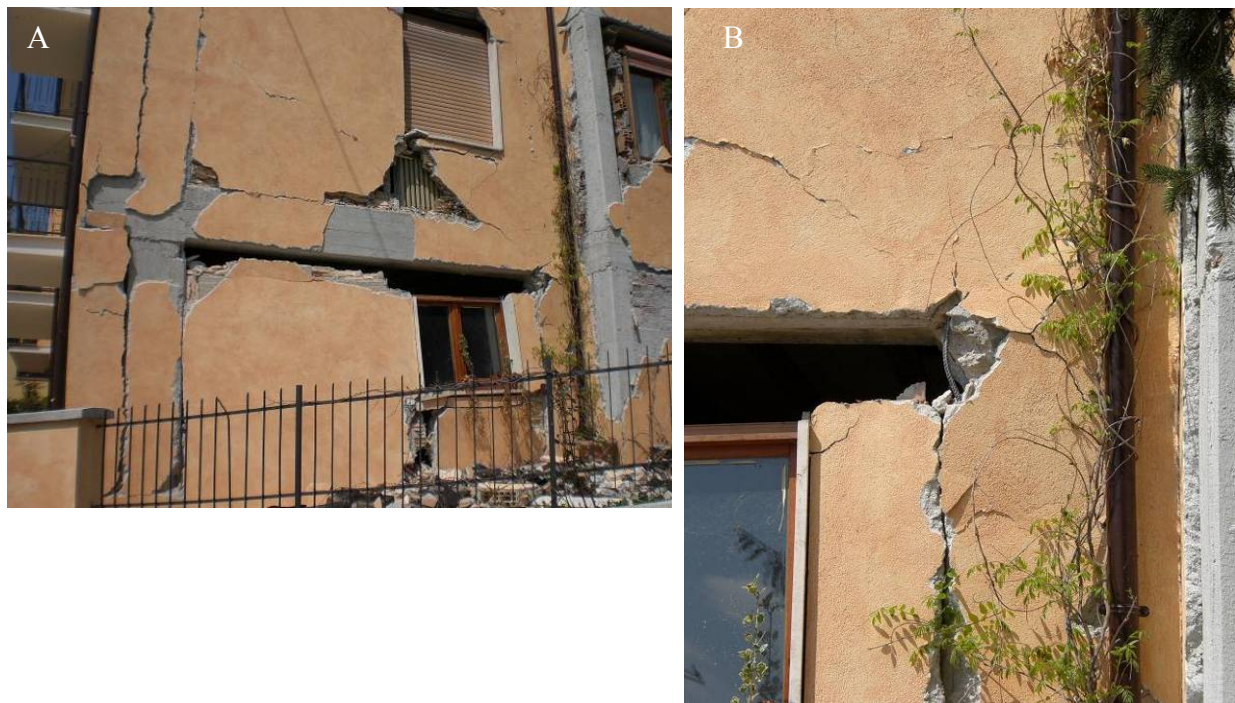
Figure 75. San Gregorio eastern part. (A) RC building with structural damage, (B) Detail of the damage to the beam-column connection.

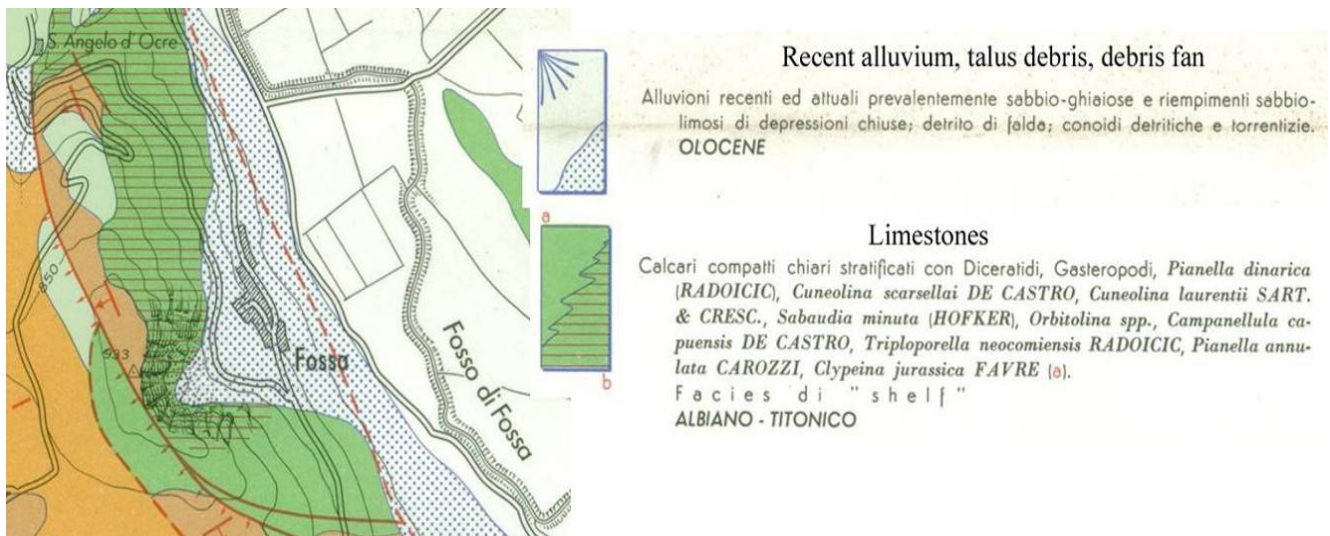
Figure 76. Geological map of Fossa (after Bosi and Bertini, 1970).

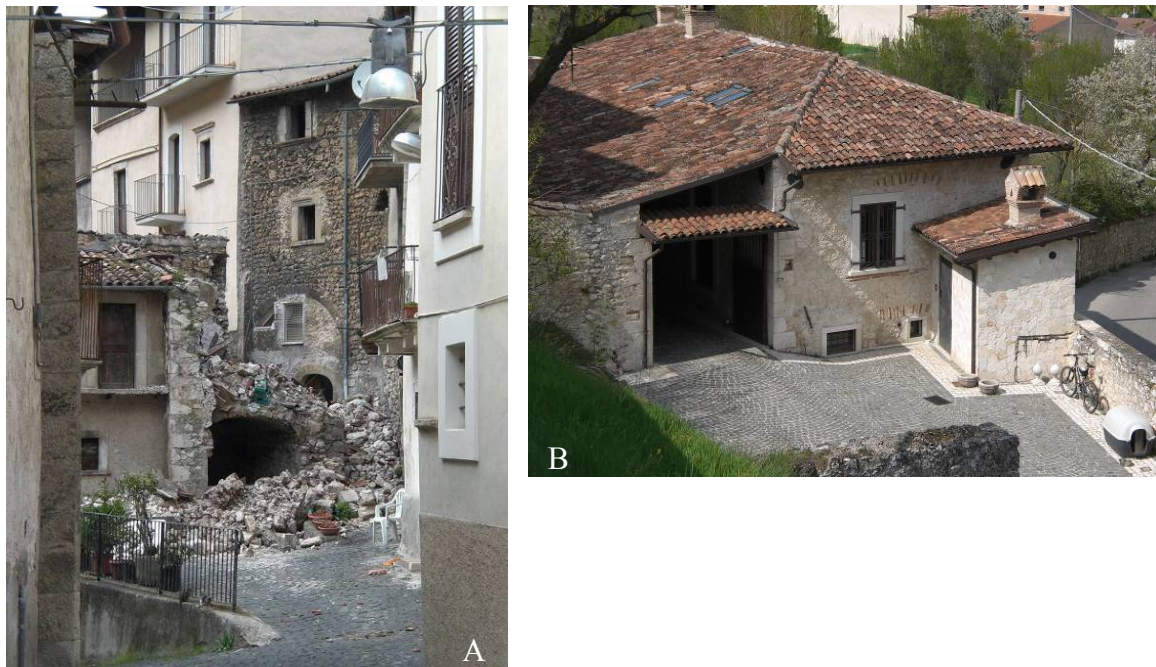
Figure 77. Fossa. (A) Collapse of masonry constructions in the historic center, (B) Strengthened masonry construction with no damage.

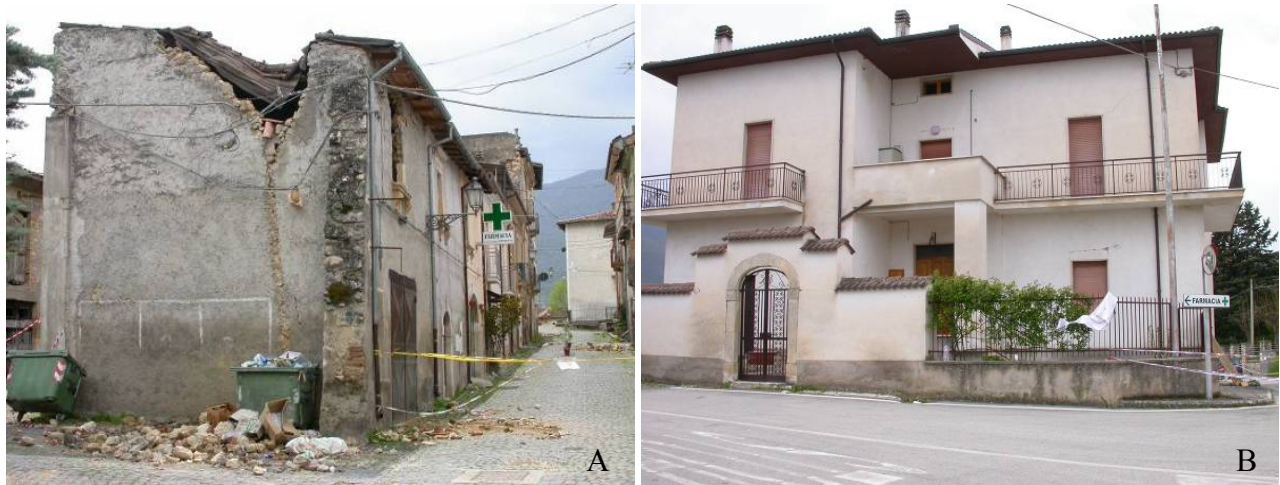
Figure 79. S. Eusanio Forconese village. (A) Partial collapse of masonry building (D4), (B) Slight damage to a RC building nearby (D1).

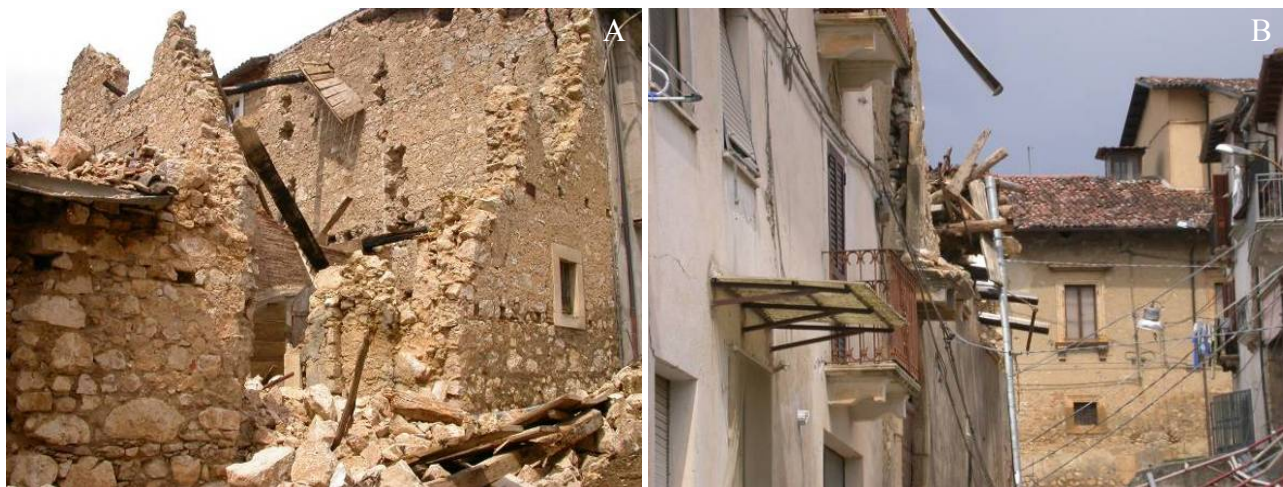
Figure 80. S. Eusanio Forconese. (A) Collapse of old masonry building (D5), (B) Partial collapse of masonry building (D4).

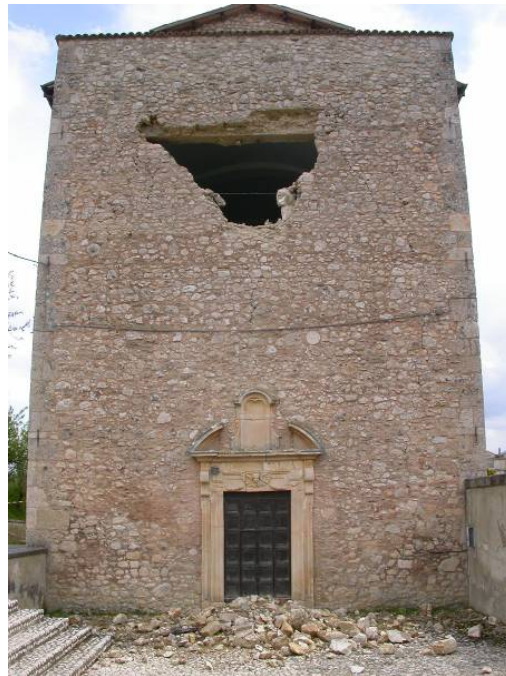
Figure 81. S. Eusanio Forconese: partial collapse of the masonry church (D4).

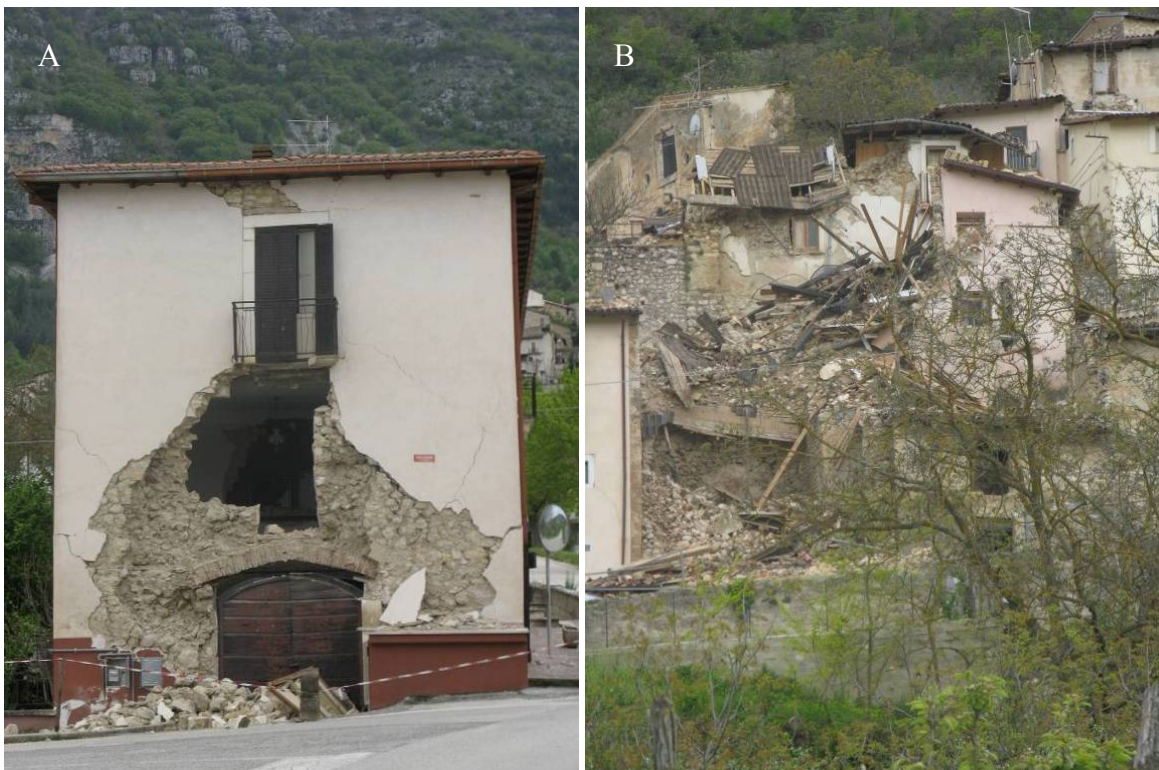
Figure 82. Casentino. (A) Partial collapse of the masonry building at the entrance of the village, (B) Collapse of old poor quality masonry buildings in the historic center.

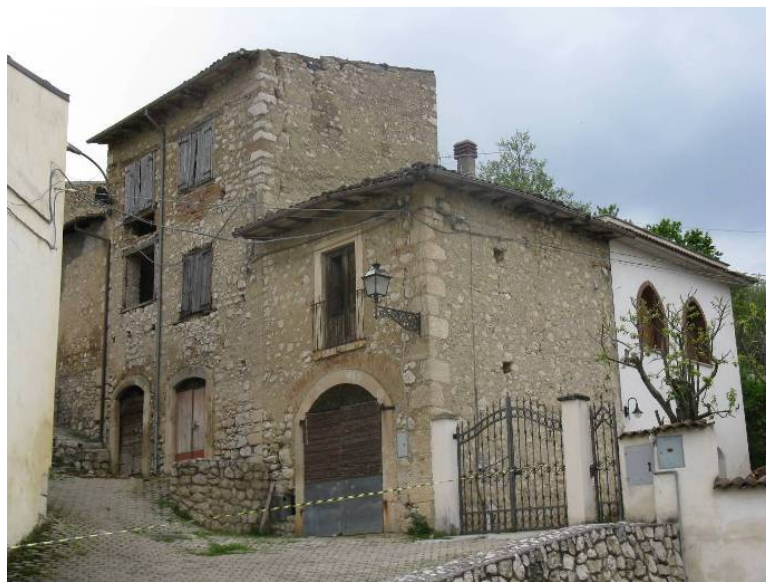
Figure 83. Casentino masonry buildings with some wall cracks.

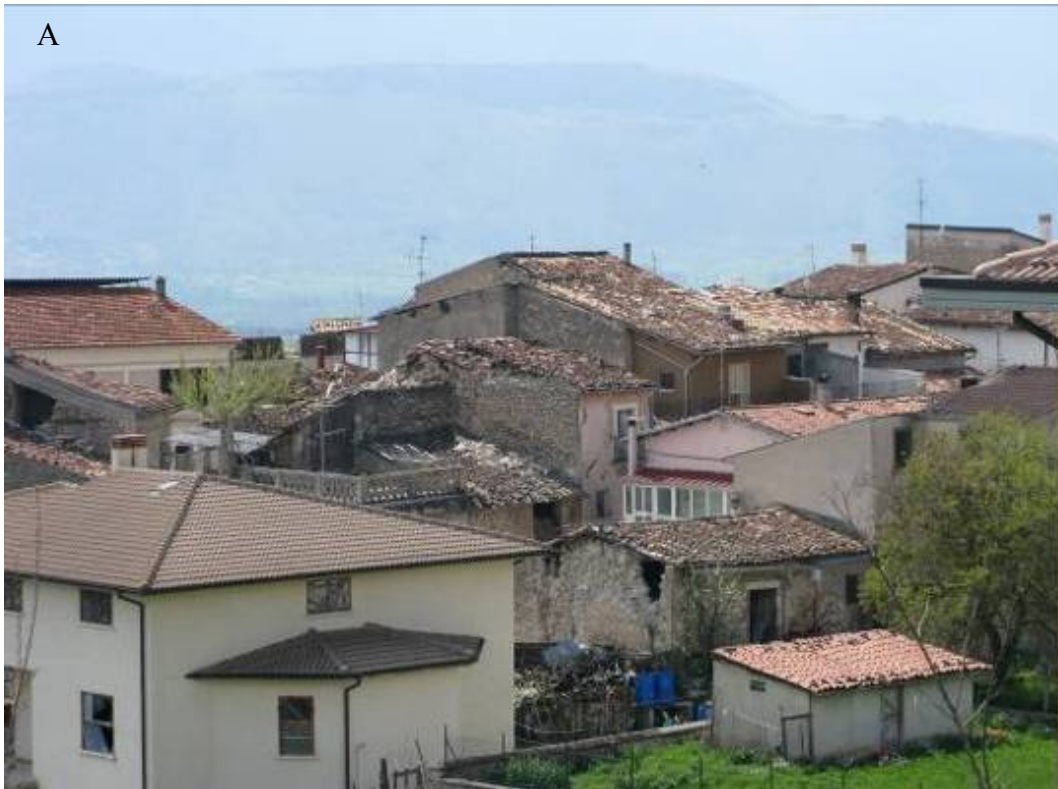
Figure 86. Poggio Picenze. (A) Variable damage (D3-D4) on masonry buildings of different style.

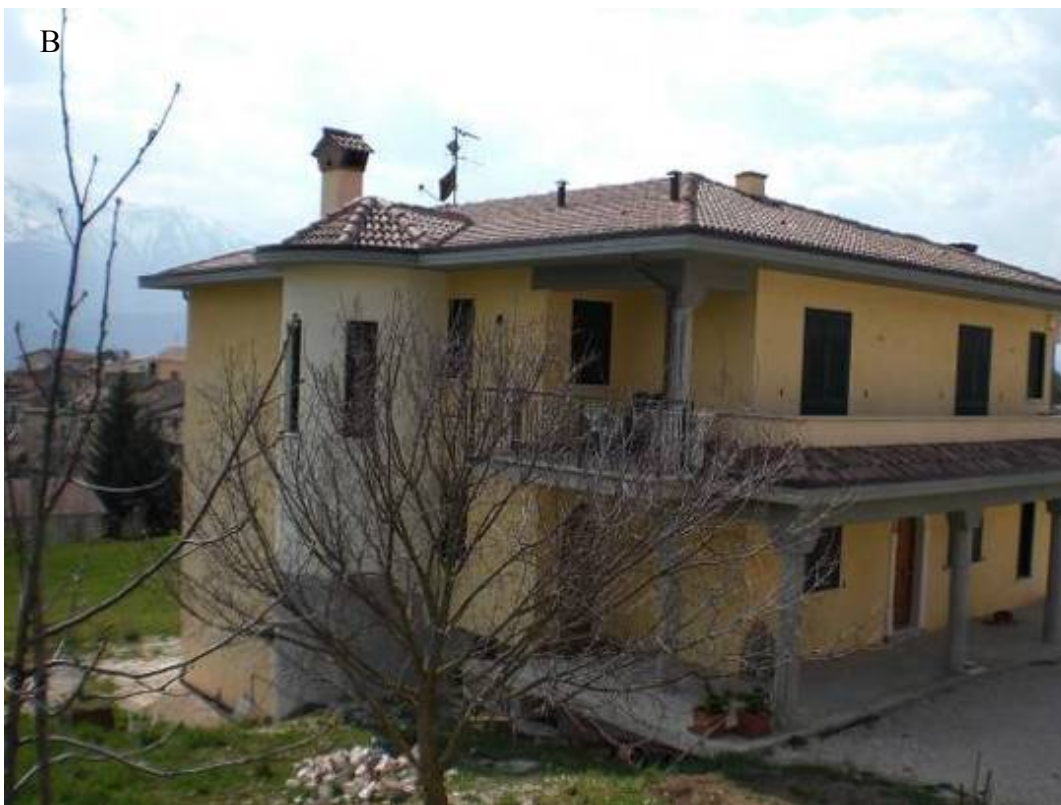
Figure 86. Poggio Picenze. (B) Undamaged RC house (D0) close to the (C) monumental church (D3).

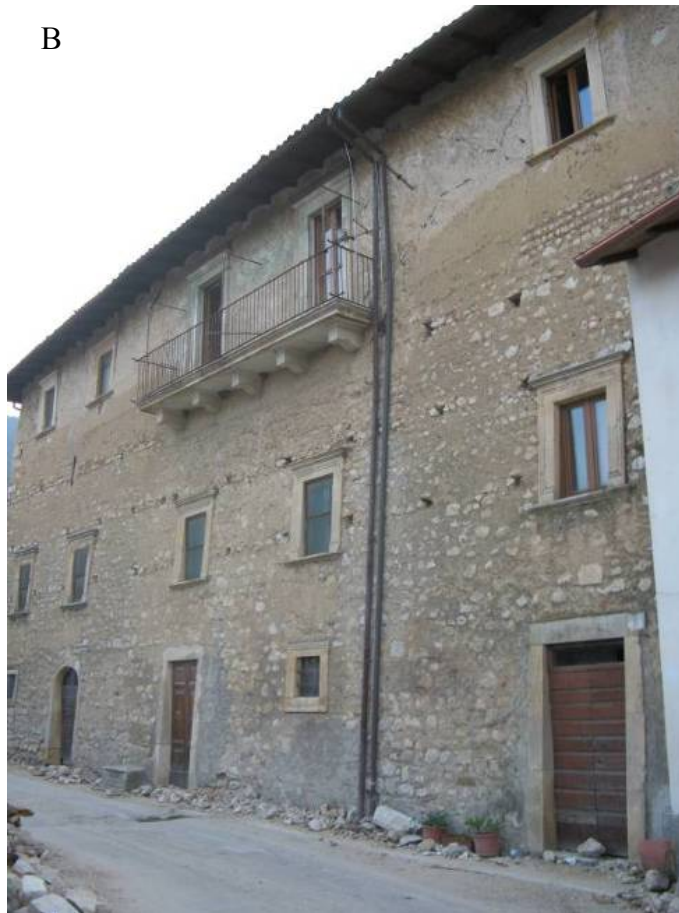
Figure 88. Villa S. Angel. (B) Reinforced masonry in the historic center with minor cracks in the highest story (D2).

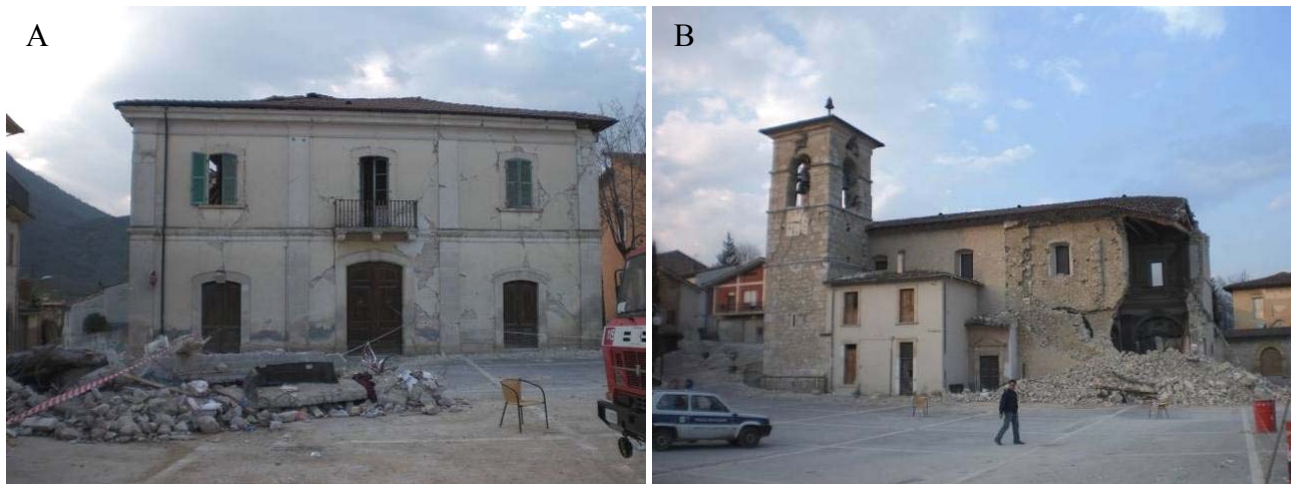
Figure 89. Villa S. Angelo, historic center with (A) masonry building crack,; (B) partly collapsed church.

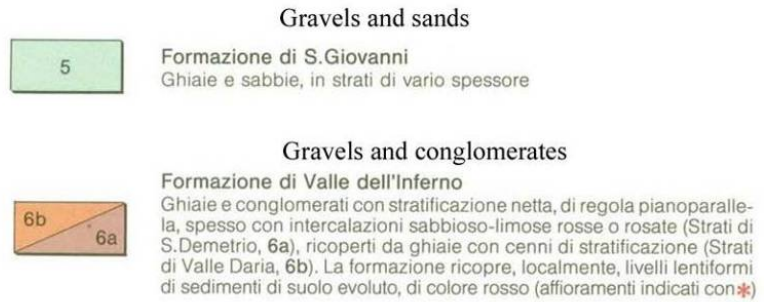
Figure 91. Geological map of S. Demetrio ne' Vestini (Bertini et al., 1989).

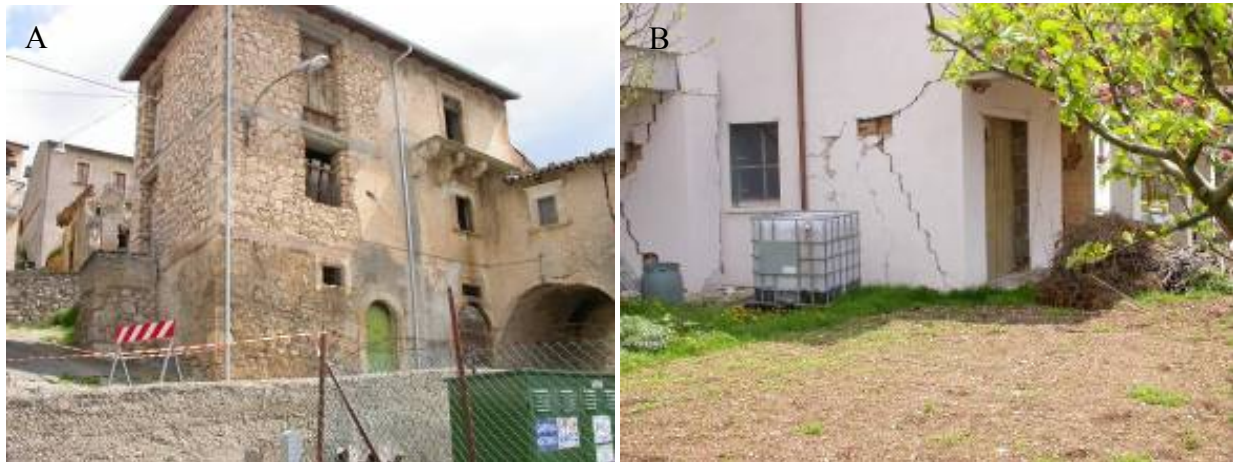
Figure 96. Barisciano. (A) Collapse (D5) of an old masonry building in background, (B) Damages (D1/D2) to RC buildings.
