Seismological and geotechnical aspects of the $M_w=6.3$ L'Aquila earthquake in central Italy on 6 April 2009

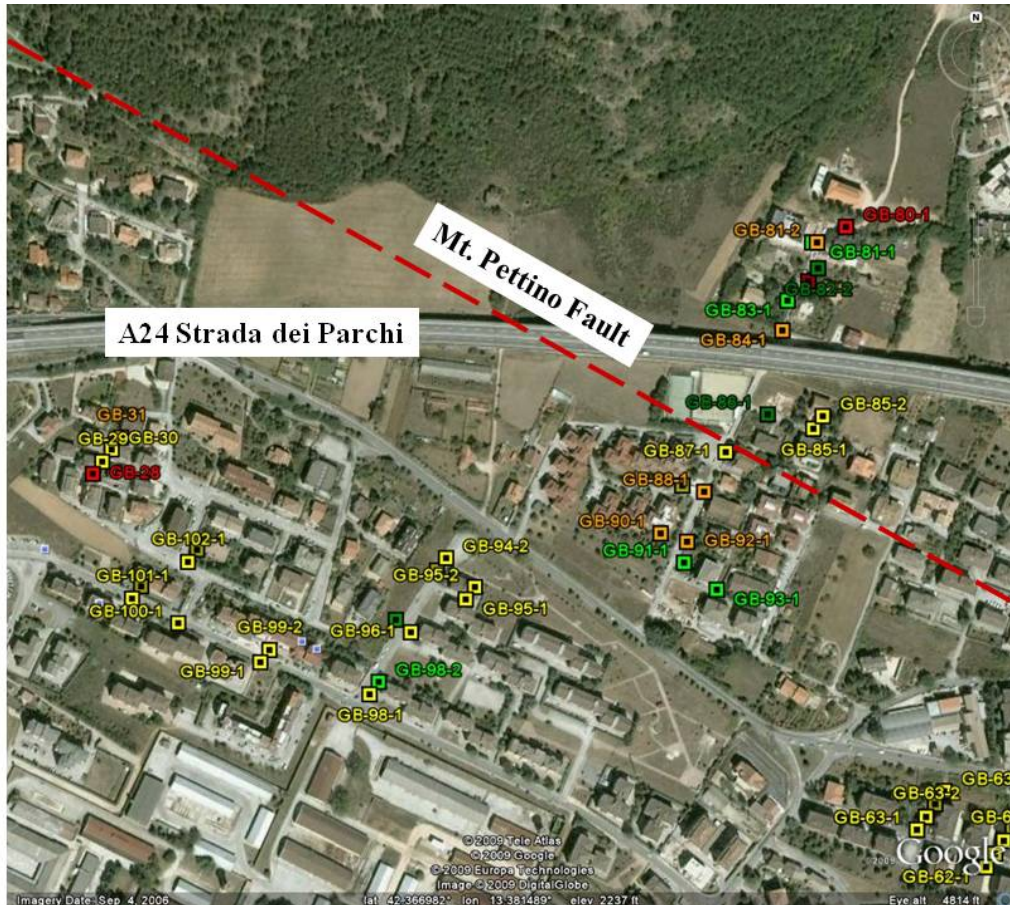
Figure 103. Zone (a) of the building damage survey along the Mt. Pettino Fault.

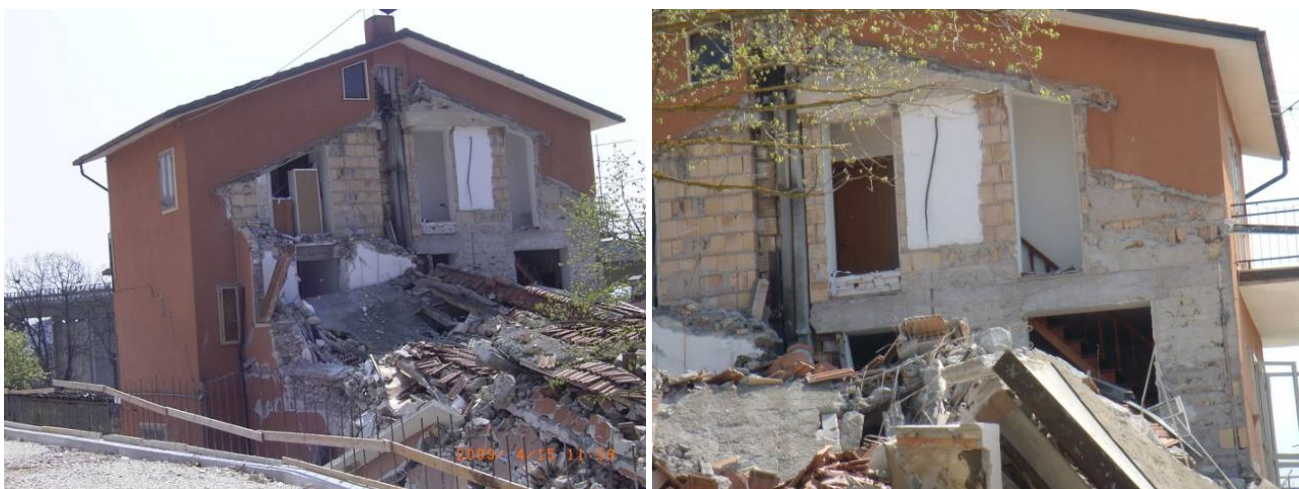
Figure 104. Masonry structure at waypoint GB-82-1.

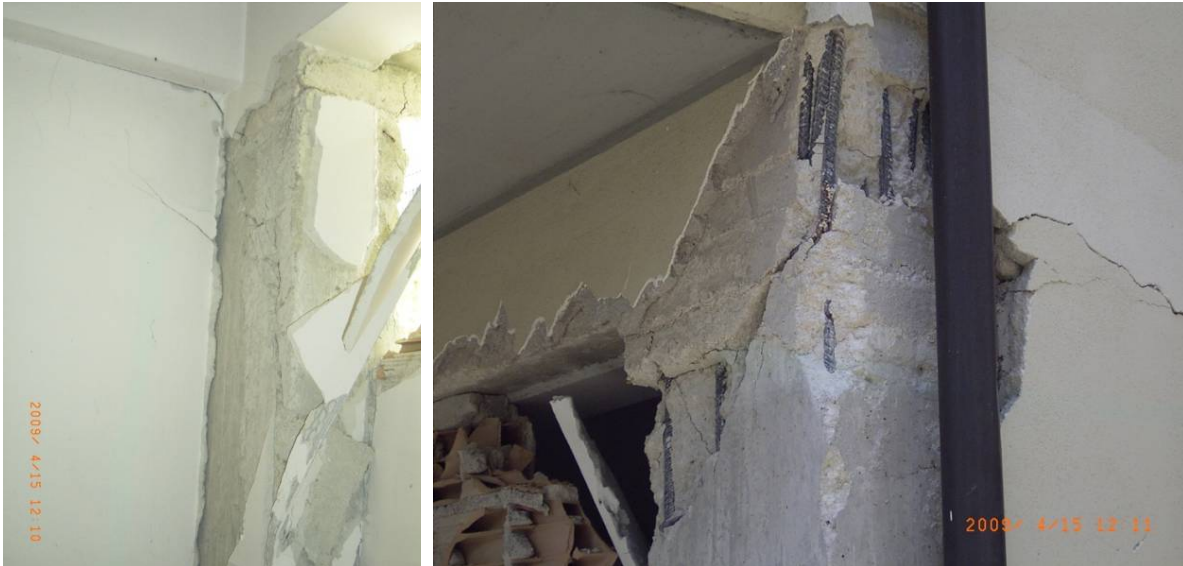
Figure 105. Example of D3 damage in the building at waypoint GB-88-1.

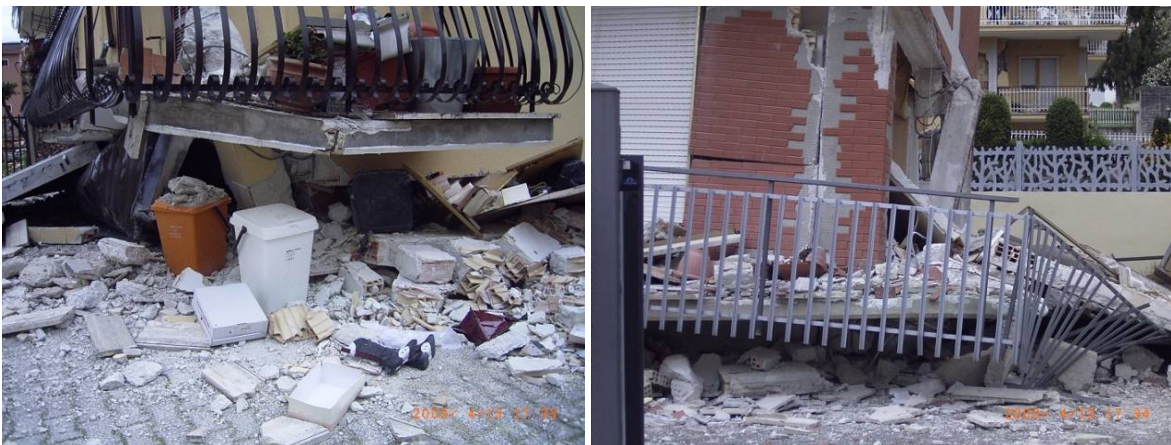
Figure 106. Example of D5 damage in the building at waypoints GB-27-1 and GB-28-1.

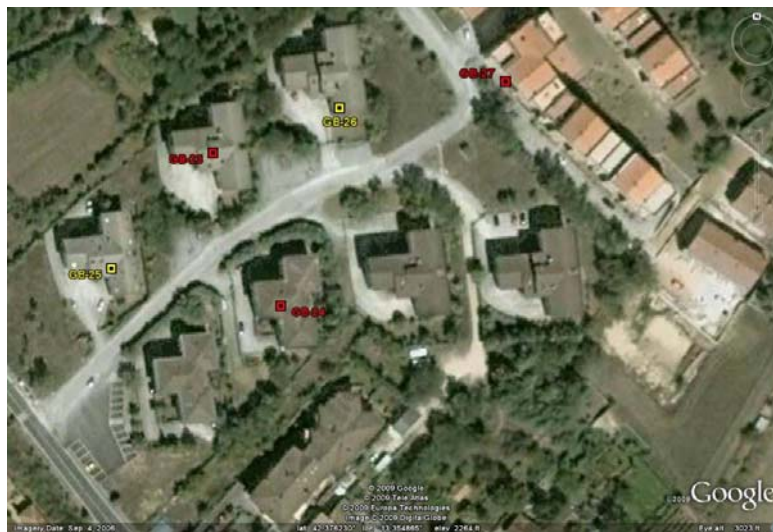
Figure 108. Cluster of damage in zone (d).

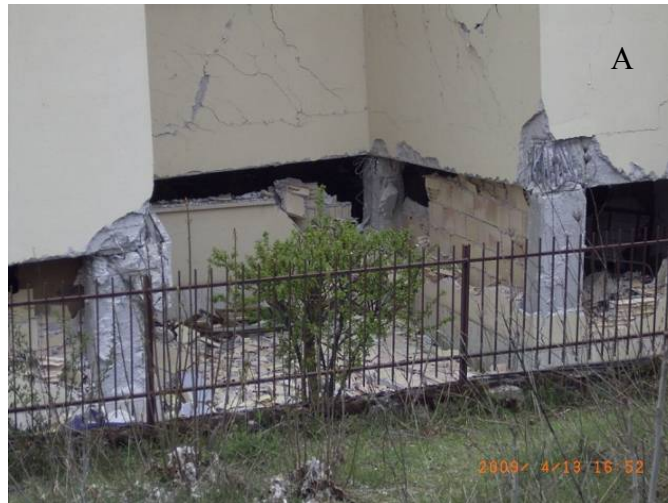
Figure 110. Damage on the structures in the cluster in zone (d). (A) Waypoint GB-24-1 (D5).

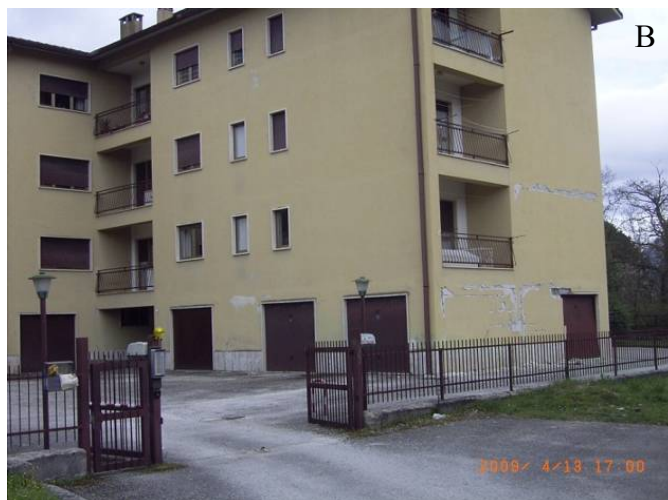
Figure 110. Damage on the structures in the cluster in zone (d). (B) Waypoint GB-25-1 (D2).

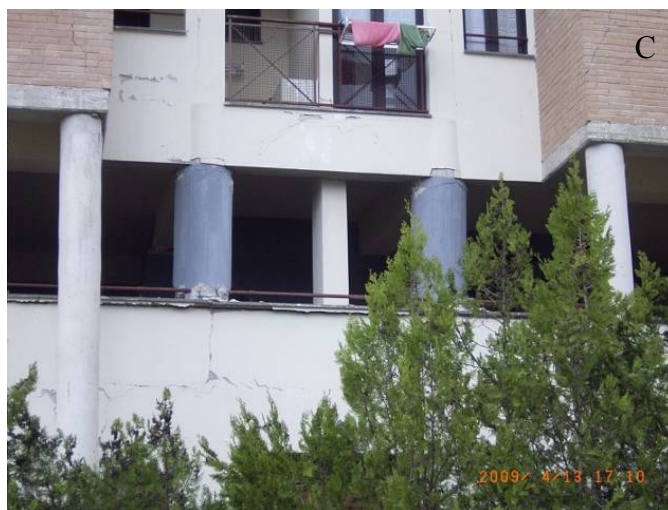
Figure 110. Damage on the structures in the cluster in zone (d). (C) Waypoint GB-26-1 (D2).

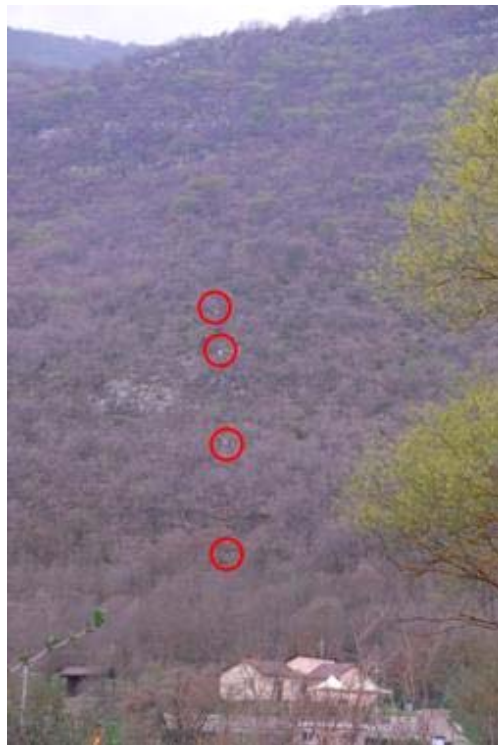
Figure 116. Additional impact marks as indicated by an alignment of fresh scars (42.255N 13.547E).

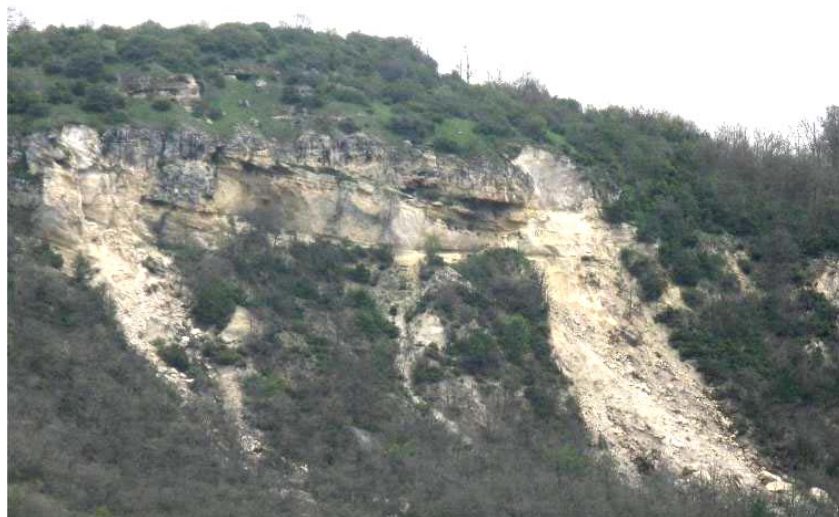
Figure 120. View of the cliff overlooking the northeastern side of Lake Sinizzo. Two failures in the overhanging thick layers of conglomerates are apparent with the related rock avalanches (42.292N, 13.580E).

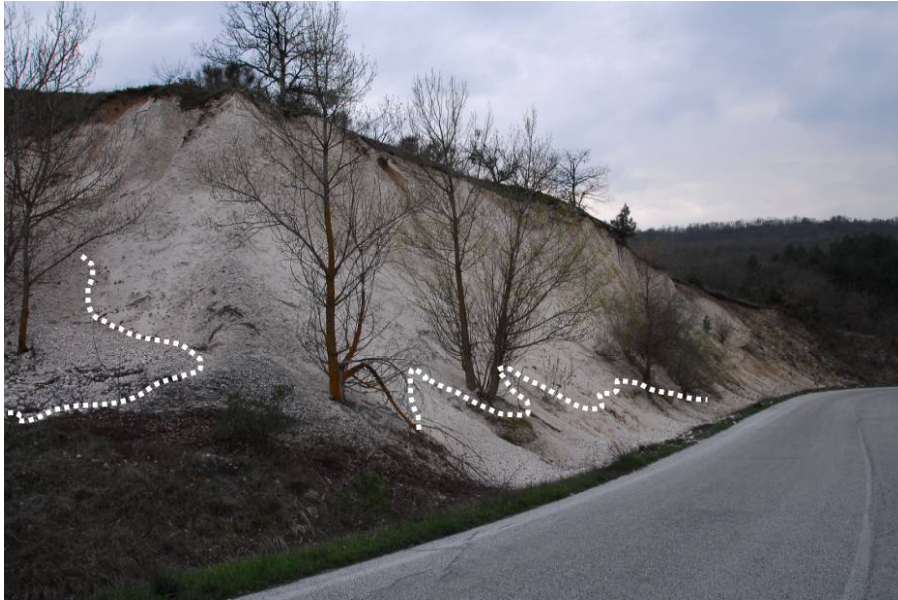
Figure 121. Minor ravelling of weakly cemented sand and gravel; dashed lines indicate the extent of freshly deposited talus along the base of road cut (Via Opi N42.261, E13.581).

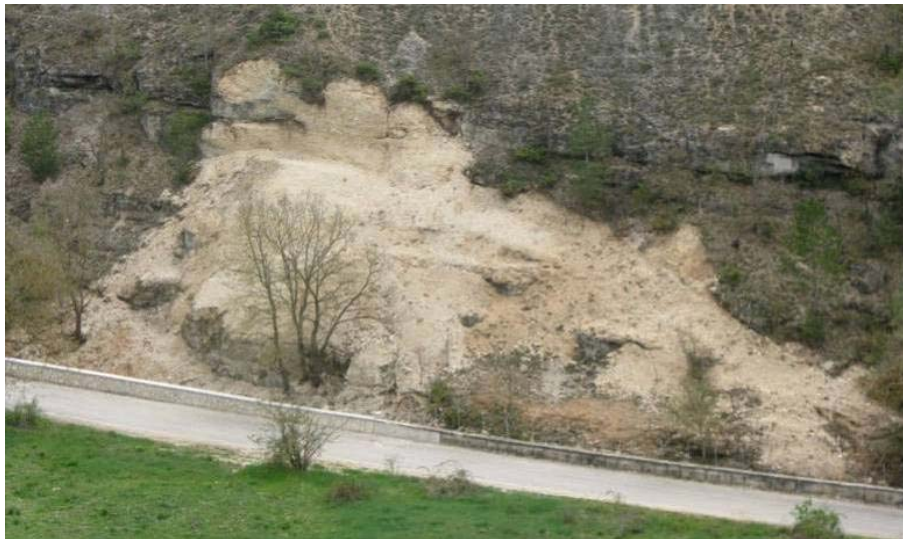
Figure 122. Ravelling along the road from S. Demetrio to Lake Sinizzo (42.28845N,13.56442E).

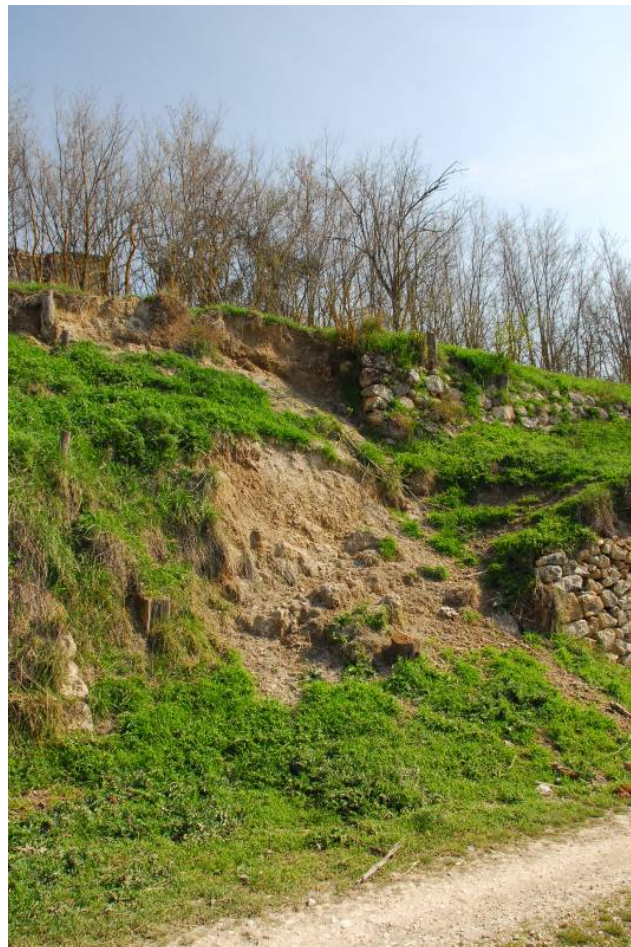
Figure 123. Shallow sloughing of regolith along road cut (southern flank of Castelnuovo N42.294, E13.628).

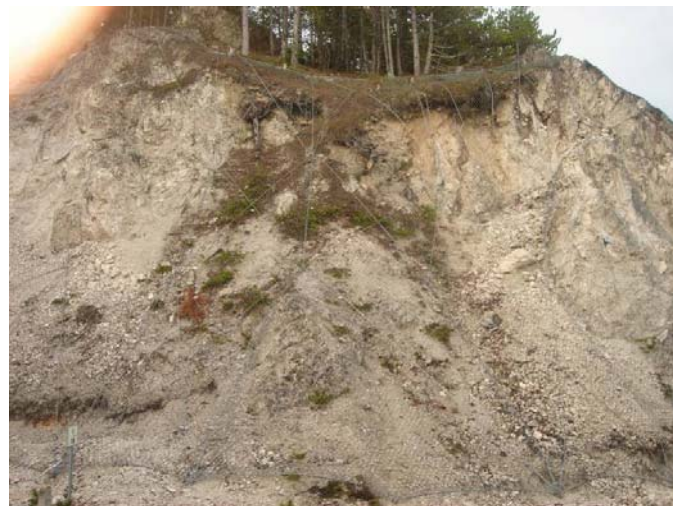
Figure 131. Ravelling in pervasively fractured/cataclastic limestones on a road cut retained by steel-net protections on SS80 at km 18.2: (DC-18-1) (42.4281N, 13.3460E).

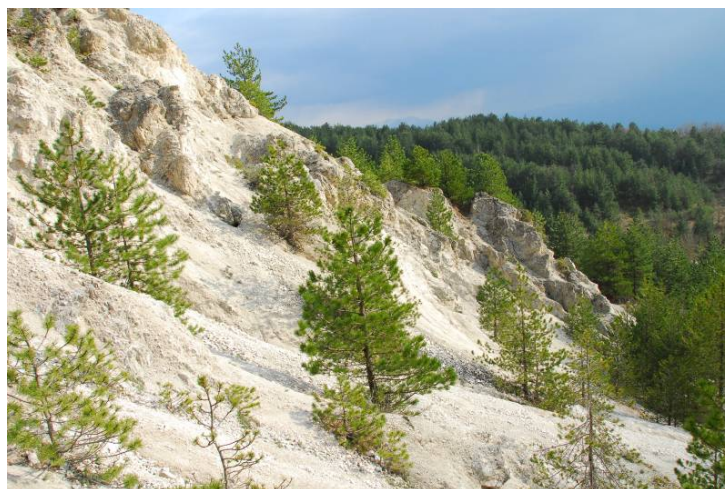
Figure 132. Characteristic erosional scars developed in cataclasite (42.434N, 13.334E).

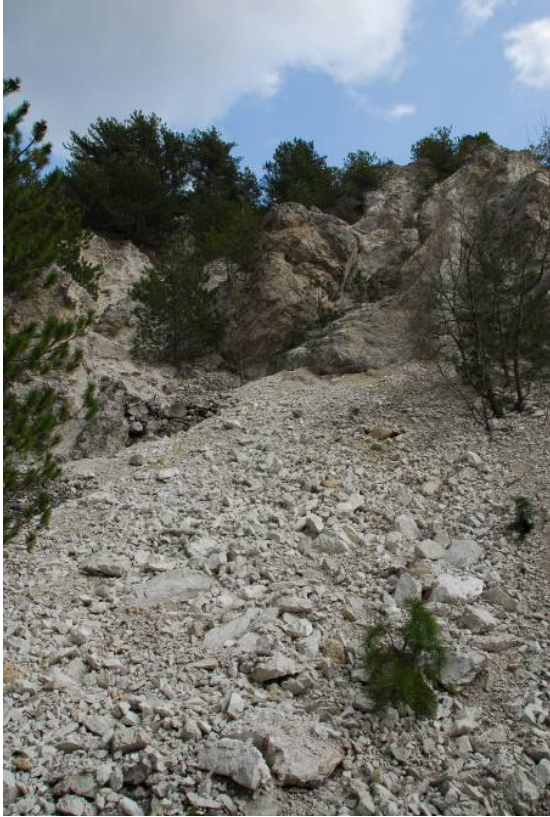
Figure 133. Characteristic ravelling-type failure in natural outcrops of cataclasite; partially buried pine trees evidence recent movement (42.434N, 13.334E).

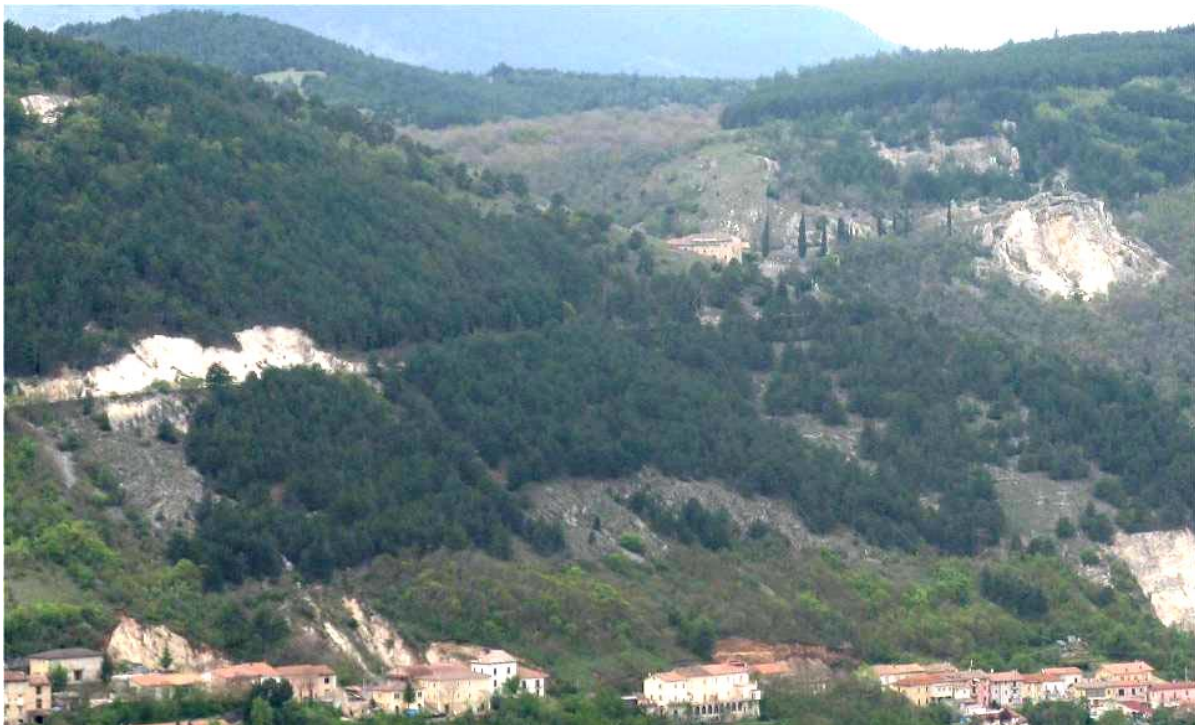
Figure 134. Slides in cataclasites along the road from Fossa to S. Angelo d'Ocre. Detail of the spur on the right is in fig 5.24 (42.29694N, 13.48469E).

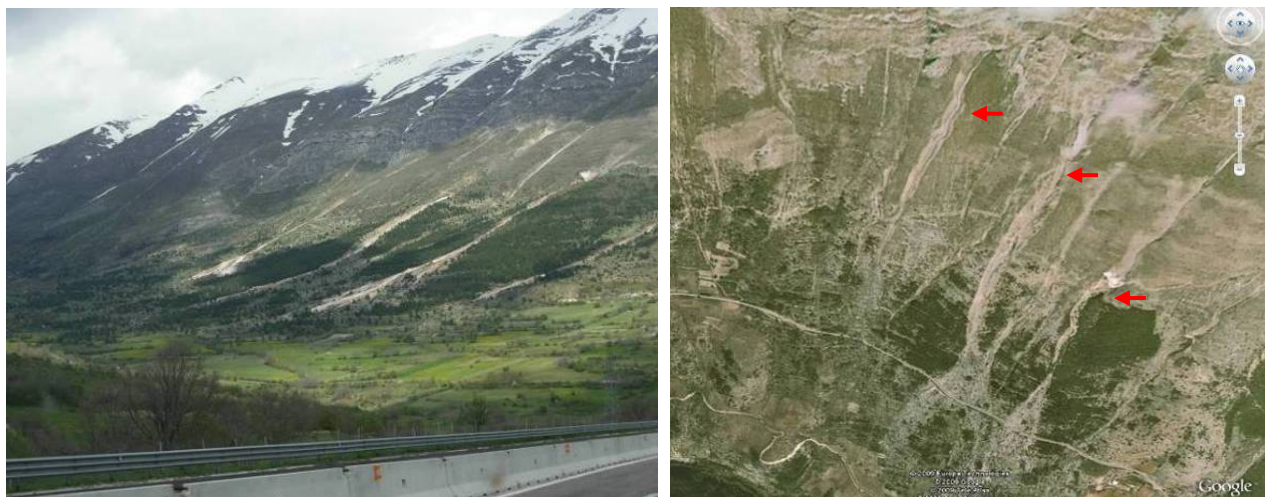
Figure 136. Left view of the Mt. San Franco flank on 4-30-2009. Right: image from Google Earth taken before the earthquake showing the debris flows (42.4368N, 13.5796E).

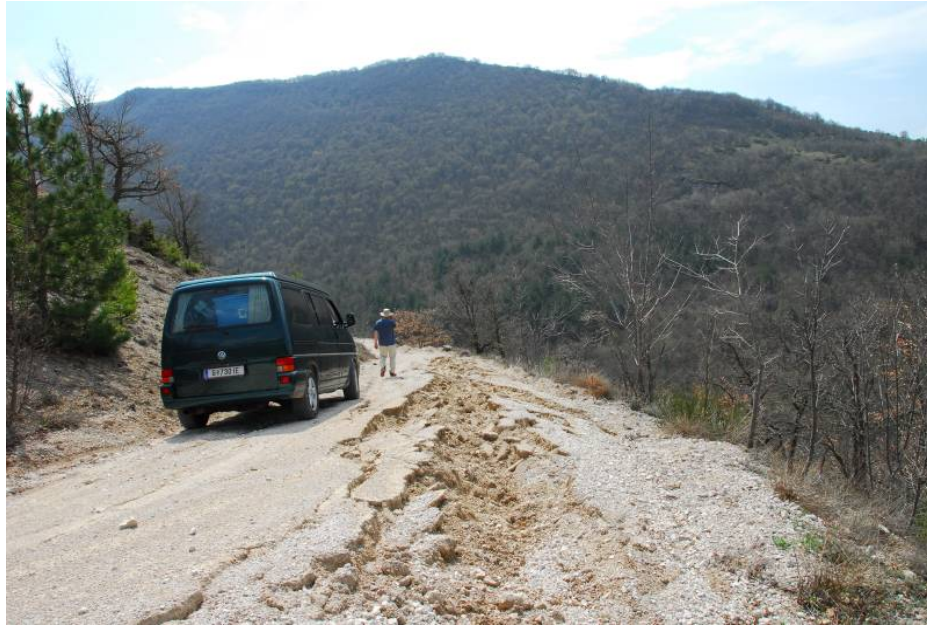
Figure 138. Failure of side-hill fill embankment (42.420N 13.376E).

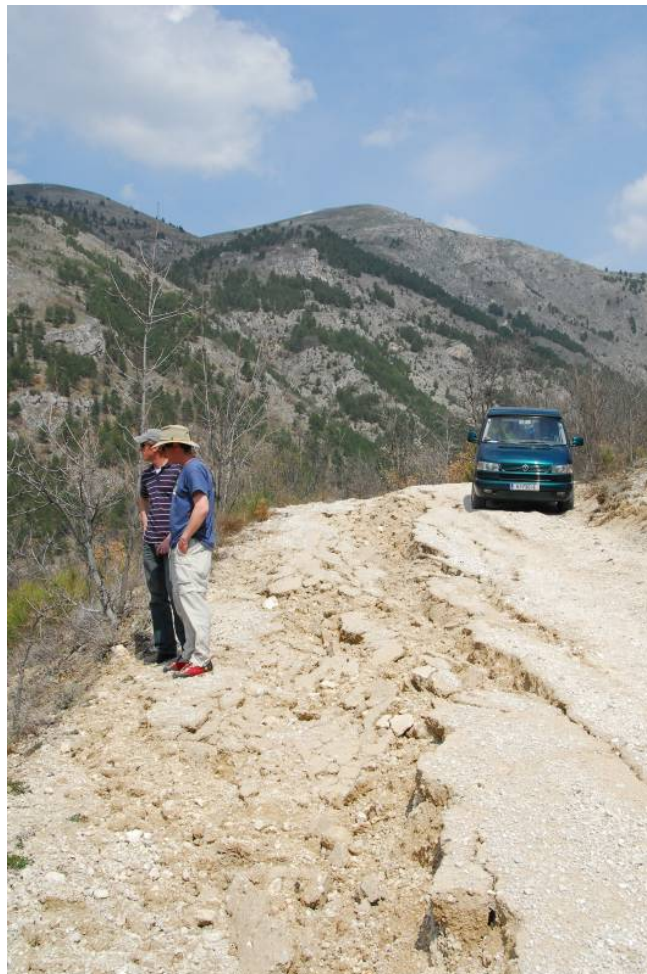
Figure 139. Failure of side-hill fill embankment (42.420N 13.376E).

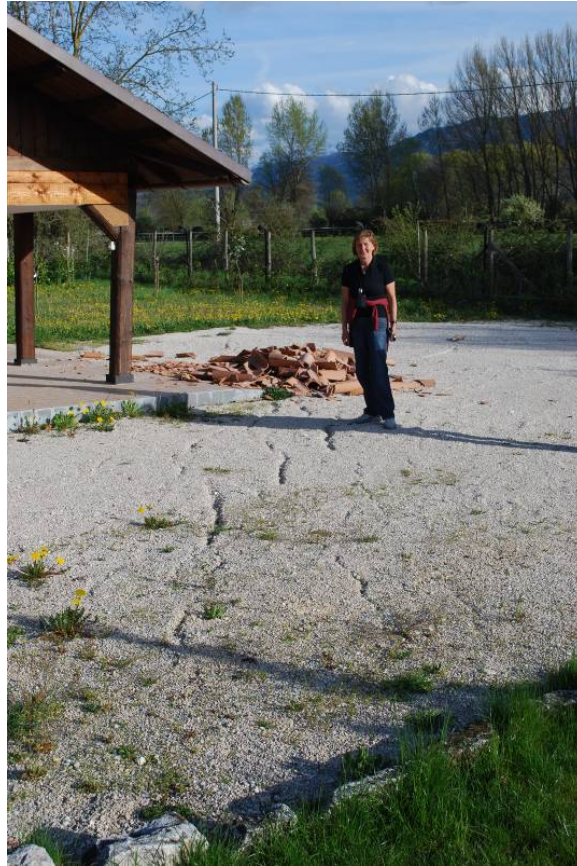
Figure 140. Ground fissures developed in alluvial floodplain directly south of central Onna and approximately 150 m from the Aterno River. Orientation of fissures is approximately parallel to the river (42.325N, 13.480E).

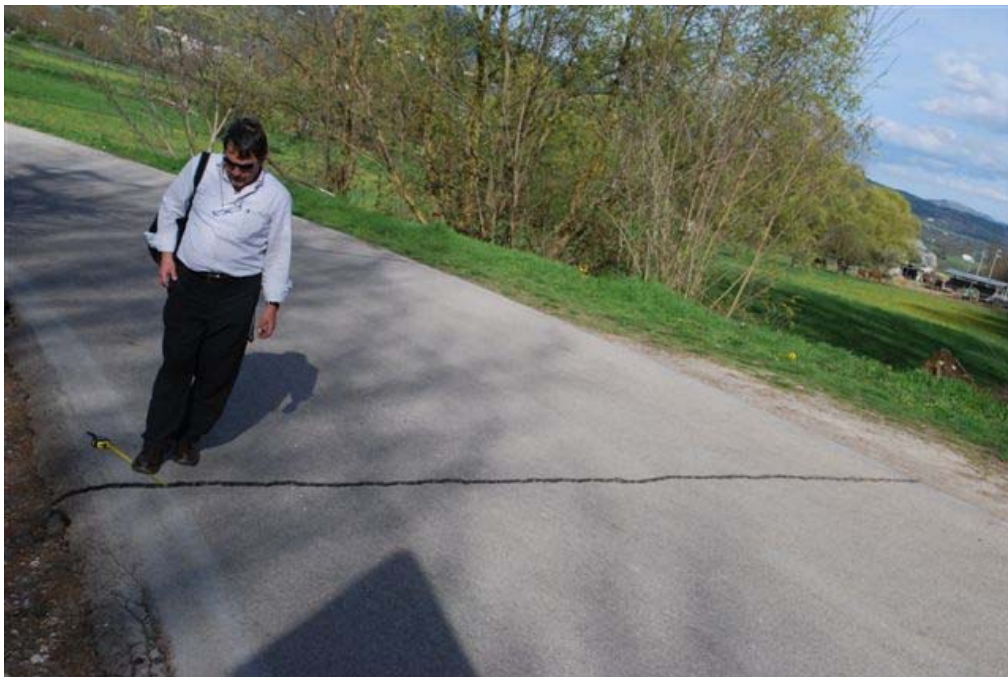
Figure 141. Characteristic crack developed in bridge approach road directly south of Onna, at distances of 15 m to 160 m from the Aterno River (42.324N, 13.478E).

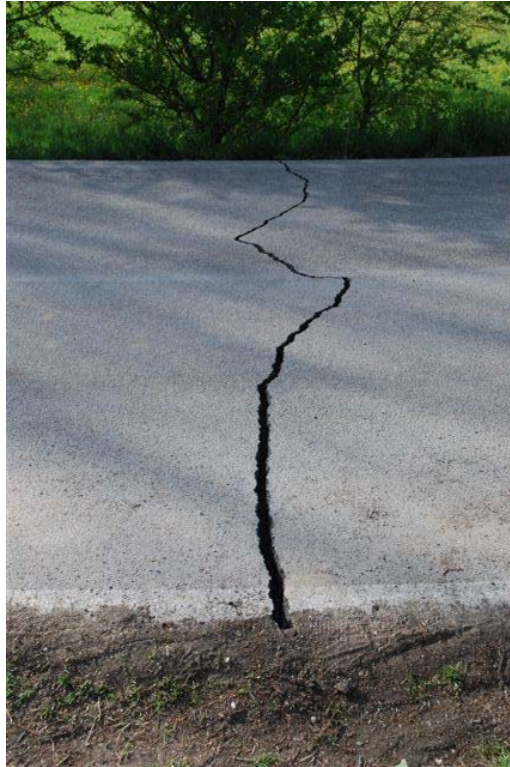
Figure 142. Typical tensile condition of road cracks, not extending into neighboring sub-base or approach fill embankment (42.324N, 13.478E).

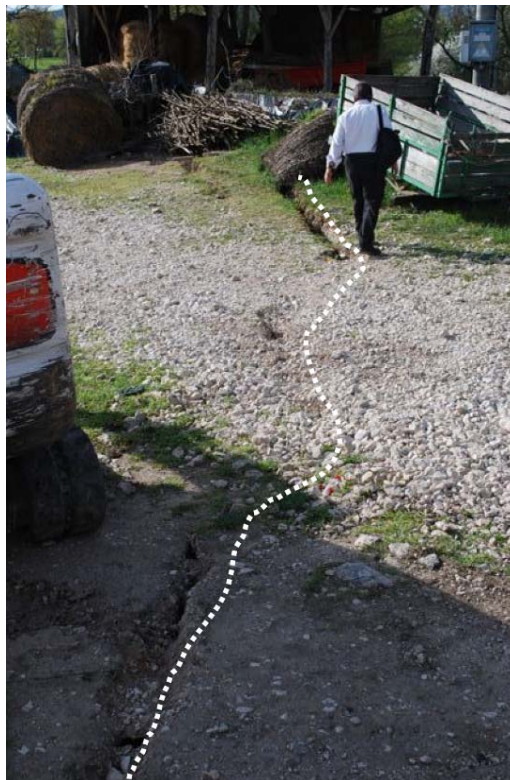
Figure 143. Ground cracks up to 1.0 m deep, 20 m long, and with maximum of 15 cm vertical displacement (down-dropped toward river) developed directly adjacent to bridge abutment (42.324N, 13.478E).

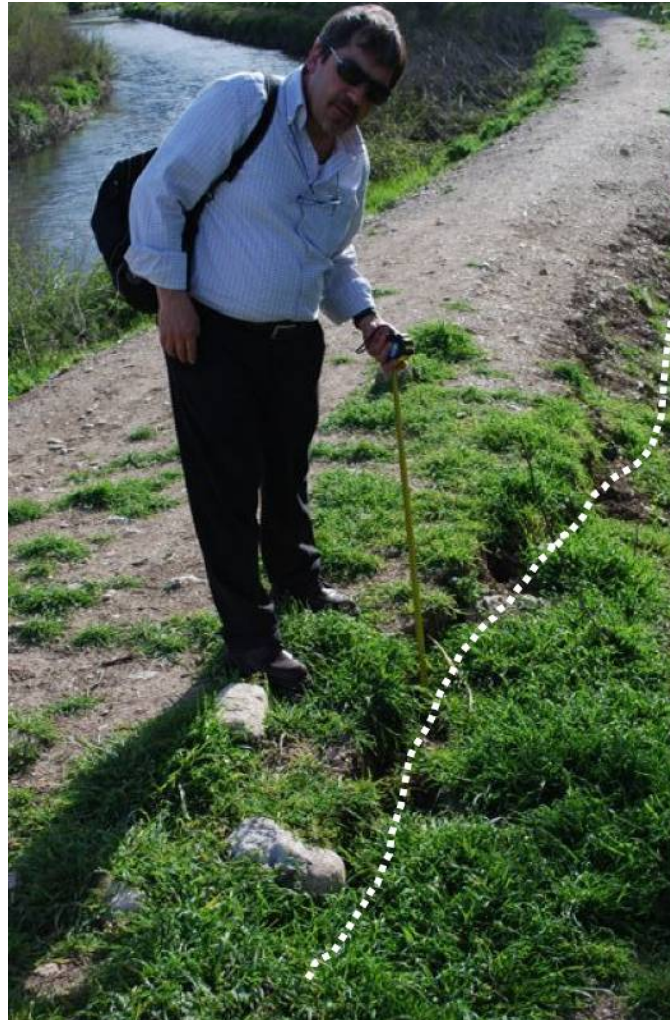
Figure 144. Ground cracks developed along levee crest adjacent to bridge abutment (42.324N, 13.478E).

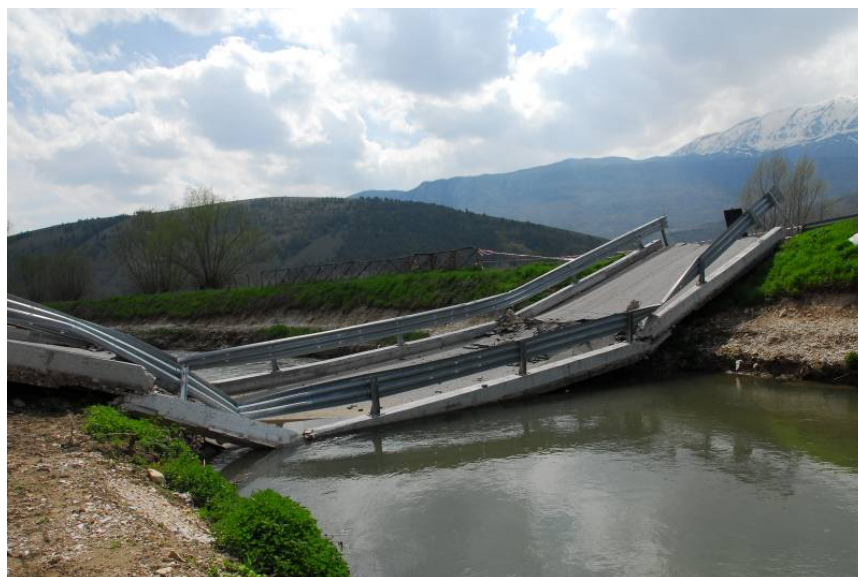
Figure 145. Bridge collapse along the Aterno River, approximately 450 m north of Monticchio (42.325N, 13.463E).

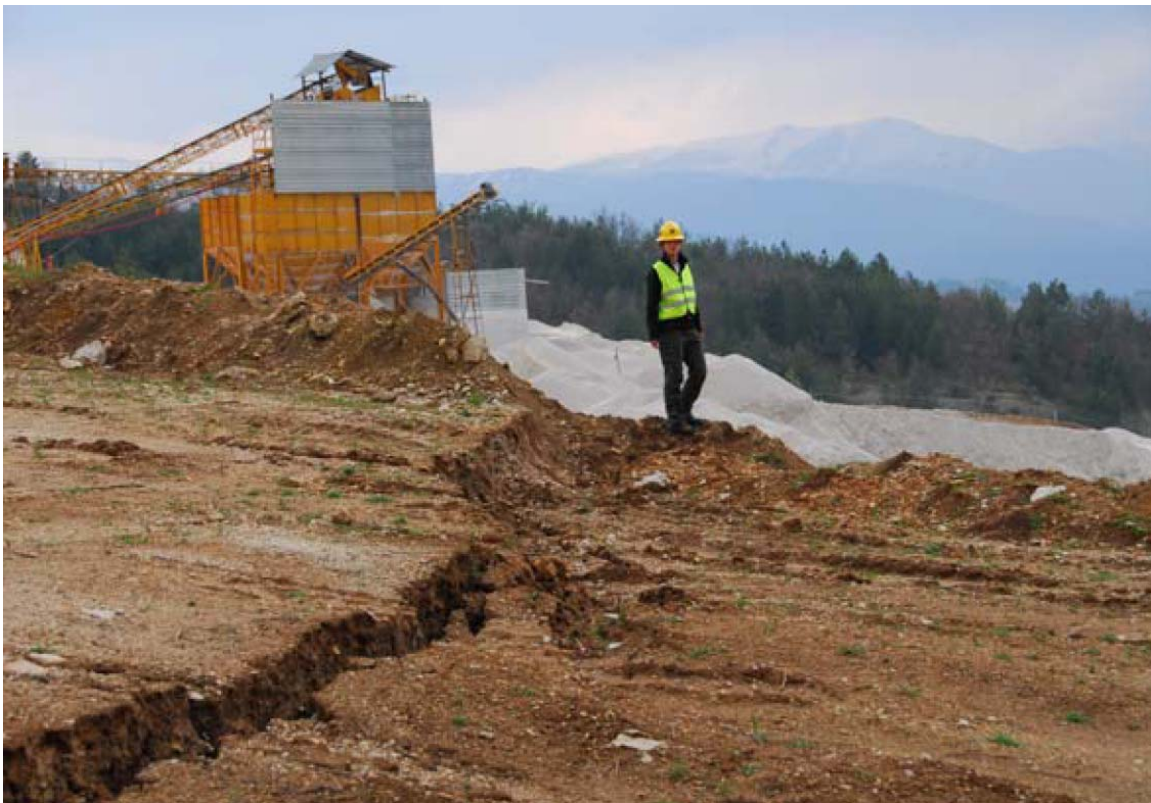
Figure 149. Shear failure developed in fill material, with vertical displacement increasing to approximately 40 cm at free slope face (42.435N, 13.330E).

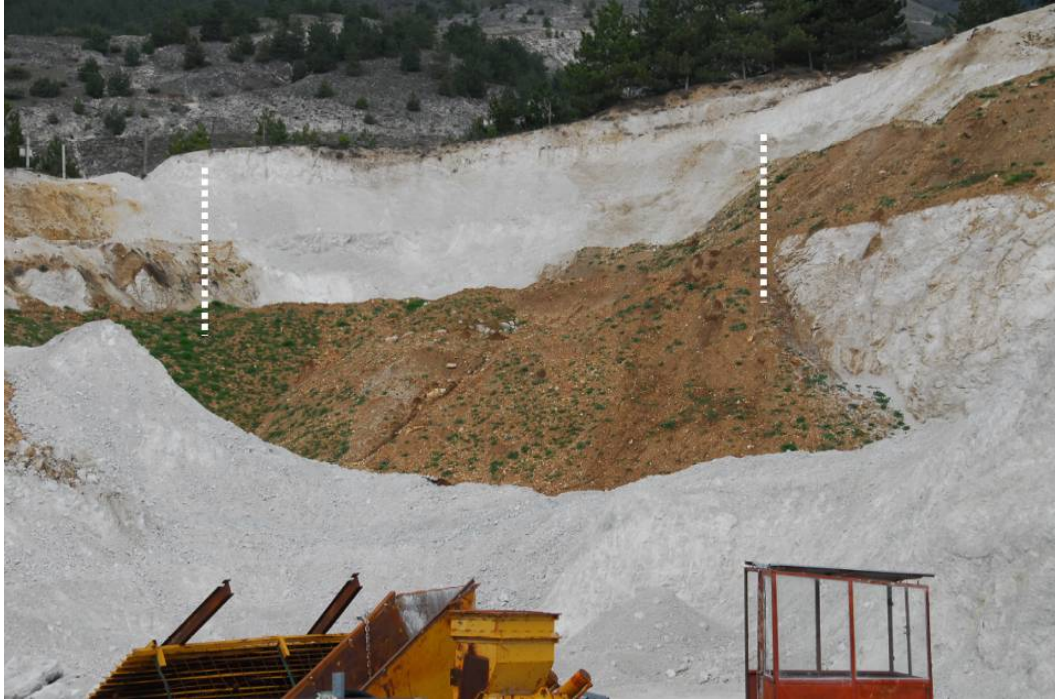
Figure 151. Graben structure (between vertical lines) and bedrock boundary conditions (42.435N, 13.330E).

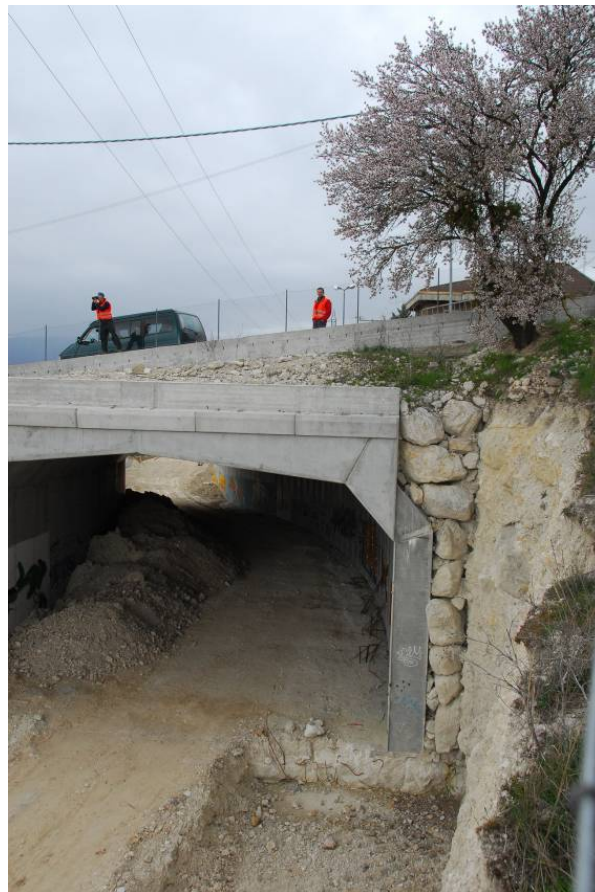
Figure 152. Boulder fill placed along side wall of cut-and-cover structure (42.358N 13.415E).

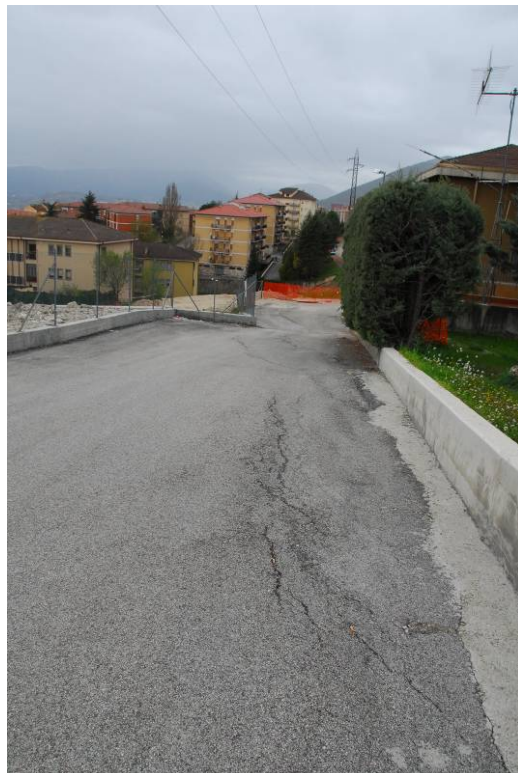
Figure 154. Cracks in the overlying asphaltic surfaces and a narrow settlement trend along the sidewall of the cut-and-cover structure (42.358N 13.415E).

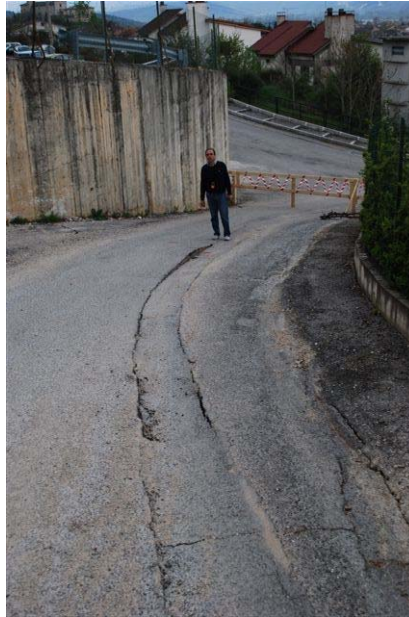
Figure 155. Seismic compression of trench backfill in the town of Paganica (42.365N, 13.465E).

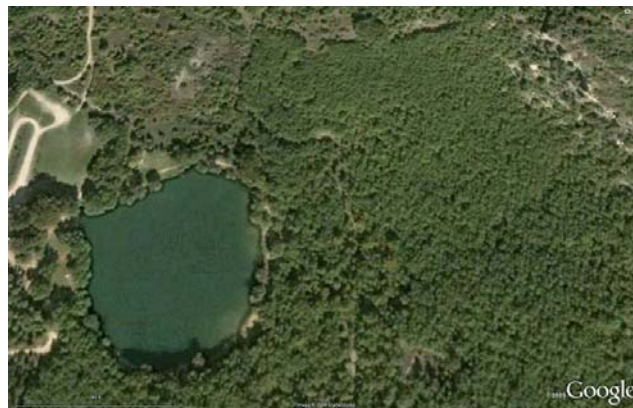
Figure 156. Overview of Lake Sinizzo with location of impounding embankment indicated by vertical white line (42.291N 13.576E).

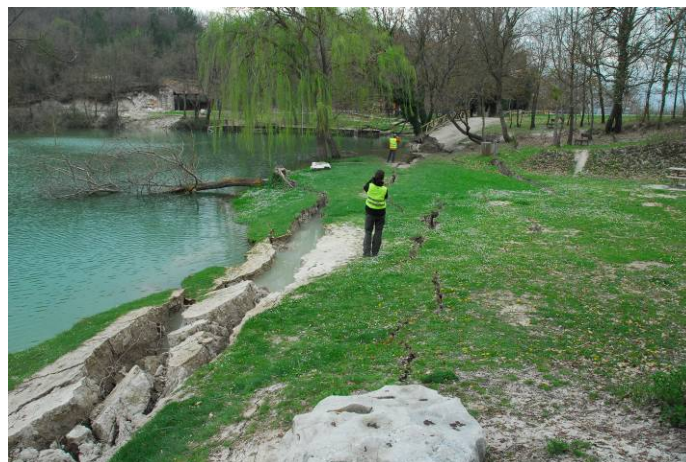
Figure 158. Ground cracks along the northwestern perimeter of Lake Sinizzo (42.291N, E13.576).

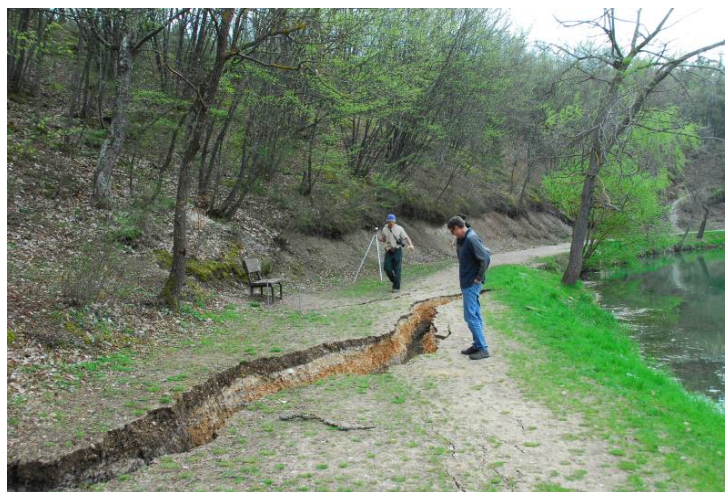
Figure 159. Ground cracks along the eastern perimeter of Lake Sinizzo (42.291N, E13.576).

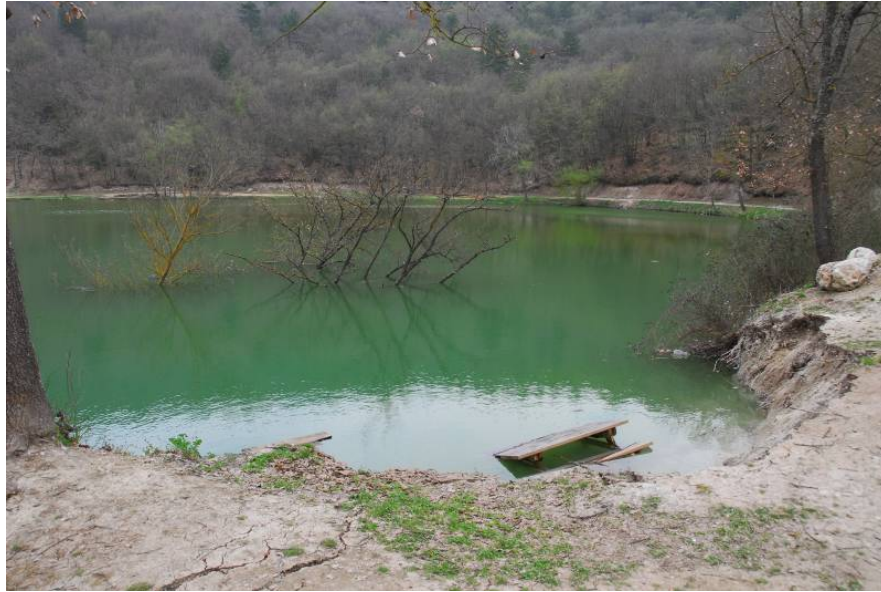
Figure 160. Submerged trees located several meters from the western margin of Lake Sinizzo; picnic table within arcuate landslide scar at shoreline. (42.291N 13.576).

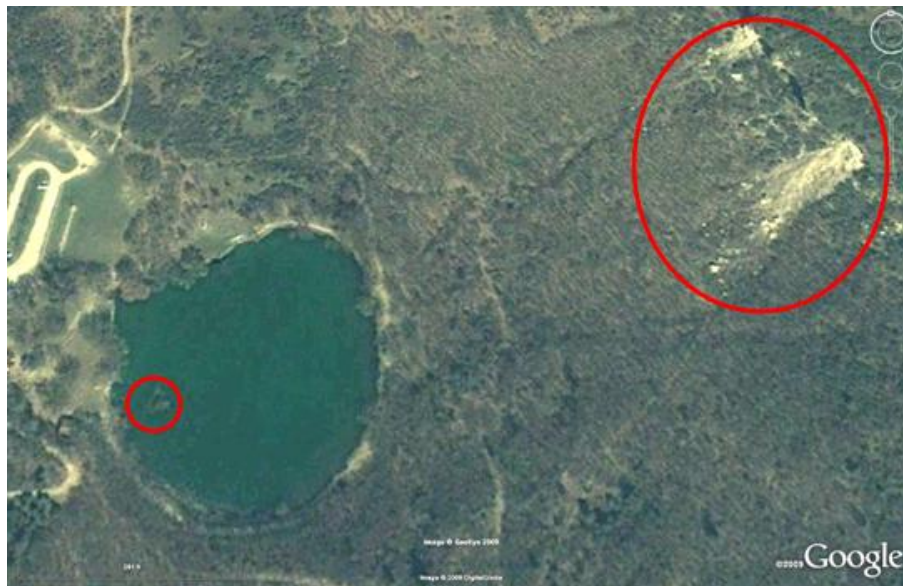
Figure 161. Post earthquake satellite imagery showing submerged trees within small circle and rock slope failures within large circle; compare to pre-earthquake imagery shown in Figure 146 (42.291N 13.576).

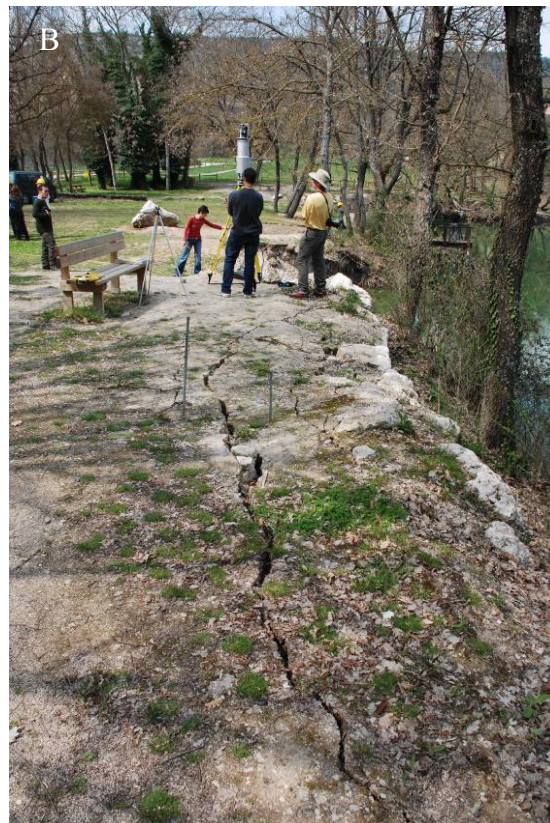
Figure 162. Ground cracks at the southwest corner of Lake Sinizzo (location WP 18) as observed on (B) 15 April 2009.

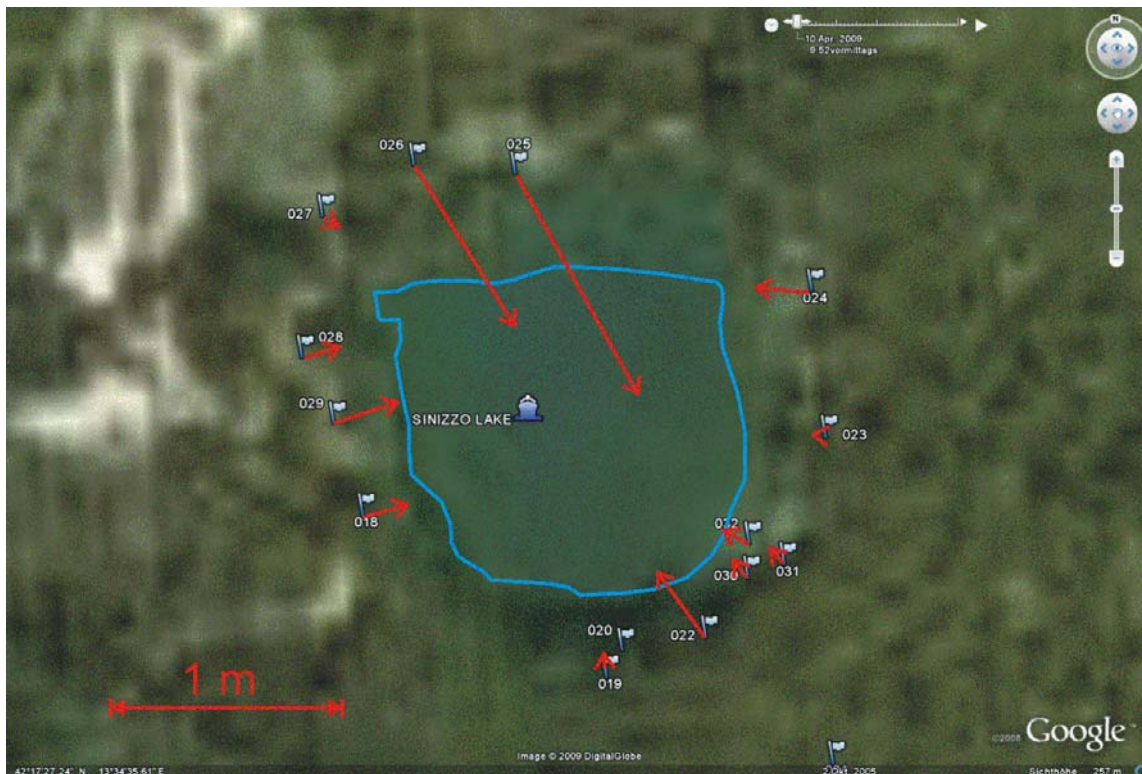
Figure 163. GPS waypoints indicating measurement locations around Lake Sinizzo. The red arrows indicate the orientation and maximum cumulative crack opening measured at each location.

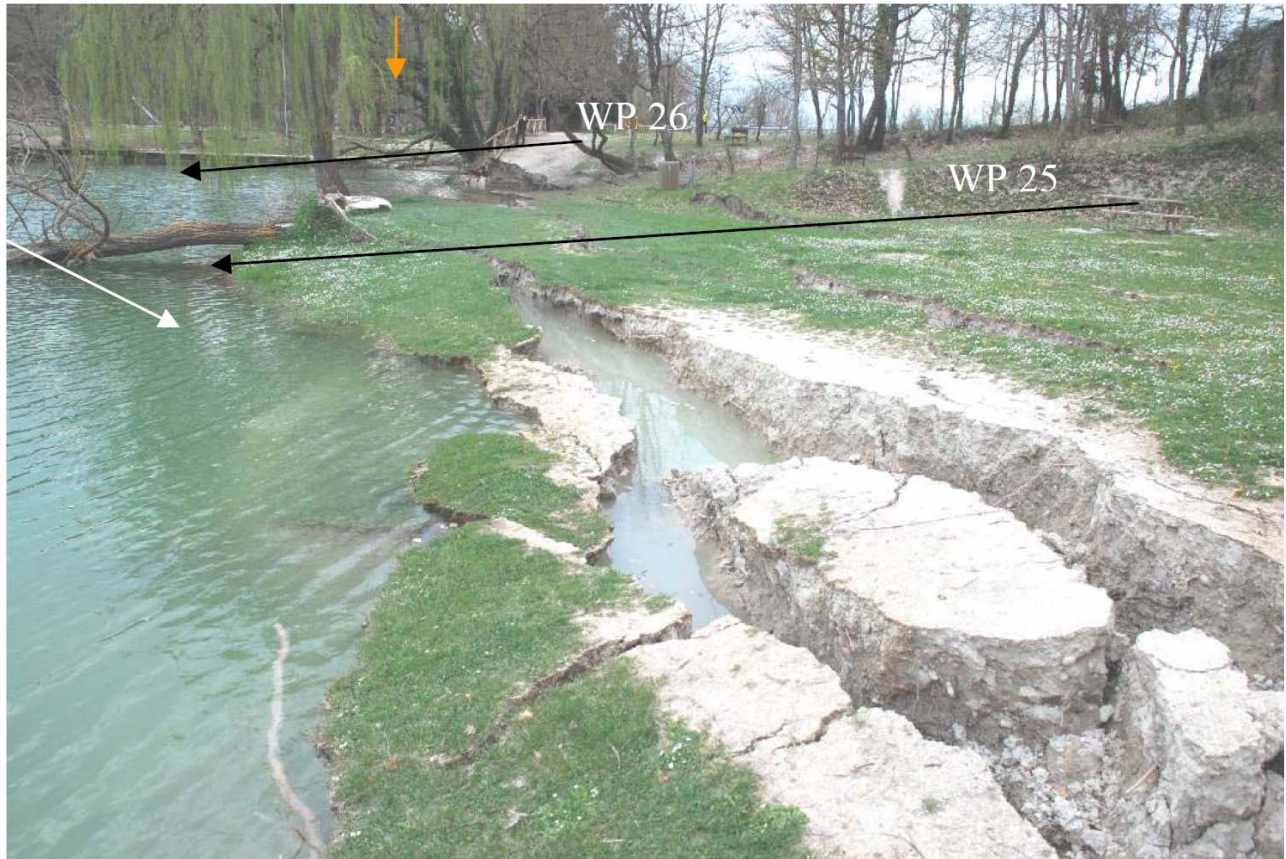
Figure 164. Blocks lying under the water (white arrow) were not included in the traverses (WP 25 and WP26). The orange arrow shows where the fence (and the slump below it) truncated the traverse at WP 27. (Photo E. Button).

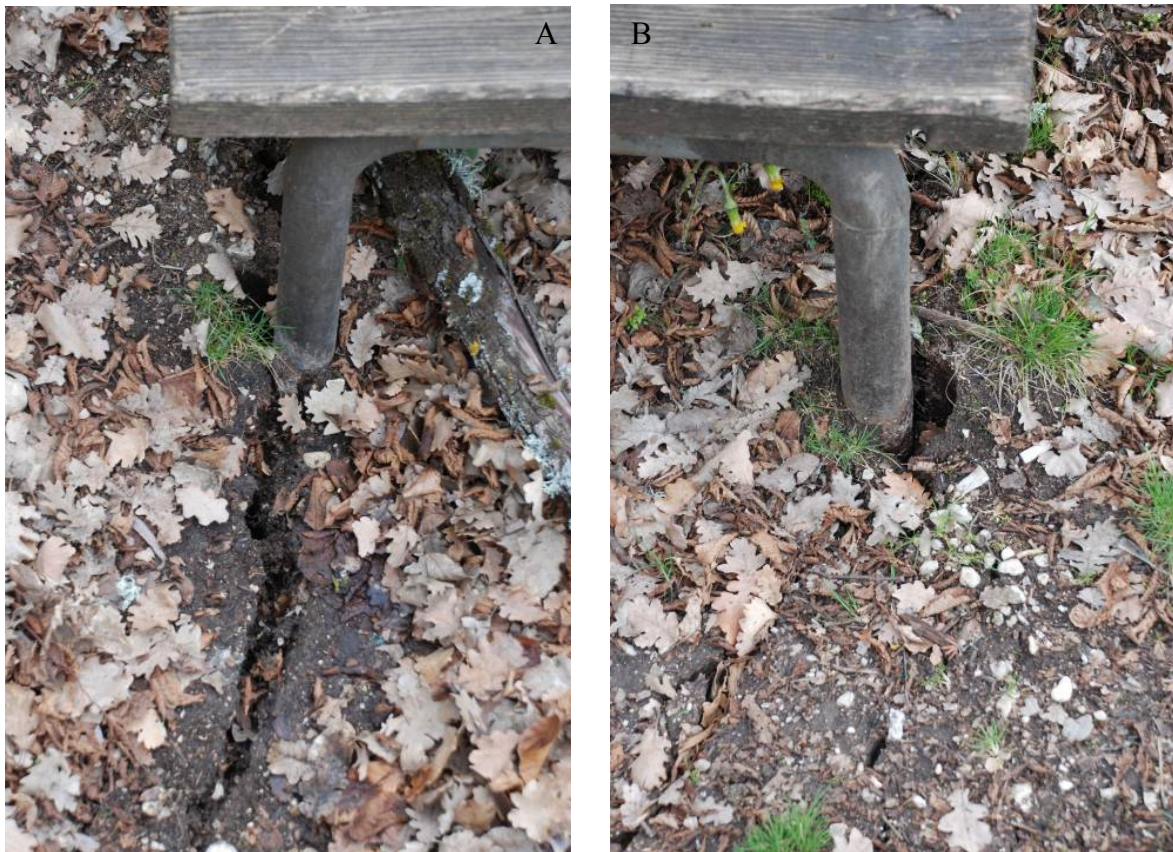
Figure 167. Characteristic deformations associated with the corners of the park bench at WP 31. (A) corner C2, (B) corner C3.
