Seismological and geotechnical aspects of the $M_w=6.3$ L'Aquila earthquake in central Italy on 6 April 2009

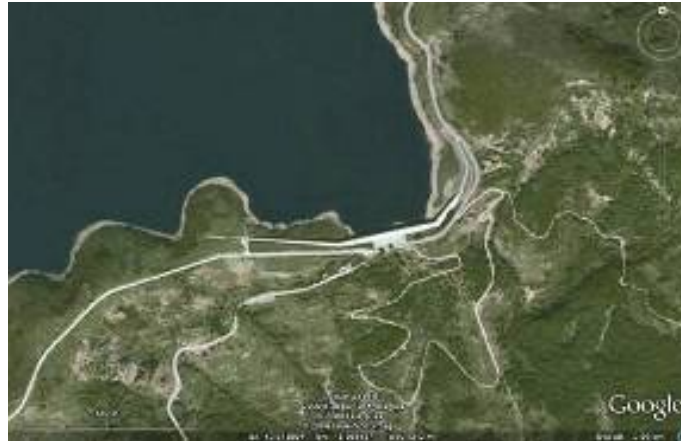
Concrete Dam Cross Section

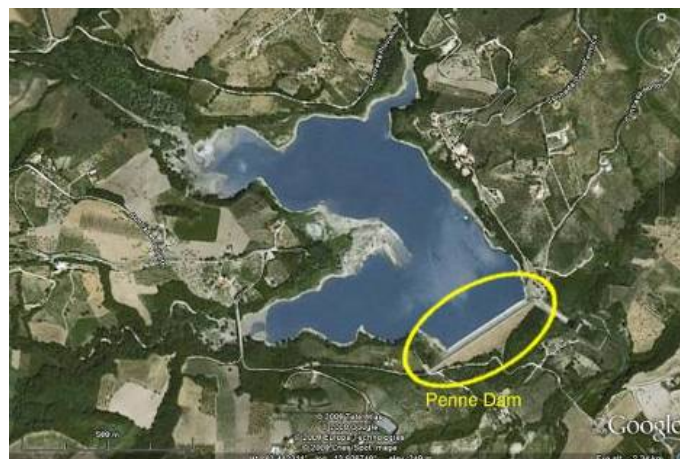
Figure 184. Location map for Penne reservoir and dam (42.438809°N, 13.913265°E).

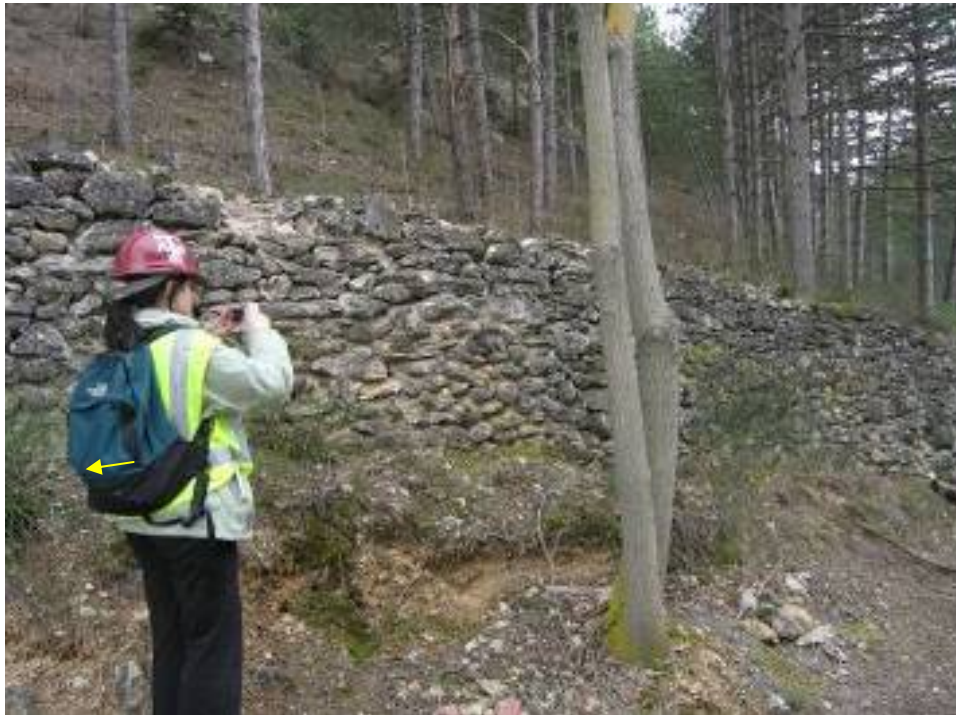
Figure 185. Minor damage on masonry wall in severely shaken Pettino area (42.374011°N, 13.367498°E).

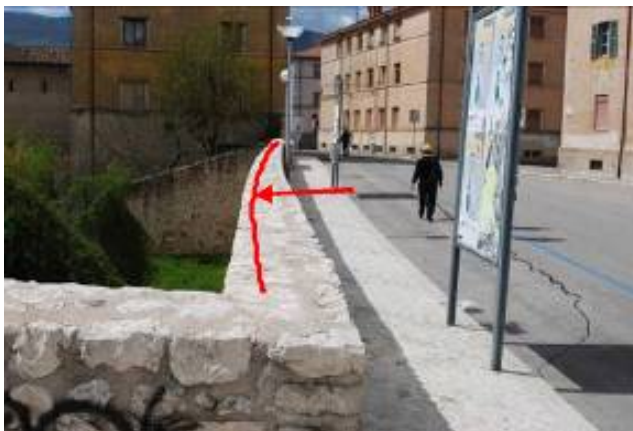
Figure 186. Stone masonry wall at L'Aquila city (42.348710°N, 13.403900°E). Note the (tolerable) outward movement at the center of the wall and the pavement cracks behind the wall.

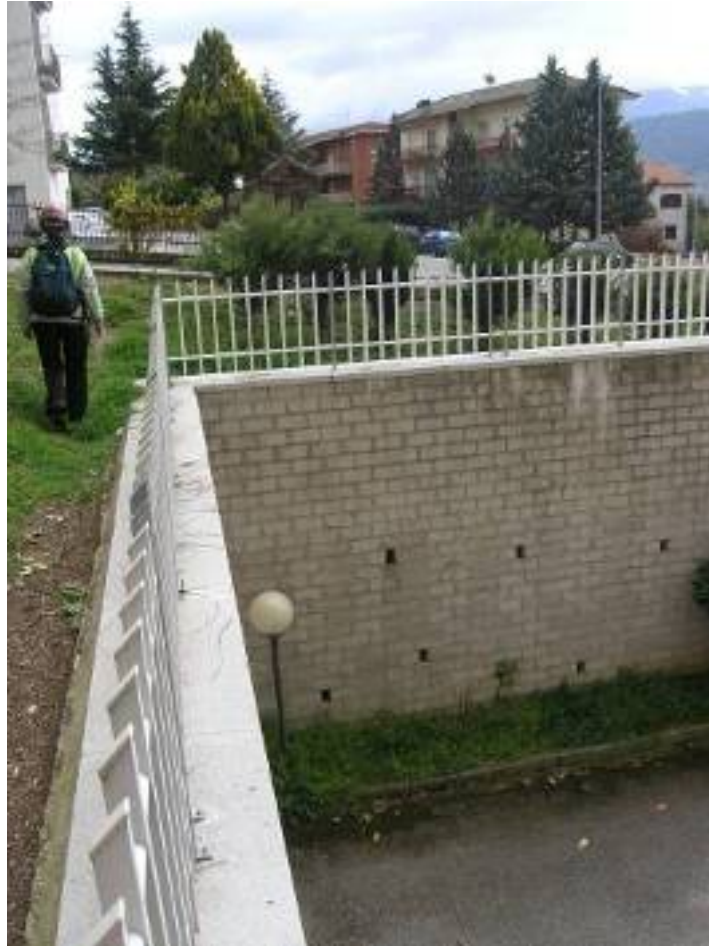
Figure 187. Undamaged wall at the severely shaken Pettino area (42.373050°N, 13.366106°E).

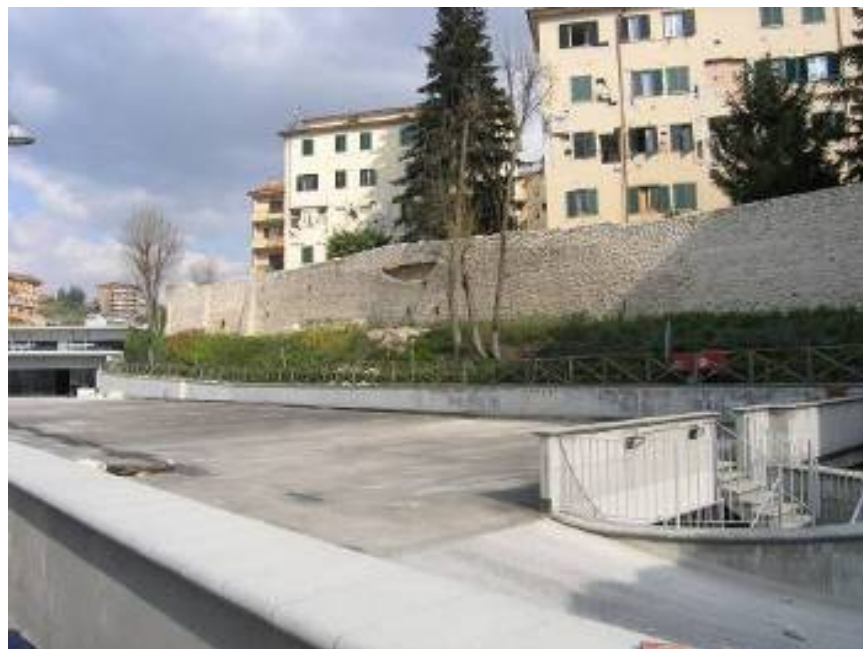
Figure 188. Damaged wall at downtown L'Aquila (42.356056°N, 13.389524°E).

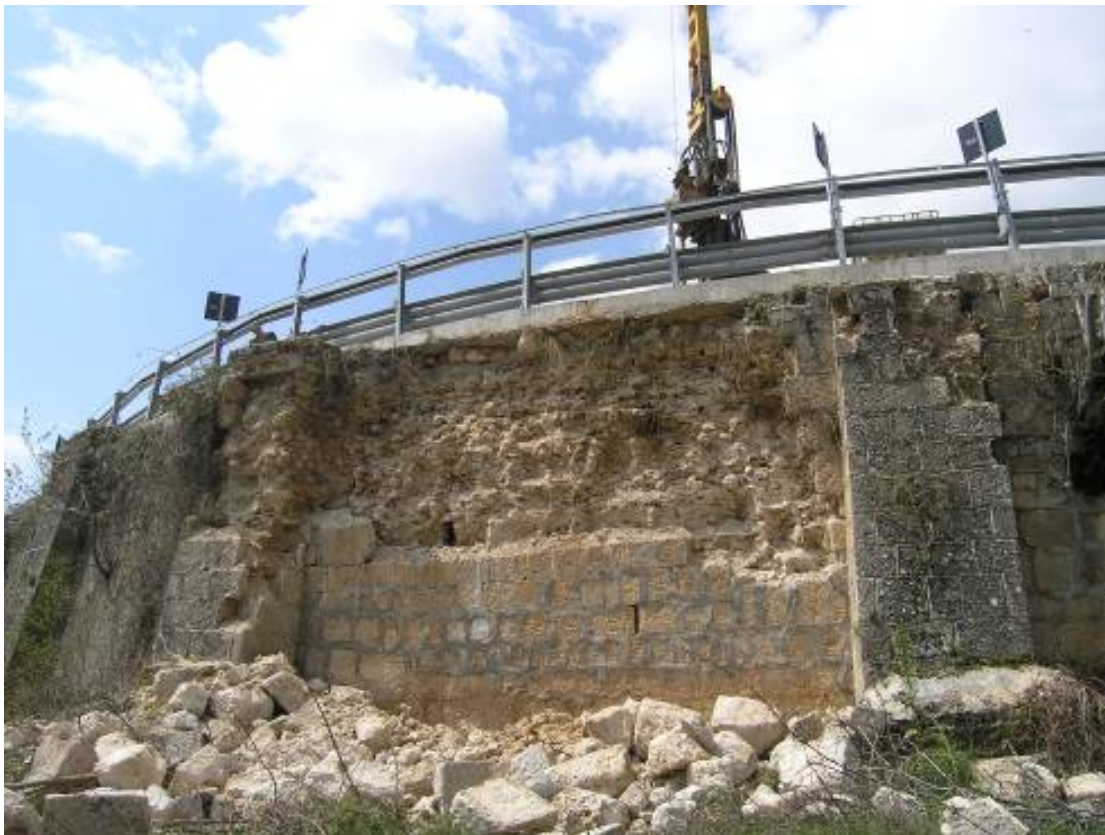
Figure 189. Partially collapsed wall at SS80 highway between L'Aquila and Campotosto ($42.420510^{\circ}\text{N}$, $13.358394^{\circ}\text{E}$).

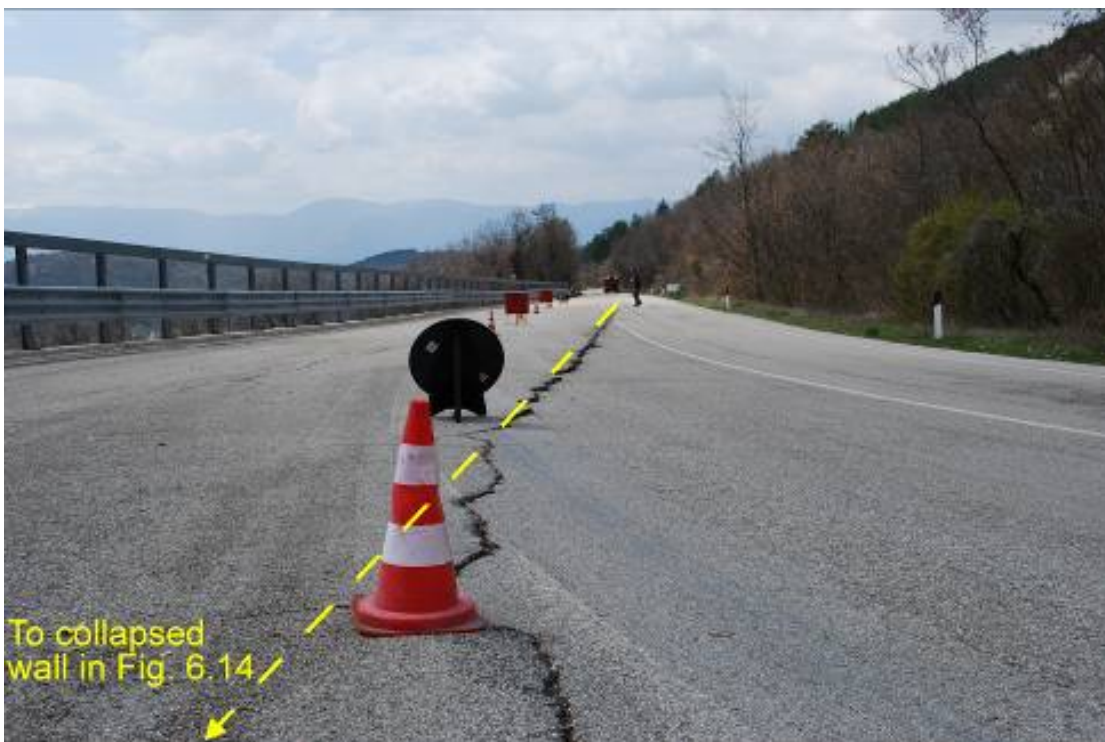
Figure 190. Pavement cracking in SS80 roadway (from L'Aquila to Campotosto) in the location of collapsed masonry retaining wall ($42.420510^{\circ}\text{N}$, $13.358394^{\circ}\text{E}$).

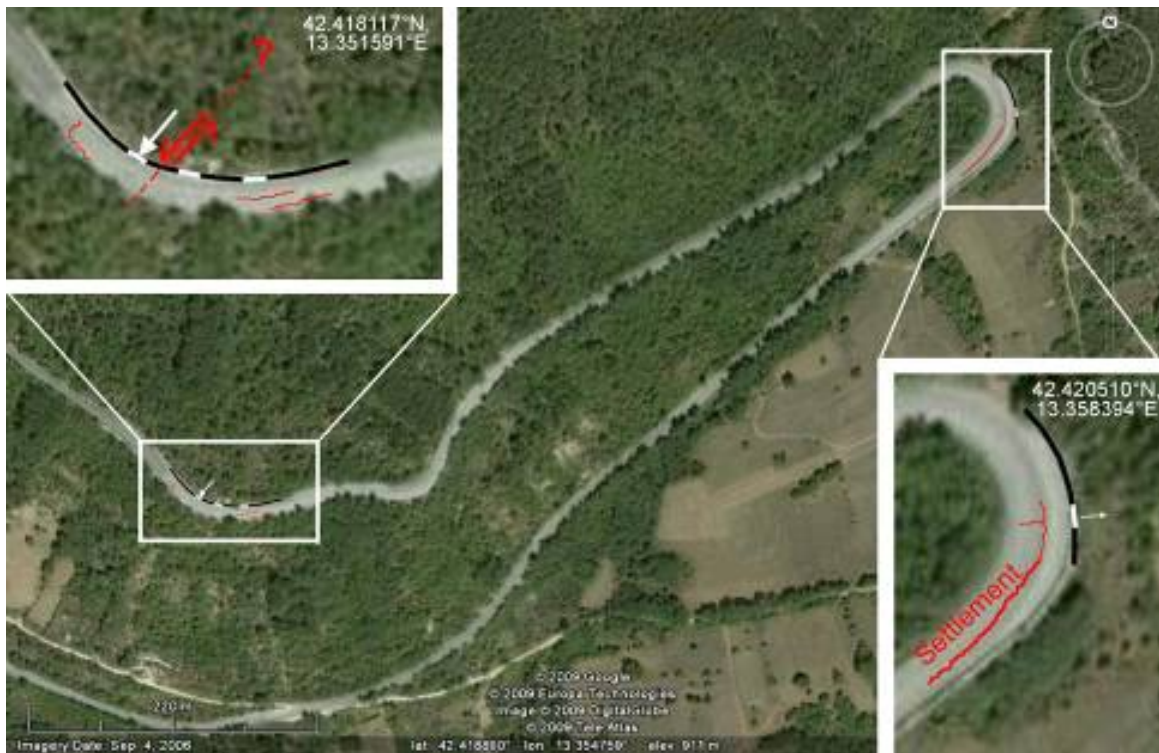
Figure 191. Locations of observed pavement cracking and associated retaining wall failures.

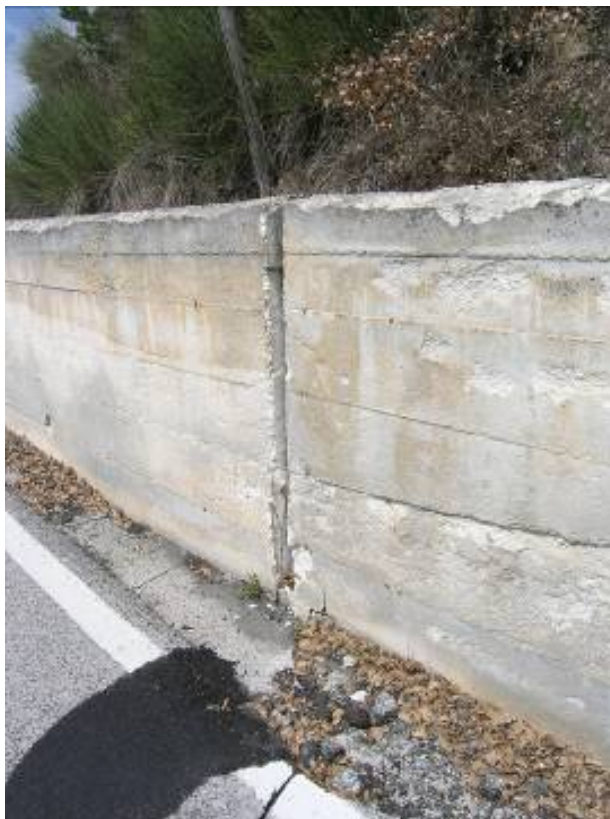
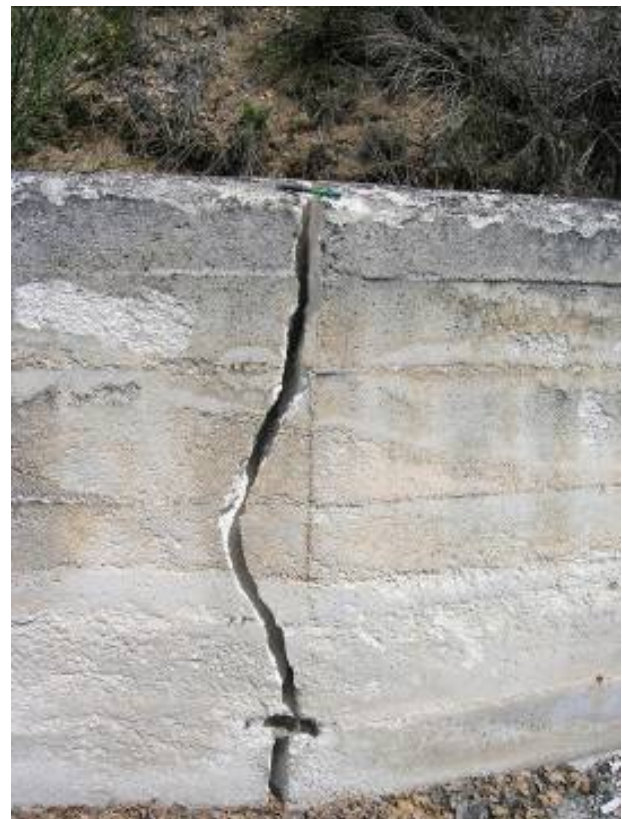
Figure 192. Ruptured retaining wall due to slope instability at SS80 highway between L'Aquila and Campotosto (42.418117°N, 13.351591°E).

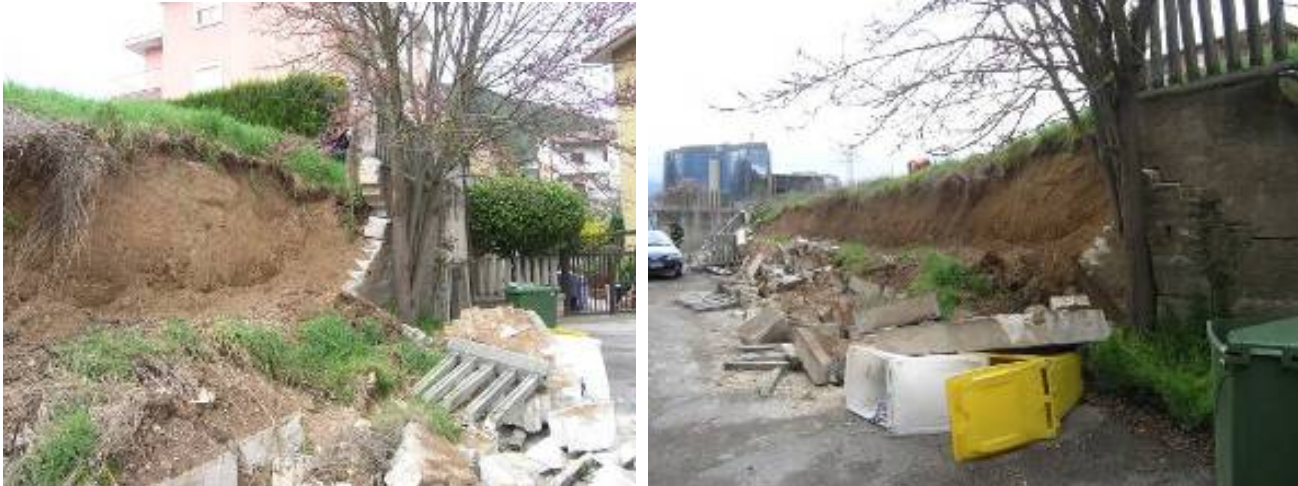
Figure 193. Toppling of masonry retaining wall at the outskirts of L'Aquila (42.366803°N, 13.376561°E).
